Client: **Greyfriars Parochial Church Council,**  
c/o JBKSArchitect,  
Suite 1 Parkwood Stud, London Road, Aston Rowant,  
Oxfordshire, OX49 5SP. Tel 01844 350101.  
[architects@jbks.co.uk](mailto:architects@jbks.co.uk). [www.jbks.co.uk](http://www.jbks.co.uk)

Site: **Greyfriars Church,**  
Friar Street, Reading, RG1 1EH.

Subject: **BS5837 Tree Survey** for proposed development  
Including:-

Surveyor: Jim Unwin  
Date: August 2011. Revised October 2017, Dec 2018 & 20<sup>th</sup> June 2019.

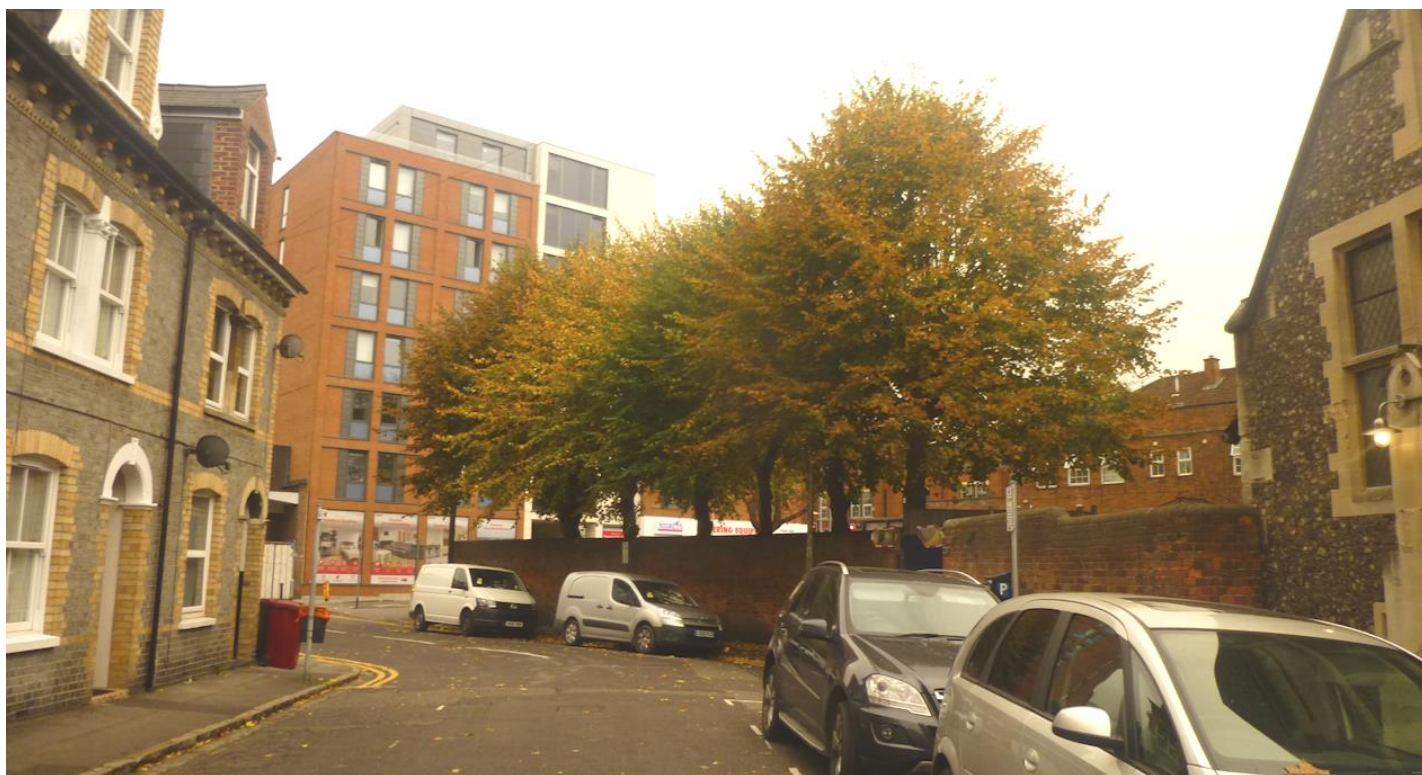
| No.<br>T=tree<br>S=shrub<br>H=hedge<br>G=group | Species | Dbh<br>(stem diam<br>@<br>1.5m<br>ht)<br>mm. | Total height. Ht<br>to base of<br>crown.<br>Est Ht in<br>10 yrs.<br>m. | | | Crown radii m. | | | | Age class | Health | Structural Condition | SULE | Comment<br>(All are in average to good health<br>and condition, unless stated<br>otherwise.) | Retention category<br>A (best) to C; U = (remove)<br>Sub-category 1, 2 or 3 | BS 5837 Root Protection<br>Area Radius, m. | Recommended WORK<br>excluding development. |
|---|---|---|---|---|---|---|---|---|---|---|---|---|---|---|---|---|---|
| T1 | Lime | 430 | 9 | 2.5 | 8 | 4 | 5 | 4 | 4 ext | M | F | F/P | 20-40 | Row of pollarded limes.<br>Last cut 2009/10. | B2 | 5.2 | Re-pollard 2019/20. |

**P1:** View south east to pollarded limes T1-T6.

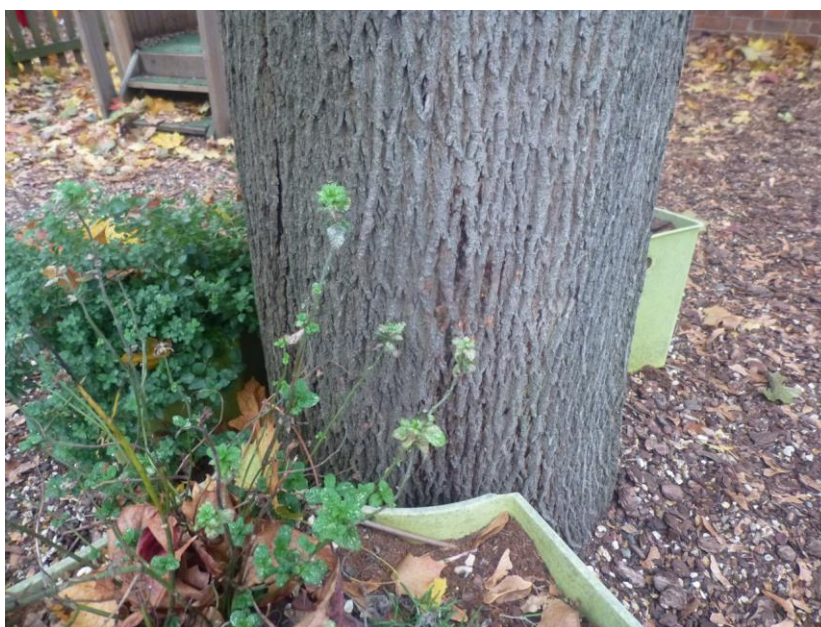
| T8 | Norway maple | 460 | 12 | 3 | 14 | 5 | 5 | 5 | 5 | M | P | F | 10-20 | Reduced, last time 2009/10.<br>Dieback.<br>Basal trunk bark death.<br>Probably rootzone damage or compaction following 2011 work. | C1 | 5.5 | Monitor condition. The whole rootzone could be aerated with Terravent air injection or radially trenched with an airspade and mulched. |

**P2:** Bleeding base of Norway maple T8. Probably construction damage to rootzone.

| T8 | Norway maple | 5.5 | Monitor condition. The whole rootzone could be aerated with Terravent air injection or radially trenched with an airspade and mulched. | |

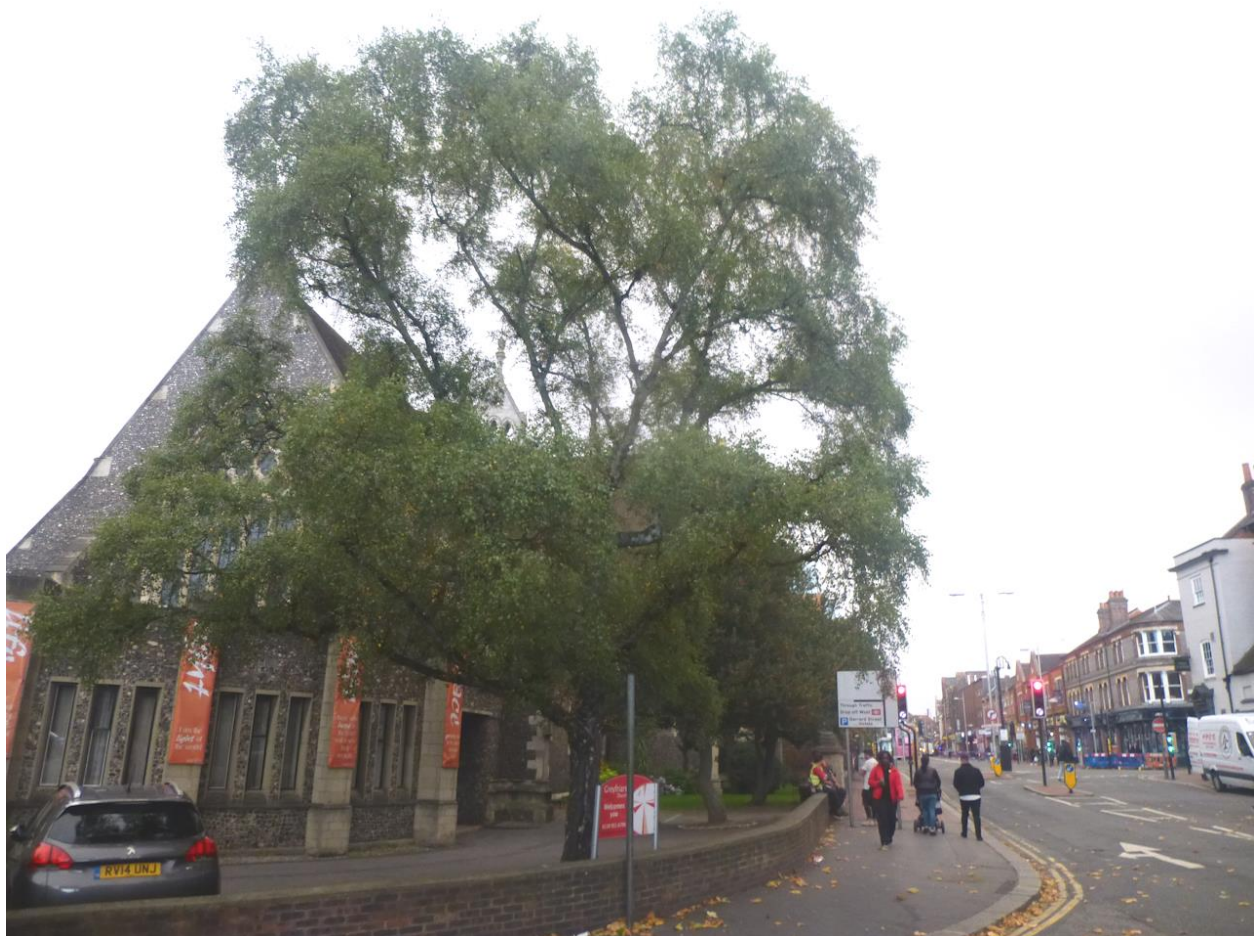
| T16 | Silver<br>birch | 430 | 10 | 2.5 | 10 | 5 | 5.5 | 4.5 | 6 | Lm | F | F | 10-<br>20 | Old tree, foliage clumped along<br>individual limbs. No real<br>change since 2011. | C1 | 5.2 | |

- Old birch T16 is close to new foyer building. It will be intolerant of any rootzone disturbance and would be dangerous to retain.
- T15 holly 28 will need its rootzone protecting from construction access. See 6.3.3 below.

**P3: View east to birch T16 close to building.**

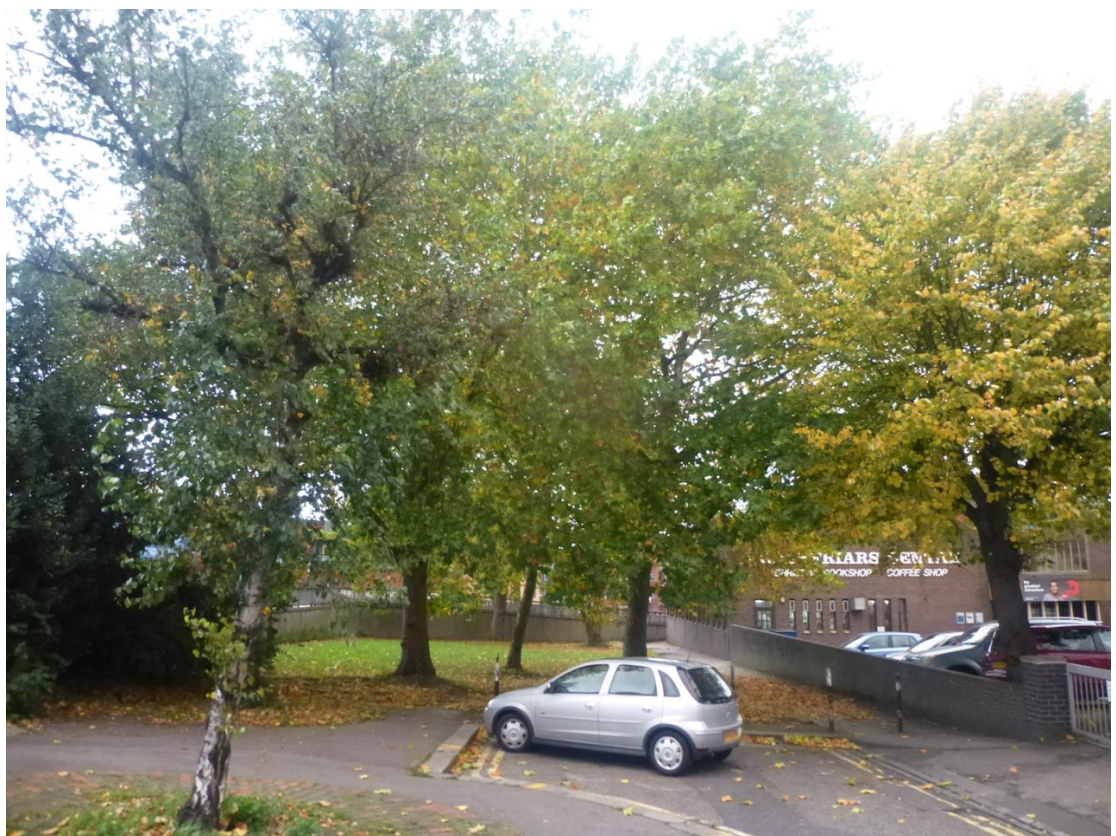
| T17 | Lime | 490 | 11 | 2 | 10 | 3 | 4 | 3.5 | 3 | M | F | P/<br>F | 20-<br>40 | High polled at 5m.<br>Last cut 2010? | B2 | 5.9 | Re-pollard 2020. |
| T18 | Silver<br>birch | 170 | 7 | 2 | 7 | 2 | 2 | 2 | 2 | Em | P | F | 10-<br>20 | Scruffy. 10% tip dieback, low<br>vitality. Planting pit may be<br>compacted? | C1 | 2.0 | |

**P4: View north to lime T17 right, birch T18 foreground, and planes beyond.**

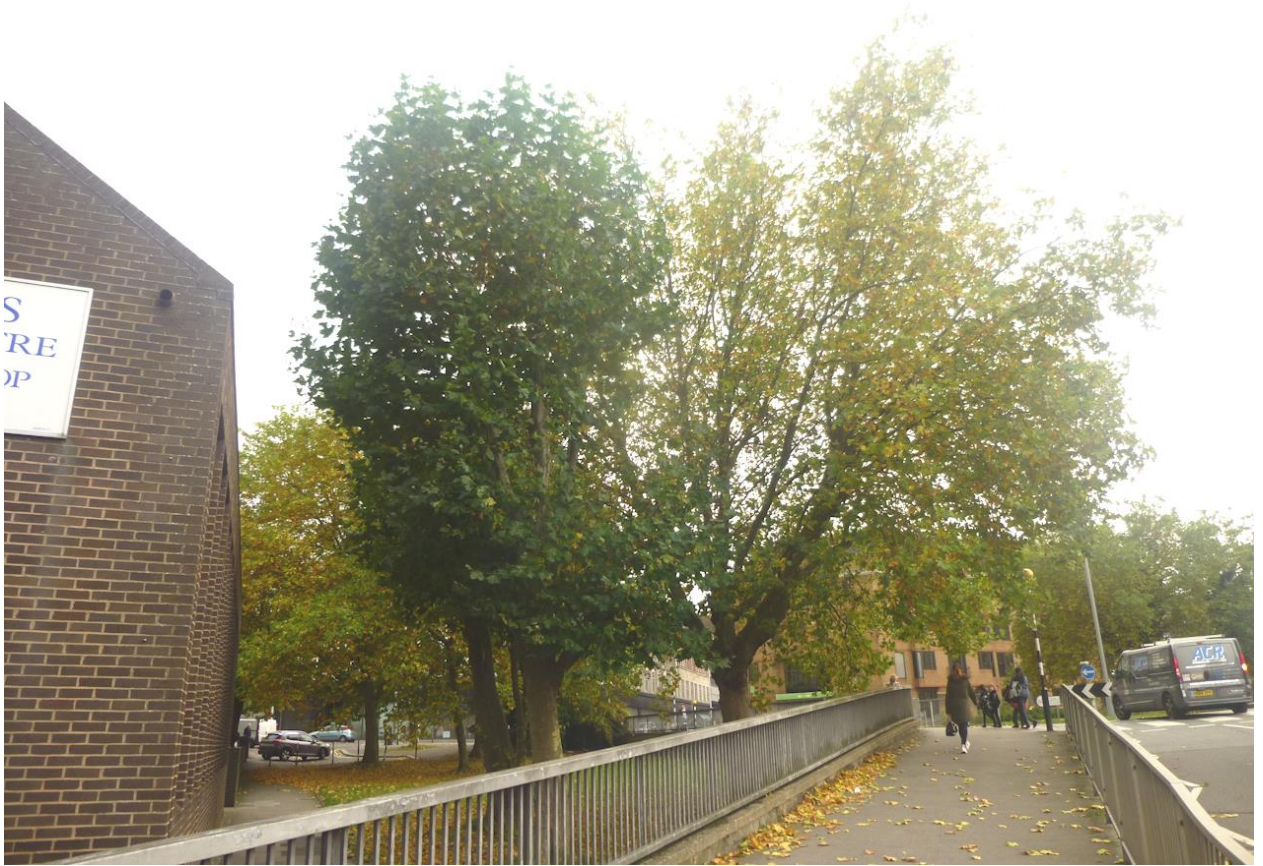
| T25 | London plane | 190, 250, 260, 430 | 8 | 4 | 10 | 1.5 | 2 | 2.5 | 1 | Sm / Em | F | P | <10 | In group of three. Pollarded 2015 at 6.5m. | C2 | 7.1 | |
| T26 | London plane | 540 | 13 | 4 | 15 | 4 | 5 | 3 | 3 | Sm / Em | F | F | >40 | In group of three. Polled at 6.5m, and 8m in 2015. Canopy resting on Church Centre roof.<br>Lifting asphalt path. | B2 | 6.5 | |

**P5: View south east to planes T26, T25 and T24 on right.**

5.7.2 Planes near the Church Centre have potential to lift lightly-loaded structures such as paths, which should be maintained to avoid resulting trip hazards.

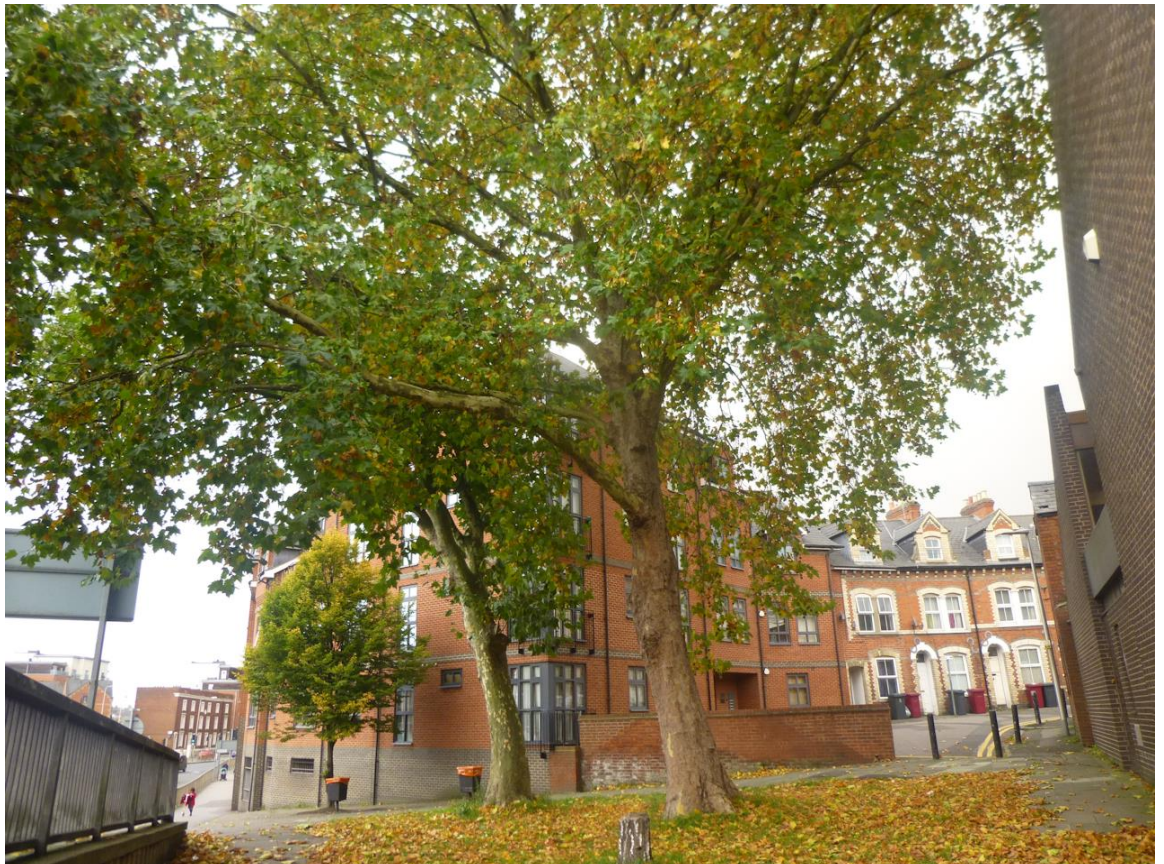
| T28 | London plane | 790 | 22 | 4 | 24 | 6 | 7 | 9 | 9 | Em | F | F | >40 | Good tree. May have been high<br>polled long ago. South side<br>close to Church Centre roof.<br>Heavy limbs over roadside<br>footway. | A1 | 9.5 | Reduce roadside limbs<br>back to railings. |
| T29 | London plane | 610 | 11 | 4 | 14 | 5 | 2 | 0 | 3 | Em | F | P/<br>F | >40* | Lean north.<br>Polled 2015.<br>* with pruning. | B2 | 7.3 | |

**P6: View east to planes T28 & T29, and hornbeam T30 left.**
