**83 Upper Woodcote Road  
Caversham  
Reading  
Berkshire  
RG4 7JR**

## **Daylight Bat Survey**

**Ref: R1892a**

**April 2018**

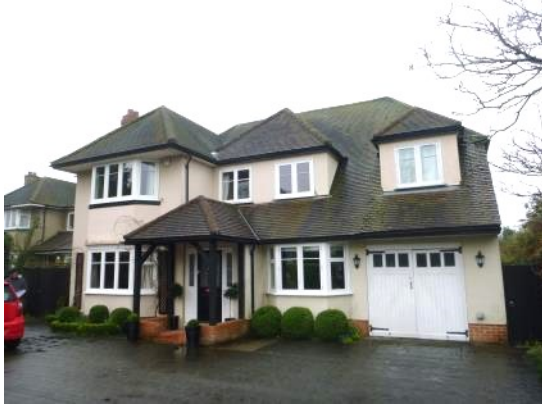
1. Front of the house viewed from the west.

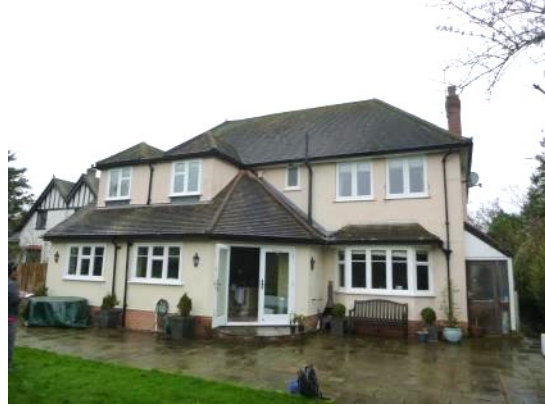
2. Rear of the house viewed from the east.

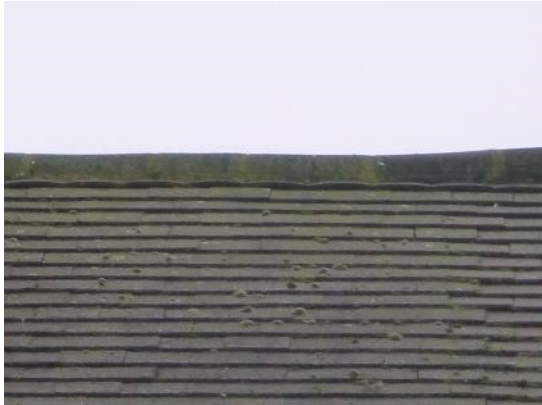
3. Row of curved roof tiles visible just below the ridge at the front of the house.

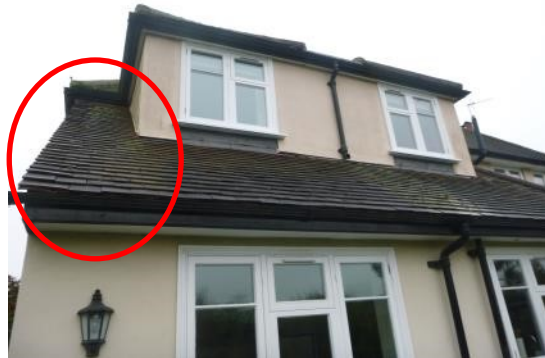
4. Lifted roof tiles towards the verge at the front of the house.

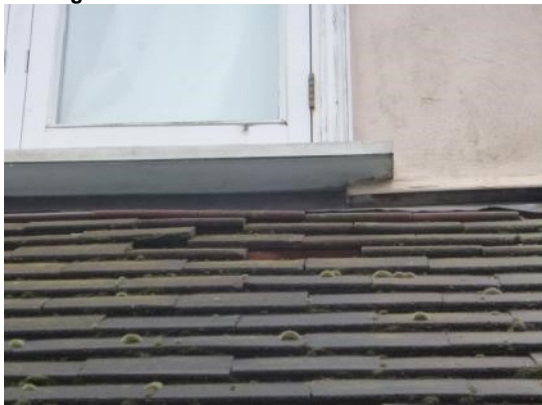
5. Missing and lifted roof tiles below the window at the front of the house.

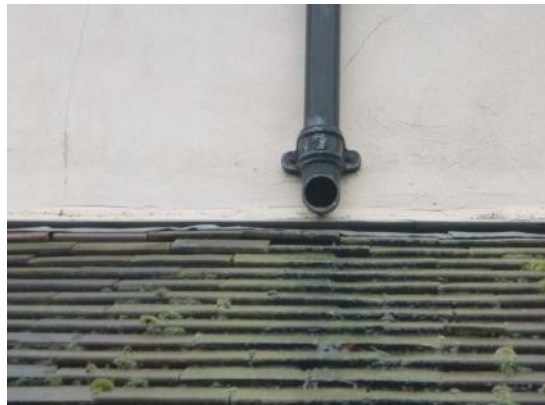
6. Missing roof tile by a pipe at the rear of the house.

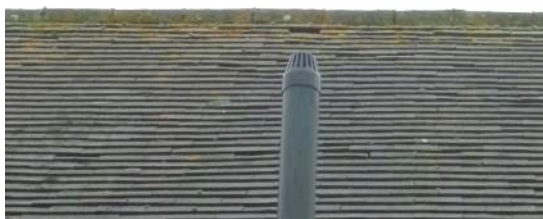
**7. Missing roof tile to the rear of the house.**

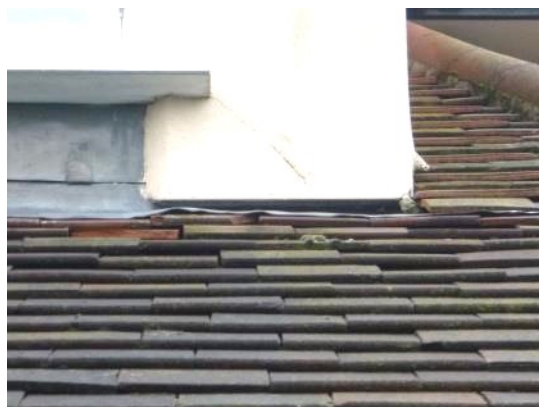
**8. Lead flashing lifted by the central window at the front of the house.**

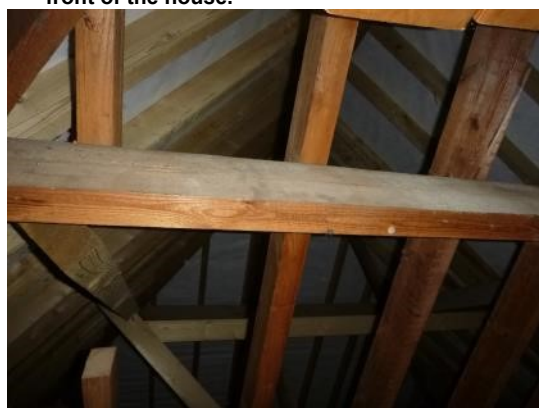
**10. Internal view of the roof space showing the junction between more modern extension and original section of the roof.**

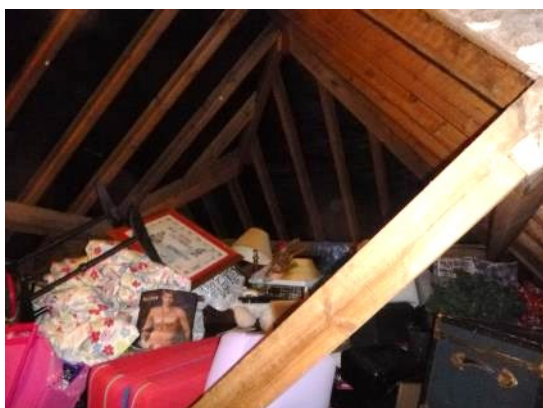
**11. The main section of the roof lined with bitumen felt.**

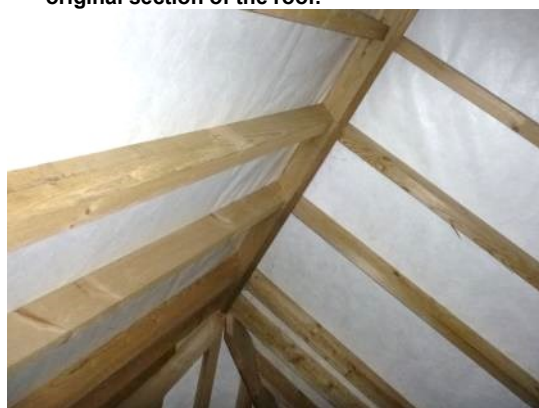
**12. The northern end of the roof space lined with breathable membrane.**

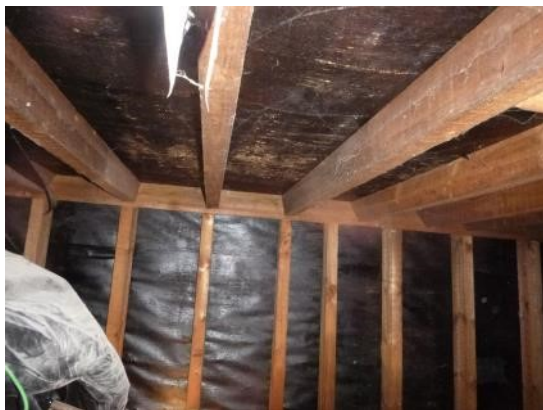
**13. The ridge lightly cobwebbed.**

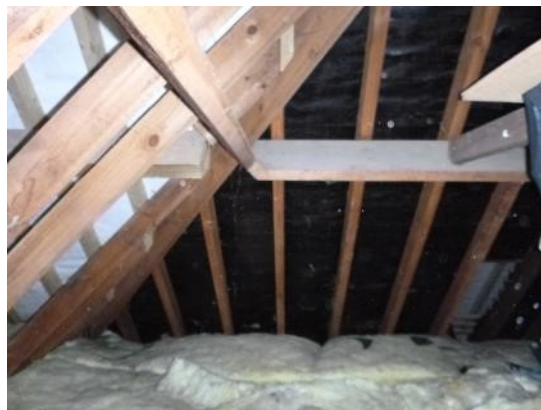
- 3.3.1** The house's roof was of traditional 'cut and pitch' construction with an exposed ridge beam and rafters (**Photograph 10**). The roof space was accessed through a loft hatch and had an estimated roof to floor height of 2.5 metres. A covered and raised water tank was present towards the centre of the roof space. The roof was mostly lined with bitumen felt, with a small, more recent extension towards the northern end, which was lined with breathable roofing membrane. The roof lining was intact and fitted tightly (**Photographs 11 & 12; Target notes 9 & 10**).
- 3.3.2** The ridge was cobwebbed lightly (**Photograph 13; Target note 11**). The floor was insulated with fibreglass insulation, which did not extend as far as the eaves, which were open to the space (**Photograph 14, Target note 12**). No evidence of bat activity was found inside the roof space.

**14. The roof space insulated with fibreglass which did not extend as far as the eaves.**

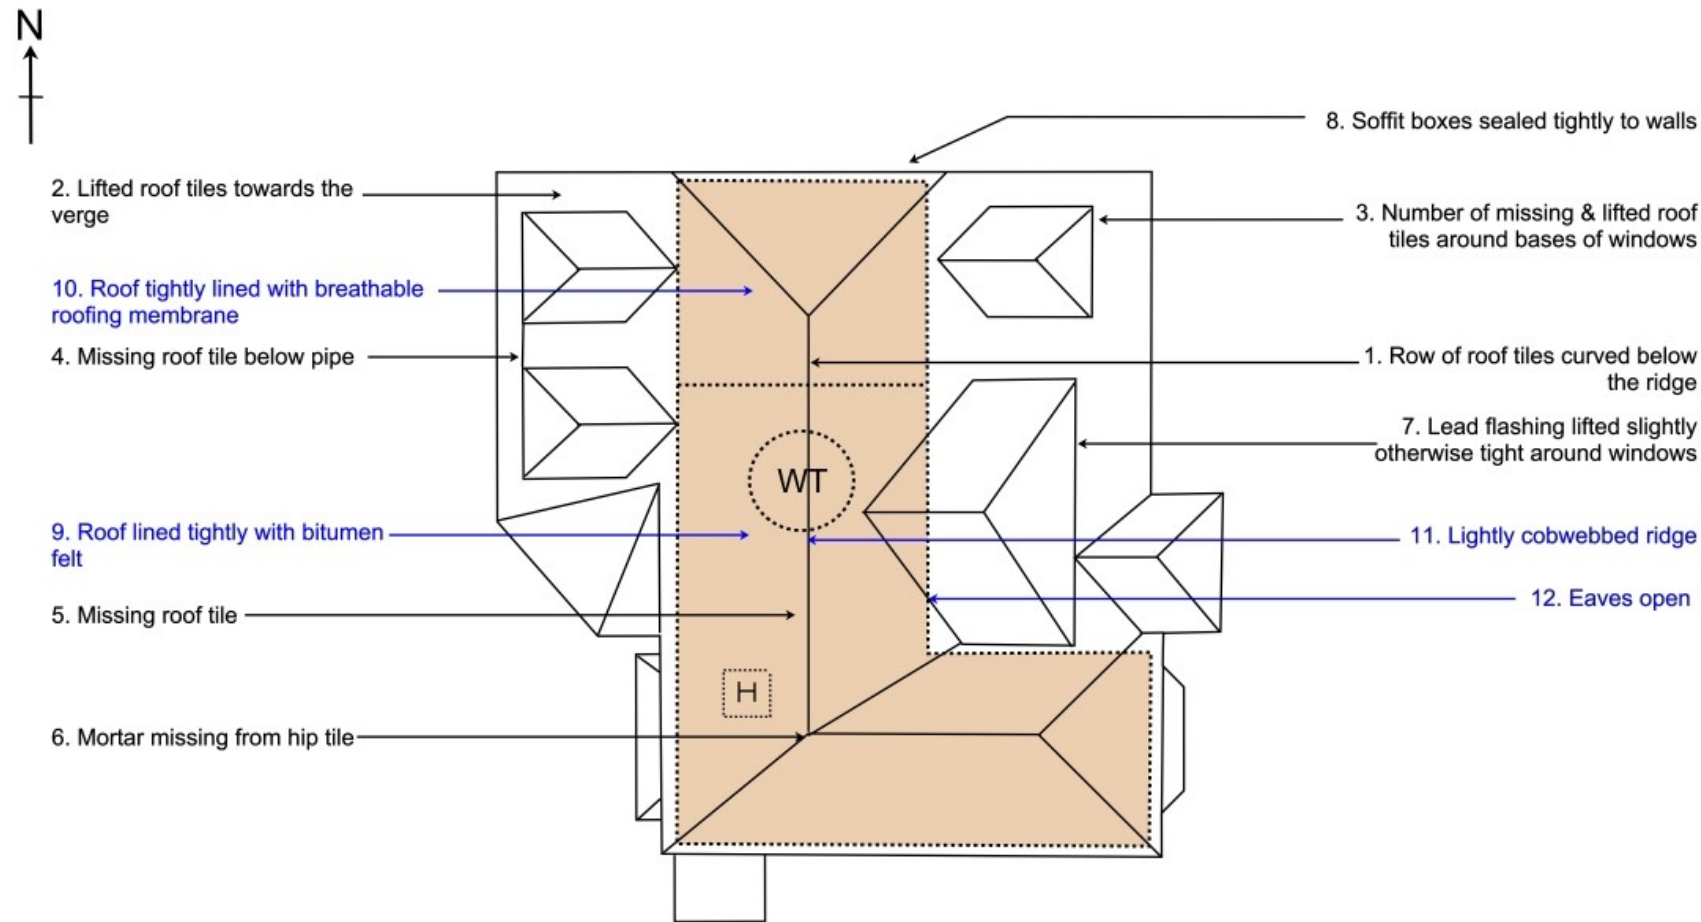
APPENDIX 2 - DAYLIGHT BAT SURVEY FINDINGS

- 3.1.1** The external and internal bat survey findings are detailed on a plan with target notes in **Appendix 2** and photographs of the site are shown in **Appendix 1**. There follows a description of the external and internal survey findings:
