88 Crescent Rd 1App Cons Area. Specification Plan Photos and Reasons (where applicable)

## Tree Work Specification.

Site: 88 Crescent Road, Reading, RG1 5SN.

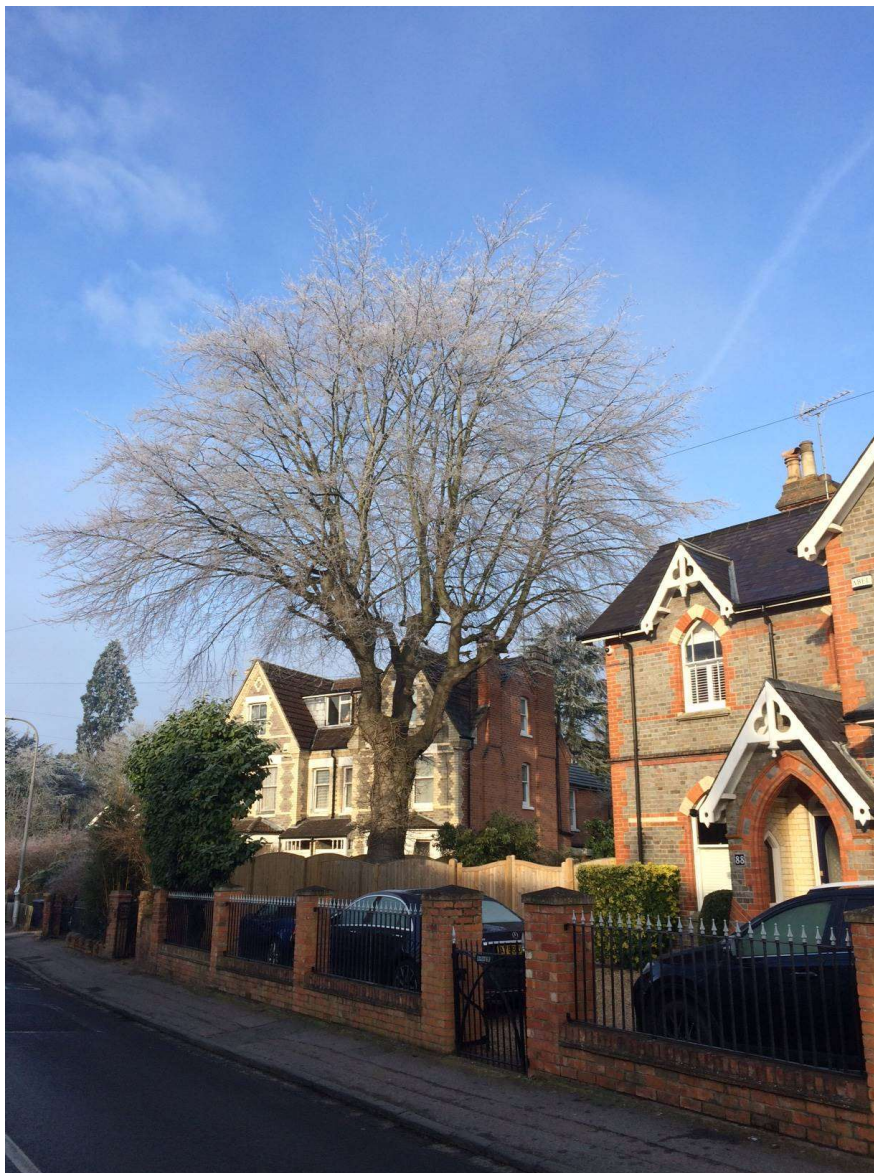
- Tree Number: T1 Purple Leaf Beech.
- Location: Left Hand side of House.
- Tree Species: 1 no. Mature Beech tree.
- Observation: This tree is a lapsed pollard which has since developed a full canopy on many stems which issue from the original pollard points. The tree stands on the boundary between 88 and 90 Crescent Road. The Canopy of the tree now extends to very close proximity with both houses, almost touching the roofs. The tree is also interfering with the telephone cable to the front boundary.

Tree viewed from Crescent Road

- Proposed Action: Reduce canopy of lateral spread of the tree to achieve approximately 2.5m clearance from the building lines of both properties and to clear the telephone lines. Similarly reduce sympathetically the remainder of the lower canopy lateral spread to retain shape and character. Height and upper canopy of the tree to remain unaltered. Include the removal of significant dead and defective branches.

- Pollard points and areas of suspected Squirrel damage to be subject to closer aerial inspection at this time.

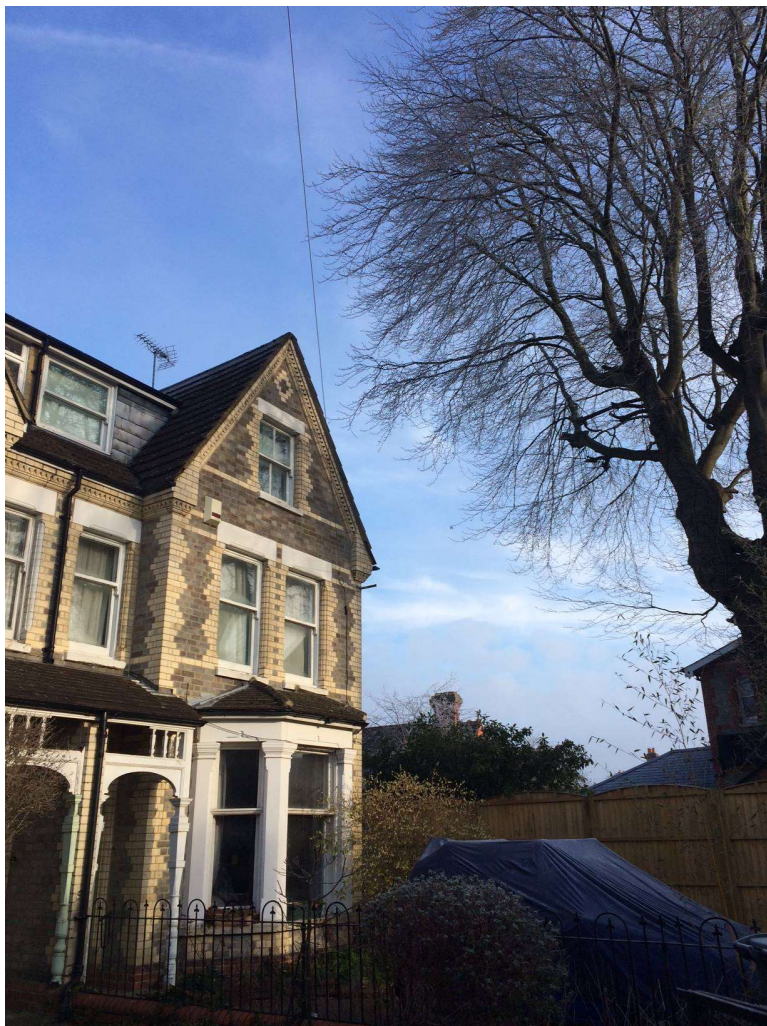
Proximity to 90 from Crescent Road

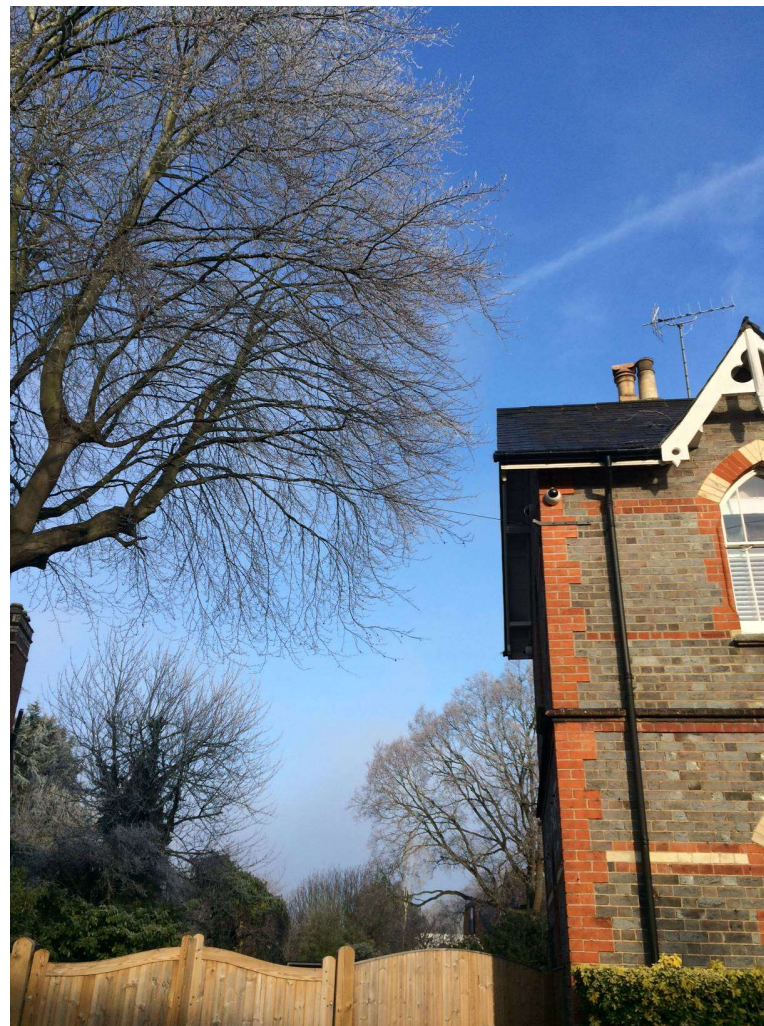
Proximity to 88 Crescent Road

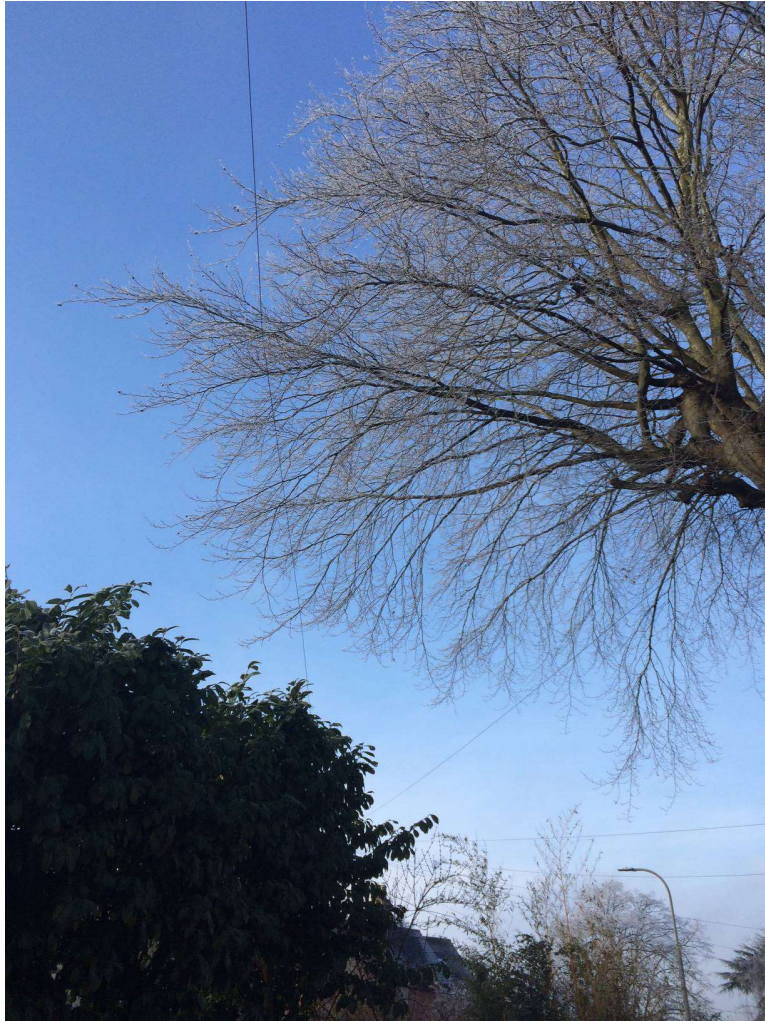
Proximity to phone line servicing 88 Crescent Road indicating deviation by branches.
