# **Asbestos Survey- R&D Report Pre-Refurbishment Inspection**

**Survey Report No: FPSJANRE1**

**CLARENDON HOUSE**

**59-75 QUEENS ROAD**

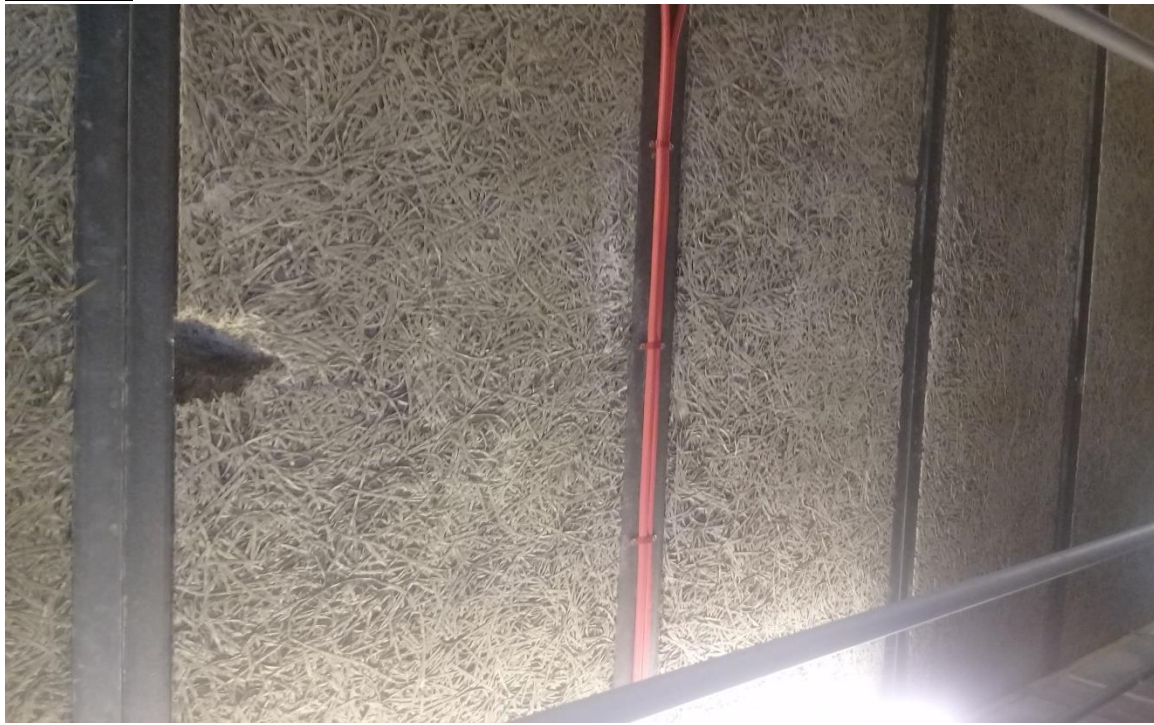
Photo ref:

| Sample No. | 001 | Analysis | NADIS |

The Picture shows the Stramit roofing panels above the plant room. On older builds Chrysotile paper has been used to line the shuttered top surface before a felt water proof membrane was added. No paper or chrysotile debris was detected in the core sample tested.

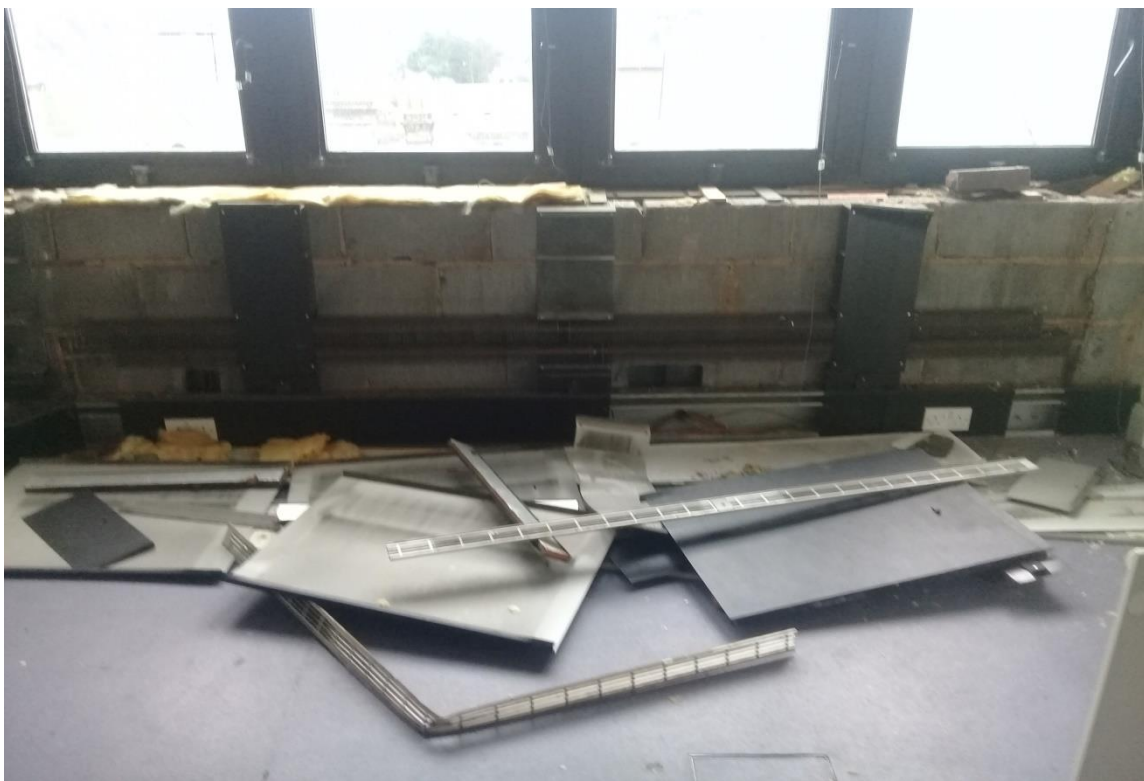
Photo ref: 125

| Sample No. | 003 | Analysis | NADIS |

Window bay deconstructed to view the cavity insulation material and the hot water fed heating system diffusers, reveals casings and associated panelling.

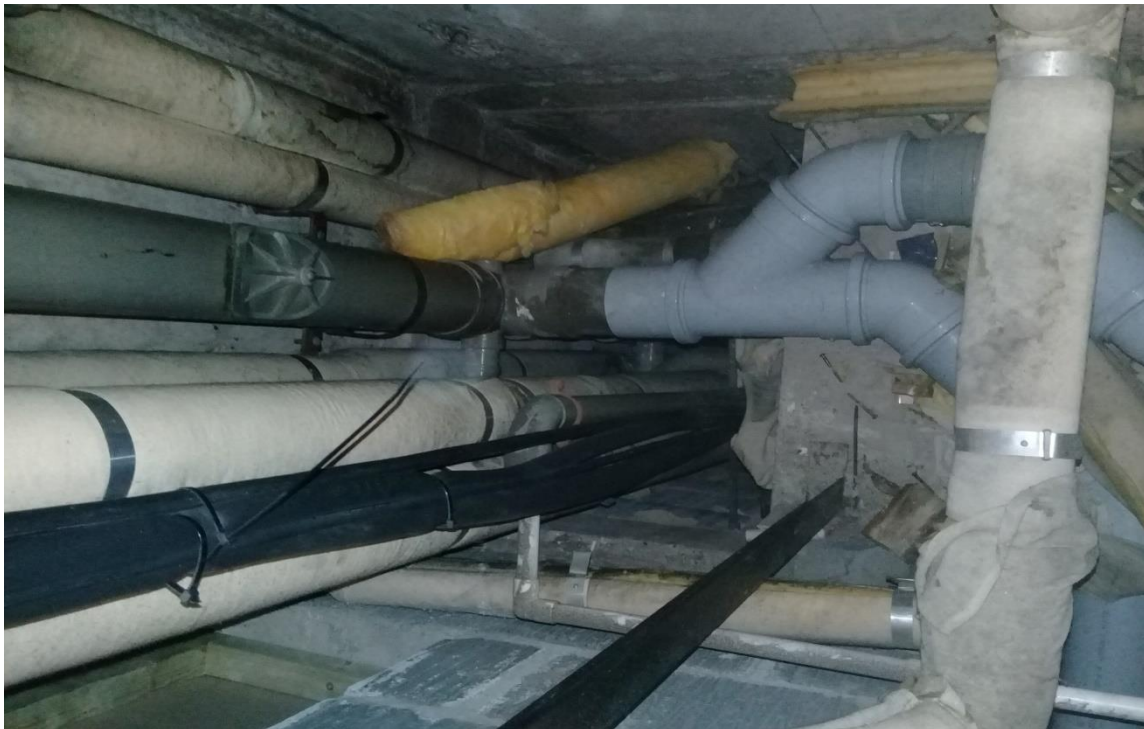
Photo ref: 124

| Sample No. | 005 | Analysis | NADIS |

| Discussion |
|---|
| Base of riser void, debris collected to examine for previous use of ACMs. No asbestos detected from sample of materials and dust sat at bottom of void area. |

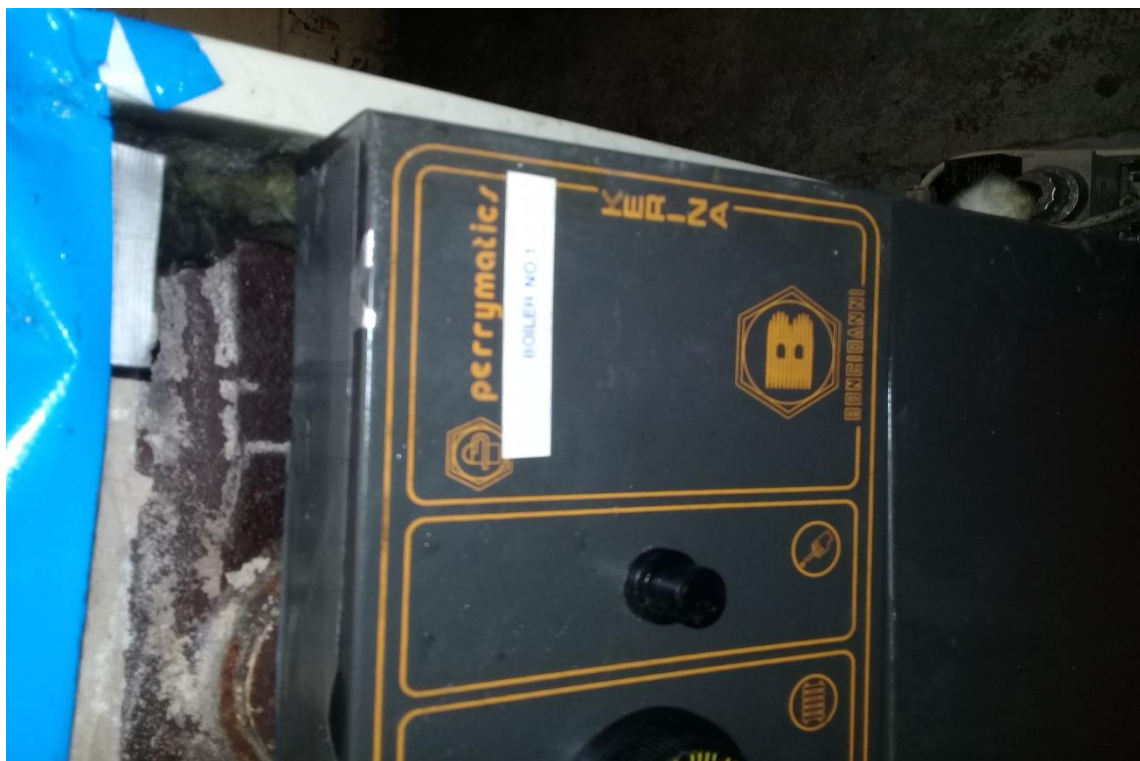
Photo ref: 123

| Sample No. | 006 | Analysis | NADIS |

| Discussion |
|---|
| <p>Rope Type gasket fitted behind Perrymatic control panel. Although panel may have been replaced the gasket behind was different in construction to the others fitted elsewhere, and therefore a sample was taken.</p> |

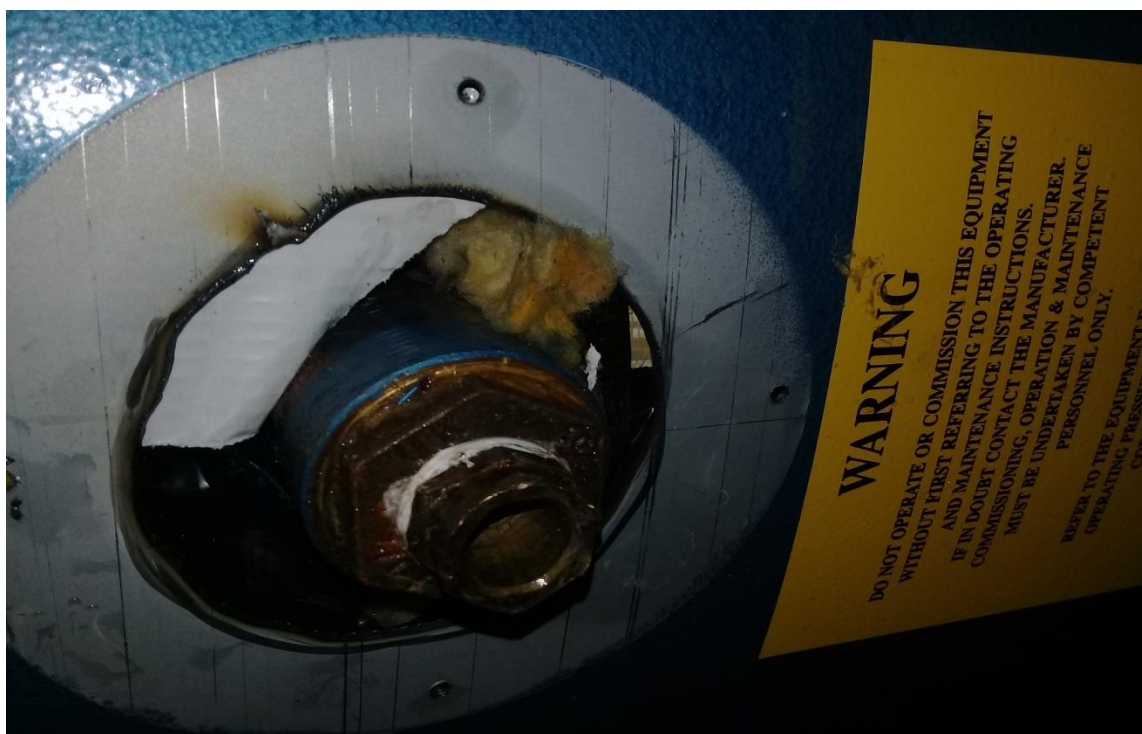
Photo ref: 127

| Sample No. | 004 | Analysis | NADIS. |

| Calorifier insulation material sampled at inspection points around the vessel.<br>Galvanised steel core and outer casing, modern pipe fixings and protrusions. |

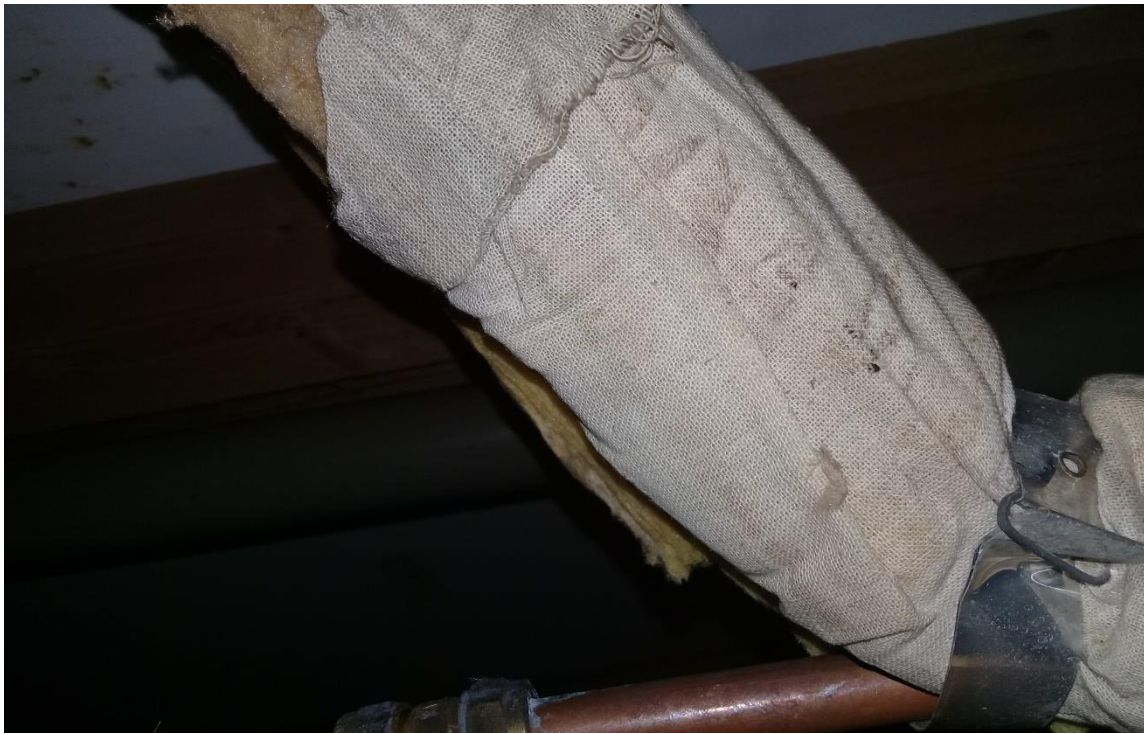
Photo ref: 128

| Sample No. | 002 | Analysis | NADIS |

| Discussion |
|---|
| Mmmf pipe insulation, sectional and prevalent throughout the building. Calico scrim jacket with metal tab wrap. |

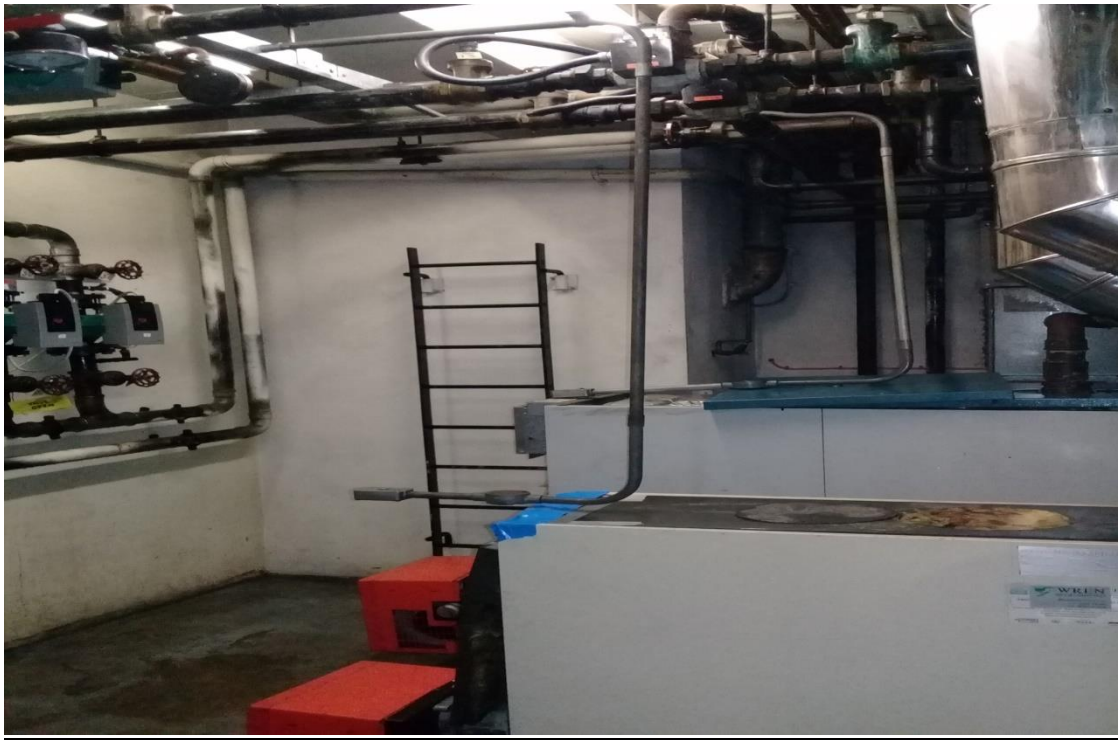
**Photo ref: 131**

| Sample No. | N/A | Analysis | No asbestos containing materials discovered |

| Pipe insulation removed for scrutiny. No ACM debris discovered. |

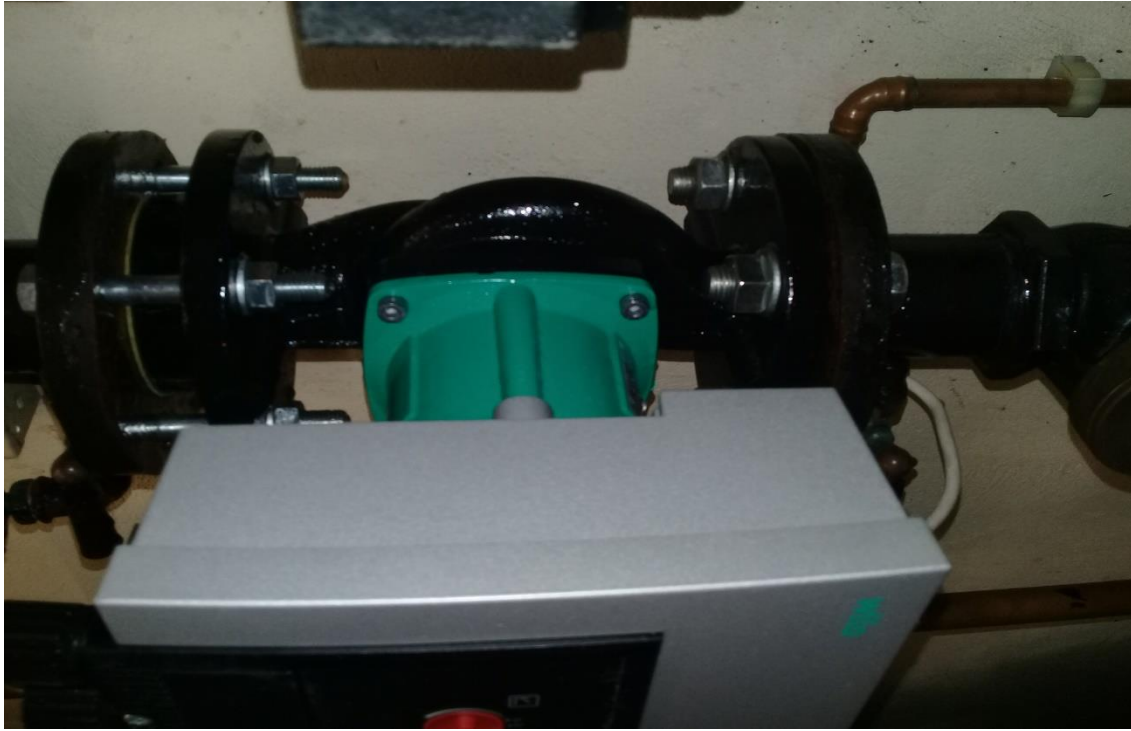
**Photo ref: 134**

| Sample No. | N/A | Analysis | No ACM debris |

| Modern pumps and controls fitted throughout the plant room. |

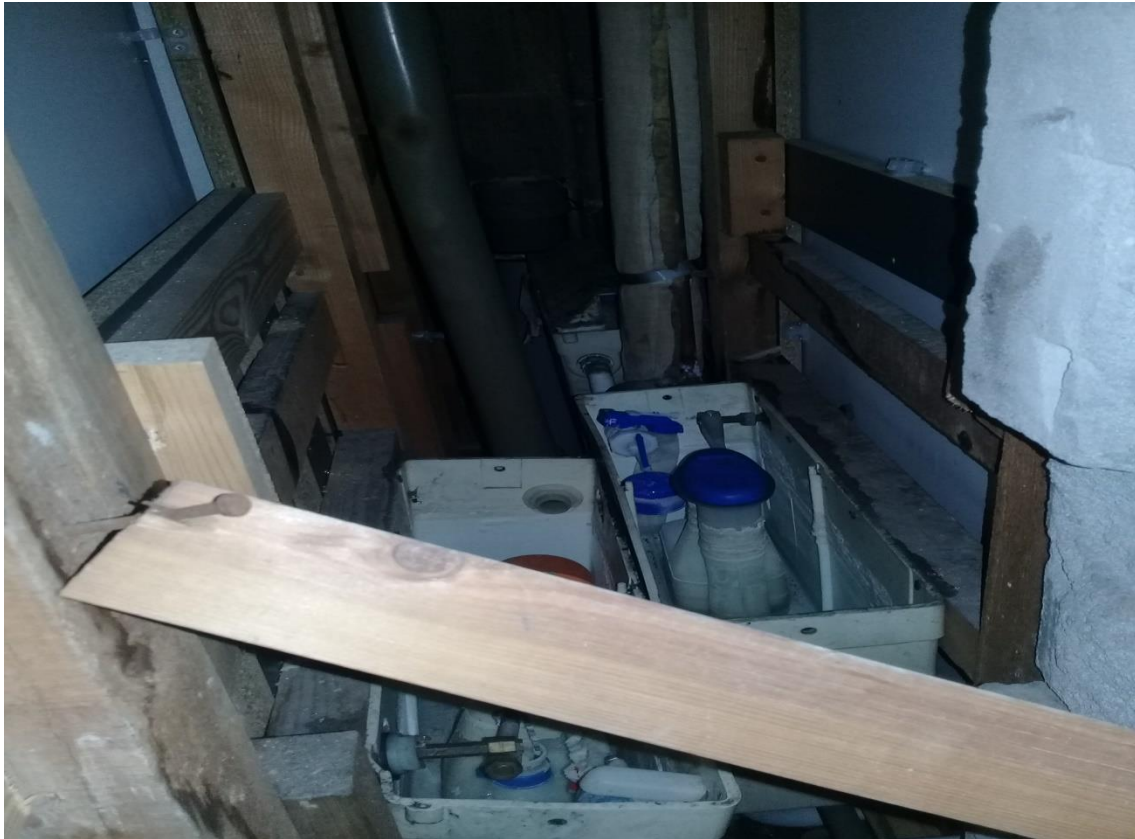
**Photo Ref: 136**

| Sample No. | N/A | Analysis | No bonded asbestos products noted |

| View of w/c service panel showing plastic cisterns and timber frames. |

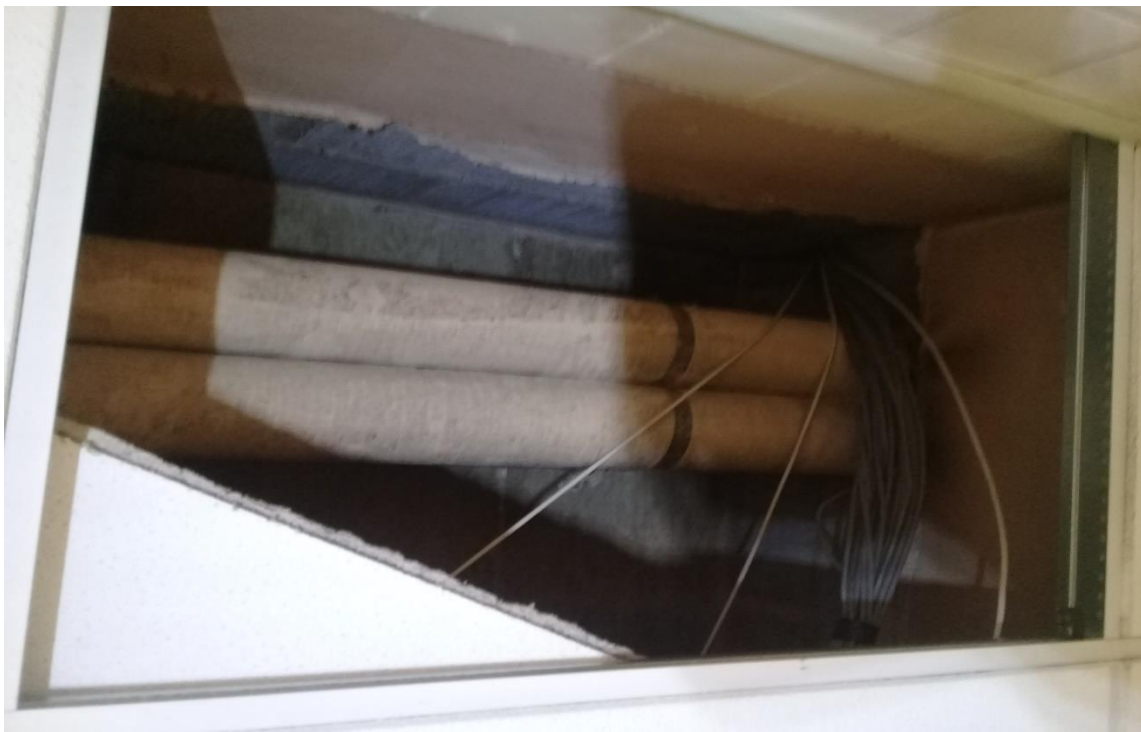
**Photo ref: 132**

| Sample No. | 002 | Analysis | NADIS |

| View of Man-made mineral fibre insulation before removal, and the search for Chrysotile paper lining. |

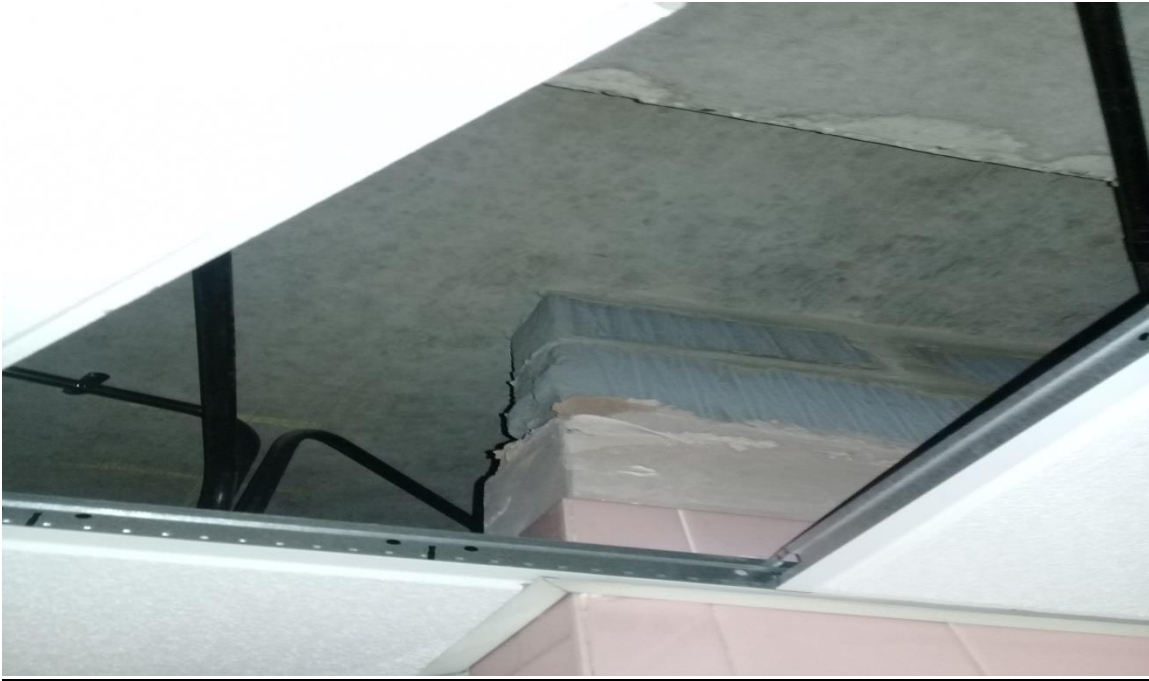
**Photo ref: 135**

| Sample No. | N/A | Analysis | No homogenous material attached to column heads. |

| Discussion |
|---|
| Typical view of each column header showing no additional fire insulation materials. |

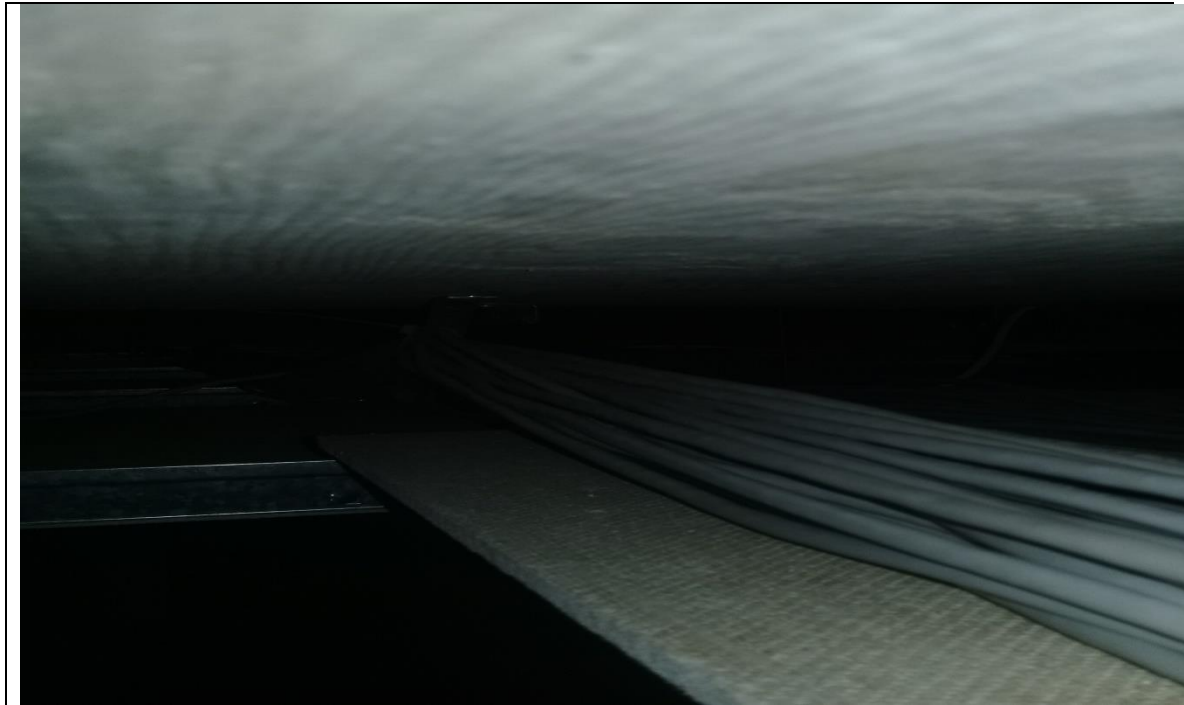
Photo ref: 143

Ceiling voids on all floor levels and cupboards where inspected to ascertain the deliberate use of ceiling void fire breaks, none were detected nor the typical footprint of a fire break was revealed.

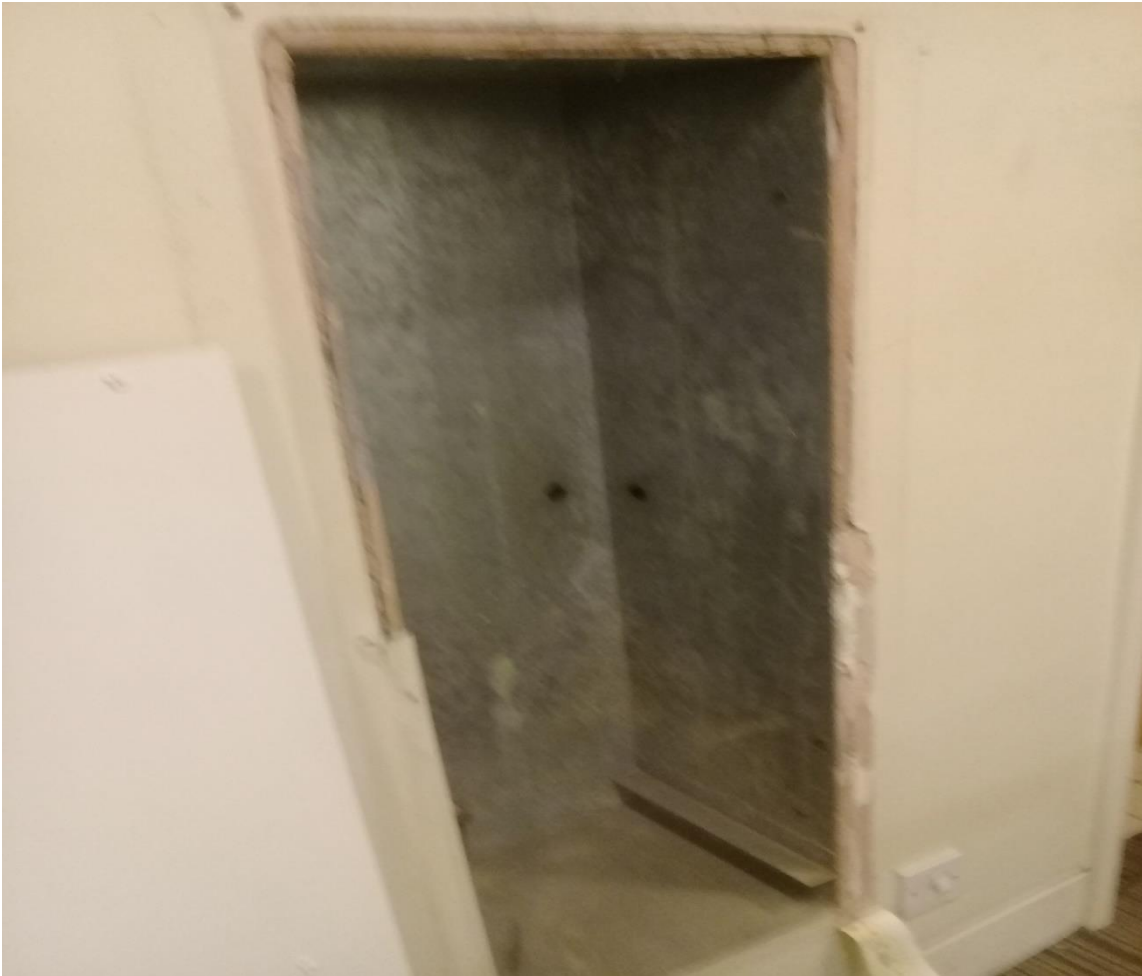
**Photo ref: 137**

| Discussion |
|---|
| <p>Old fire extinguisher cabinets sited on the landing of each floor level. No fire retardant boarding attached to either side of galvanized unit.</p> |

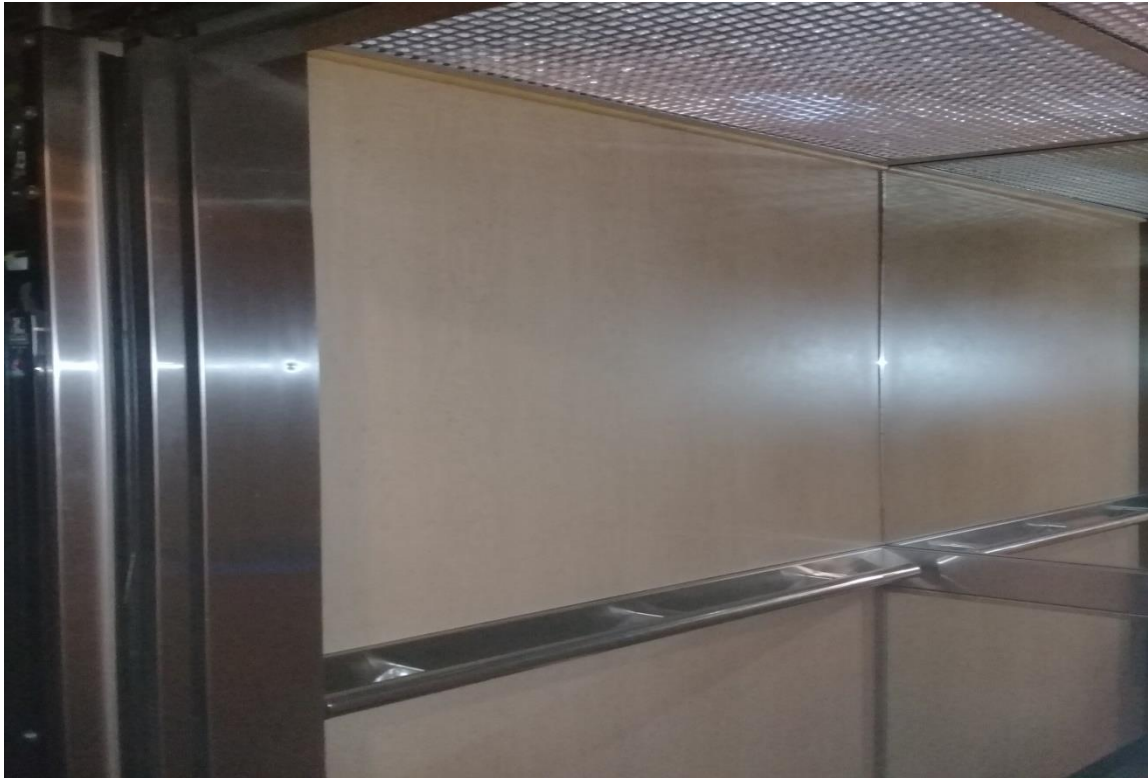
Photo ref: 144

| Sample No. | N/A | Analysis | No ACM materials discovered in the lift construction |

| Discussion |
|---|
| Construction of the passenger goods lift, stainless steel and laminate faced wall panels. Lightweight perforated metal Ceiling panels for access to the lift roof. |

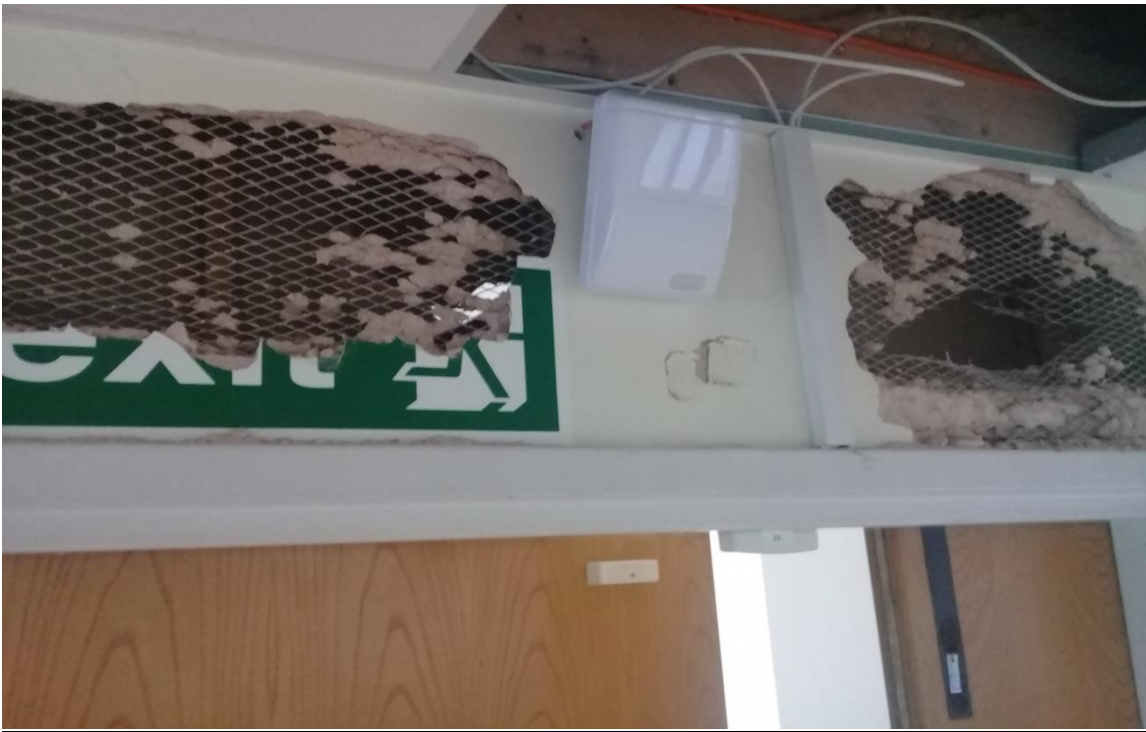
Photo ref: 145

| Sample No. | N/A | Analysis | No additional homogenous boarding integrated |

| Discussion |
|---|
| Plaster board and galvanized mesh door headers. Typical of all the fire exits on each level. No extra fire protection was revealed in the surrounding frames. |

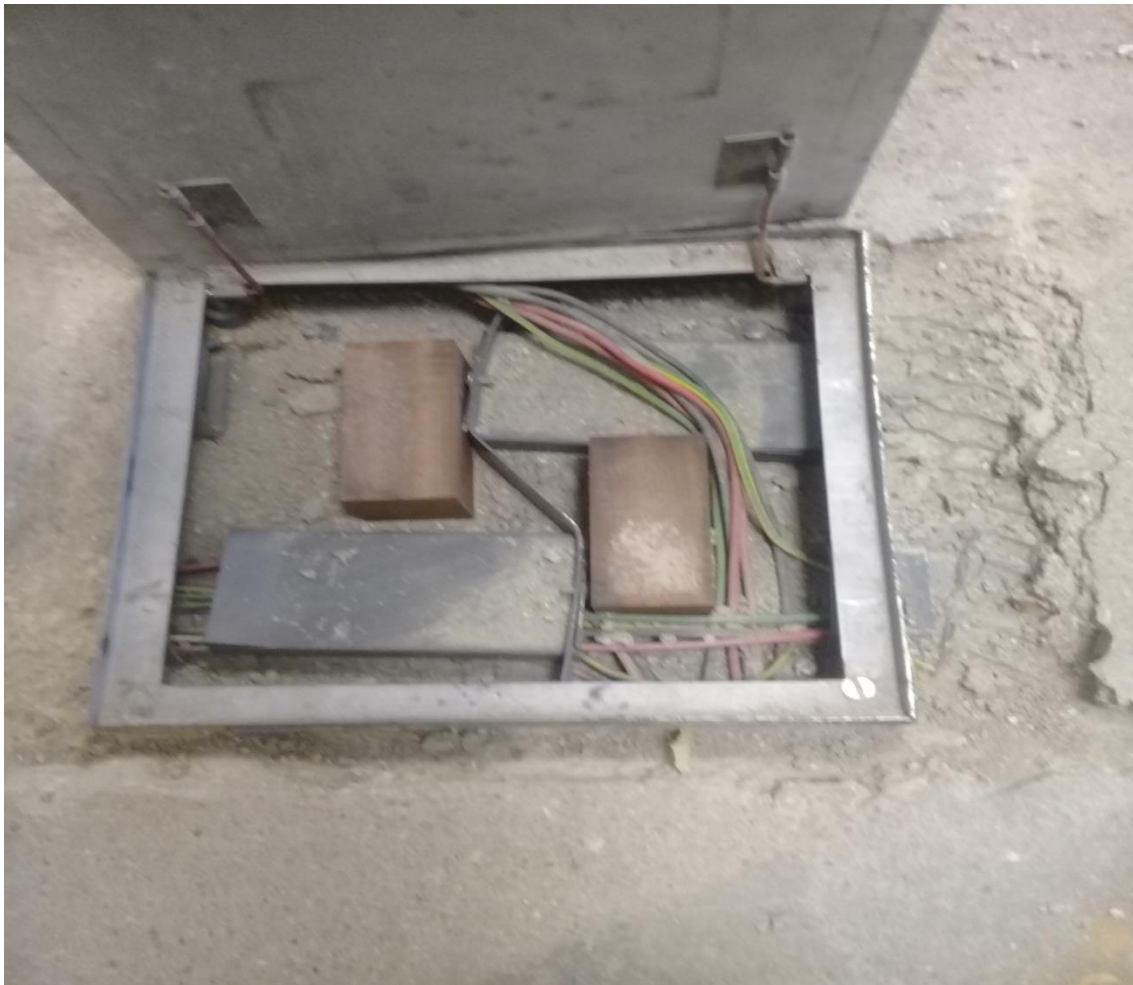
Photo ref: 146

| Sample No. | N/A | Analysis | No additional fire rated fillets added to shuttering |

| Discussion |
|---|
| Recessed electrical floor sockets. Broken up to view floor layer and galvanized wire shuttering and no AIB fillets added during construction. |

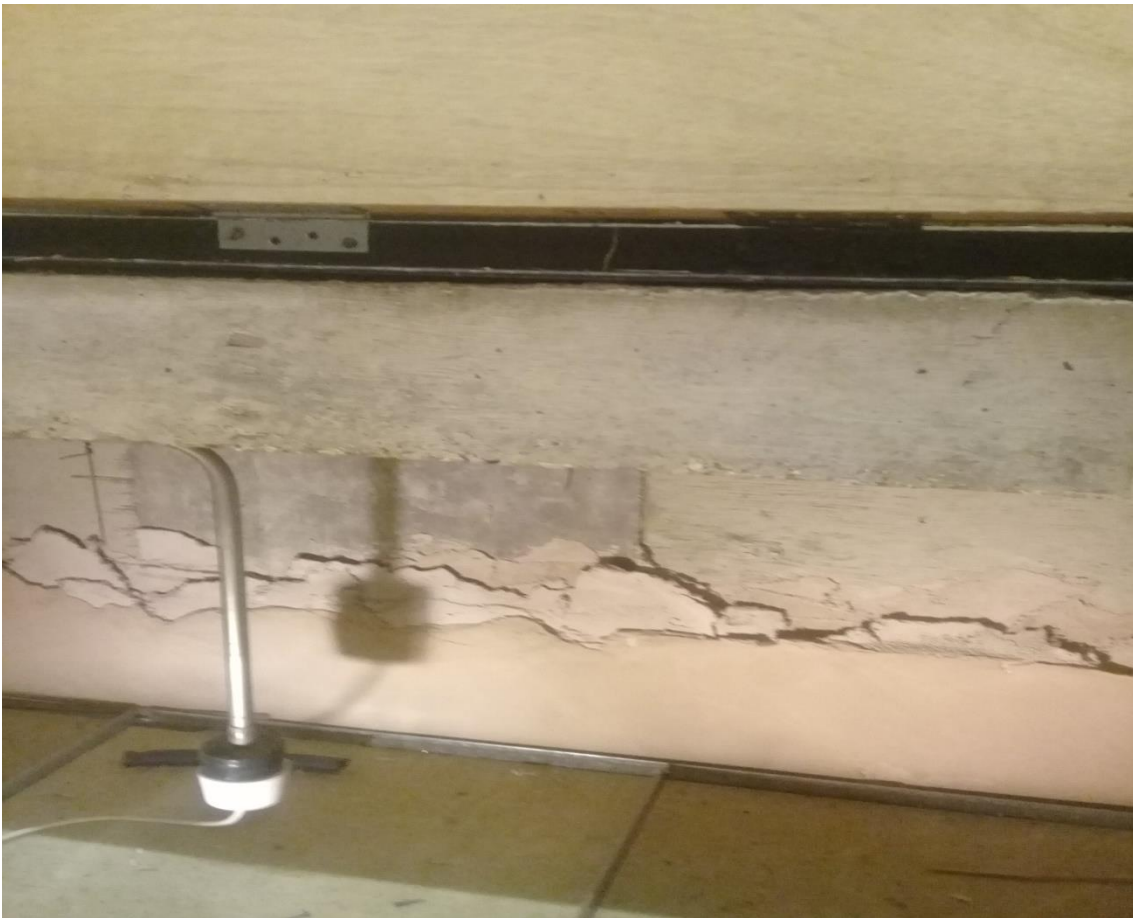
Photo ref: 147

| Sample No. | N/A | Analysis | No ACM attached to stairwell and shaft wall. |

| Discussion |
|---|
| Wall construction under lift motor room access panel, forming lift shaft wall. No additional fire protection is added to the construction materials. |

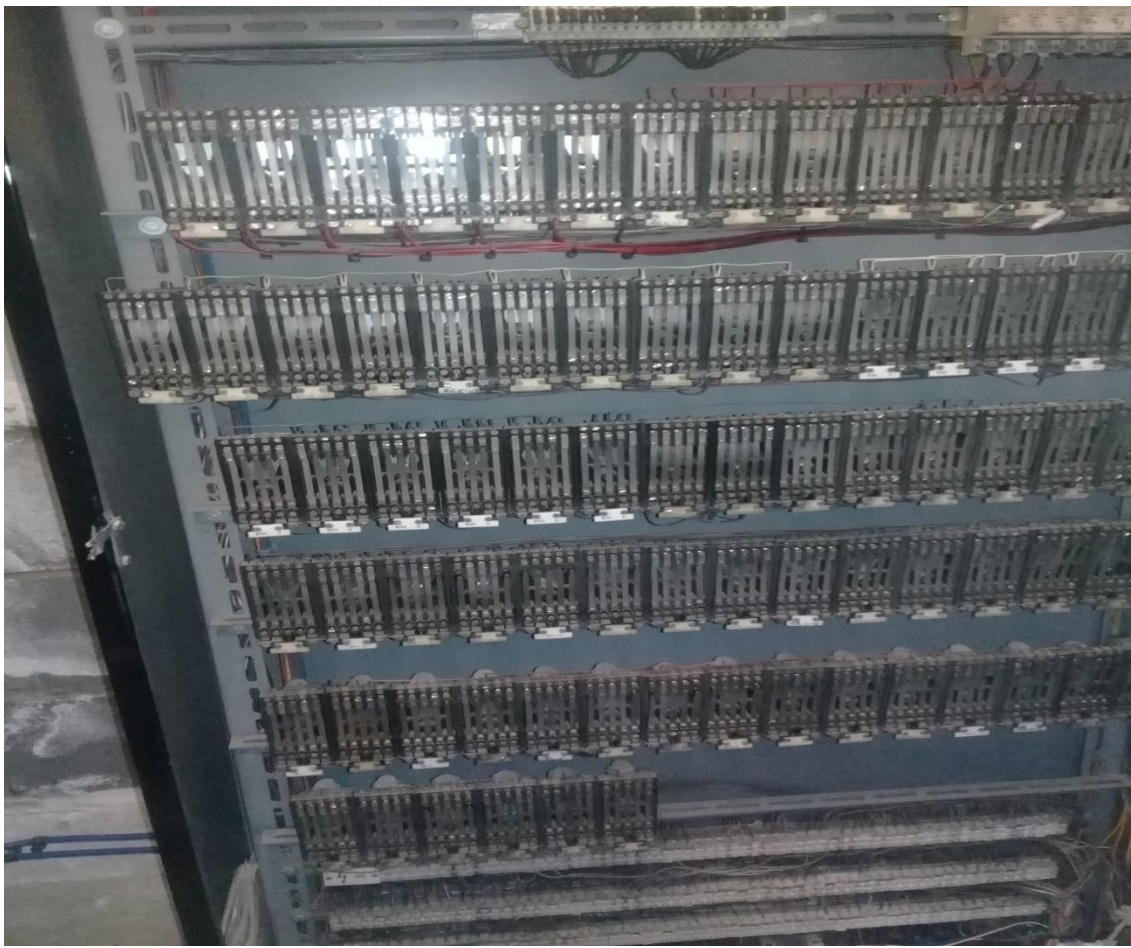
Photo ref: 148

| Sample No. | N/A | Analysis | No chrysotile flash guards found in any panels |

| All the control panels and switch boxes were inspected for old type chrysotile cloth flash guards. |

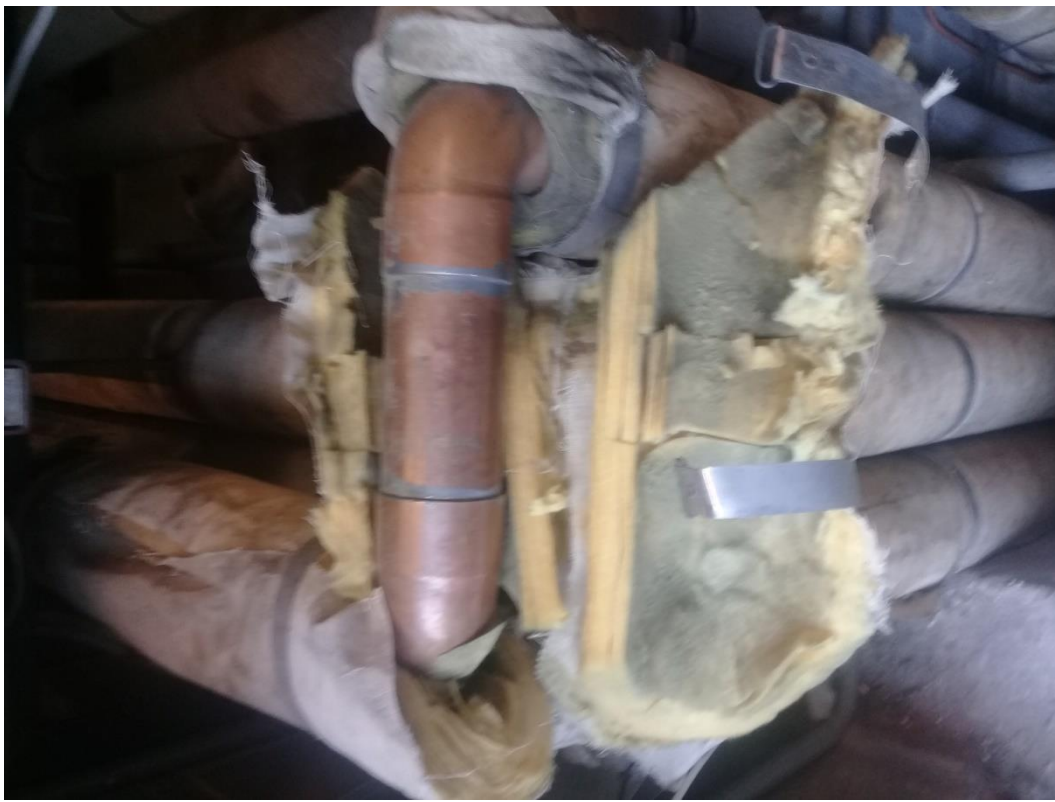
**Photo ref: 149**

| Sample No. | 002 | Analysis | NADIS |

| Discussion |
|---|
| Copper pipe feed from the hot water tank within the plant room. No paper lining or evidence of ACM debris on pipes. |

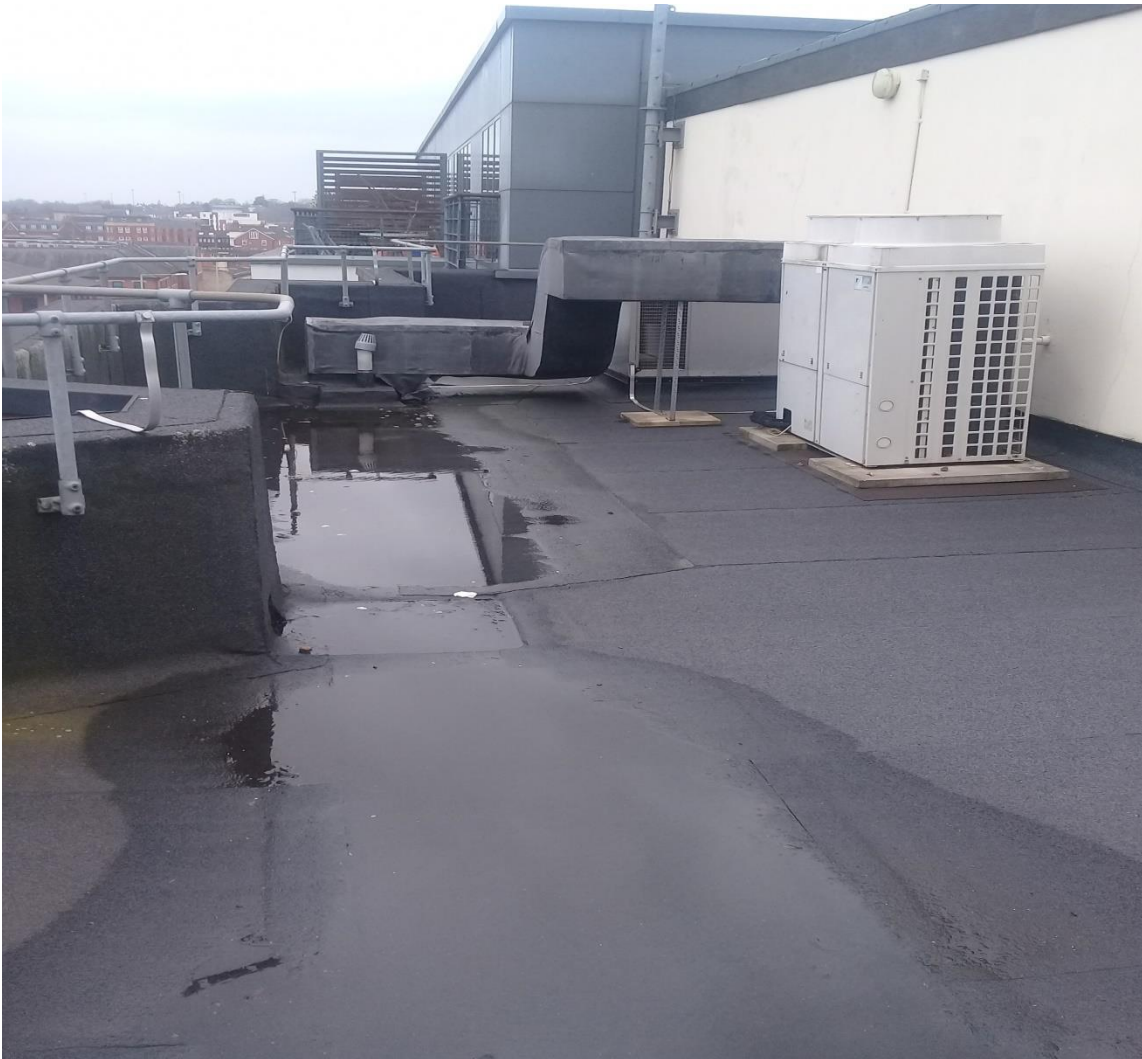
**Photo 150**

| Sample No. | N/A | Analysis | No bonded asbestos materials revealed |

| Discussion |
|---|
| DPM covering to external ducting, protecting O class foil coated mmf 'insulation blanket. |

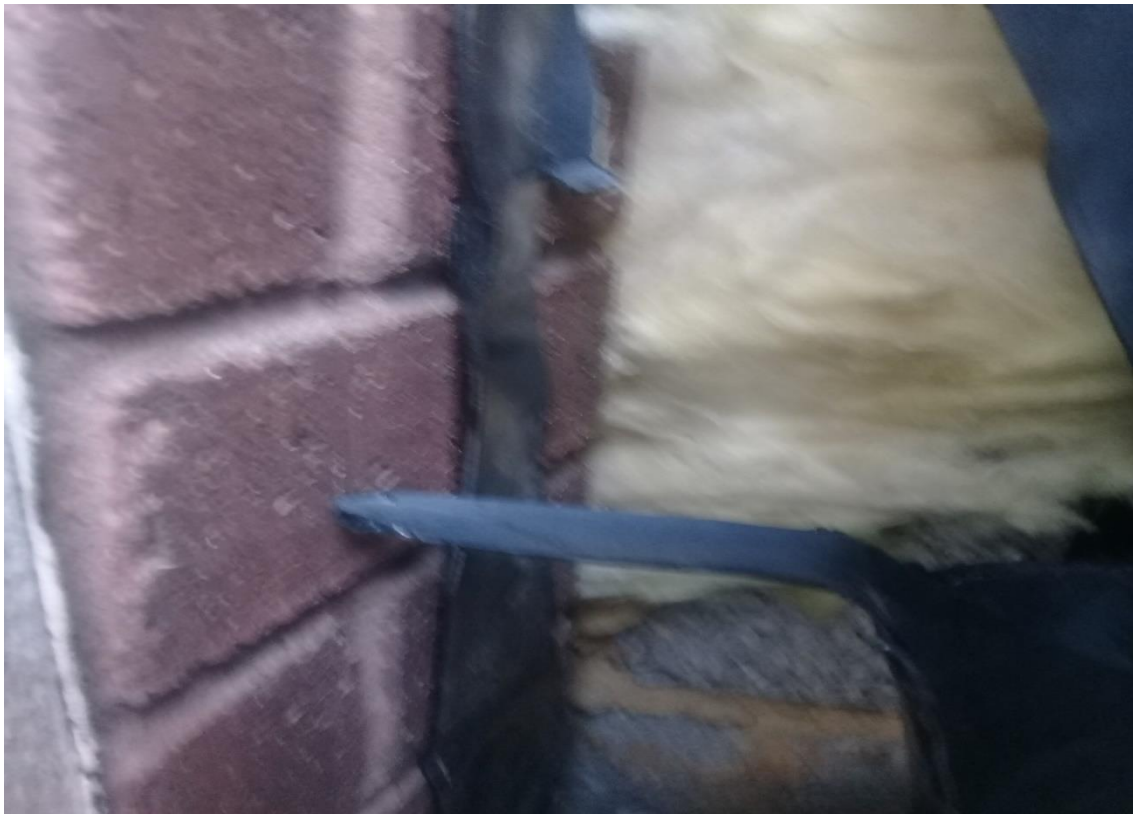
**Photo 151**

| Discussion |
|---|
| <p>Profile sheeting removed to inspect the building materials sandwiched between the neighbouring buildings. No homogenous asbestos boarding fixed to block work.</p> |

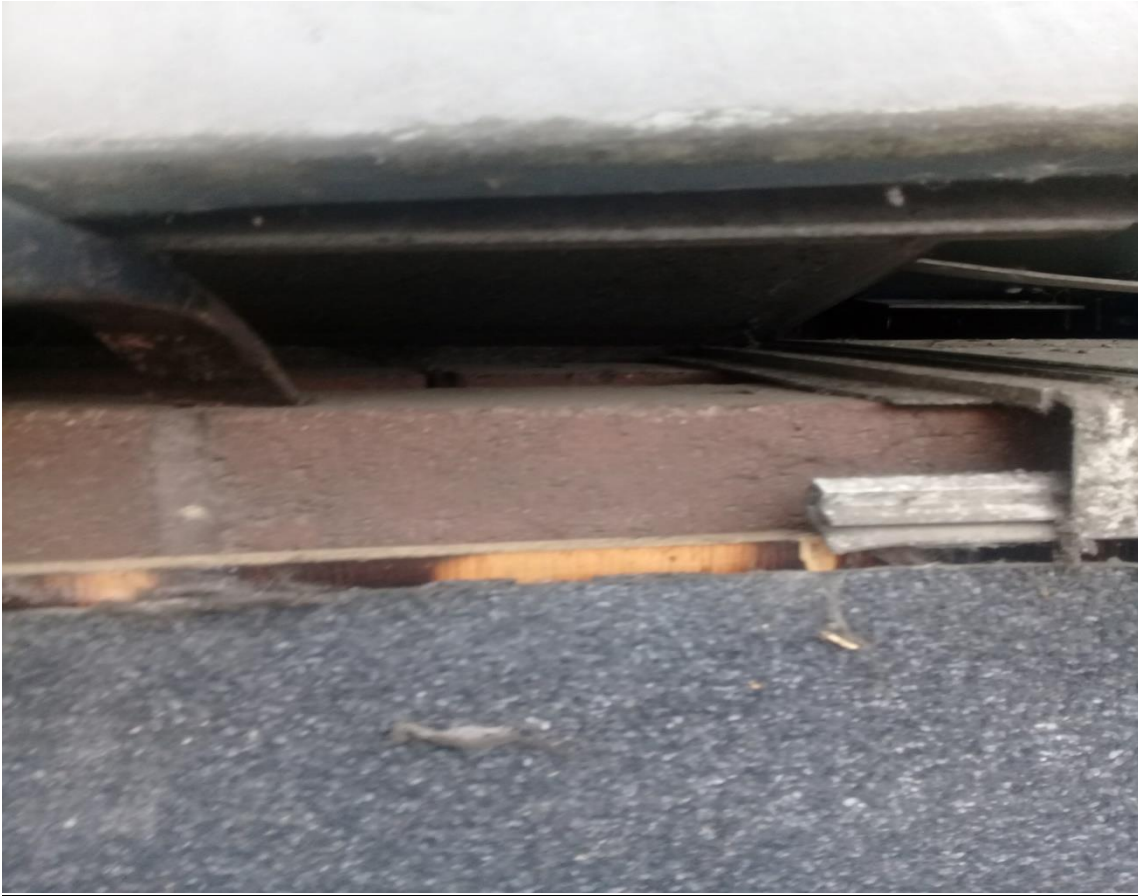
**Photo 152**

| Sample No. | N/A | Analysis | No ACM uncovered |

| Discussion |
|---|
| Aluminium capping lifted to inspect the brick cavity and under side of the cap. No fire rated boarding or paper lining was uncovered. |

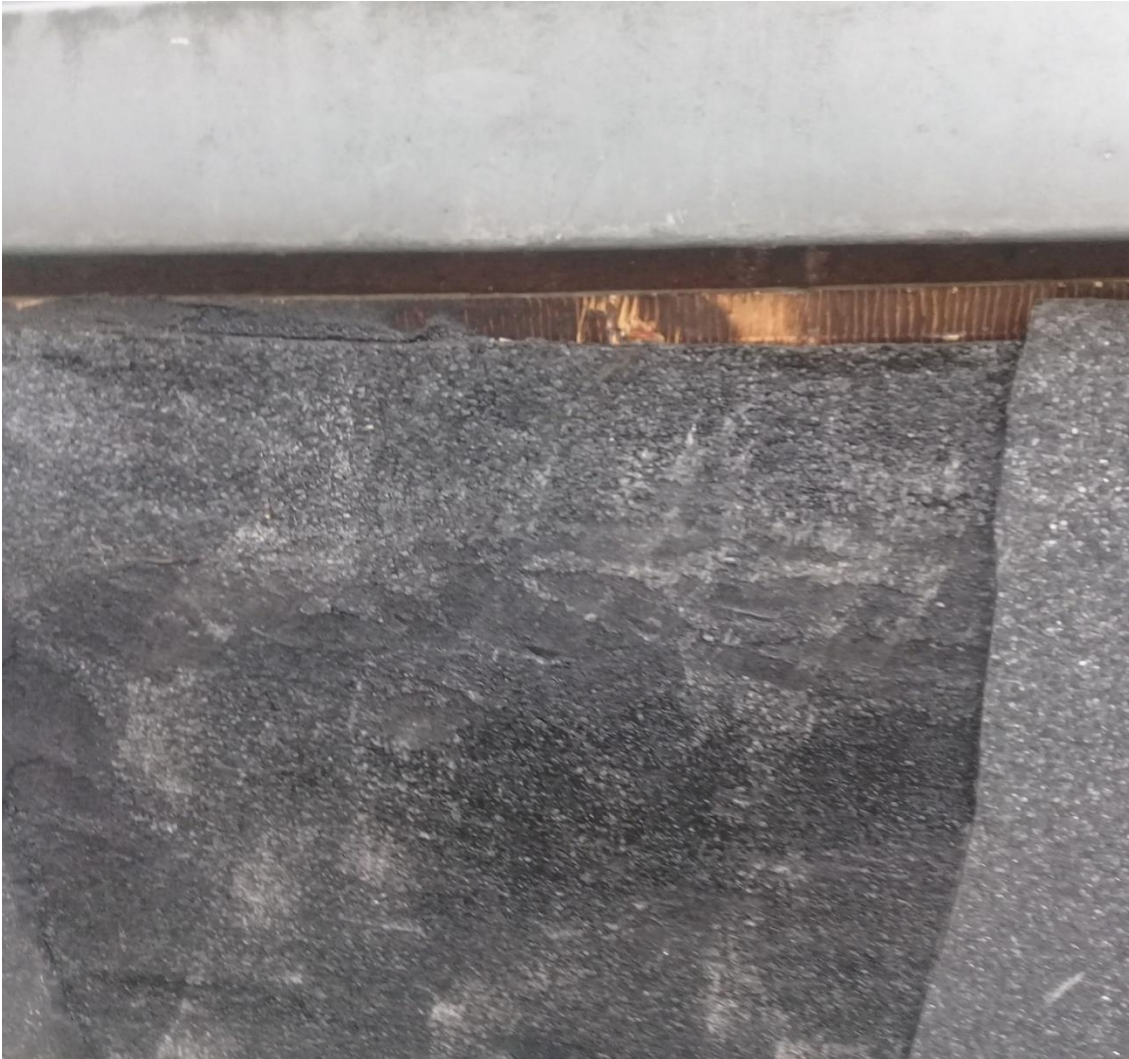
**Photo 154**

| Sample No. | N/A | Analysis | No ACM boards used in the upstand covering. |

| Discussion |
|---|
| During the building of the upstand walls no asbestos boarding was used in its construction. |
