# **Asbestos Survey- R&D Report Pre-Refurbishment Inspection**

**Survey Report No: FPSJANRE1**

**CLARENDON HOUSE**

**59-75 QUEENS ROAD**

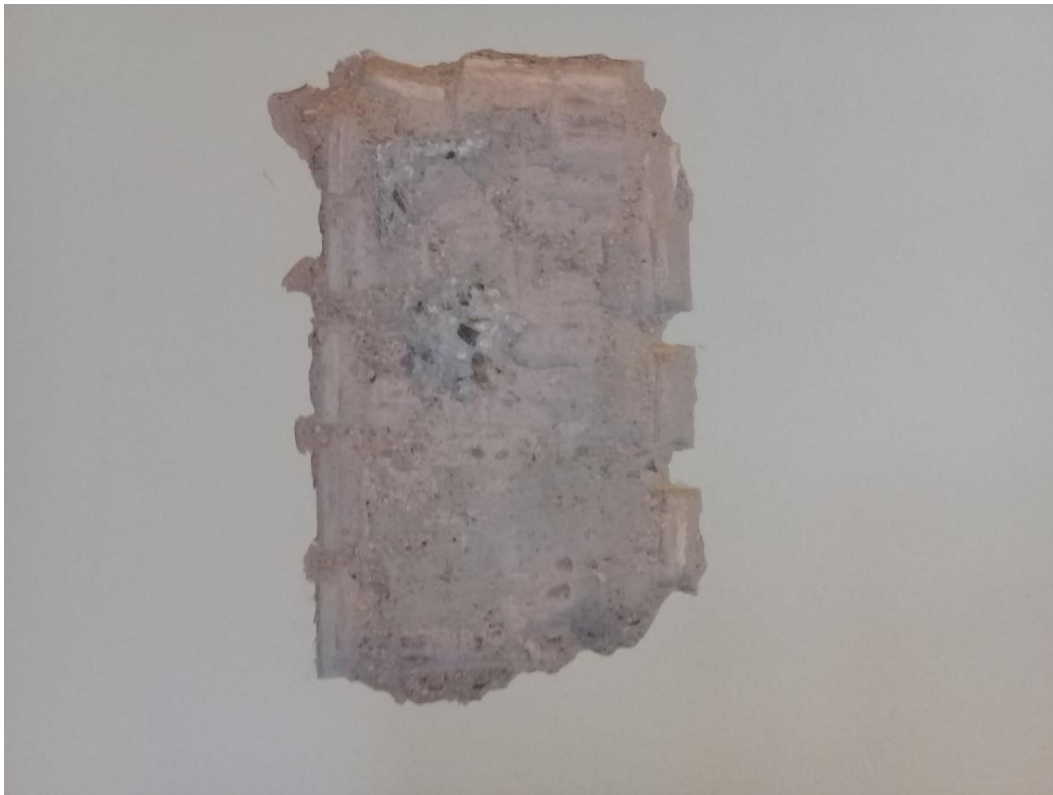
**Photo 156**

| Sample No. | N/A | Analysis | No additional fire boarding added to walls. |

| Discussion |
|---|
| Hole in staircase wall at lower level reveals no changes in construction below the surface of the wall. |

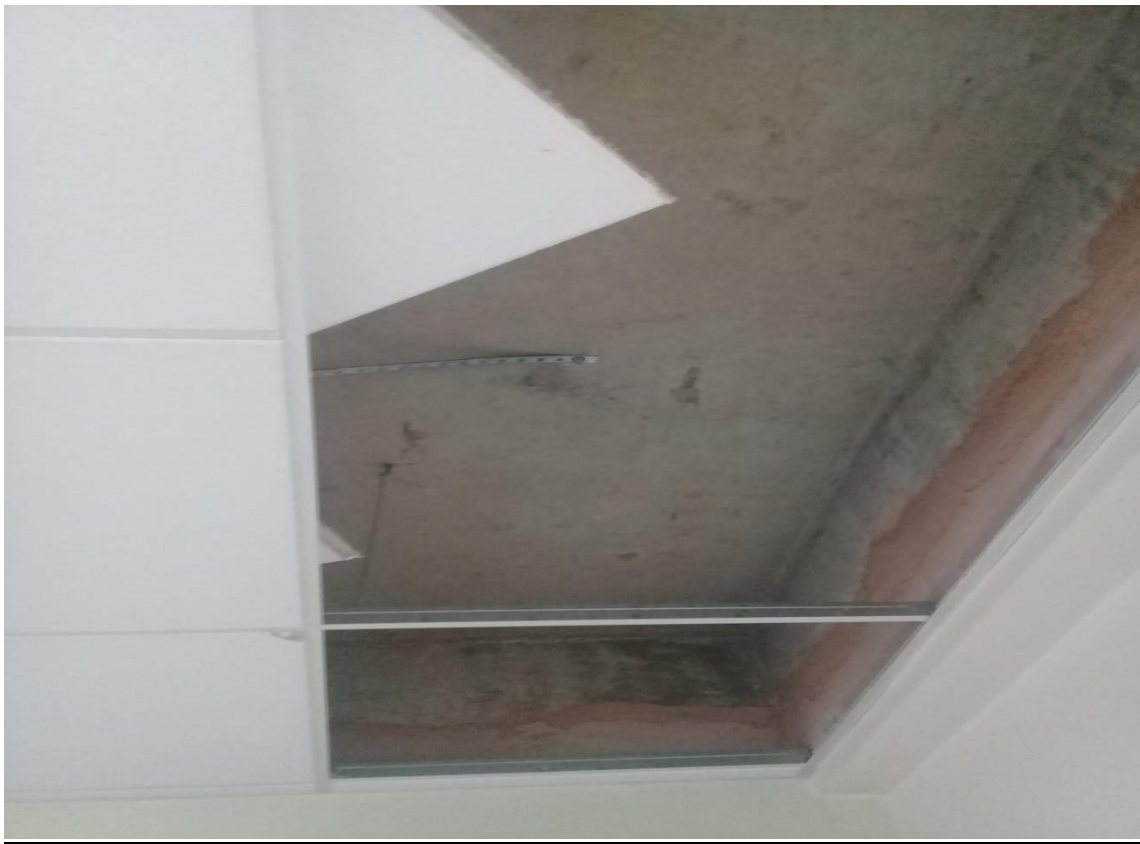
### **Photo 157**

| Sample No. | N/A | Analysis | No additional fire boarding added to east end of building. |

| Discussion |
|---|
| This view is of the east end of the office space above the suspended ceiling; no extra fire rated insulation has been attached or laid onto the ceiling tiles. |

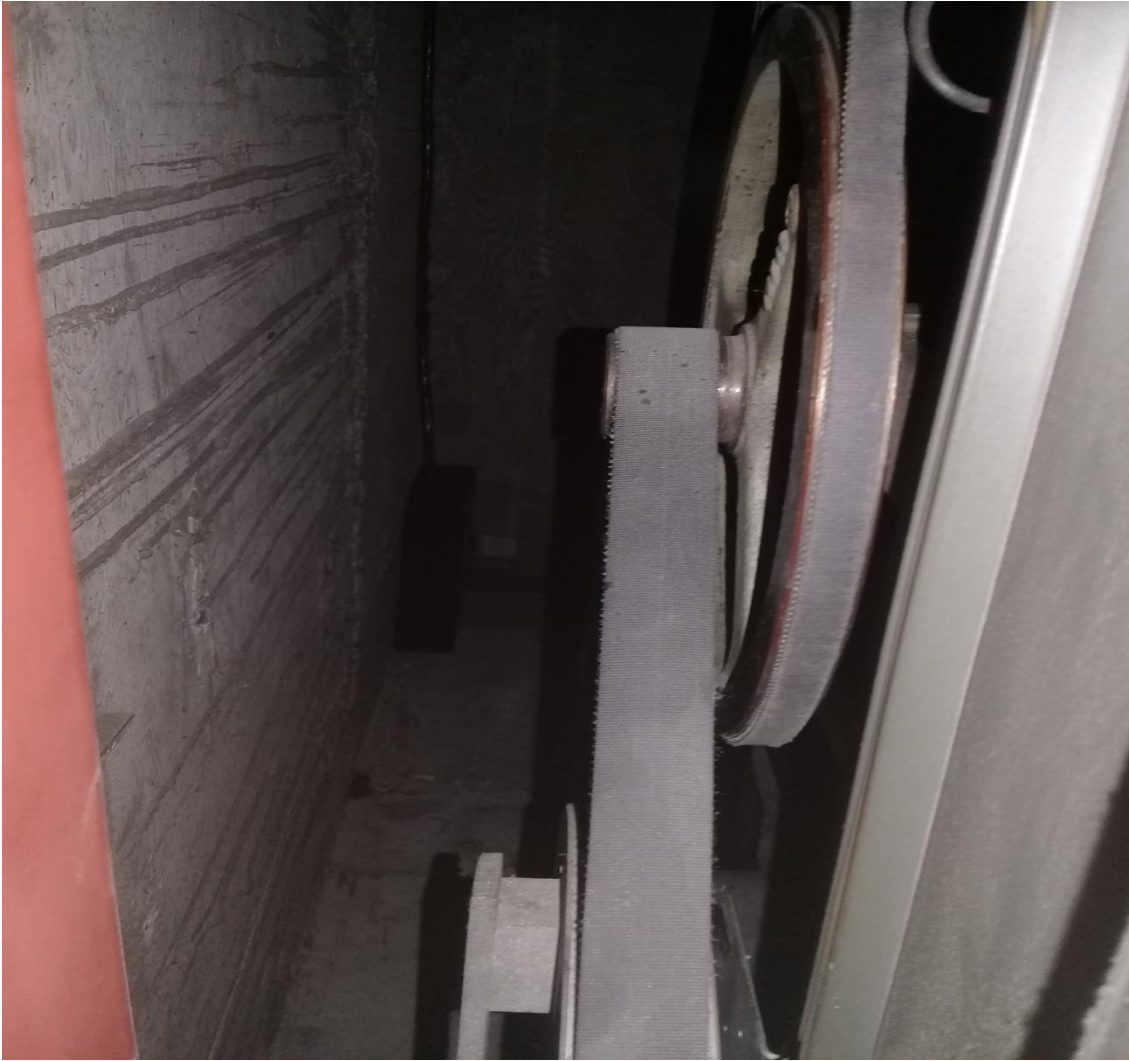
**Photo158**

| Sample No. | N/A | Analysis | No ACM viewed from the roof of the lift |

| Discussion |
|---|
| No ACMs found around the lift alignment tensioners, bushes and adjacent wall surfaces. |

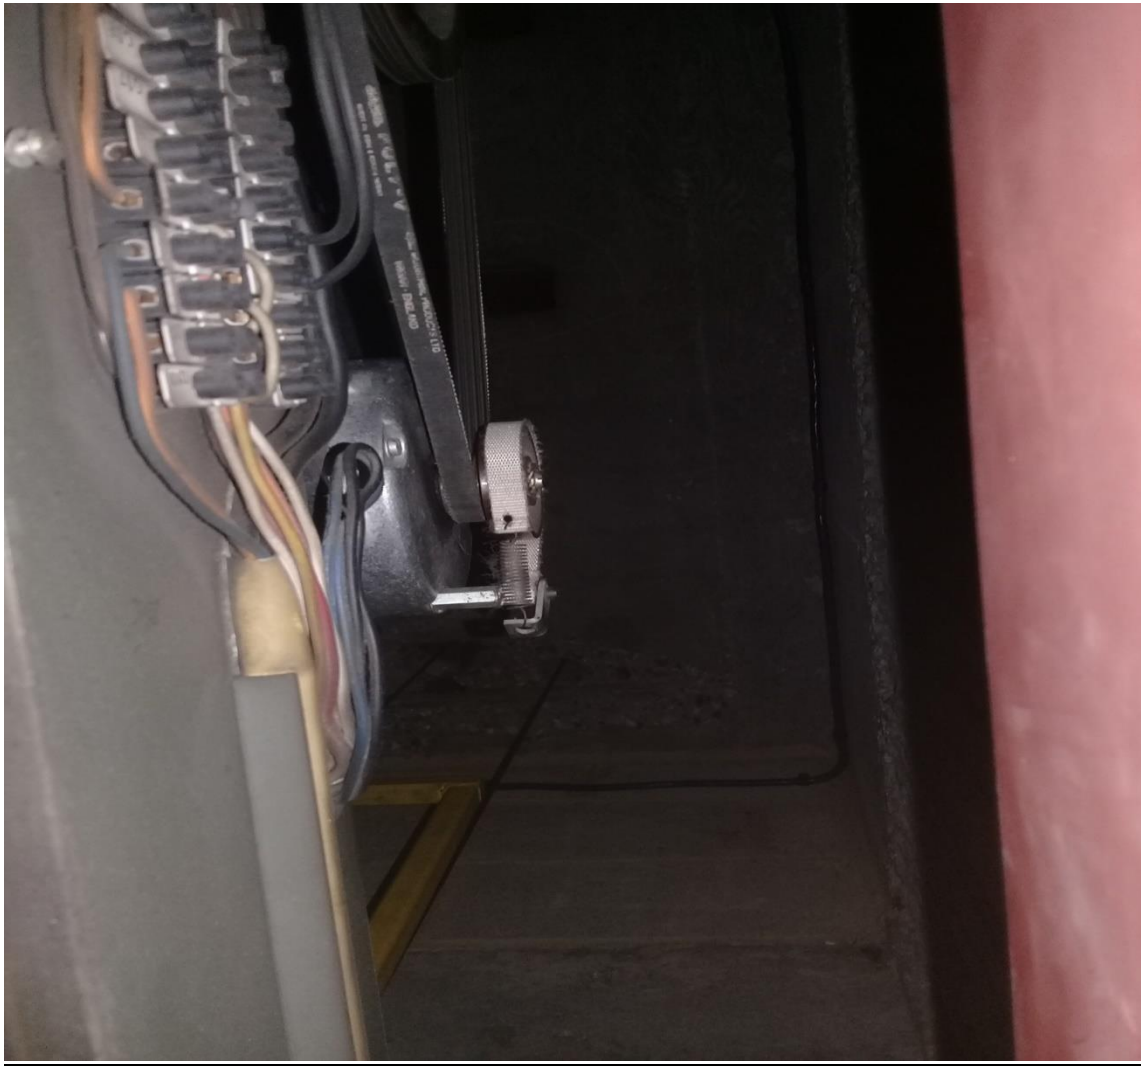
**Photo159**

| Sample No. | N/A | Analysis | No homogenous fire boarding fitted around lift door controls. |

| View of the door closing governor and drive belt mechanism for opening the doors. |

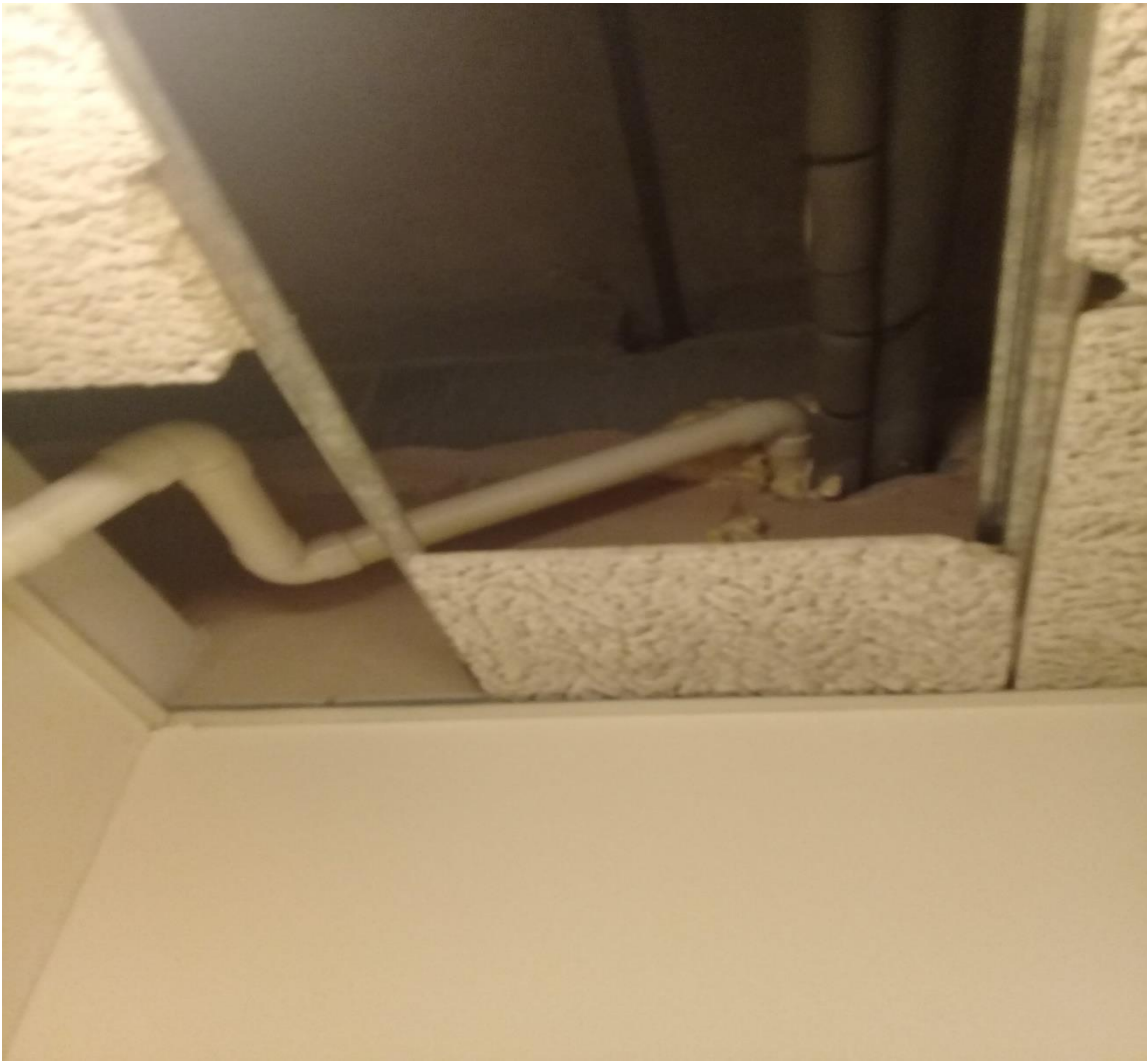
**Photo160**

| Sample No. | N/A | Analysis | No ACM revealed in ceiling void of cleaners cupboards. |

| Discussion |
|---|
| No integrated fire resistant boarding or fire breaks in the ceiling void of any of the cleaning cupboards. |

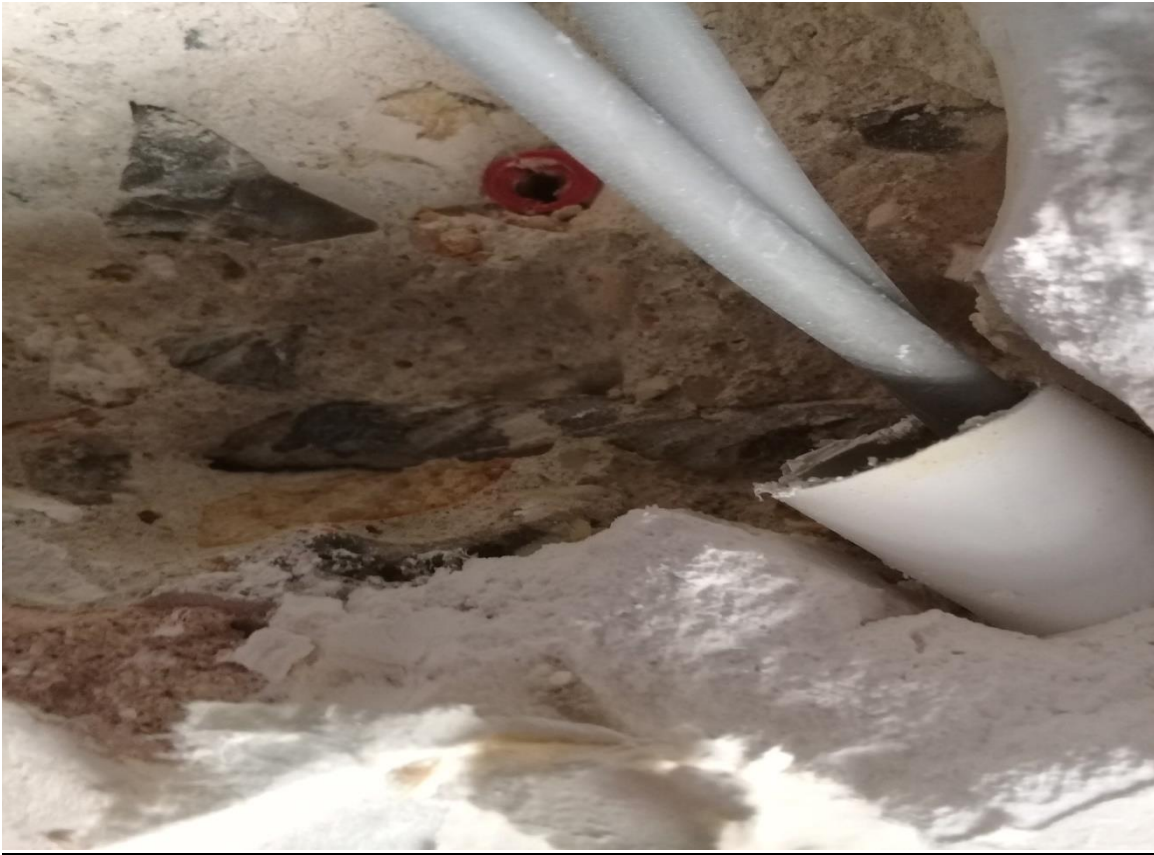
**Photo 161**

| Sample No. | N/A | Analysis | No ACM discovered. |

| The column was core sampled to inspect the construction material for the use of homogenous asbestos fillets or boarding. |
