**Re: Castle Crescent, Reading – Existing Building**

Further to our telephone conversations and my recent visit to site, we report as follows:

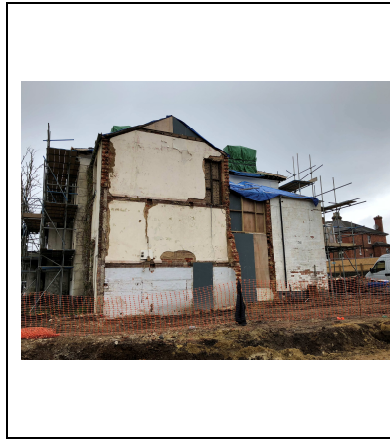
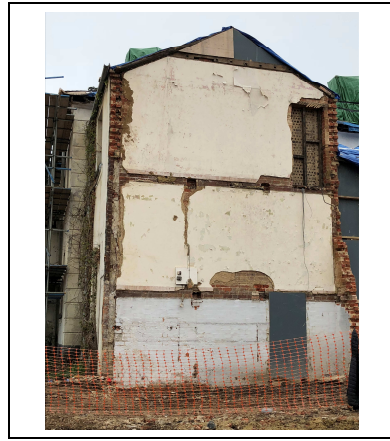
Photos of Flank Wall

1. The side extension has been demolished leaving the flank wall exposed.
2. The flank wall appears unconnected to the rear wall and there is a crack for most of the height which increases in width towards the top. The top section of the rear wall looks to be unstable and has moved outwards. It is also likely that there are no restraint straps at this level given the age of the building.
3. The proposed works include:
  - a) A new escape stair from the basement to be constructed adjacent to the rear wall which given its level may undermine the foundation.
  - b) Replacement of the roof and first floor.
4. Taking these factors into consideration, we are of the opinion that it would be prudent to reconstruct the flank and rear walls, on new foundations which are stepped down to suit the adjacent structures.
