**01: existing roof plan 1:50**

| ferguson mann architects | | | | | | | | | | | | | |
|---|---|---|---|---|---|---|---|---|---|---|---|---|---|
| Job Title<br>149-150 Friar Street, Reading | | | | | Drawing Title<br>Roof Plan<br><br>Existing Plans | | | | | | | | |
| Client<br>One Reading LLP c/c TCN UK | | | | | | | | | | | | | |
| Scale | 1:50@A1<br>1:100@A3 | Date | 05.07.18 | Dwn | FM | Cchd | JC | Job No | 10768 | Drawing No | PL 0015 | Rev | A |

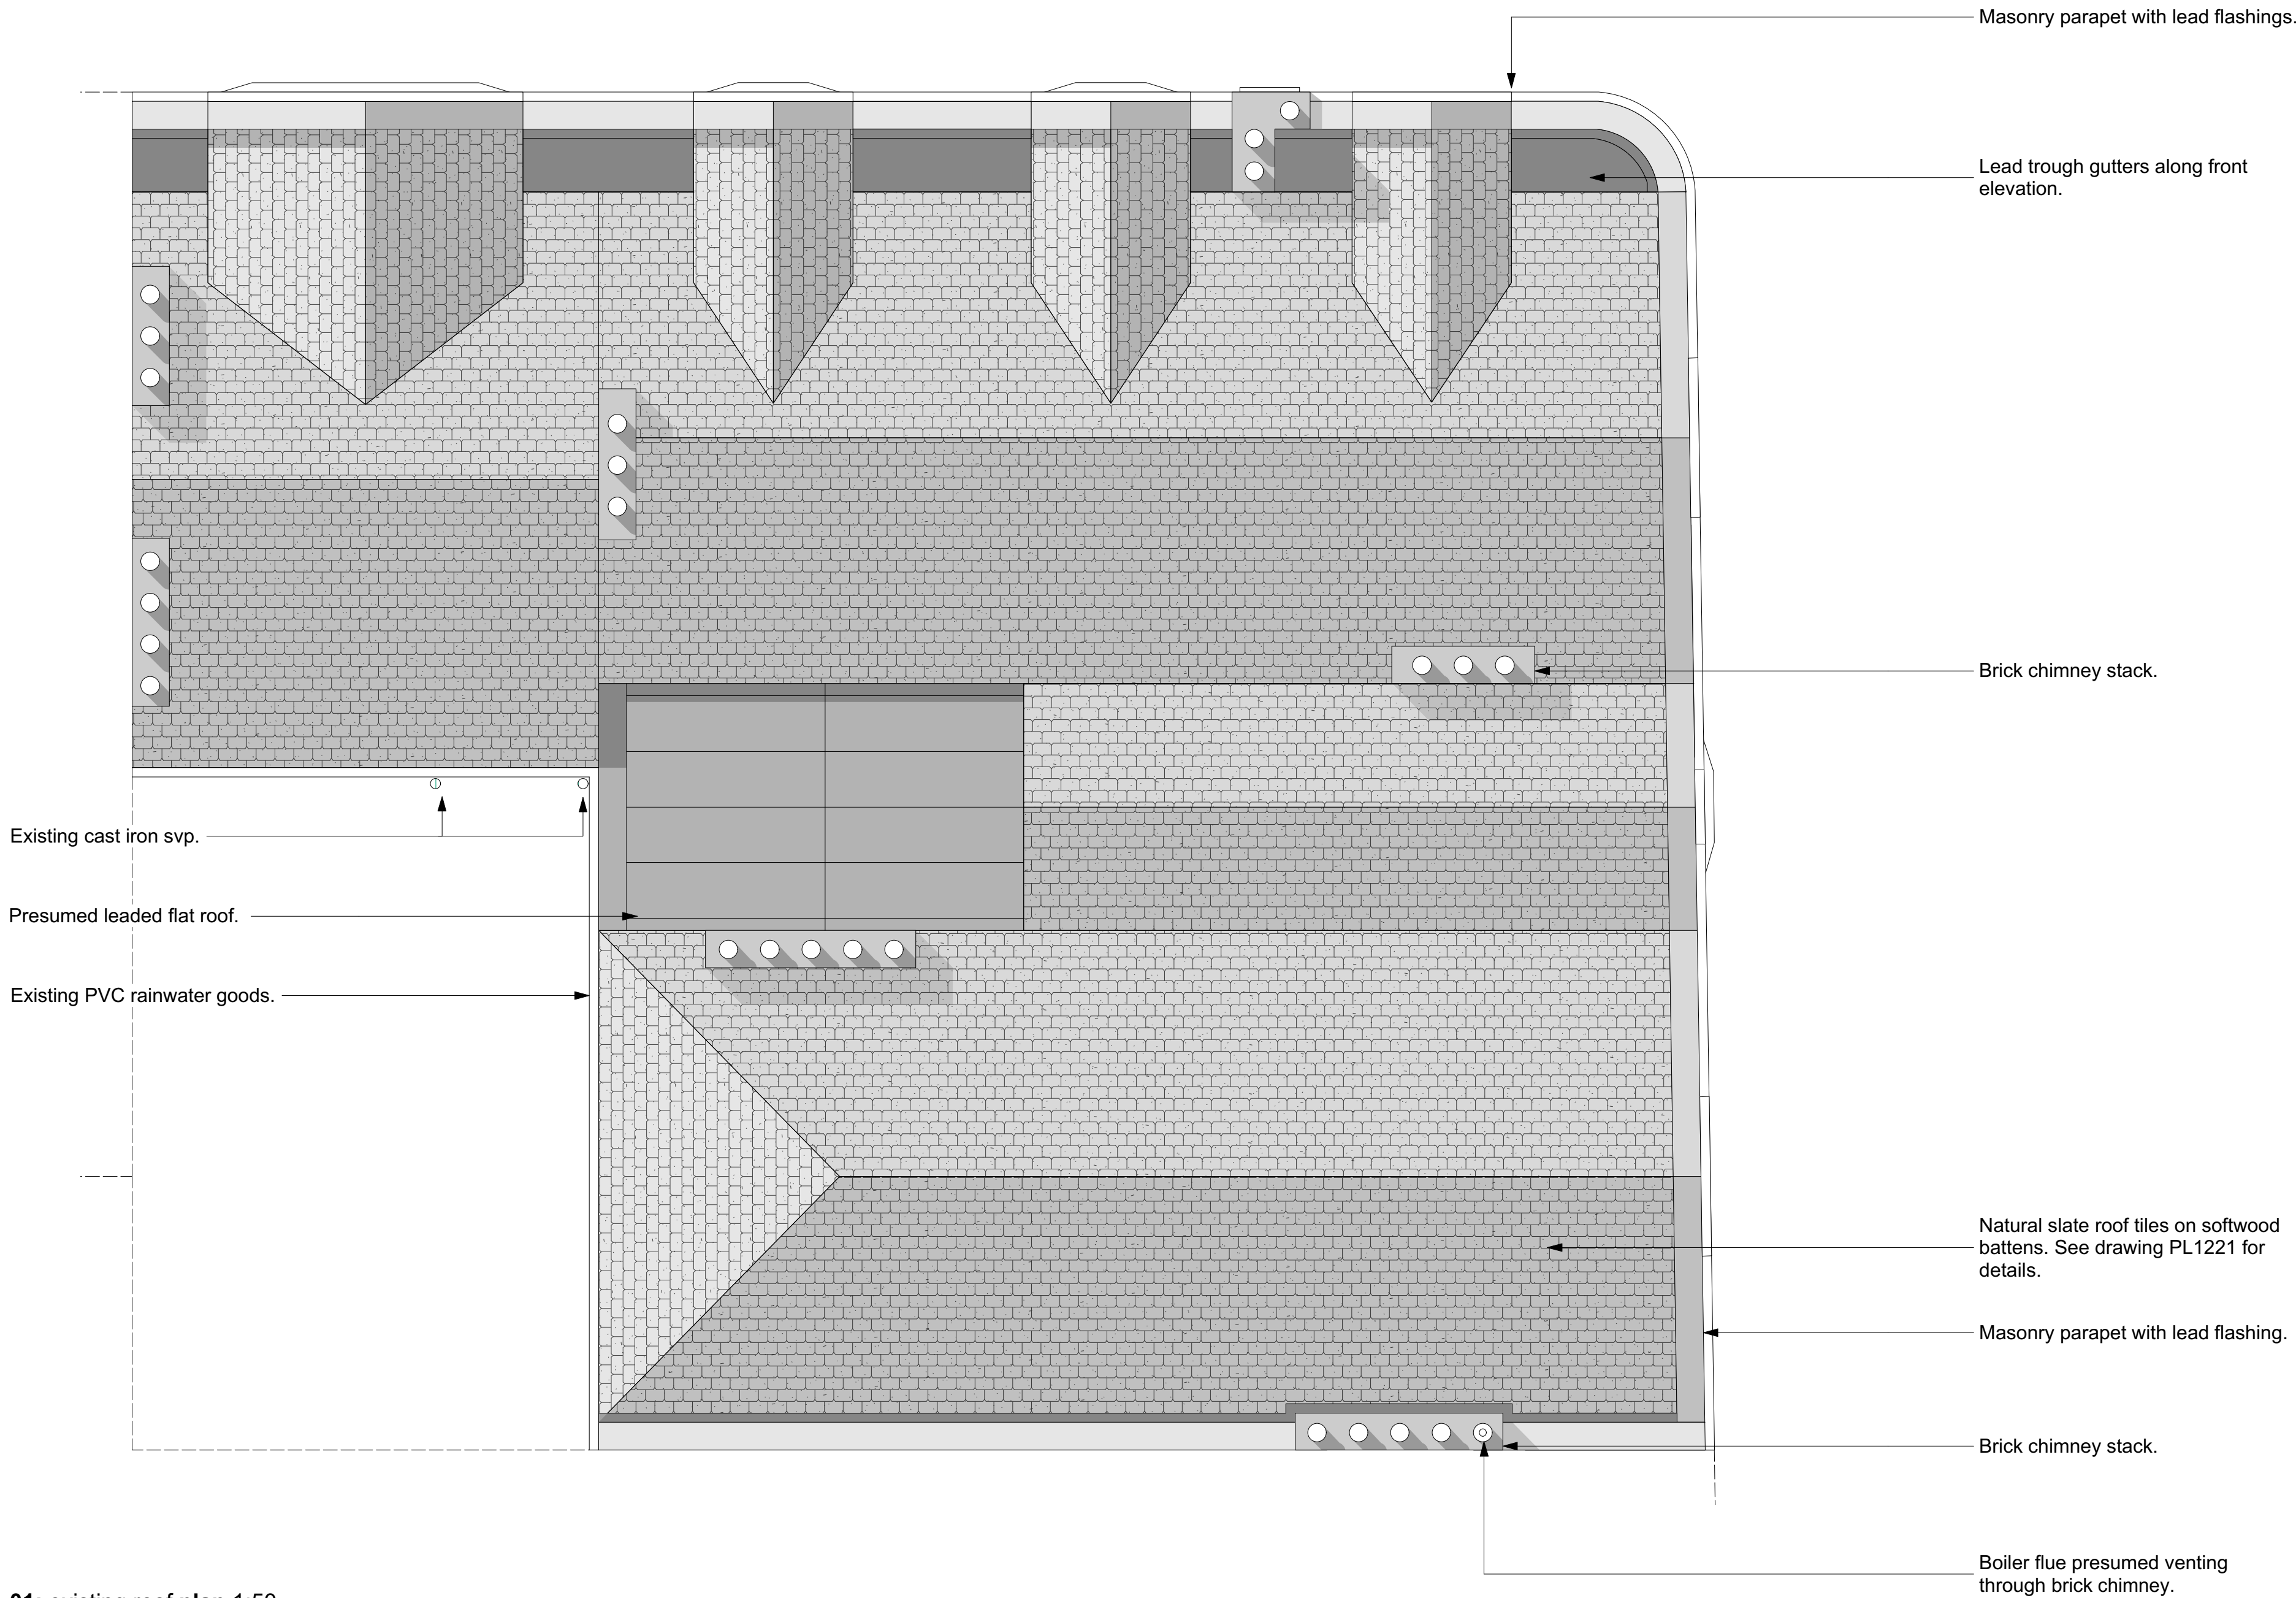
Slate on battens, supported on rafters and purlins. Larger king-post trusses spanning accomodation area. Extensive distribution of repairs, including lead and slate replacement.
