## Design Statement - 29 Christchurch Road, RG2 7AA

### 1. Proposed Damp Works

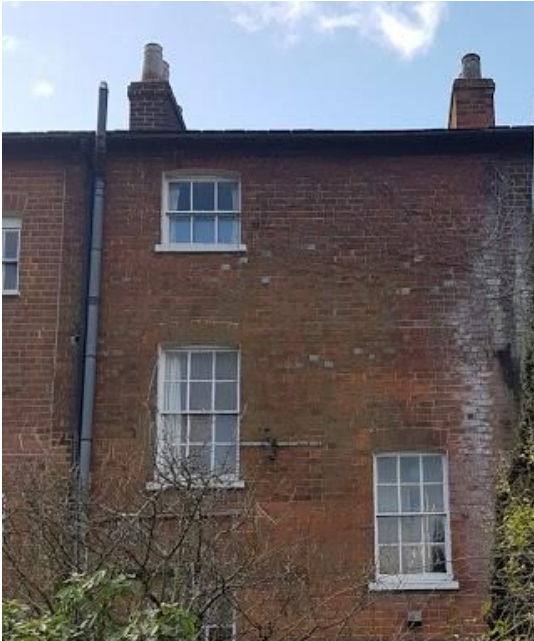
There is show of damp on rear external walls and the initial inspection shows that this is due to water ingress from due to

- damaged pointing & brickwork on the rear wall.

The current proposal to deal with the damp is by fitting new bathroom and fixing any plumbing issues. Remove the patches of plaster and replaster with similar material. Also if waterproofing of basement is required, it will be performed as per guidelines that are acceptable to listed buildings.

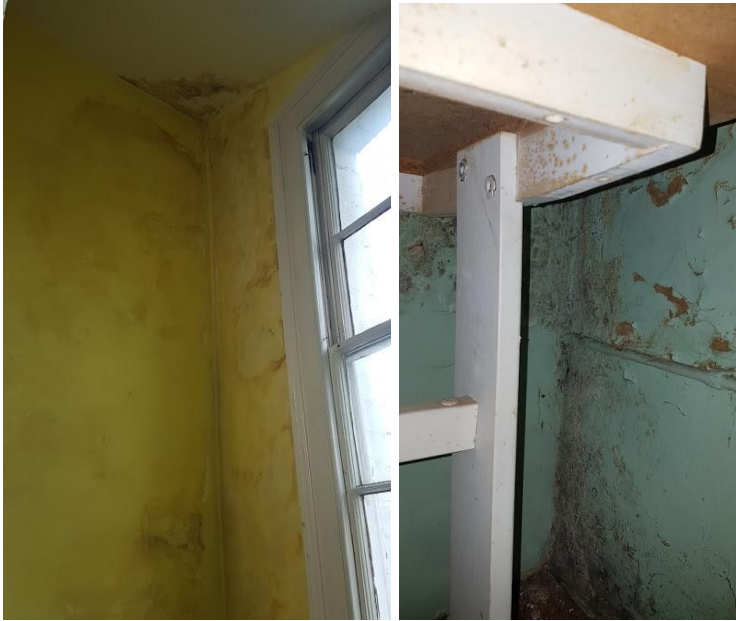
- Some leaky overflow pipes and faulty plumbing of 27, Christchurch road. The neighbours have been informed and will be discussing with them separately again

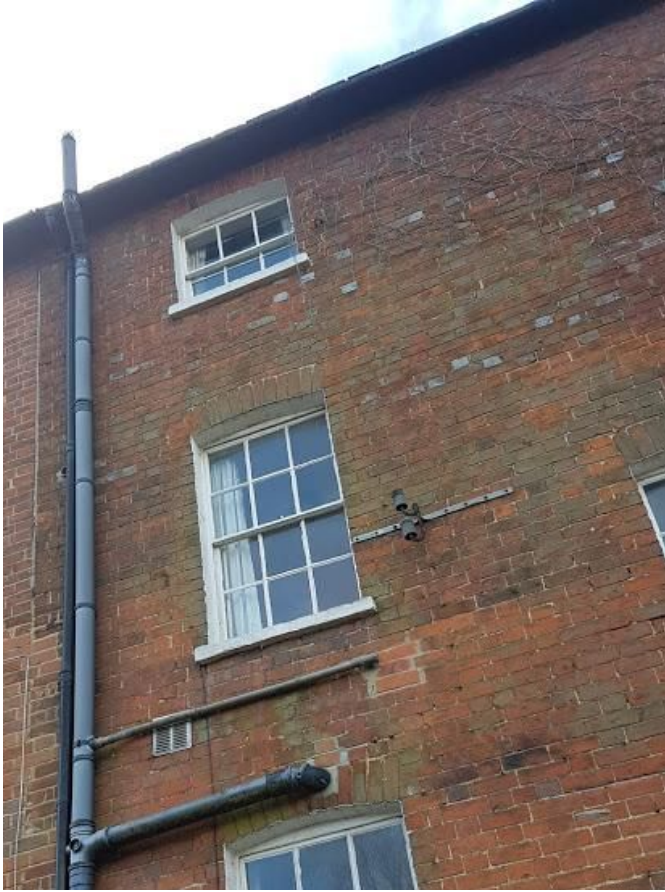
The current leaky PVC guttering and downpipes should be replaced with a like for like ones such that no water ingress into the real wall.

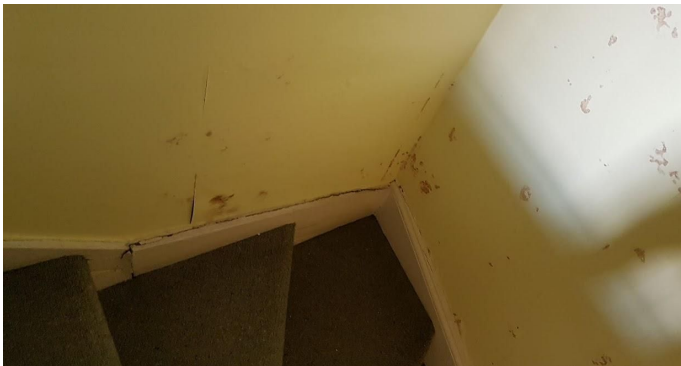
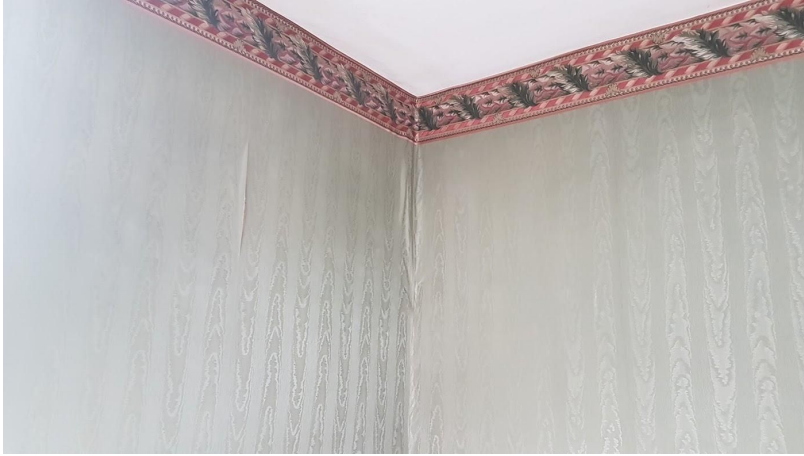
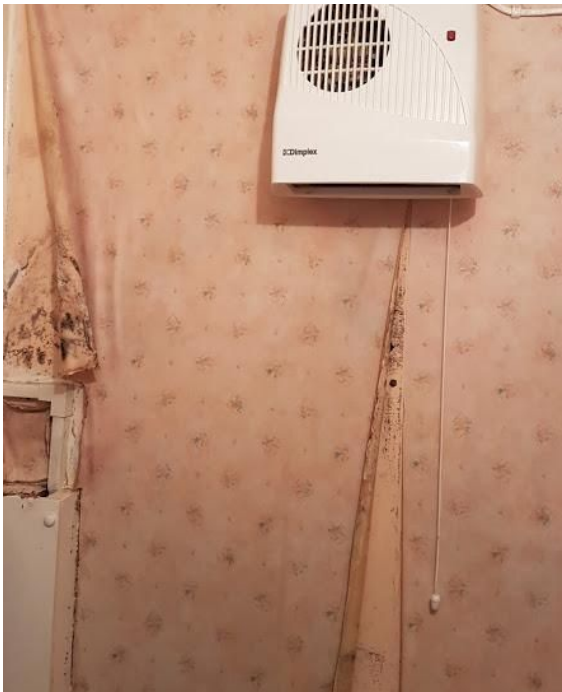
Internal walls show sign of lack of maintenance and needs redecoration for most of the walls. Currently some rooms are covered with varied wallpapers that are partly peeled off.

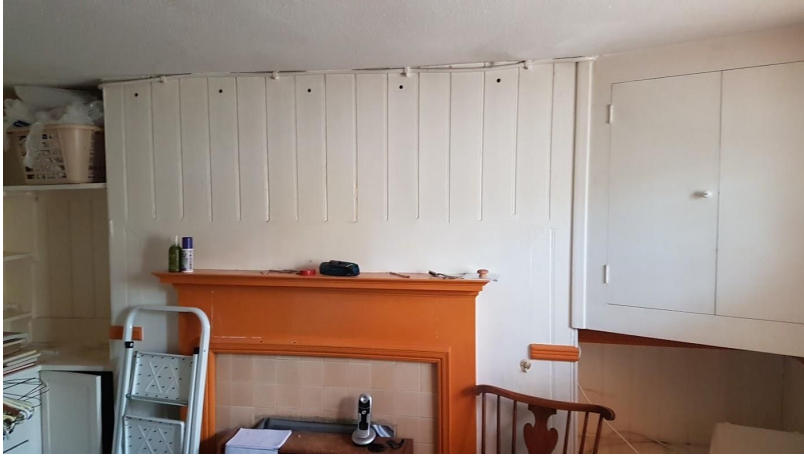
Some internal walls are covered with panels and plasterboards and depending on condition during the works they will be removed, repaired or replaced to reinstate with rest of the property.

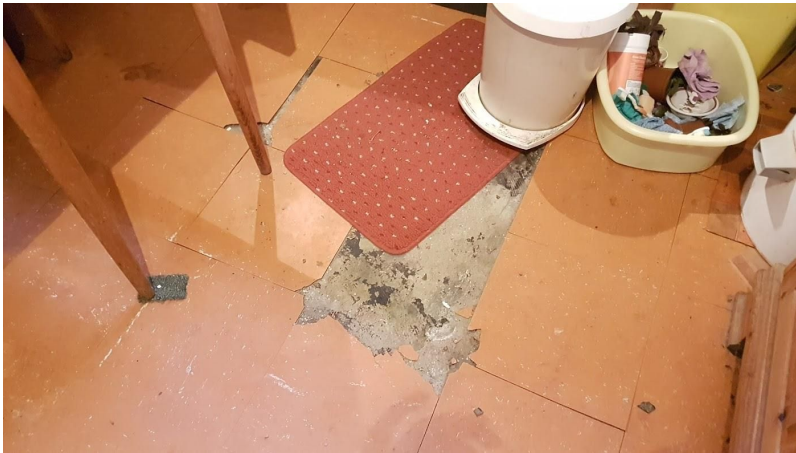
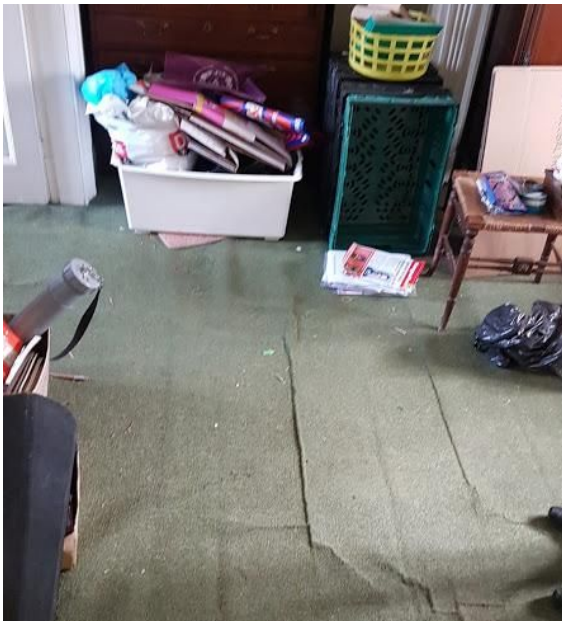
The floor covering needs replacing most of the floor levels.

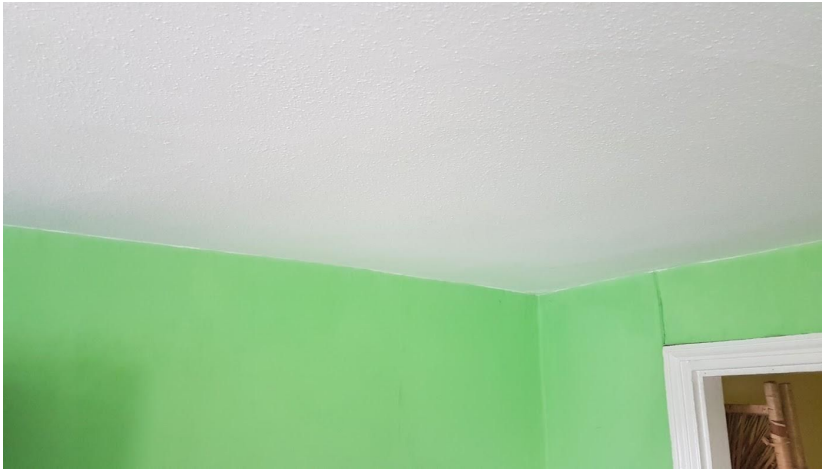
The Ceiling in the top floor is showing signs of lack of rigidity and hold and will be inspected thoroughly and if it cannot be repaired it will have to be replaced.
