**Arboricultural Impact Assessment**

**Yeomanry House**

**131 Castle Hill**

| <b>Document ref:</b> | ARB1578 |

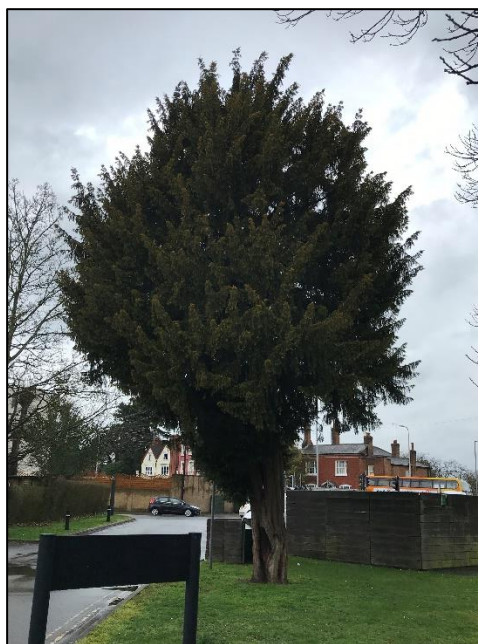
- 3.14 T2 was an early-mature European yew *Taxus baccata*. T2 had two co-dominant stems from the base, the union was weak and showing signs of failure. There was also a large bark wound with prevalent decay on the easterly side of the stem as well as multiple areas of bark damage. The tree had developed a lower secondary crown implying it was under stress. It is recommended that T2 is removed.

| Tree number | Tree species | Age class | Estimated remaining contribution (years) | Tree Height (m) | Number of stems | Stem diameter (mm) | Crown spread (m) | | | | Height to underside of canopy (m) | Physiological condition | Structural condition | Quality Assessment Category | Comments and observations | Recommended works | Root Protection Area Radius (m) for |
|---|---|---|---|---|---|---|---|---|---|---|---|---|---|---|---|---|---|
| T2 | European yew | EM | 10 -20 | 13 | 2 | 440<br>545 | 3 | 3 | 3 | 3 | 2 | F | P | C1 | Weak union from base. Bulges present with minor lean to the south implying decline and failure. Secondary crown growth present - tree under stress. | Remove | 8.4 |

**Photograph 2:** T2, bulge in stem visible lower right of stem.

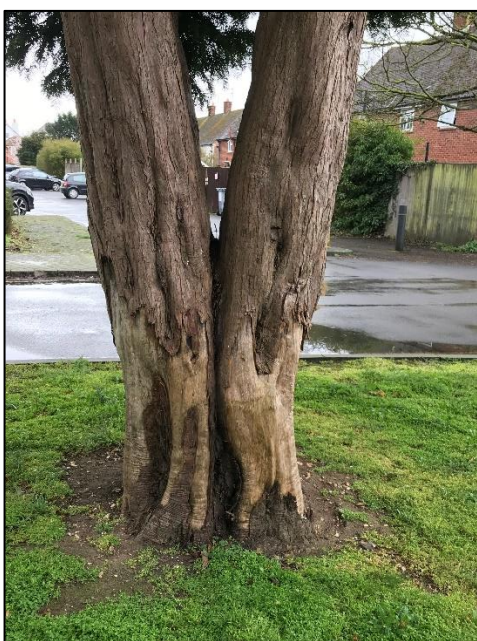
**Photograph 3:** T2's weak union, co-dominant stems and bark damage.

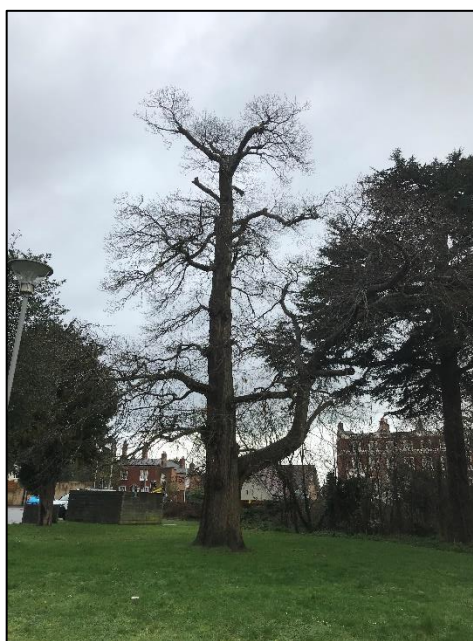
**Photograph 4:** T3

- 3.3 There were seven individual category A1 trees subject to survey, T3, T6, T7, T8, T13, T17 and T18.
- 3.4 T3 was a mature sweet chestnut *Castanea sativa*. T3's crown had been kept compact, but it was a good example of the species growing in relatively open ground with good levels of new growth.

- 4.9 Special methods will need to be designed and considered for the installation of the new hardstanding for the carparking that encroaches into the RPAs of T3 and T8.

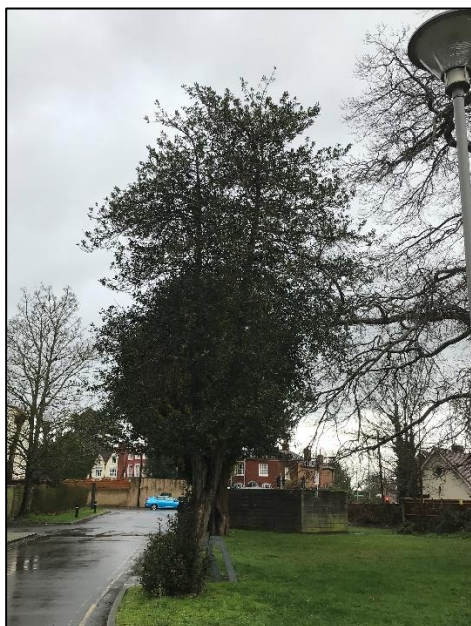
- 3.15 T4 was a young European holly *Ilex aquifolium*. There was a large bark wound on the easterly side of T4's stem running from the base to approximately 1.5m and on the north-westerly side from the base to 0.5m. The wounds were partially occluded but decay was evident. It is recommended that T4 is removed.

| T4 | European holly | Y | 10 -20 | 6.5 | 1 | 315 | 2 | 2 | 2 | 1.5 | 2 | F | F | C1 | Large bark wounds on stem. Easterly from base to 1.5m. North-westerly from base to 0.5m. Some occlusion but decay evident. Additional cavity on southern limb right through branch. | Remove | 3.8 |

**Photograph 5:** T4 with T2 behind.

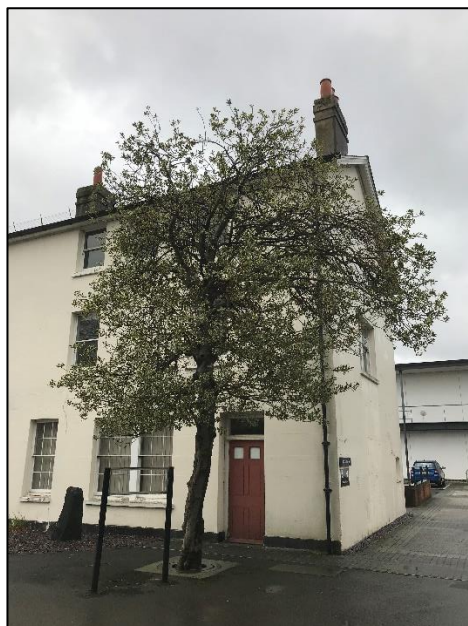
**Photograph 6:** T5

- 3.24 There was one individual category U tree, T5 and one category U group of trees, G2 subject to survey.
- 3.25 T5 was a semi-mature European holly. T5 had been planting in an inappropriate position close to the Yeomanry House building and access road. As a result, the tree has been regularly pruned back from the building and the road leaving it with many pruning wounds. Deadwood and apical dieback were present, and the tree was in a slow state of decline. It is recommended that T5 is removed.

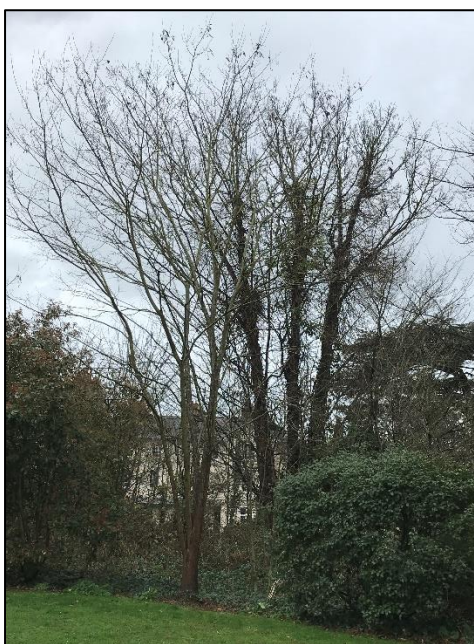
- 3.16 T9 was a young false acacia *Robinia pseudoacacia*. T9 was growing well but had some smaller lower lateral branches that had weak unions. This branch could be removed successfully due to the trees young age and would promote healthy future growth patterns.

**Photograph 8:** T9 in foreground, T10 behind.

- 6.8 T15 is also in conflict with the development however the recommendation to remove this tree is made irrespective of the proposals.
- 6.9 The two lower limbs of T9 should be removed due to weak unions. The tree is still young enough and the limbs small enough that this will not create large pruning wounds.

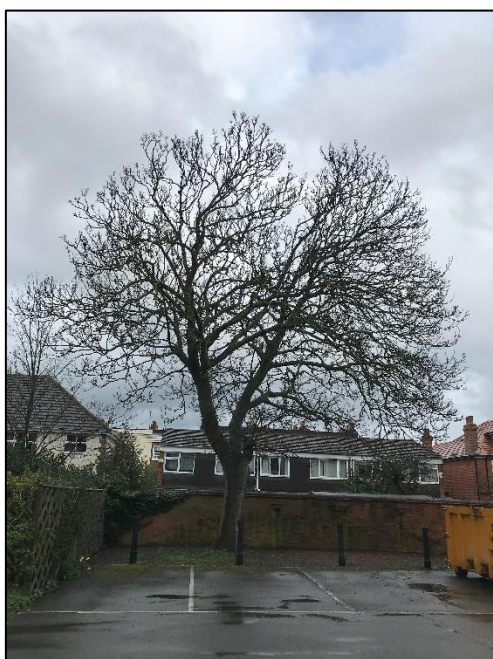
**Photograph 11:** T15

- 3.20 T15 was a mature sycamore, T15 had some apical dieback and deadwood in the crown. The tree had two-codominant leaders and the form and growth patterns of the T15 were poor overall with the southerly leader leaning away from the main stem of the tree. A third large leader appears to have snapped out in the last five years leaving a large branch stub. Due to the surrounding residential gardens and the high levels of public access to the site it is recommended that T15 is removed as its safe useful life expectancy is considered limited and the surrounding target areas if it were to fail high.

| T15 | Sycamore | M | 20- 40 | 16 | 1 | 610 | 5.5 | 5 | 6 | 5.5 | 2.5 | G | F | C1 | Dieback and deadwood, uneven form with two co-dominant leaders, southerly leader leaning. Third leader has broken off. No safe useful life expectancy. | Remove. | 7.3 |

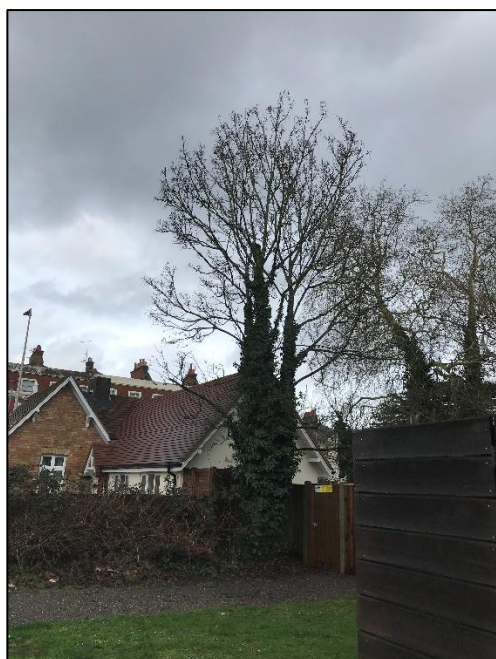
**Photograph 12:** T16

- 3.21 T16 was an early-mature sycamore. The tree was self-sett and very close to an adjacent cottage building. The tree was ivy clad but appeared to be growing well. The ivy growing on T16 could be severed.

- 6.10 It is recommended that the ivy is severed at the base of T16 to allow for future monitoring and inspection.
- 6.11 T17 and T18 are overhanging the traffic lights on the adjacent Castle Hill. It is recommended that the crowns of these trees are lifted so the traffic lights are fully visible.

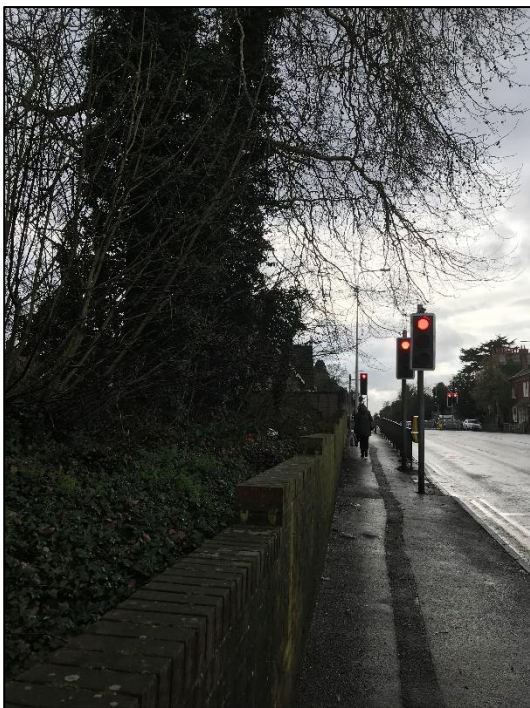
- 3.9 T17 and T18 were early-mature London planes *Platanus × hispanica*. T17 and T18 were rooted close to the adjacent footpath and highway on Castle Hill. Small areas of the tree's crowns were overhang the traffic lights on the junction. It is recommended that T17 and T18 have their crowns lifted away from the traffic lights on Castle Hill.

**Photograph 15: T17 and T18 overhanging traffic lights on junction of Castle Hill and Coley Avenue.**

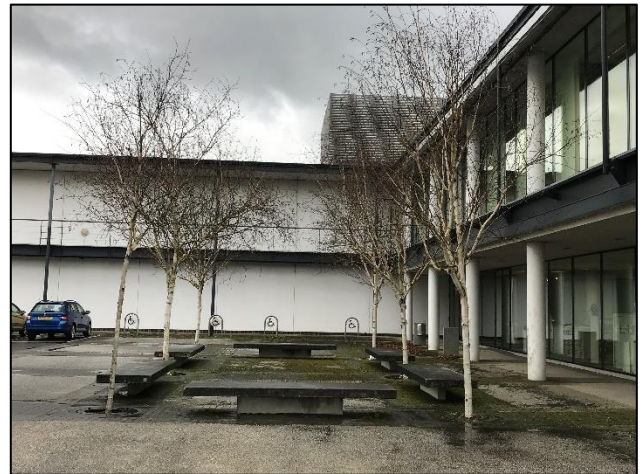
**Photograph 16: G1**

- 3.22 G1 was a young group of West Himalayan birch *Betula utilis* var. *jacquemontii*. There were six trees in G1 rooted in hard standing with grates. The trees form part of a seating area between Yeomanry House and Reading Records Office. The trees in G1 were developing well but would benefit from formative pruning to encourage healthy future growth habits.

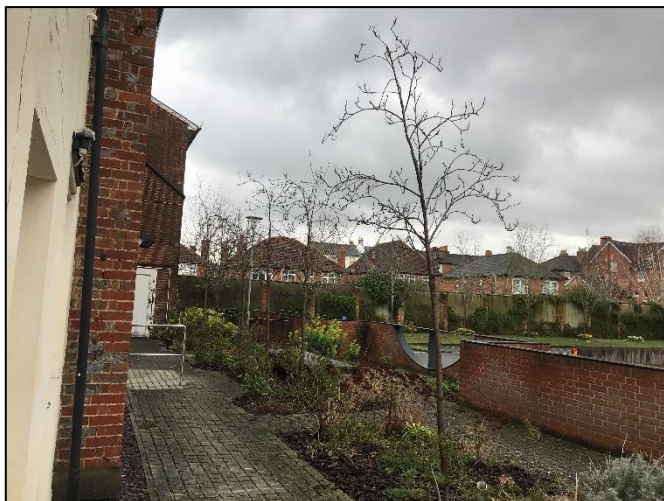
**Photograph 17: G2**

- 3.26 G2 was a young group of *Prunus sp.* There were five trees in G2 all of which were in the later stages of decline. Dieback in the crowns was extensive and bark was sloughing from the main stems and crown, some limbs had also snapped out. It appeared that the new trees were in decline due to a lack of water which is important for newly planted trees. It is recommended that the five trees in G2 are removed as recovery is very unlikely.

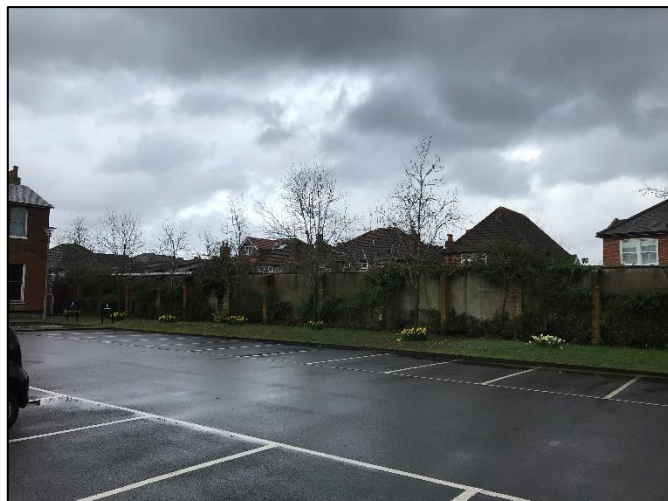
**Photograph 18: G3**

- 3.23 G3 was a young group of common rowan *Sorbus aucuparia*. There were seven trees in G3 which were all showing signs of apical dieback with dead buds present. These trees should be reinspected in the Spring/Summer when they are in leaf to assess the level of dieback.
