**SCHEDULE OF REPAIRS**  
1-3 Castle Crescent, Reading, RG1 6AQ

Prepared for: Lucas Design  
Issue 3: 08 December 2017  
Ref: BS8170910/AM/DW/007

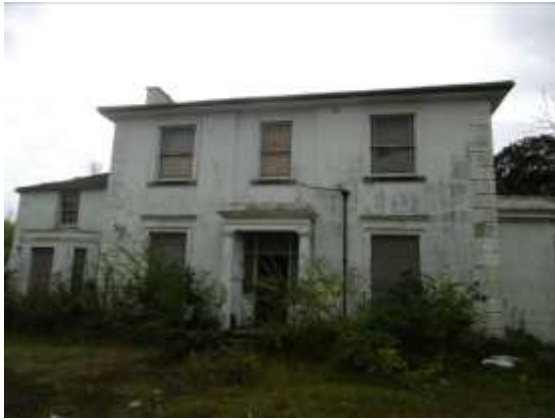
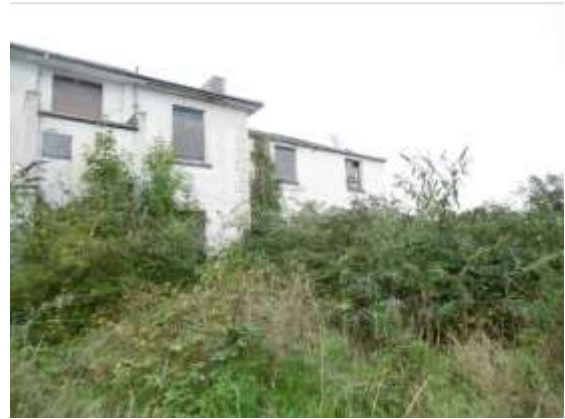
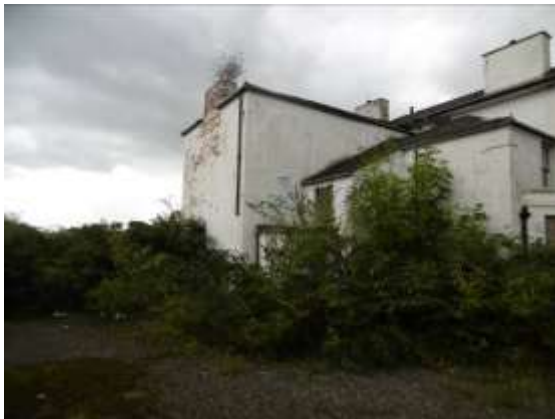
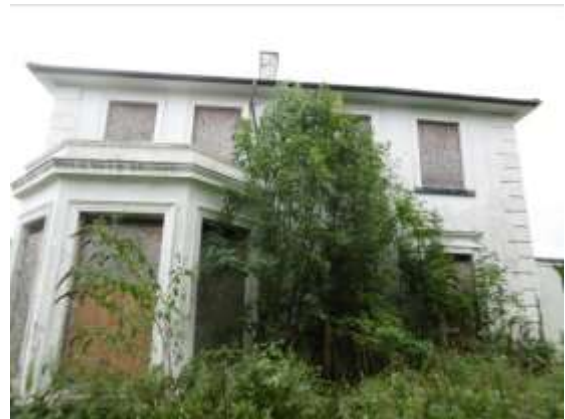
| Item | Location / Element | Defects | Repairs | Photo Ref |
|---|---|---|---|---|
| 1.1 | Vegetation | Substantial overgrown vegetation and trees to all elevations and in the curtilage restricted our inspection of all of the walls at low level and upper parts to the west flank and rear elevations. | All trees and vegetation concealing parts of the building to be cut back and removed including grubbing out roots to expose the walls and enable further investigations and trial pits to be dug as part of structural investigation and design process. | 1-4 |

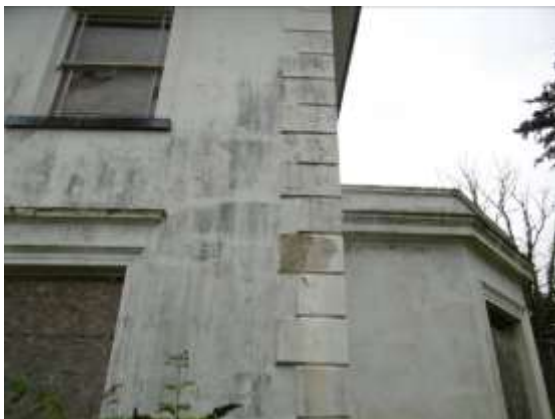
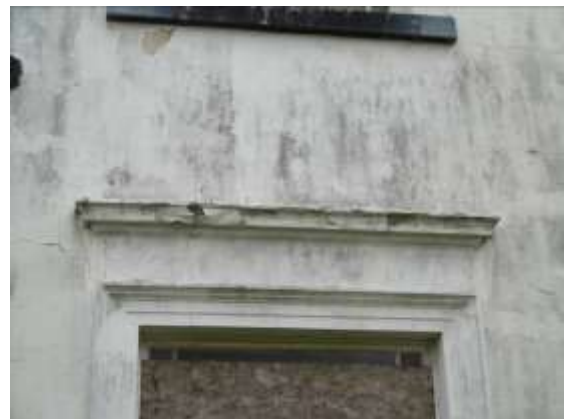
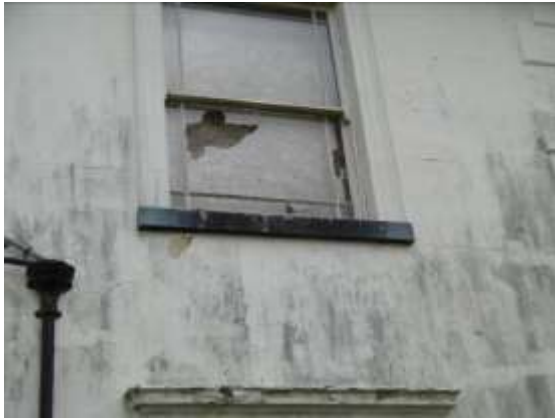
| Item | Location / Element | Defects | Repairs | Photo Ref |
|---|---|---|---|---|
| 2.1 | Render Coating and Plinth to Walls | <p>Crazed cracking to render across all elevations; white painted surfaces peeling, discoloured and deteriorating.</p> <p>Black colour painted render plinth cracked and deteriorated.</p> | <p>Carefully remove flaking and peeled paint with a wire brush and/or pressure washer to expose render. Treat surfaces and remove organic growth. Fill cracks and carry out patch repairs to the walls, plinth, quoins and mouldings. Redecorate surfaces with a Keim mineral paint system or traditional lime wash to a colour agreed by the Listed Building Officer.</p> | 5-7 |

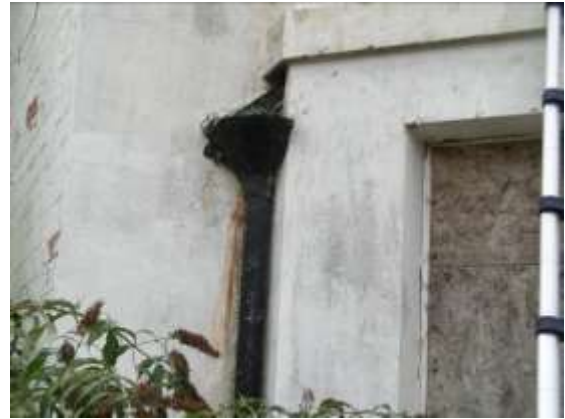
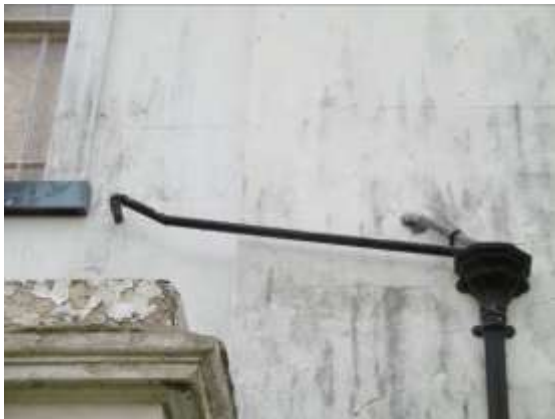
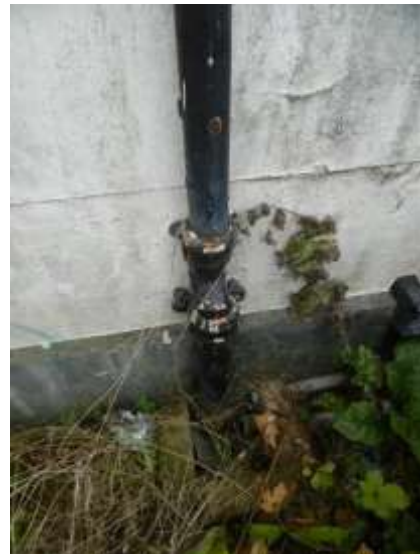
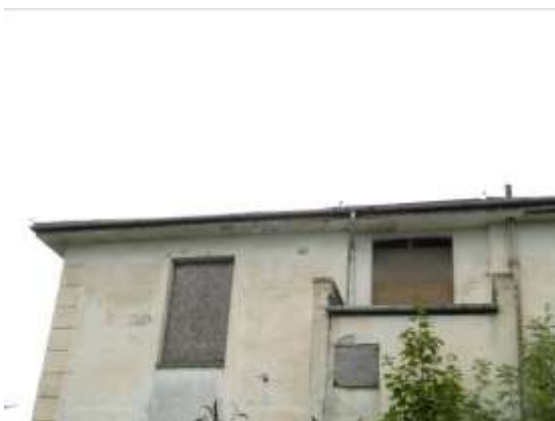
| Item | Location / Element | Defects | Repairs | Photo Ref |
|---|---|---|---|---|
| 2.2 | Rainwater Goods | <p>Generally half round plastic guttering of some age and likely to be brittle and leaking.</p> <p>Black colour painted cast iron downpipes and hoppers are corroded and blocked with vegetation.</p> <p>Missing downpipe section to West flank elevation. Possible contributory factor to collapsed bay window roof structure and damp penetration.</p> | <p>Remove and cart away all existing rainwater goods including guttering, downpipes, hoppers and brackets. Replace with aluminium rainwater goods with heritage / traditional style hoppers and half round guttering sympathetic with the building period.</p> <p>Hoppers and downpipes picking up waste connections should be omitted and new waste connections redirected into a new soil and vent pipe.</p> | 8-11 |

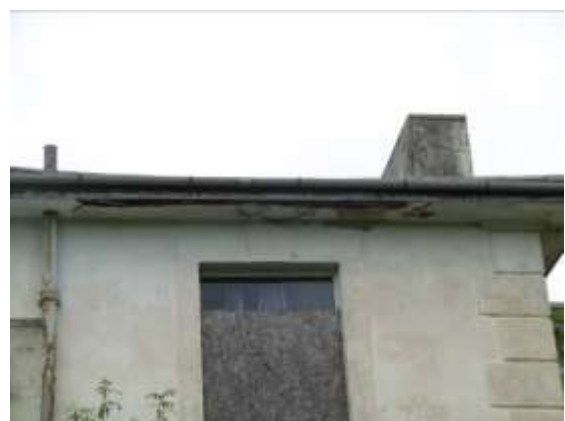
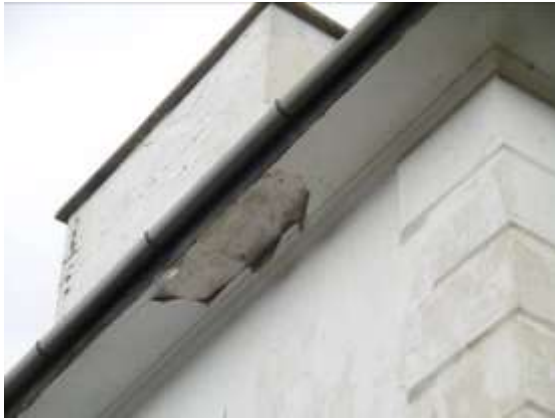
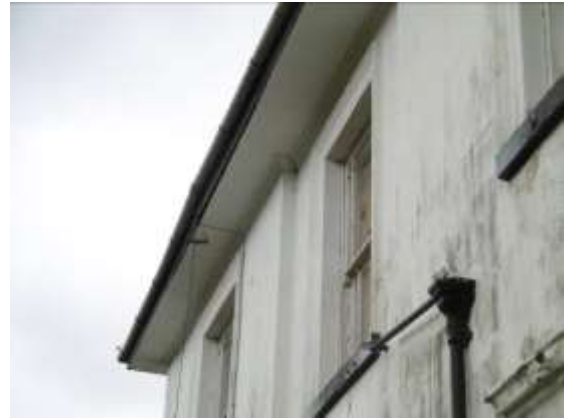
| Item | Location / Element | Defects | Repairs | Photo Ref |
|---|---|---|---|---|
| 2.3 | Fascia and Soffits | <p>Timbers are decayed and sections missing. Decorations are deteriorated.</p> <p>NB - There is a risk of the presence of asbestos cement board (section exposed to east flank were decorations deteriorated).</p> | <p>Any asbestos found is to be removed by licenced contractor in advance of demolition/strip out works.</p> <p>Remove and cart away existing materials and replace with new timber fascia and soffits.</p> | 12-14 |

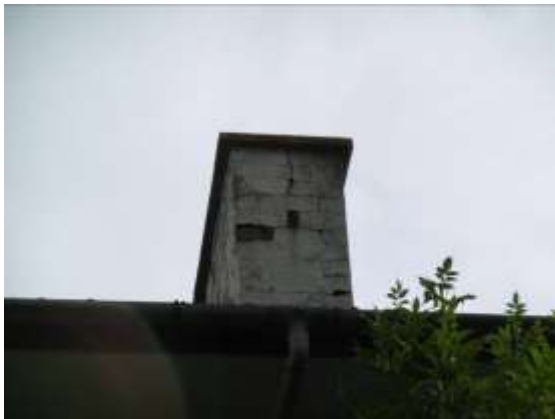
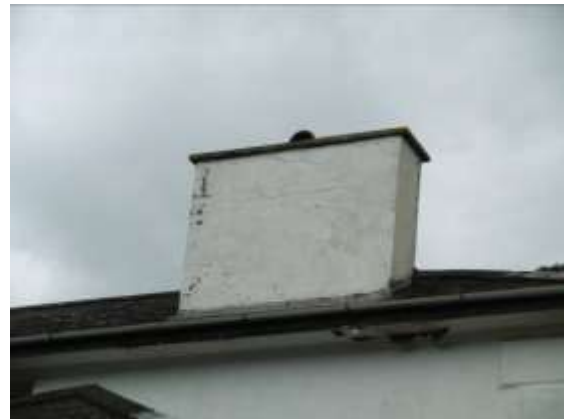
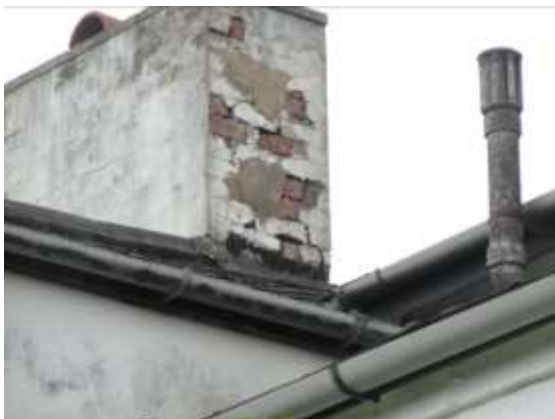
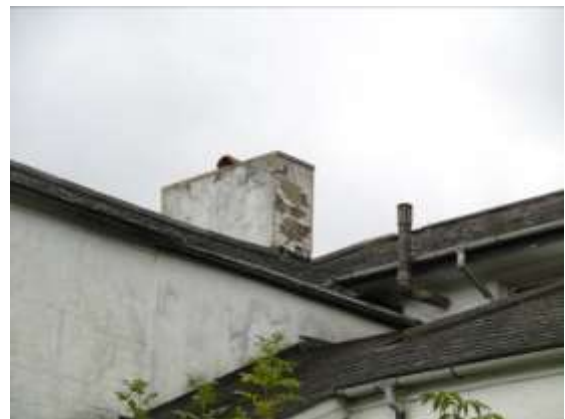
| Item | Location / Element | Defects | Repairs | Photo Ref |
|---|---|---|---|---|
| 2.4 | Chimney Stacks | <p>It was not possible to fully inspect the stacks from an external ground level; only very limited site lines were possible in some areas, although the tone of condition could be established from this.</p> <p>The render coating where visible in areas has crazed cracking and is missing. Decorations are poor; brickwork and pointing cracked, eroded and deteriorated in areas; clay pots are missing; lead flashings likely to have failed/missing and it was not possible to confirm if lead soakers are present. No significant leaning to visible stacks seen.</p> | <p>A thorough overhaul is required. Replace render coatings which generally appear cracked and deteriorated beyond repair. Cut out defective bricks and replace; rake out mortar joints and re-point. Set aside original clay pots for re-instatement. Allow to renew cement flaunchings, cappings, cowl, flashings. Ensure surfaces are clean and free from organic growth and grease; carry out redecorations.</p> | 15-18 |

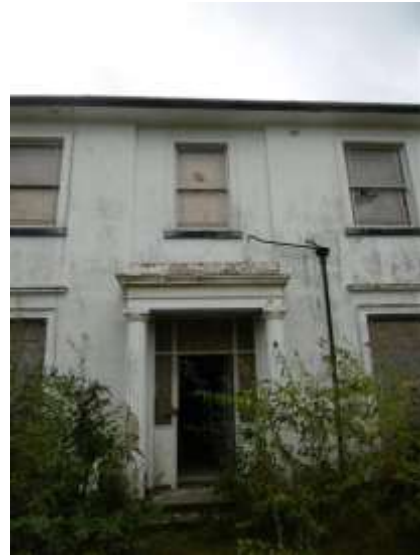
| Item | Location / Element | Defects | Repairs | Photo Ref |
|---|---|---|---|---|
| 3.0 | Entrance Door and Glazing | Timber entrance door damaged and in very poor state of repair from previous break-ins and works to secure premises. The timber surroundings have some localised damage and glazing is missing. | Allow to replace the door with a purpose made timber door to a design that matches the existing, including the original 6 panel and moulding details. Door bell and knocker features replaced are to closely match the original. Retain existing timber surrounds, scarf in new timbers, fill, prepare surfaces and carry redecorations. Replace broken and missing glazing with safety glazing. | 19-20 |
| 3.2 | Windows and Glazing | Timber sash, single glazed windows are boarded over internally and externally in many locations and not visible. Later alterations have been carried out altering the form of the windows. Glazing is broken and missing, joinery is weathered, muntins missing and wet rot evident. | The surviving timber multi-pane sash windows with glazing bars and decorative detailing should be retained and refurbished as existing. Replacement glazing should be toughened, single glazed safety glass with an internal secondary glazing system.<br><br>Where the original sash windows have been altered to glazed slatted windows (e.g. ground floor room G2); the windows should be replaced with new to | 7,20,28 |

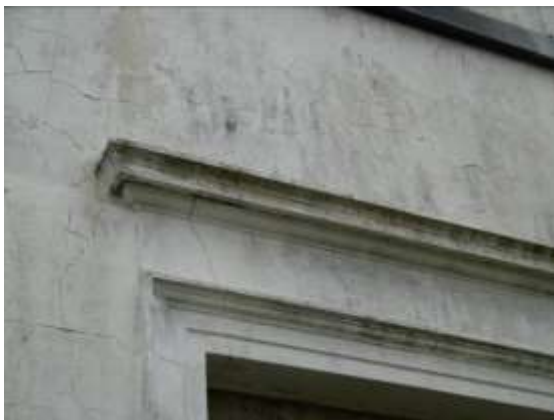
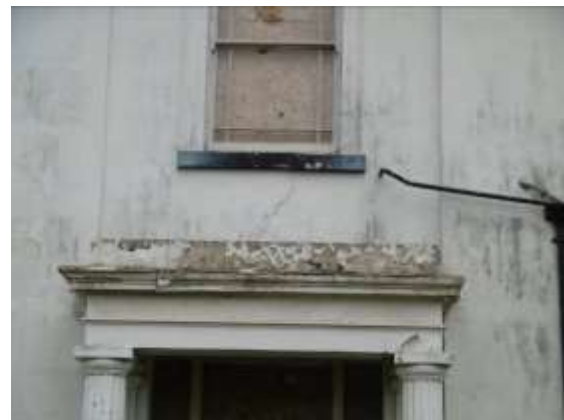
| Item | Location / Element | Defects | Repairs | Photo Ref |
|---|---|---|---|---|
| 3.1 | Window and Door Openings | Vertical cracking above all window openings. Some mouldings have dropped out of alignment.<br><br>Large vertical crack above portico structure / entrance opening; circa 5mm wide. Window sill above dropped on right side. | Provide support and carefully open up structure from internal side to inspect lintels. Allow to replace all existing lintels and beams to Structural Engineer's design and specifications prior to making good.<br><br>Externally, fill cracks prior to redecorations. Where the transom of the mouldings have dropped out of alignment due to failed lintels and structural movement, fill cracks and repair or remove and replace to match existing. | 6, 21-23 |

| Item | Location / Element | Defects | Repairs | Photo Ref |
|---|---|---|---|---|
| 3.4 | Window Sills | Nearly all concrete sills are cracked and some spalled; all painted surfaces are flaking and peeling. | Rub down surfaces, treat with biocide and fill cracks prior to redecorations. Where sills have dropped out of alignment due to cracking from structural movement, carefully remove and replace with new to match existing. | 7,22,25 |

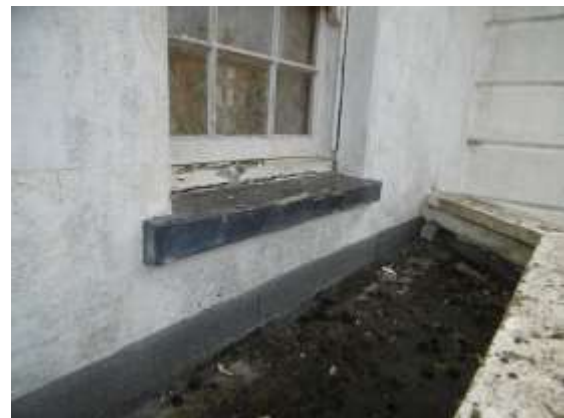
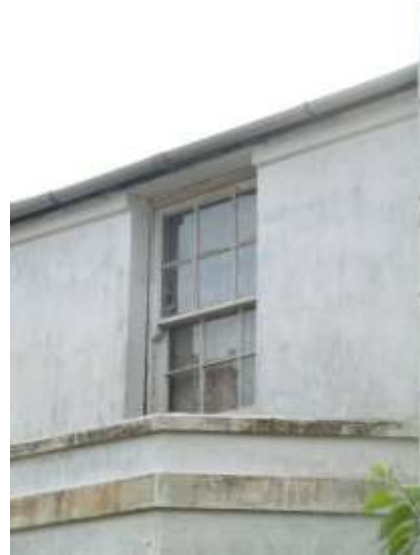
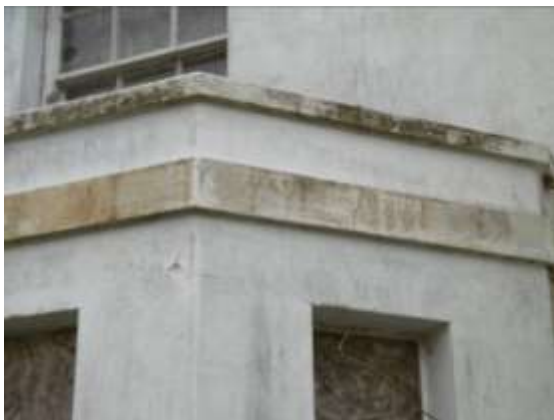
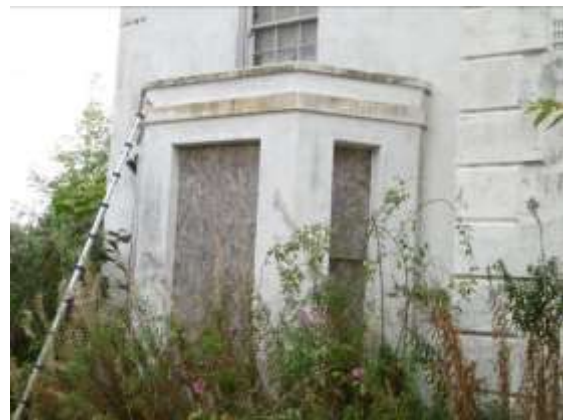
| Item | Location / Element | Defects | Repairs | Photo Ref |
|---|---|---|---|---|
| 3.3 | Bay Window | <p>Vertical cracks below and above window openings. Cracks join-up horizontally and extend up through string course and copings to parapet.</p> <p>Flat roof covering deteriorated and lead flashings missing. Roof has failed causing substantial water ingress into room below.</p> <p>Building wall above bay (below 1<sup>st</sup> floor window) showing vertical cracking and sill has dropped. Open joints around window opening approximately 10-30mm wide indicating structural movement.</p> | <p>Provide support to structural opening in wall and allow to open up structure internally above bay to inspect the bressumer beam / lintel and replace with new to engineer's design prior to making good.</p> <p>Replace timber roof structure, including insulation, coverings and leadwork to Architect's detail and engineer's design.</p> <p>Further investigations of the sub-structure and ground conditions are recommended as a precautionary measure. Dig trial holes to expose and allow inspection by Structural Engineer of foundations and soil conditions. Underpinning of the bay window may be required.</p> | 24-28 |

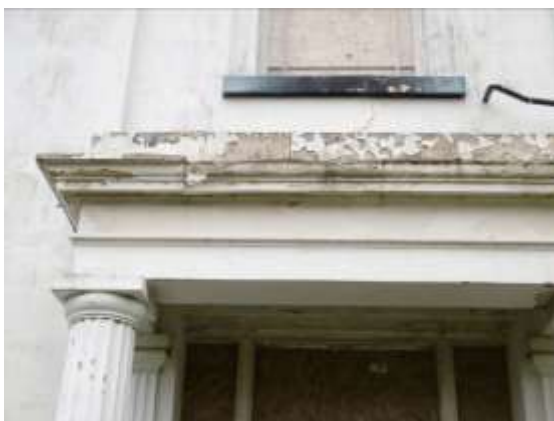
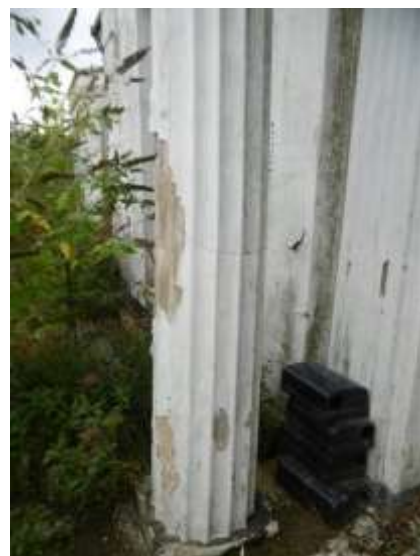
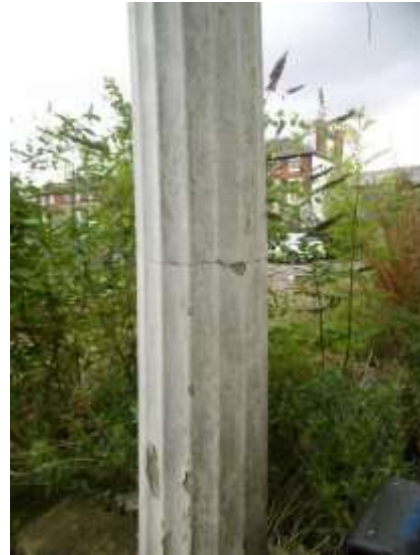
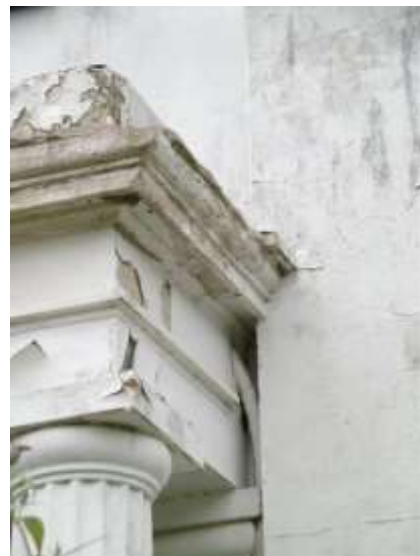
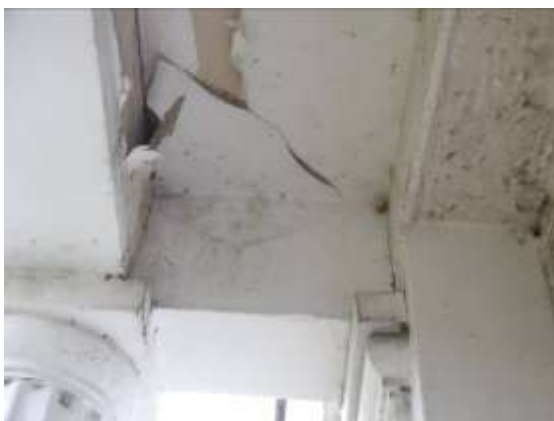
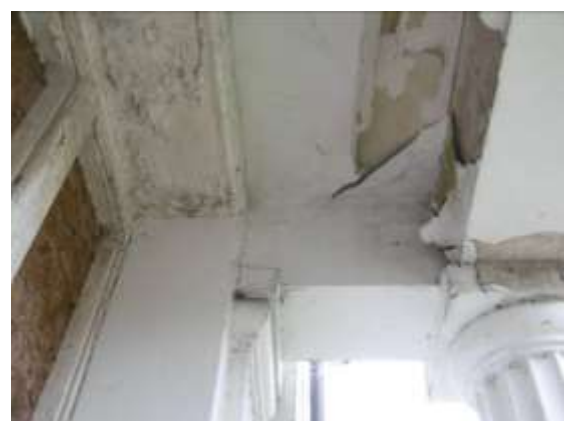
| Item | Location / Element | Defects | Repairs | Photo Ref |
|---|---|---|---|---|
| 3.5 | Portico Structure | <p>No inspection of roof surface possible. Visible evidence of structural movement - open joints at abutment; vertical cracks through string course and underside of roof. String courses to front face dropped, horizontal cracking below extending round to flank and joining up with others. Substantial water erosion to parapet / string courses at upper parts.</p> <p>Left column surfaces to lower sections deteriorated from water erosion and cracking and shear failure seen extending through column transverse section to lower section.</p> | <p>Provide support and carefully remove upper parts and string courses to lintel / plinth level above columns. Inspect lintel / plinth for cracking and replace sections as necessary to match existing. Ensure portico structure adequately tied back to building. Replace eroded and cracked string courses in agreed stonework and mouldings to match existing. Carefully dismantle damaged column and replace eroded and cracked sections of left column with new to match the existing. Rub down peeled and flaking paintwork and prepare surfaces prior to redecorations.</p> | 22,29-37 |

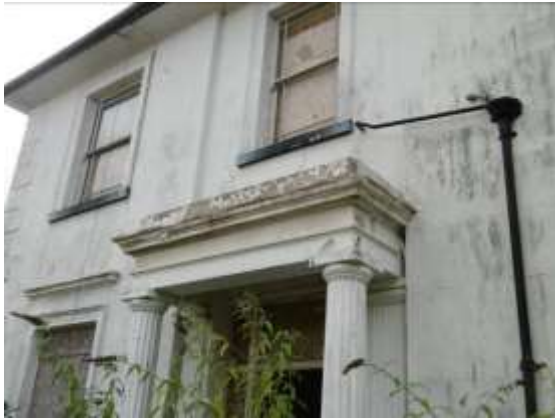
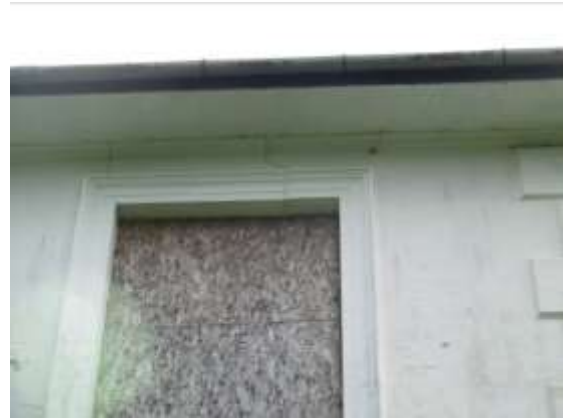
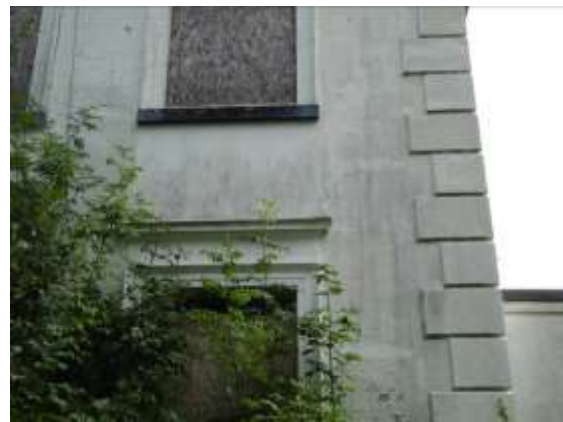
| Item | Location / Element | Defects | Repairs | Photo Ref |
|---|---|---|---|---|
| 4.0 | Windows and Openings | It was not possible to inspect the first floor windows fully due to obstruction by vegetation growth. Vertical cracks were present above all of the visible openings and likely to be above others. | Remedial works as items 3.1 and 3.2. | 4,38,40 |
| 4.1 | Southwest corner of building | Structural movement possible; vertical cracking visible from ground level extending up past openings to eaves level. Lintel to first floor dropped to one side. Slight buckle of rear elevation noted. | Possible cause of cracking from structural movement in roof and further advice should be sought from a Structural Engineer. As a precautionary measure, dig trial holes for structural engineer to inspect sub-structure and soil conditions. | 38-40 |

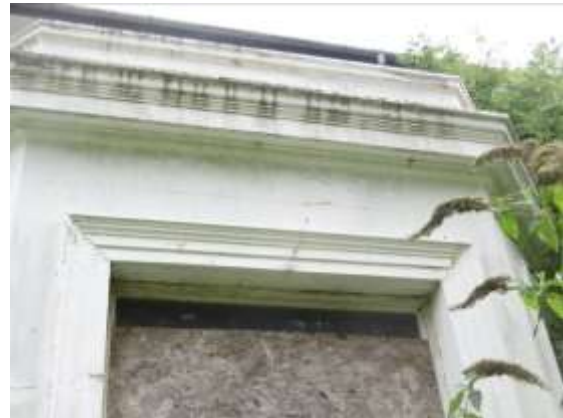
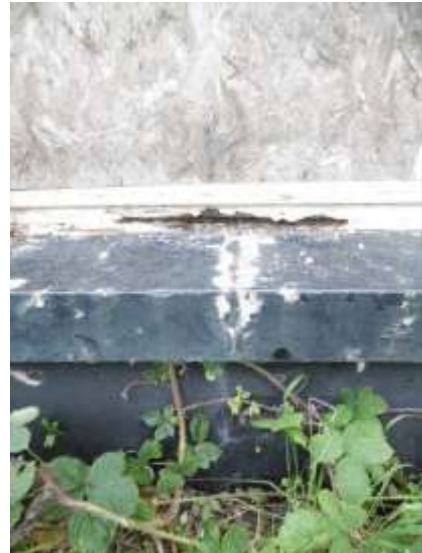
| Item | Location / Element | Defects | Repairs | Photo Ref |
|---|---|---|---|---|
| 4.2 | Bay Window | Cracking above and below all structural openings. No access to inspect high level; roof structure collapsed inside room below. | Provide support to structural opening in wall and open up structure internally above bay to inspect the bressumer beam / lintel and replace with new as required to engineer's design prior to making good. Allow to replace timber roof structure, including insulation, coverings and leadwork to Architect's detail and engineer design. Mullions to bays to be rubbed down, cracks filled and preparations carried out prior to redecorations. Further investigations of sub-structure and ground conditions are recommended as a pre-cautionary measure. Dig trial holes to allow inspection by Structural Engineer of foundations and soil conditions. Underpinning of the bay may be required. | 41-44 |

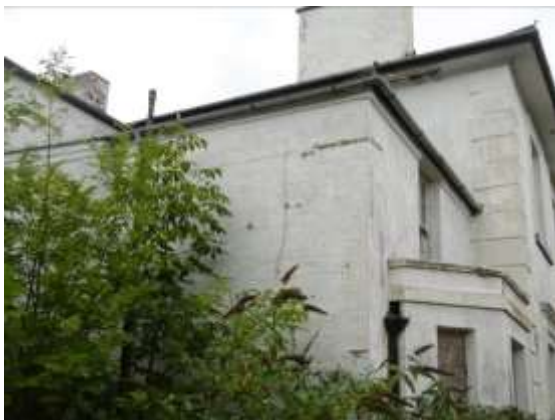
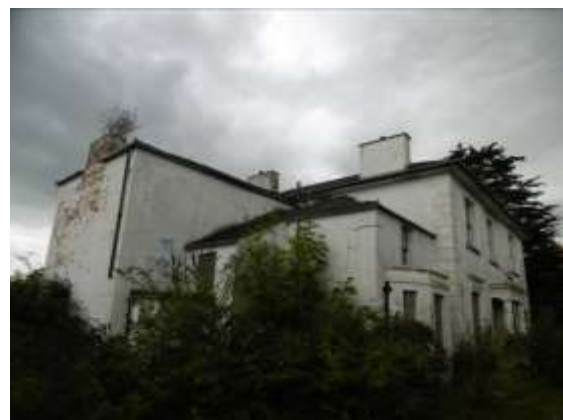
| Item | Location / Element | Defects | Repairs | Photo Ref |
|---|---|---|---|---|
| 5.0 | Walls | <p>Later additions to this elevation are to be demolished as part of the redevelopment of the site. The existing construction to be demolished concealed the majority of the structure being retained. The first floor window and box gutter were not possible to inspect or visible from ground level.</p> <p>Stepped cracking at eaves level seen by downpipe.</p> <p>Drill holes in brickwork to corner at first floor level and evident of deteriorated and spalled brickwork present.</p> | <p>Brickwork to be inspected following demolitions and repairs completed as necessary.</p> <p>Temporary weatherproofing of newly exposed walls to be provided including securing existing openings to prevent unauthorised access until area watertight and secure.</p> <p>Rub down decorations and prepare substrate to receive redecorations.</p> | 45,46 |

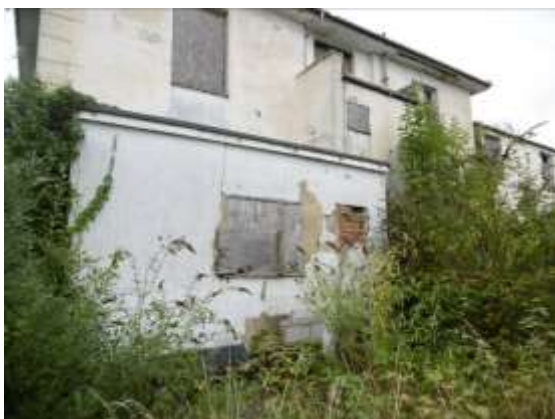
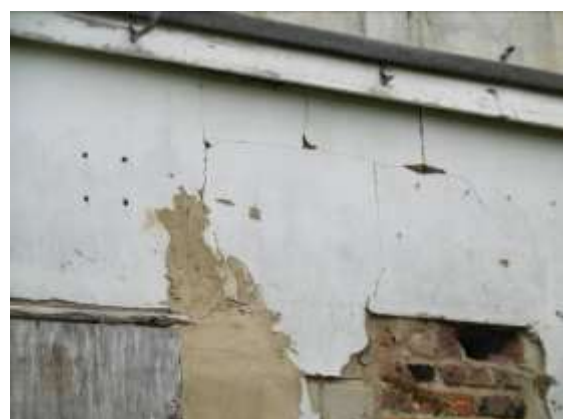
| Item | Location / Element | Defects | Repairs | Photo Ref |
|---|---|---|---|---|
| 6.0 | Single Storey Flat Roof Structure | Substantial cracking to rear wall, poor brick infill of existing window. Basic construction (possible ½ brick thick walls). | <p>The construction is basic and considered at the end of its useful life. Demolition and reconstruction including excavations to replace sub-structure would be necessary, all to Architect's and engineer's design.</p> <p>Temporary weatherproofing and securing of the newly exposed walls and openings at ground floor level may be necessary following demolitions until watertight and secure from construction.</p> | 47,48 |

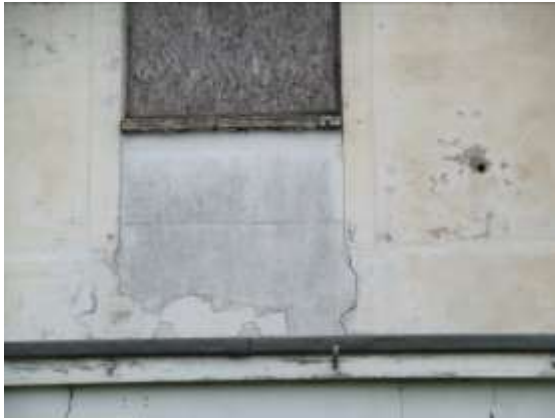
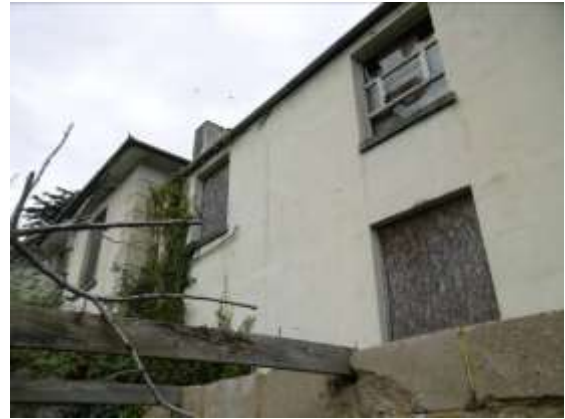
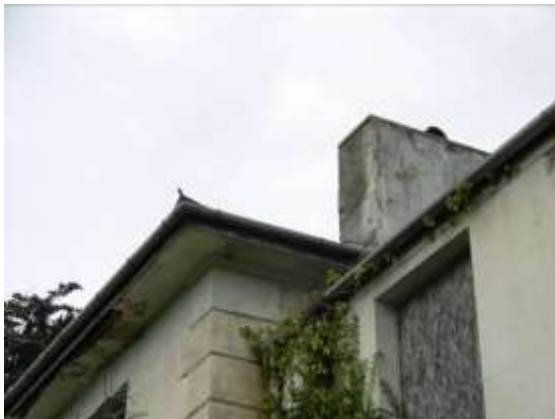
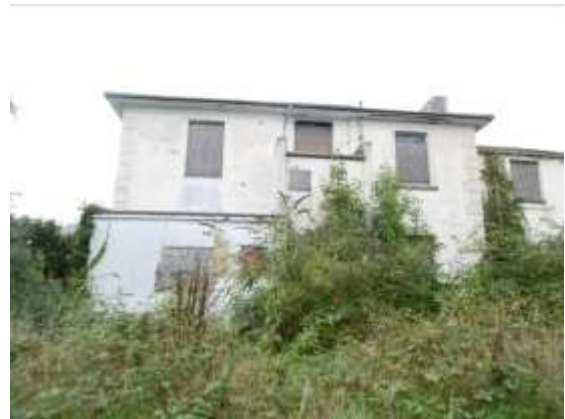
| Item | Location / Element | Defects | Repairs | Photo Ref |
|---|---|---|---|---|
| 6.1 | Walls | <p>Wide vertical cracks in structure visible to southwest corner below first floor window and above flat roof structure.</p> <p>Climbing ivy and vegetation to south east of rear wall up to eaves level. Ingress into first floor bathroom present and likely into roof void.</p> | <p>Vegetation to be removed as part of refurbishment works to obtain access to repair render and replace eaves and roof structure.</p> <p>Further investigations needed including opening up works to inspect structure. Repairs to likely to include replacement of defective masonry and reinstatement of render coating to newly exposed areas.</p> | 49-52 |

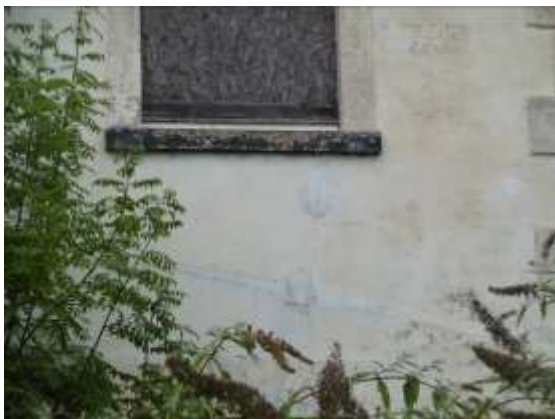
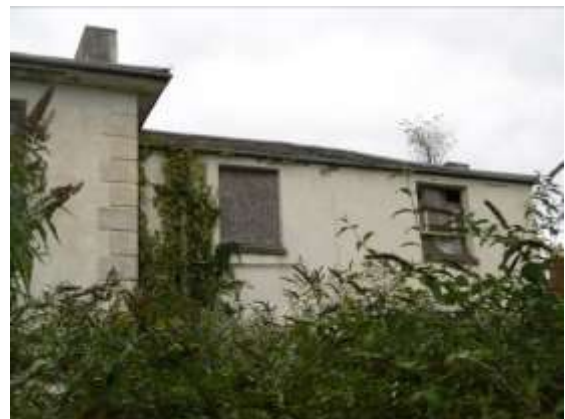
| Item | Location / Element | Defects | Repairs | Photo Ref |
|---|---|---|---|---|
| 6.2 | Windows and Openings | Cracks visible over openings to rear, windows missing in areas. | As items 3.1 and 3.2. Newly exposed openings surrounds and windows to match original design with keystone on rear elevation. | 52-54 |

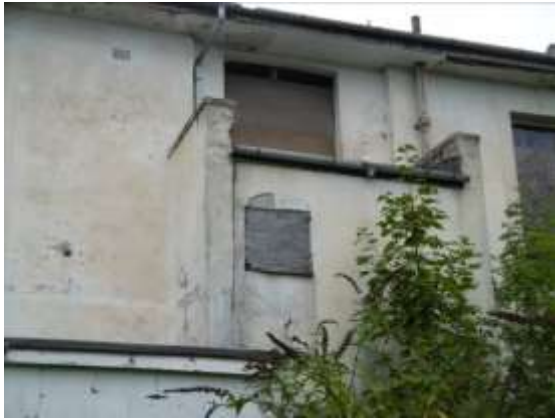
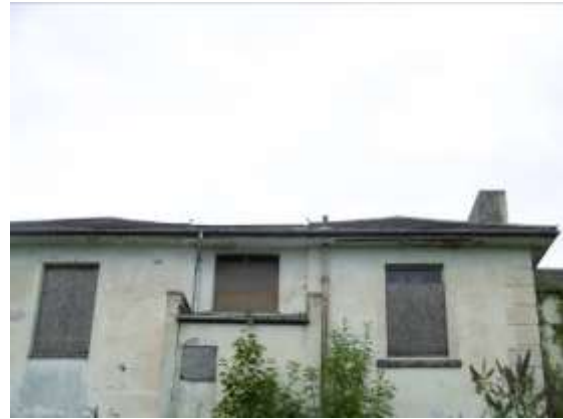
| Item | Location / Element | Defects | Repairs | Photo Ref |
|---|---|---|---|---|
| 6.3 | Two Storey Flat Roof Structure | It was not possible to inspect the flat roof and walls from an external ground level due to dense vegetation. The roof is covered with mineralised roofing felt probably of some age and in need of replacement. | <p>Replace existing roof structure, coverings, flashings and insulation to engineer and Architect design.</p> <p>Inspect structure closely when access possible to confirm it is tied back to main wall and structurally sound. Further repairs may be needed.</p> | 55-56 |

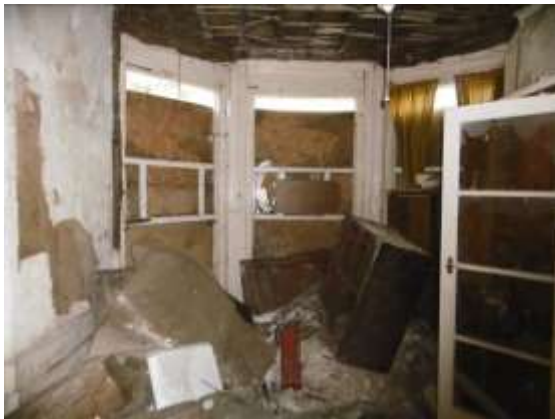
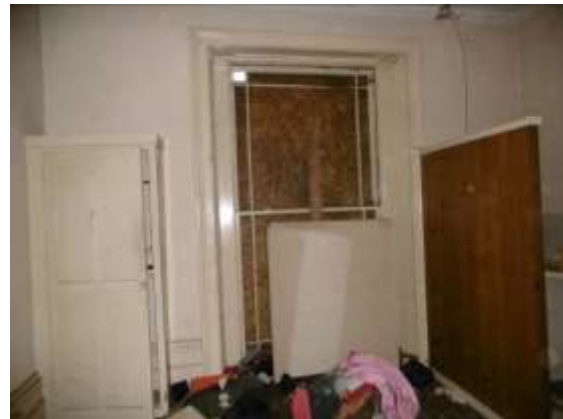
| Item | Location / Element | Defects | Repairs | Photo Ref |
|---|---|---|---|---|
| 7.1 | Floor Structure | <p>Inspection of the floor structures was limited due to fixtures, fittings, detritus and floor finishes and no safe access to inspect the sub-floor void. The majority of timbers were concealed and not possible to inspect. Some sections of floor boards were missing/collapsed and unsafe.</p> <p>There is evidence of significant water ingress and risk of hidden dry rot and wood boring insect attack. A tin of dry rot fungicide treatment was seen in the building.</p> | <p>All detritus, finishes, fittings, fixtures etc. should be removed to expose the floor structure. Lift sufficient timber boards to enable a full and thorough inspection of the sub-floor void, joists and boards by a damp and timber specialist, registered with the Property Care Association for evidence of rot and wood-boring inspect infestation. Recommended repairs to be covered by a minimum 25 year insurance backed guarantee.</p> <p>The small area of original (wide) timber floorboards to the ground floor front room 'G1' should be retained/ reinstated after treatment and other boards retained/reinstated where in good condition and fit for purpose.</p> | 57-59 |

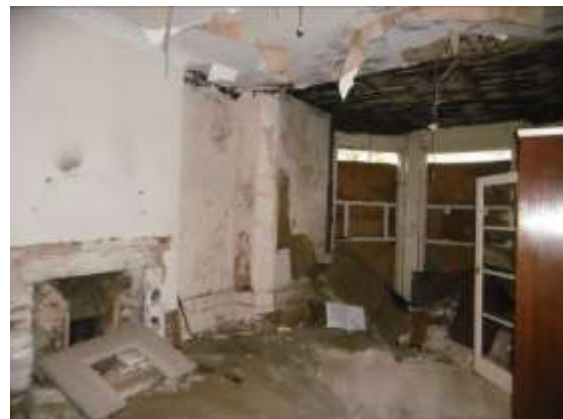
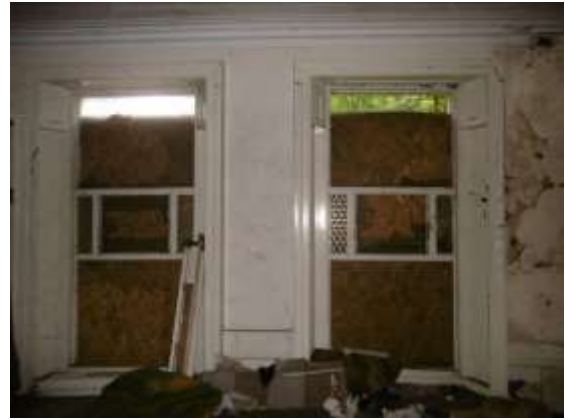
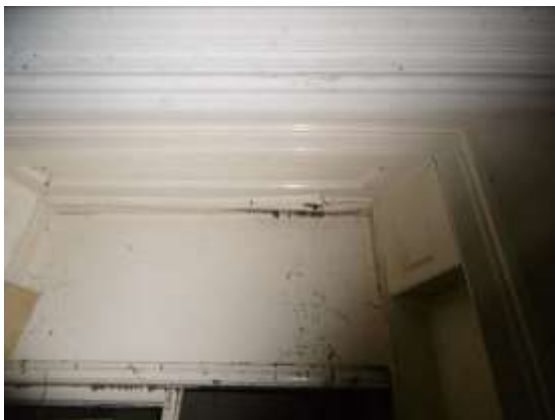
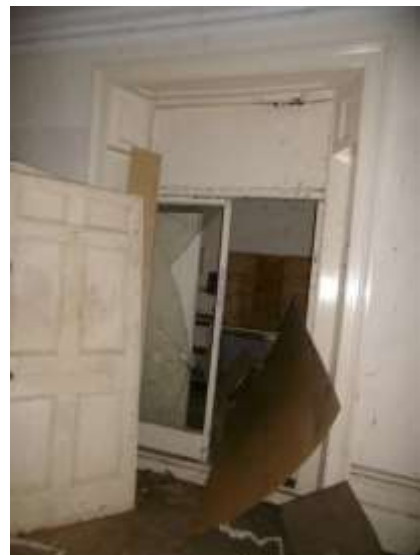
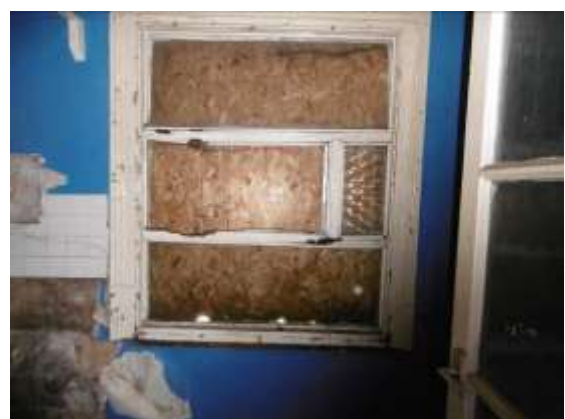
| Item | Location / Element | Defects | Repairs | Photo Ref |
|---|---|---|---|---|
| 7.2 | Internal Joinery | <p>The timber stairs in the entrance lobby and to the north east of the building appeared to be in a sound condition, but are in need of an overhaul. The balustrade to the main flight is loose with missing sections.</p> <p>The balustrade to the stairs from the half landing up to first floor level is loose and should be overhauled as part of the refurbishment to the building.</p> <p>The internal doors whilst some are original, many are missing, have no ironmongery and are not modern fire doors and a health and safety risk in a block of residential units.</p> <p>There is rot to the door frame head between room G2 and the bathroom.</p> <p>There is evidence of wet and dry rot to the skirtings, support battens, window sub-frames, mouldings and linings where in contact with penetrating damp. This is in particular around the ground floor bay windows where the roofs have collapsed and to the right window of G2, but also at first floor level.</p> | <p>Skirting boards should be carefully removed and set aside so their condition can be inspected by the Listed Building Officer. Original skirting boards to be refurbished and refitted in locations to be agreed with the LBO.</p> <p>Window mouldings and linings are to be retained and refurbished where not rotten and decayed. Where there is damage joinery should be replaced to match the existing profiles.</p> <p>For comment on sashes and glazing refer to 3.2.</p> | 60-69 |

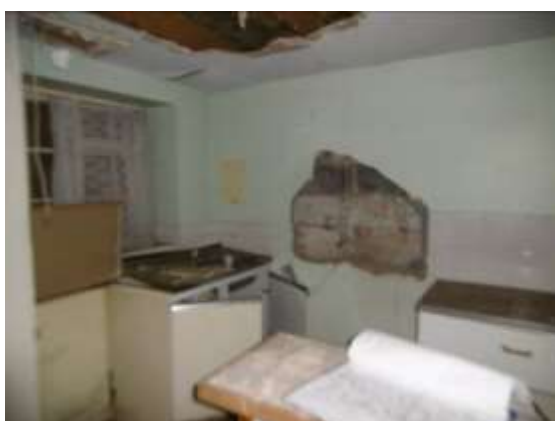
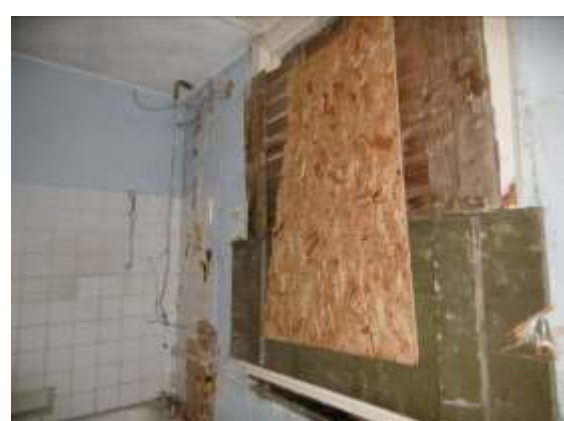
| Item | Location / Element | Defects | Repairs | Photo Ref |
|---|---|---|---|---|
| 7.3 | Fixtures and Fittings | All of the fixtures and fittings (kitchen and bathroom units, cupboards etc), are in a very poor state of repair. | Strip out and remove all fixtures and fittings and dispose off-site. | 70-71 |

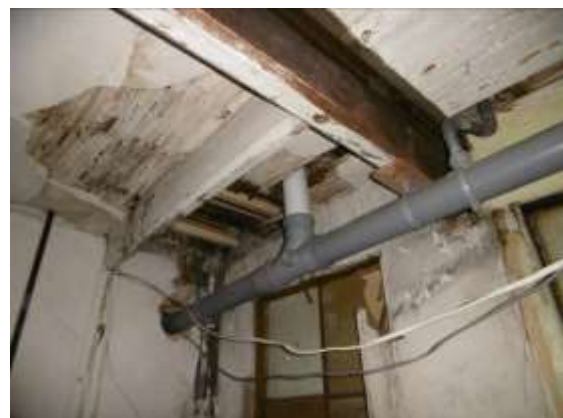
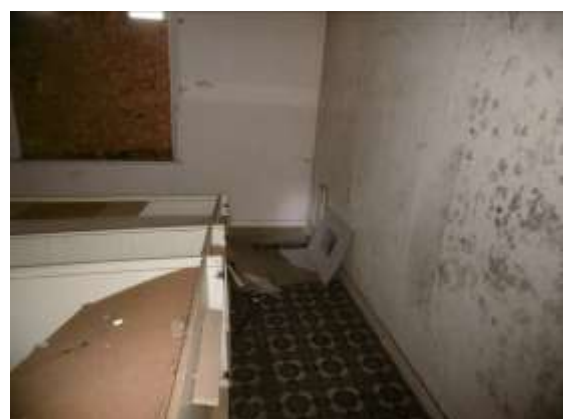
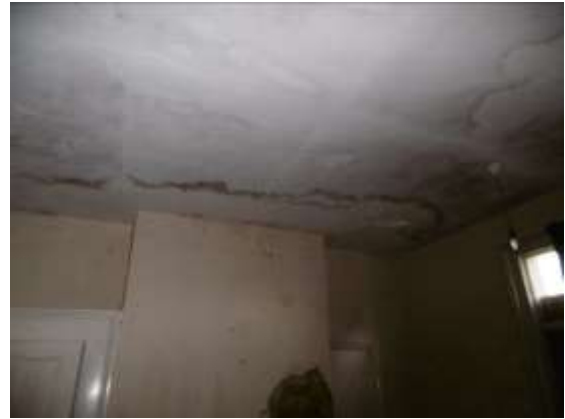
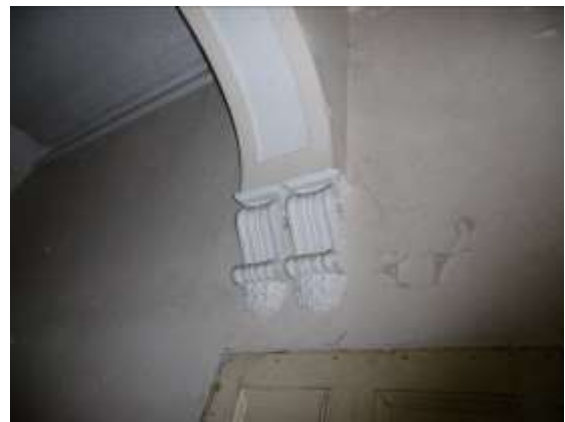
| Item | Location / Element | Defects | Repairs | Photo Ref |
|---|---|---|---|---|
| 7.4 | Ceilings and Walls | <p>There is substantial dampness and mould growth affecting all rooms in the building which has been ongoing for some time. Ceilings have collapsed in areas and the internal condition is very poor.</p> <p>Most of the ceilings are of lath and plaster construction. Cracks were present to many of the surfaces as a result of age and deflection/warping in the floor structure.</p> | <p>Mould growth to ceiling and walls surfaces should be washed with diluted bleach to kill spores.</p> <p>Original ceilings and cornicing should be retained and a false ceiling installed below to provide protection and a surface to install sound insulation, light fittings and create a service void.</p> <p>The decorative plaster ceilings in the entrance lobby should be retained and left in-situ. There is a small section of cornicing missing that requires repair.</p> <p>The plaster mouldings to the bases of the arched opening in the entrance lobby should be retained. A ceiling rosette in G3 should be retained and left in-situ.</p> <p>It is possible there is no damp proof course (DPC) to the base of the walls or some areas have failed and repairs may be needed. Any damp proofing works should be carried out by a damp and timber contractor registered with the Property Care Association (PCA) and covered by a 25 year or similar insurance backed guarantee.</p> | 57,60, 72-82 |

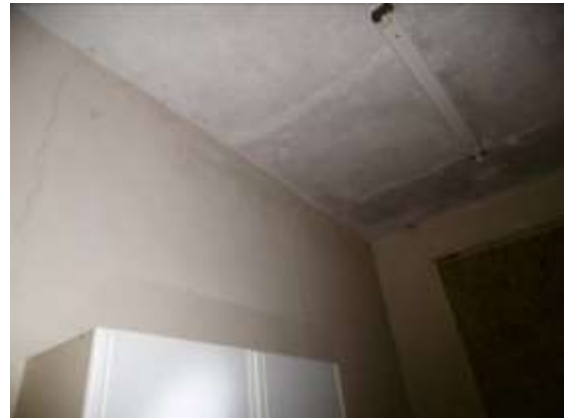
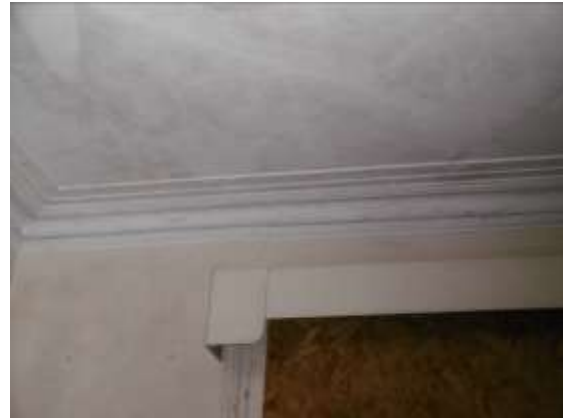
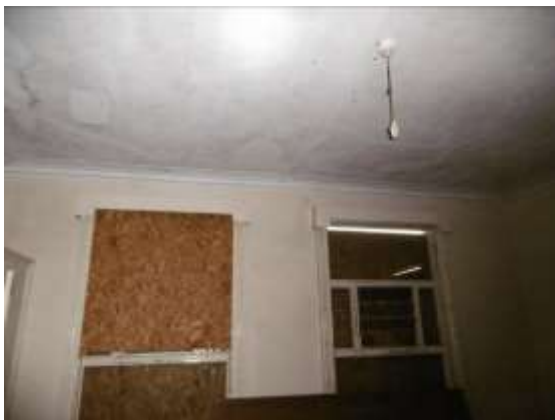
| Item | Location / Element | Defects | Repairs | Photo Ref |
|---|---|---|---|---|
| 7.5 | Room F1 | Vertical and horizontal cracking seen to the ceilings and walls in the room. Cracks in corresponding location visible on the other side in the kitchen. The cracks join up from walls to ceilings and around openings in the walls. The wall has dropped at lintel level above one window opening. Structural movement evident possibly the result of failed roof structure and lintels. | Further investigations needed once plaster finishes, fixtures and fittings are removed and the structure can be seen.<br><br>Repairs will include providing support, replacing lintels, damaged and deteriorated brickwork. | 83-87 |

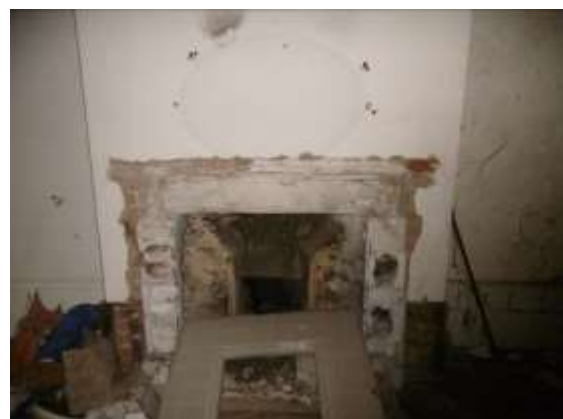
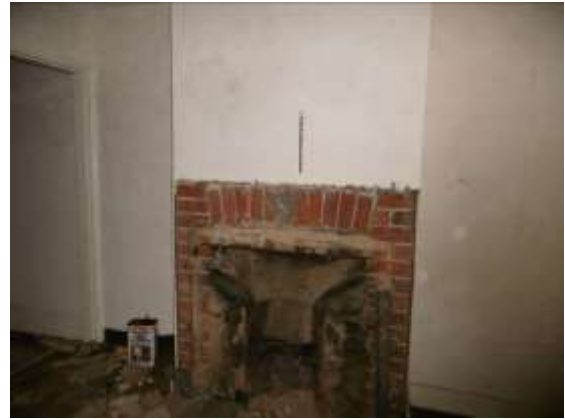
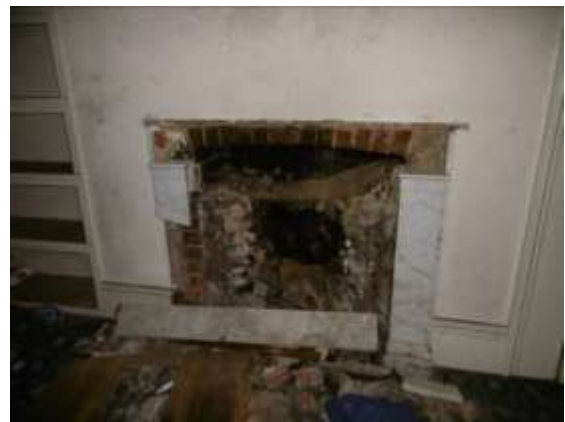
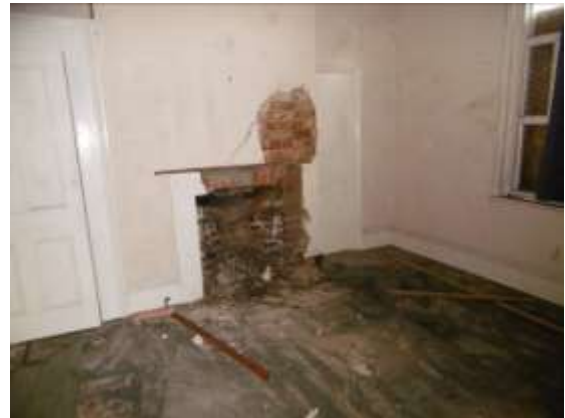
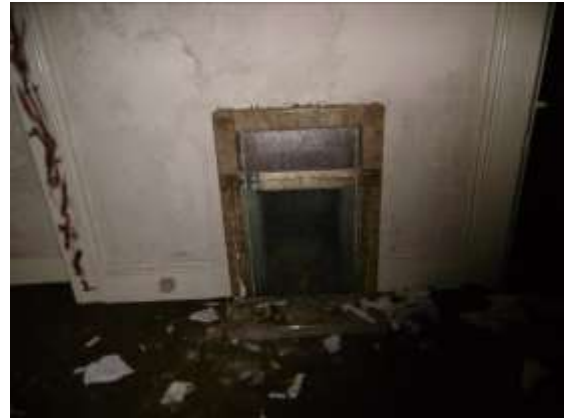
| Item | Location / Element | Defects | Repairs | Photo Ref |
|---|---|---|---|---|
| 7.6 | Fireplaces / Chimney Breasts | Chimney breasts were concealed behind wall finishes, but substantial damp penetration was noted to the breast in room F4 and large areas of brickwork in this area are disintegrated to dust that was loose when touched. Flues are likely to be blocked.<br><br>The fireplace surrounds were not present and thought to be removed when the site was occupied as a squat. | Re-building and re-pointing areas of the chimney breasts where erosion of the brickwork has occurred from water ingress is likely to be required and further investigations are needed by removing plaster finishes for inspection behind.<br><br>Flues should be swept clean and openings where fireplace surrounds are missing boarded over and the flues capped and vented.<br><br>Fireplaces to be reinstated through repair of existing where possible or renewal to a matching design. | 88-97 |
