Site : Queen Victoria Street,  
Reading,  
RG1 1TG

### **METHOD STATEMENT FOR THE REPAIRS OR REBUILDING OF THE HIGH LEVEL GABLES.**

## **HIGH LEVEL GABLE REPAIRS TO QUEEN VICTORIA STREET, READING**

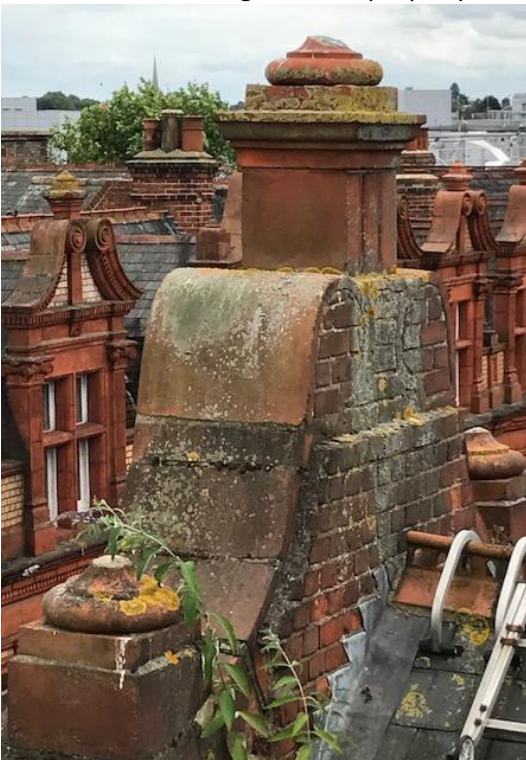
Large Gable

**Large Gables** : The majority of these have been compromised by the failure of the joints/pointing and in some the actual units have spalled and split. We may be able to salvage these with resin and stainless steel pins, if the terracotta has not become too friable and weak, but if this is not possible we can either cast new ones in our yard or construct new ones on site from coloured mortars. If there are numerous failed units that are the same it is more economic to cast new ones in the yard, so this is something we cannot determine until the gables are properly accessible.

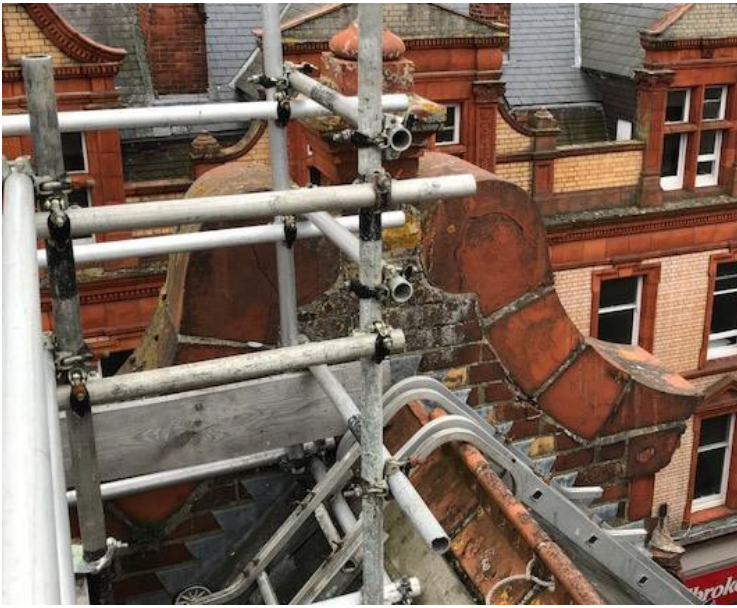
**Small Gables** : These gables have the same problems as the larger gables, but because they contain less detail and scroll work they have been less vulnerable to the problems of damp penetration. The face brickwork within these gables has been reasonably well protected, but there are numerous splits and cracks that are allowing water and damp penetration.

Small Gable from rear.

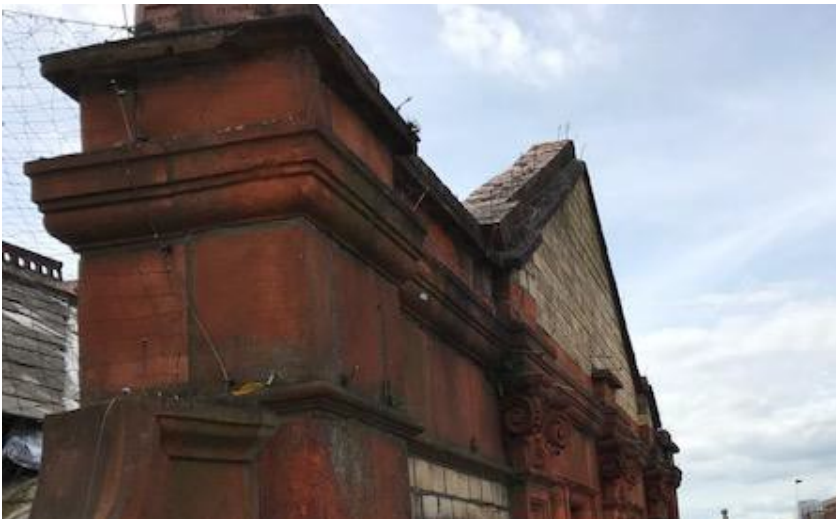
Gable to Front elevation : There is a long low level gable to the front elevation which overlooks Friar Street – it is gaunt brick to the upper levels and terracotta features to the window level. The terracotta has suffered erosion due to weathering and cement pointing, but generally appears in reasonable condition – although there is no direct access at present. The upper level of the gable is crowned with a brick on edge feature that seems to have been an afterthought and is not a good weather proofing as the pointing has failed and the bricks do not oversail the wall beneath. We would recommend removing the brick on edge detail and installing a terracotta or similar coping to guarantee a waterproof covering.

Friars Street Gable with failing brick on edge coping.

Remove existing brick on edge and replace with new coping to match. Rake out and repoint brickwork and terracotta.
