Our Ref: RT-MME-127659

**Endoscope Bat Survey– Mercedes Benz, Richfield Avenue, Reading.**

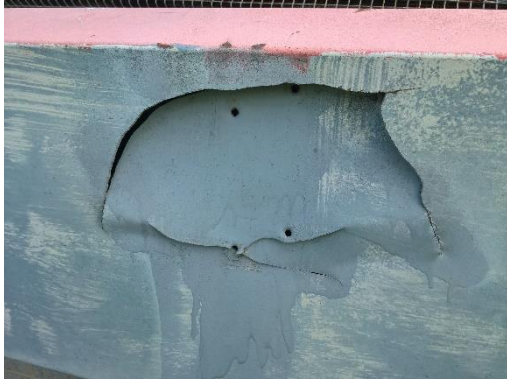
Following an inspection of the features with the aid of a MEWP, the damaged metal fascia board and holes around piping were found to provide access into a thin metal gutter. The gutter was fully inspected and no evidence of bats was recorded within the feature which could be fully inspected.

**Plate 1: Building 1 - Damaged Metal Gutter**

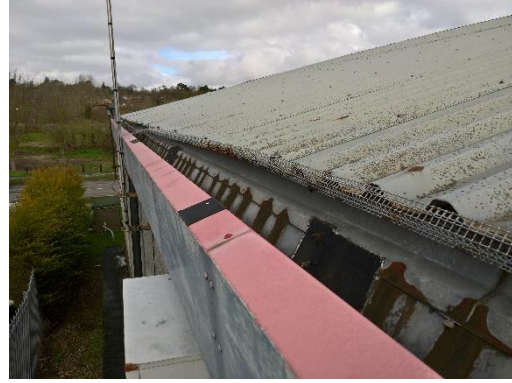
**Plate 2: Building 1 – Thin Metal Gutter**

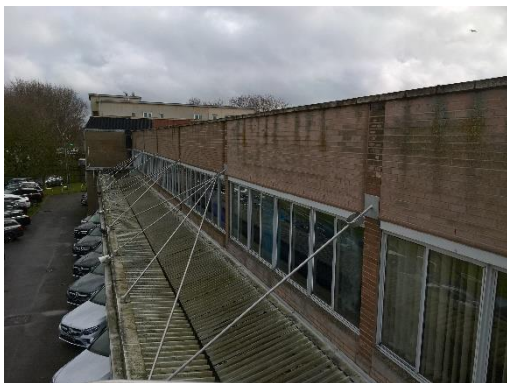
**Plate 3: Building 2 – Weep Holes above Windows**

There were 27 weep holes located at height (approximately 6 m) on the northern elevation of building 2, above windows. There were 6 further weep holes above windows on the northwest corner of the building. Of the weep holes, 10/27 on the northern elevation and 4/6 weep holes on the western elevation were either filled with debris, heavily cobwebbed or were too narrow to provide access for bats.

These features were fully inspected. The remaining weep holes provided clear access into the cavity wall, which cannot be inspected with an endoscope. There were no indications that bats had been using the features. However, as there was an open flight path to the weep holes and low levels of disturbance, it is not possible to rule out occasional usage of the features by bats.

It is therefore recommended that a single pre-demolition works bat emergence survey is carried out on the structure. It is understood that demolition is planned for mid-april. The pre-works emergence survey will be carried out in suitable weather conditions immediately prior to demolition when bats are considered to be active. If bats are discovered roosting in the building during the survey then works should cease and a bat licence application to Natural England would need to be applied for to support the demolition process and associated survey work to support the application would need to be carried out.

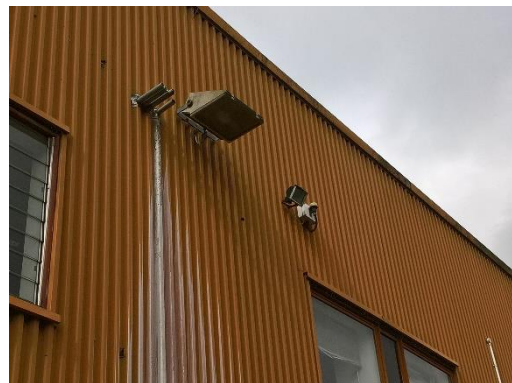
Following an inspection of the features with the aid of a MEWP, the pipe holes and crevices under metal cladding on the western aspect were fully inspected. No evidence of bats was recorded within the features.

**Plate 4: Building 2 – Pipe Holes in Wall**
