Condition Survey Report – 17-27 Queen Victoria Street, Reading (Pictures provided by Volute and Numbers provided by Volute)

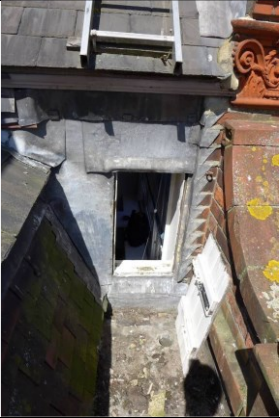
| | <p><b>Photo 7: South Cheek of Dormer to No 21</b></p> <p>Note access hatch to provide access onto parapet gutter. Lead dressing to the dormer cheek has been basically dressed in areas.</p> | | <p><b>Photo 10: Detail rear of No.17</b></p> <p>Note the plant growth (buddleia). Which will increase the rate of deterioration.</p> |

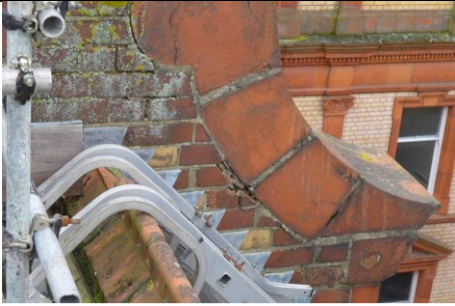
| | <p><b>Photo 9: Detail of gable to no 15.</b></p> <p>Open pointing and evidence of water movement washing out joints. Reflecting the deteriorating and potentially dangerous condition of the gables.</p> | | <p><b>Photo 8: Crash deck scaffold to the gable to neighboring building (#15)</b></p> <p>Note the netting placed over the gable; this has been provided to reduce the risk of masonry falling onto the busy street below.</p> |

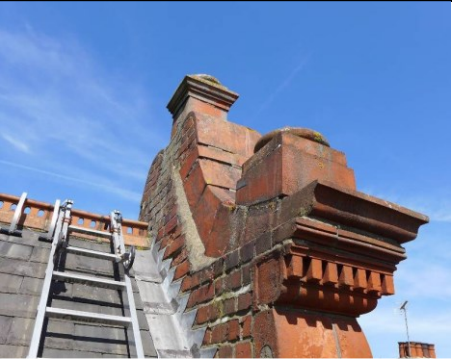
| | <p><b>Photo 11: Rear of No. 23 Gable</b></p> <p>Note open joint to terracotta "coping", cement fillet, spalled brick and washed out pointing and patch repairs to the lead flashing</p> | | <p><b>Photo 12a View and detail of rear gable neighboring building</b></p> <p>Note that the brickwork to the rear face has been rebuilt, reflecting existing or potential similar failure/need for repair to the rear of the gables to the subject building.</p> |

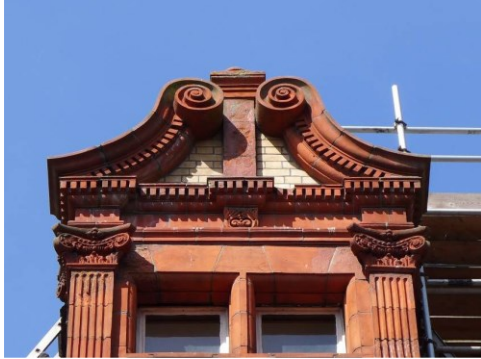
**Photo 12: Gable to No 17**  
Note missing section of cornice illustrating the potential for further deterioration providing loose masonry at risk of falling onto the street below. Staining reflecting water movement and increasing the risk of deterioration and corrosion of any ferrous fixings. Painted / treated terracotta which is a poorly matching remedy.

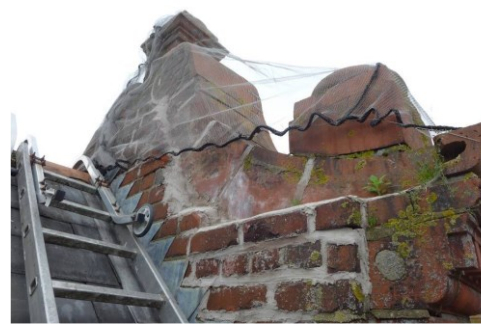
**Photo 12b View and detail of rear gable neighboring building**  
Note that the brickwork to the rear face has been rebuilt, reflecting existing or potential similar failure/need for repair to the rear of the gables to the subject building.

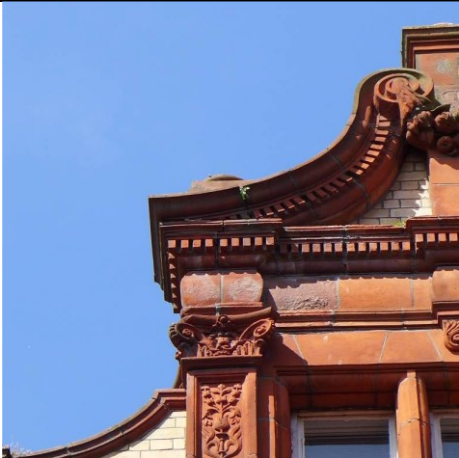
**Photo 14: Detail of gable to No 19**  
Note plant growth; open joints and treated/painted terracotta, and a missing piece to the capital. These are all indicators of the deteriorating condition of the terracotta.

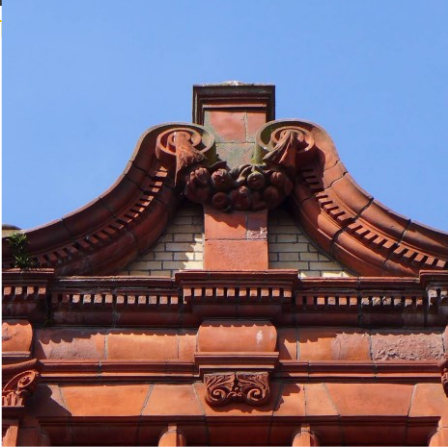
**Photo 16: Detail of the gable to No 21**

The indicators of deterioration are repeated. The gables are in a poor and rapidly deteriorating condition.

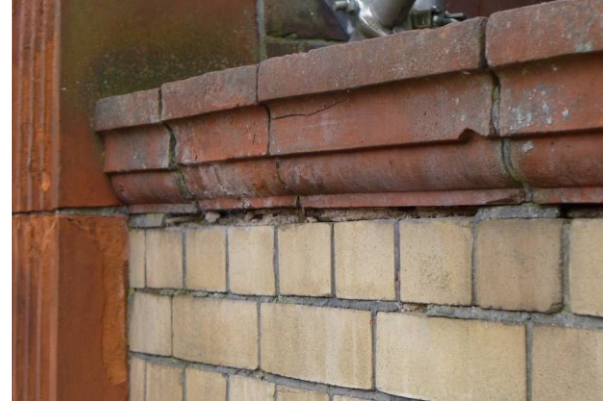
**Photo 20a: Details of copings to the front parapet wall**  
Photo shows the copings to No.17; note cracking to a coping, water staining and deterioration to the mortar of the bedding joint. There is a high risk of imminent failure

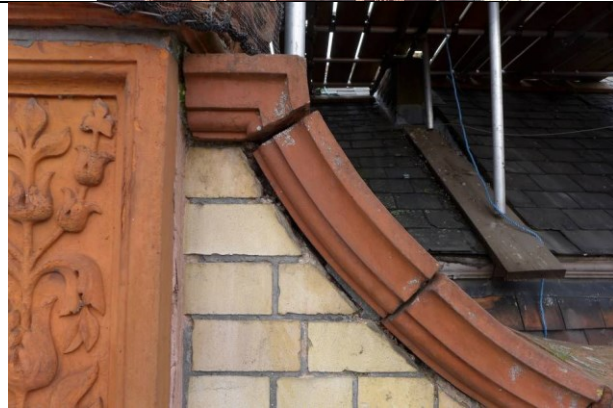
**Photo 20b: Details of Copings to the front parapet wall**  
The photo shows the lifting of the copings to No 15(neighboring building) with the creation of open joints that will be prone to water penetration and associated problems of damp and decay.
