**Former Royal Public House  
15 Oxford Road  
Reading  
RG1 7HS**

**Daylight Bat Survey**  
Ref: R1924/a

**May 2018**

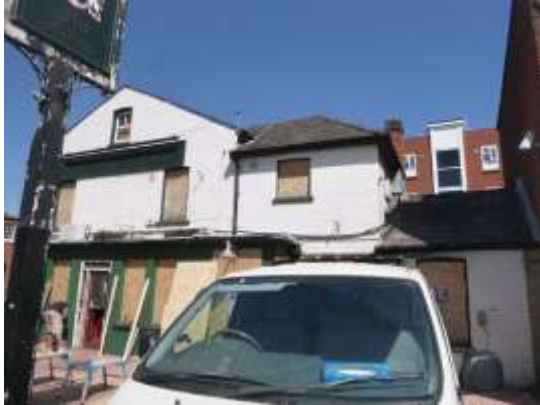
- 3.2.1** The former public house was of painted, solid brick wall construction with a pitched roof covered with slates. The main pitched roof was formed by two sections; one off-set slightly from the other. A two-storey hipped section and single storey roof adjoined the main roof at the south eastern corner (**Photographs 1-4**).

1. Former public house viewed from Oxford Road to the south.

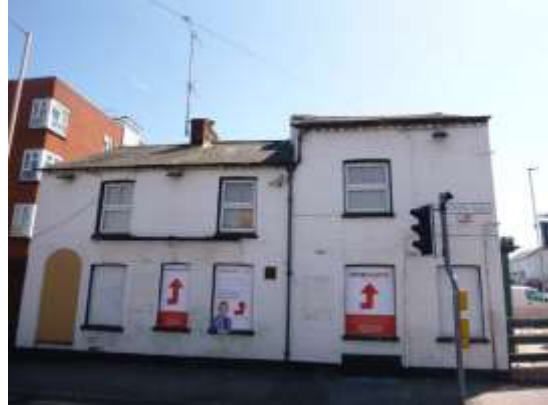
2. Pub viewed from the west.

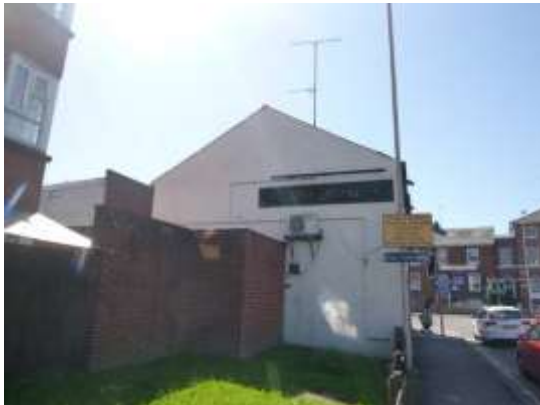
3. The pub's northern side.

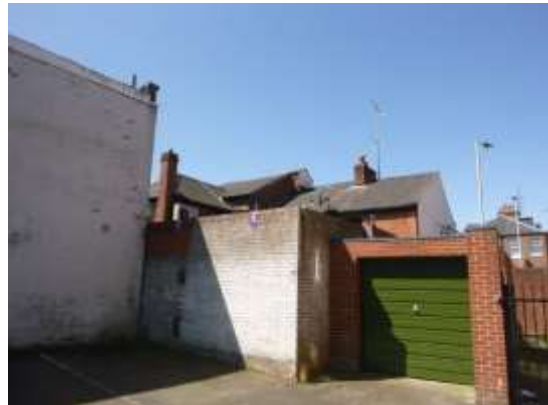
4. The pub viewed from distance to the north western corner

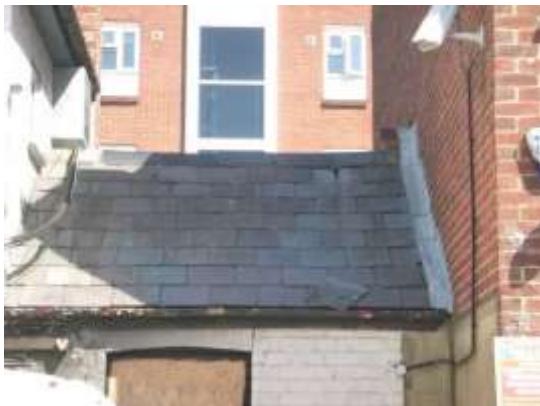
**4.1.1** There was no evidence of the former public house's roof being used by roosting bats and it is unlikely therefore that the property supports species that primarily occupy roof voids such as long-eared bats (*Plecotus* sp.). On the whole the building lacked features externally suitable for bats that occupy crevice roosts; a gap beneath a slipped tile on the low level roof lacked any evidence of use by bats when inspected closely.

5. The low level roof in the south eastern corner showing slipped slate.

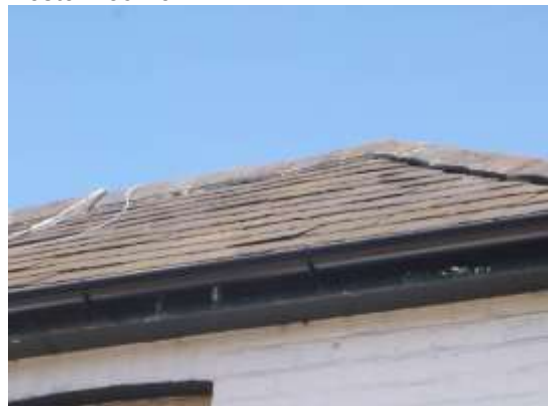
- 3.2.2** The slates covering the main roof were all in place and flat providing no visible opportunities for bats (**Target notes 4 & 7; Photographs 9 & 10**). The flashings around the chimney were fitted closely to the slates also (**Target note 5**). One slate was lifted slightly on the southern side of the hipped section to the front (**Target note 9; Photograph 6**) but the gap created was small and considered to be unsuitable for bats. A slate had slipped on the low level roof adjoining the hipped section at the south eastern corner but this showed no evidence of use by bats when inspected closely.

6. Slightly lifted slates on the hipped roof at the south eastern corner.

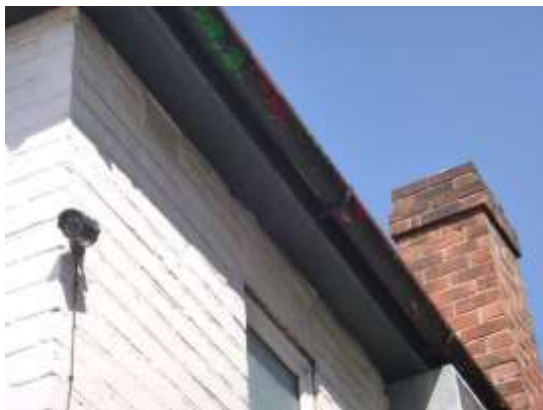
- 3.2.3** The northern and southern gable ends had no enclosed soffits and the slates were fitted tightly to the walls at both ends (**Target notes 1 & 6; Photograph 8**). The soffits on the western elevation were formed by brickwork, which was intact and lacked any visible gaps (**Target note 8**). Timber soffit boxes formed the roof line of the hipped section in the south eastern corner and these were completed and fitted tightly to the walls (**Target note 2; Photograph 7**).

**7. The complete and tightly fitted soffits at the south eastern corner.**

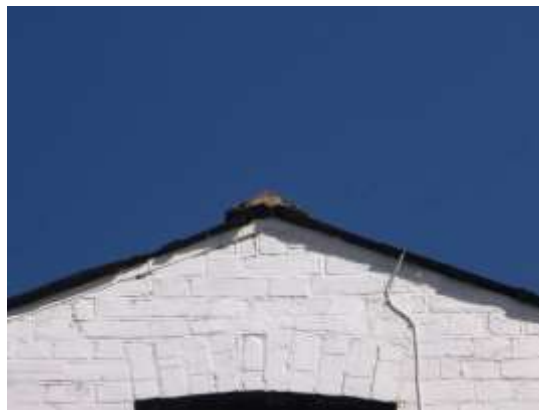
**8. The slates fitted tightly to the brickwork at the south facing gable end.**

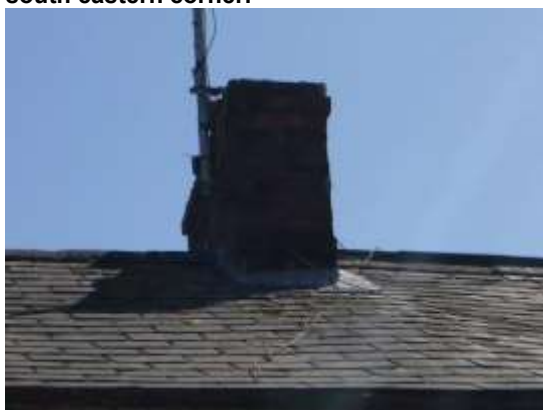
**9. The flat slates and closely fitted lead around the chimney viewed from the west.**

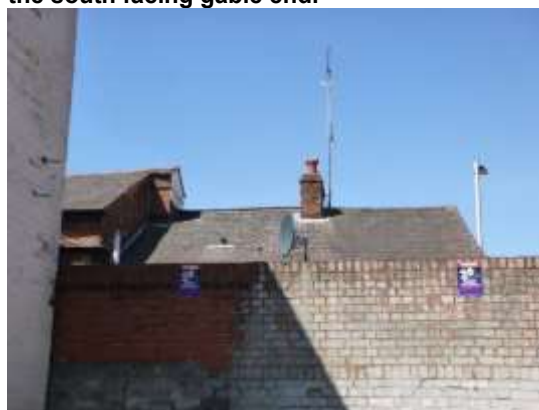
**10. The flat slates and closely fitted lead viewed from the east.**

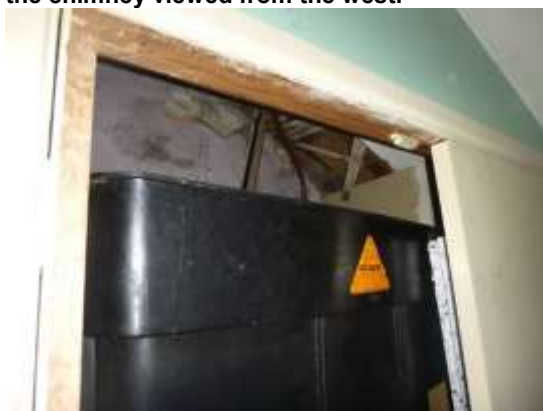
**3.3.2** A water tank was situated within an enclosed cupboard in the converted loft space in the south eastern corner of the roof (**Photograph 11**).

**11. The enclosed cupboard containing the water tank; remainder of roof space converted to living space.**

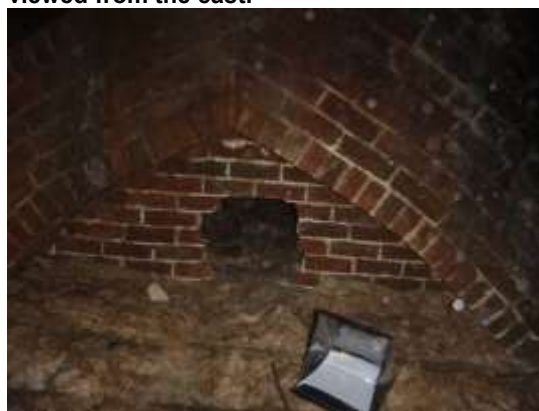
subdivided into two spaces linked via a small, low level opening in the brickwork (**Target note 12; Photograph 12**). The roof had a floor to ridge height of approximately 1.75m and was lined with bitumen and hessian felt (**Photograph 16**), which was largely intact and cobwebbed lightly at the ridge; a small tear allowed daylight through in the south eastern corner (**Target note 10**). A small, old wasps' nest was situated at the ridge at the northern gable end (**Target note 11; Photograph 13**). Gaps were present between the brickwork and timbers at the northern and southern gables but the gaps were cobwebbed and no daylight was visible. The eaves were filled mostly with fibre glass (**Photograph 15**). Rat droppings were scattered on the new fibre glass insulation and on the older droppings beneath also (**Photograph 14**).

**12. The main roof void showing the opening linking the two halves of the space.**

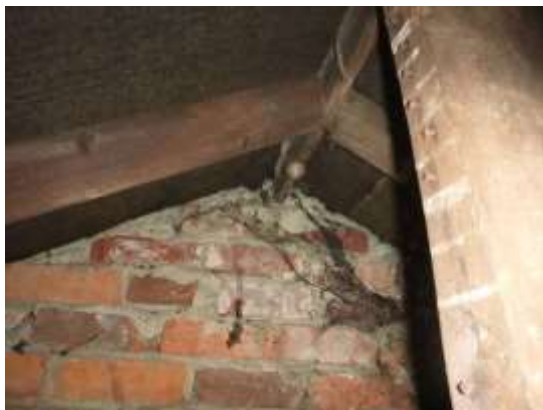
**13. A small wasps' nest at the northern gable end.**

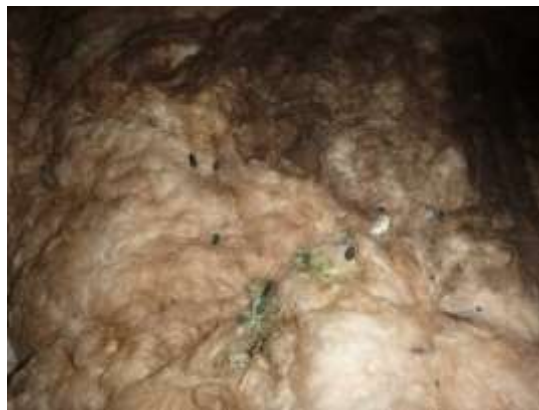
**14. Scattered rat droppings on the fibre glass throughout the void.**

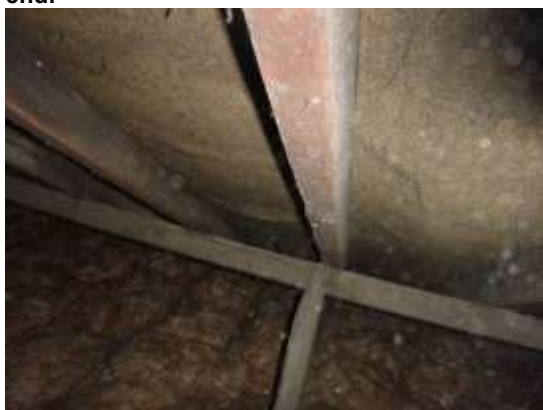
**15. The eaves filled with fibre glass.**

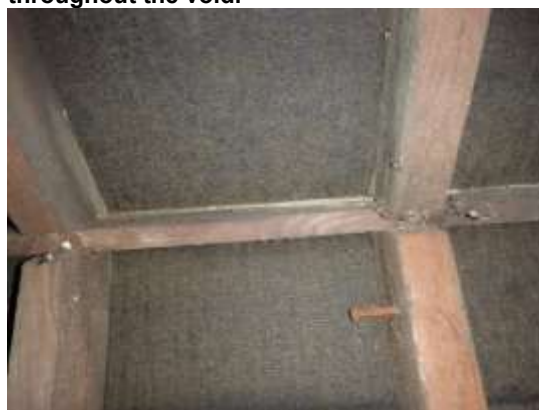
**16. The intact bitumen felt lining the roof and lightly cobwebbed ridge.**
