| Job Title<br>149-150 Friar Street, Reading | | | | | Drawing Title<br>Basement Floor Plan<br><br>Existing Plans | | | | | | | | |

Drawing Title  
**Basement Floor Plan**

## Existing Plans

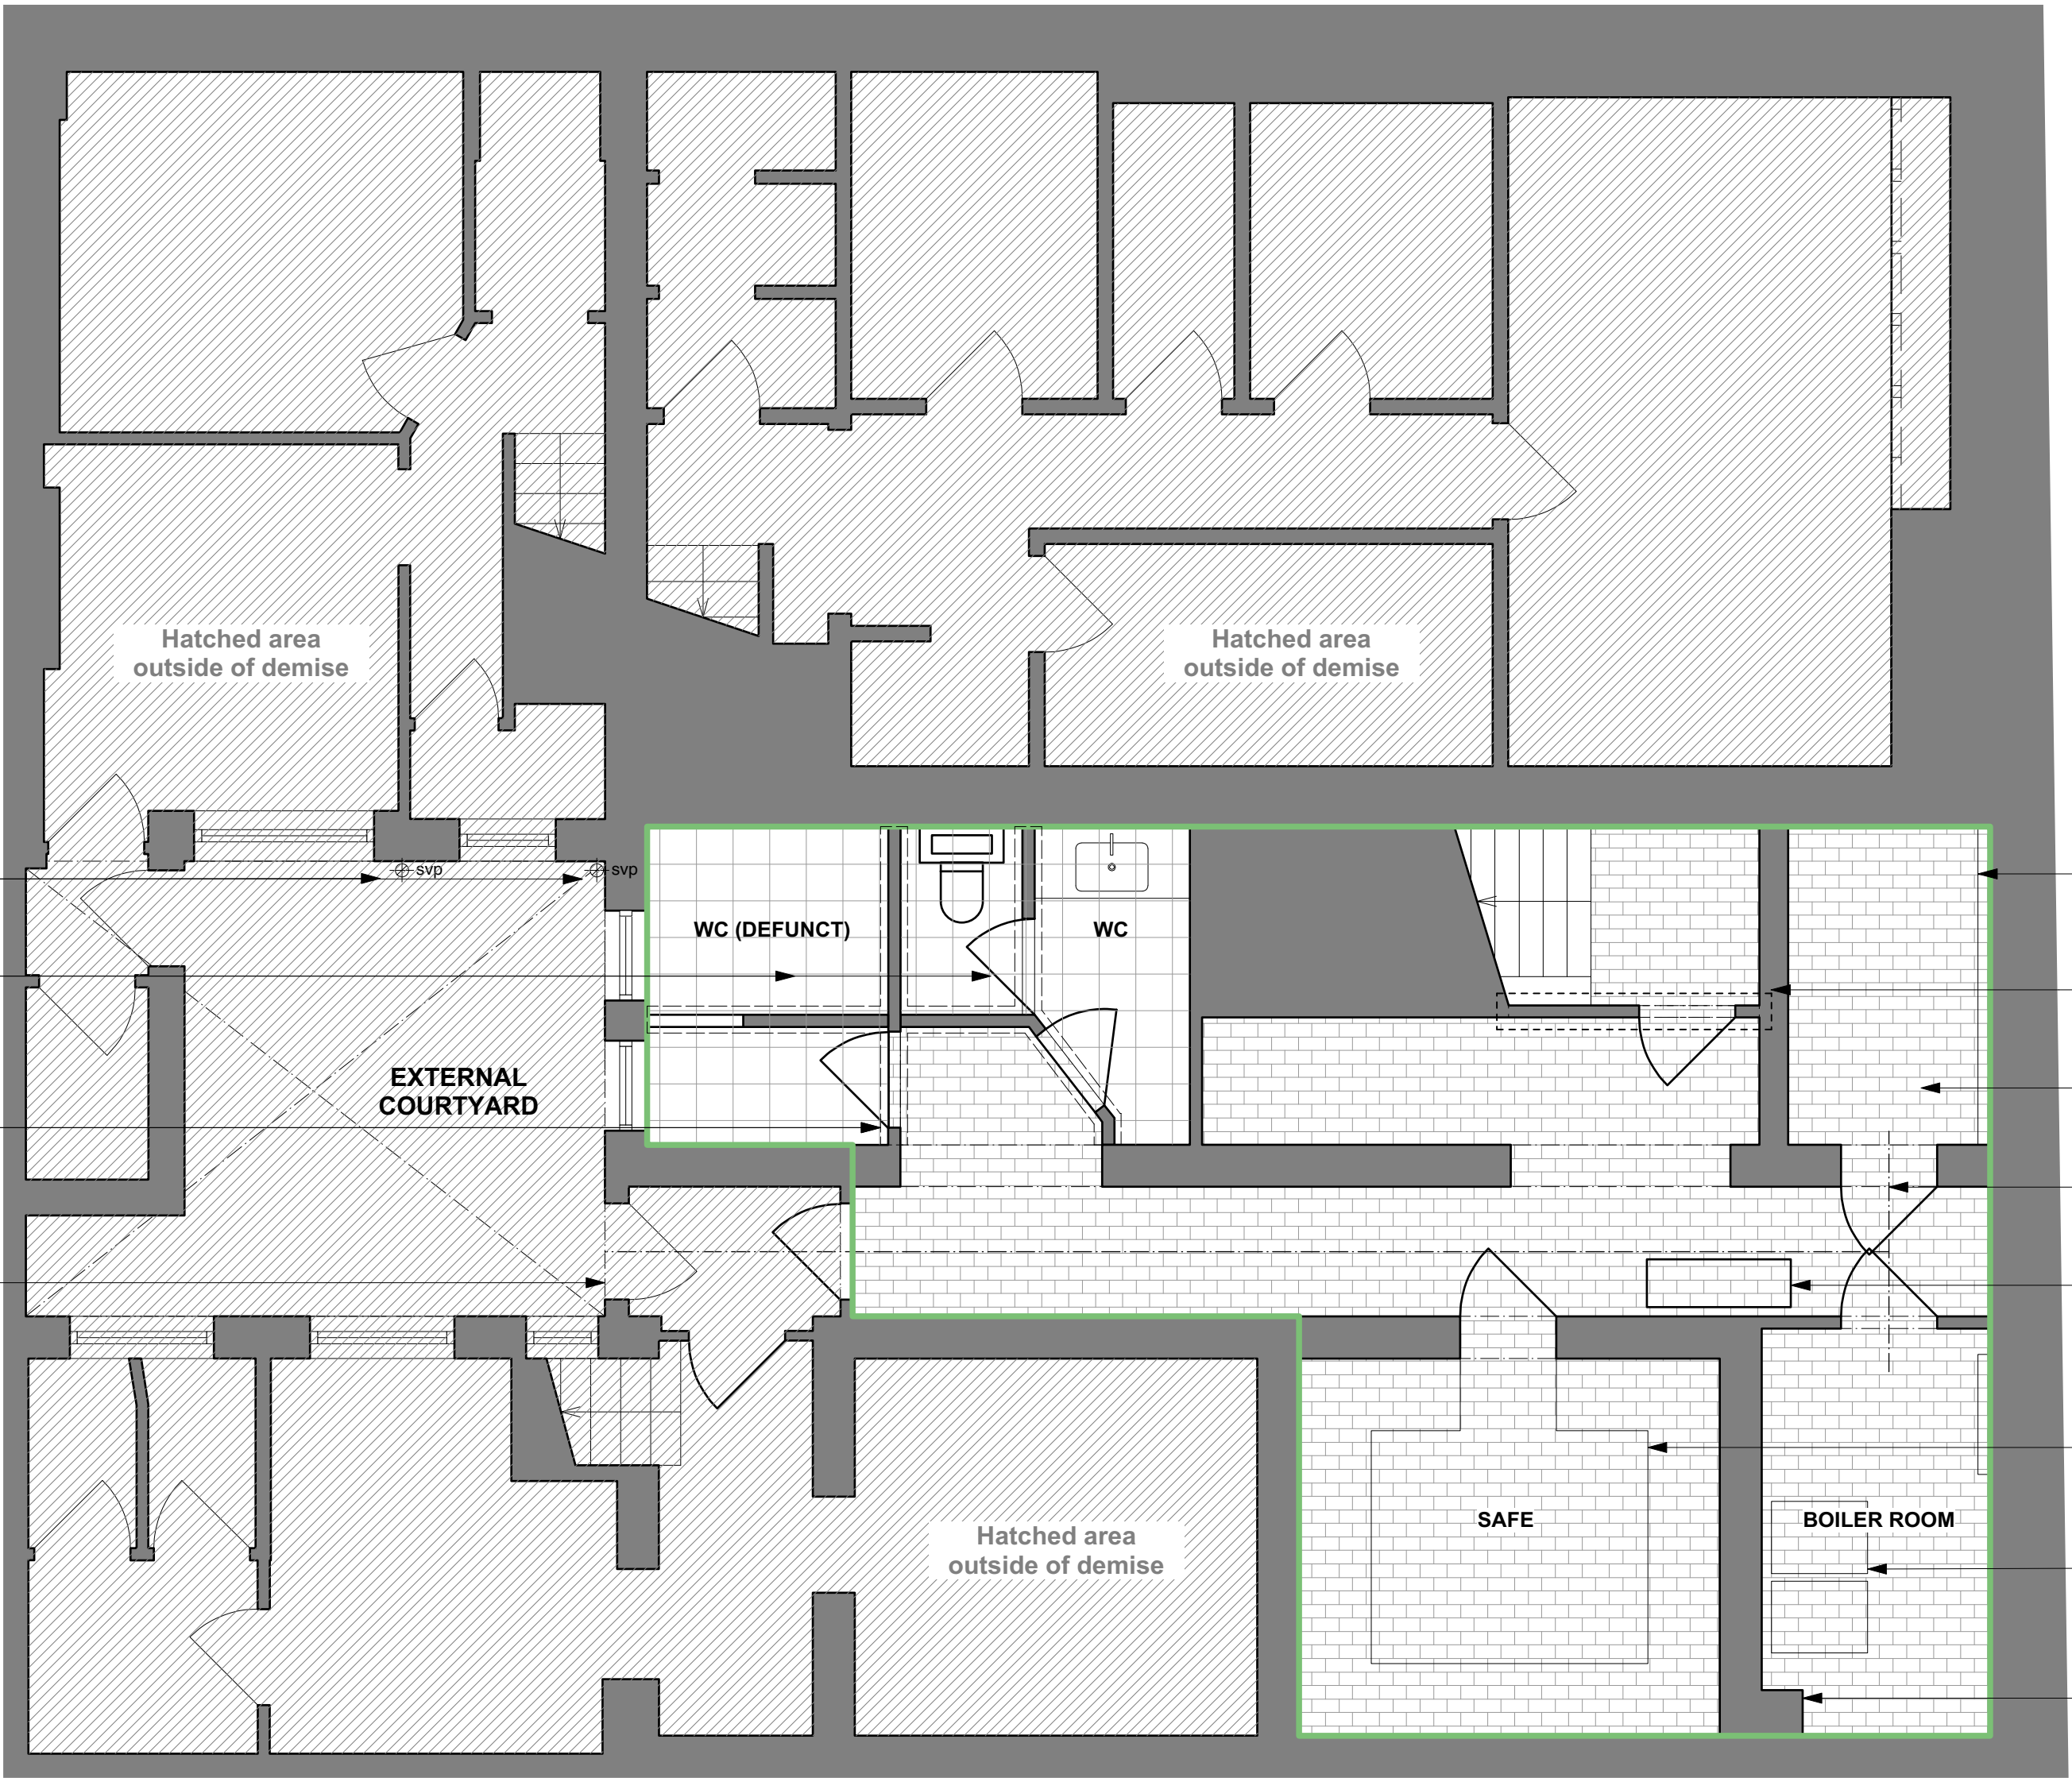
Incoming electrical supply, and associated modern boards.

Mid-late 20thC partition and doors.

Brick floor throughout basement.

High-level modern vent and services secured to brick vaulted ceiling.

Modern gas meter.

Presumed original safe fitout, including timber backing, slate shelves and steel door.

Mid 20thC boilers and associated flues.

Boiler flue, presumed to rise to roof via chimney stack.
