Tuesday, 07 November 2017

Our Ref: J171030CL01

**Re: Former "C Building", Gillette, Reading, RG2 0QE**

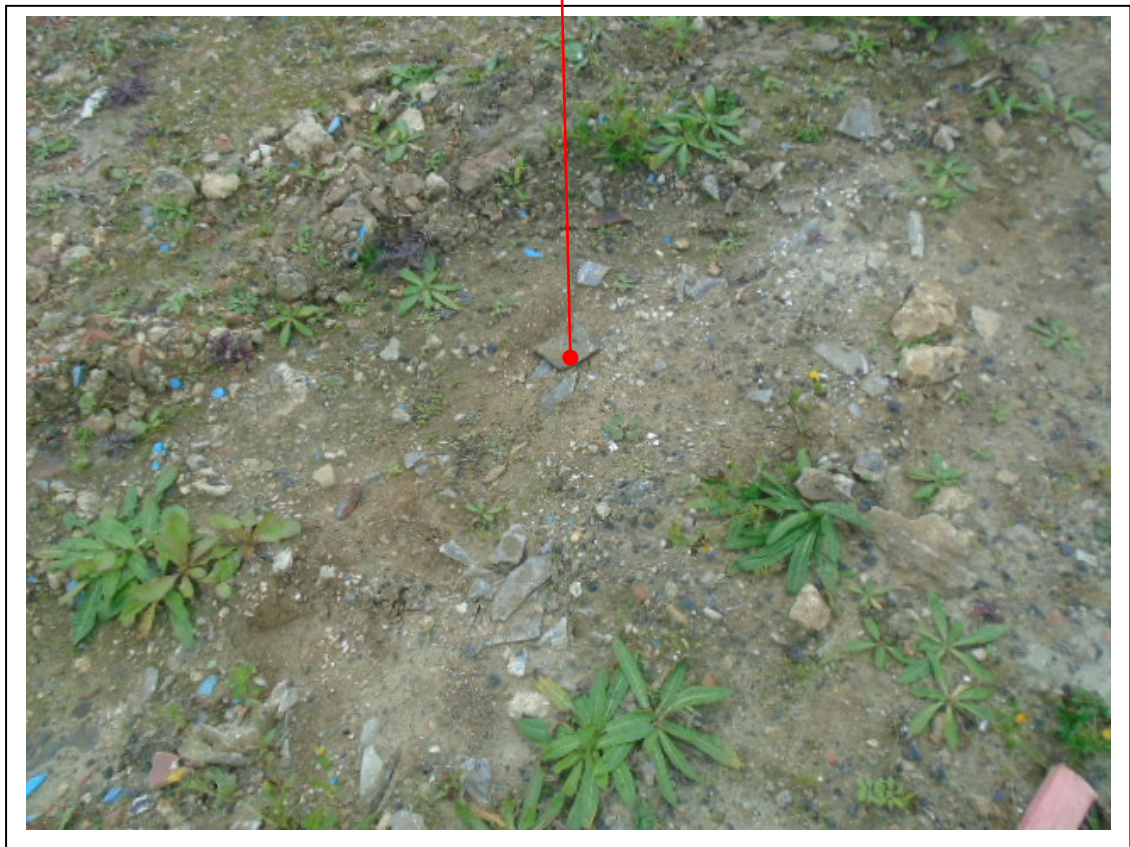
| Sample Reference: GILL/C/01 | Location: On Surface of Crushed Materials |

| Material: Cement Sheet Debris | Extent: Not Quantifiable (presumed throughout) |
| Condition: High Damage | Surface Treatment: Bare |
| Accessibility: Routine Disturbance | Friability: Medium |
| Asbestos Type: Chrysotile (white asbestos) fibres detected in sample. | Material Assessment Score: 6 |

| Recommendation: Remove using a suitably trained and competent contractor | |

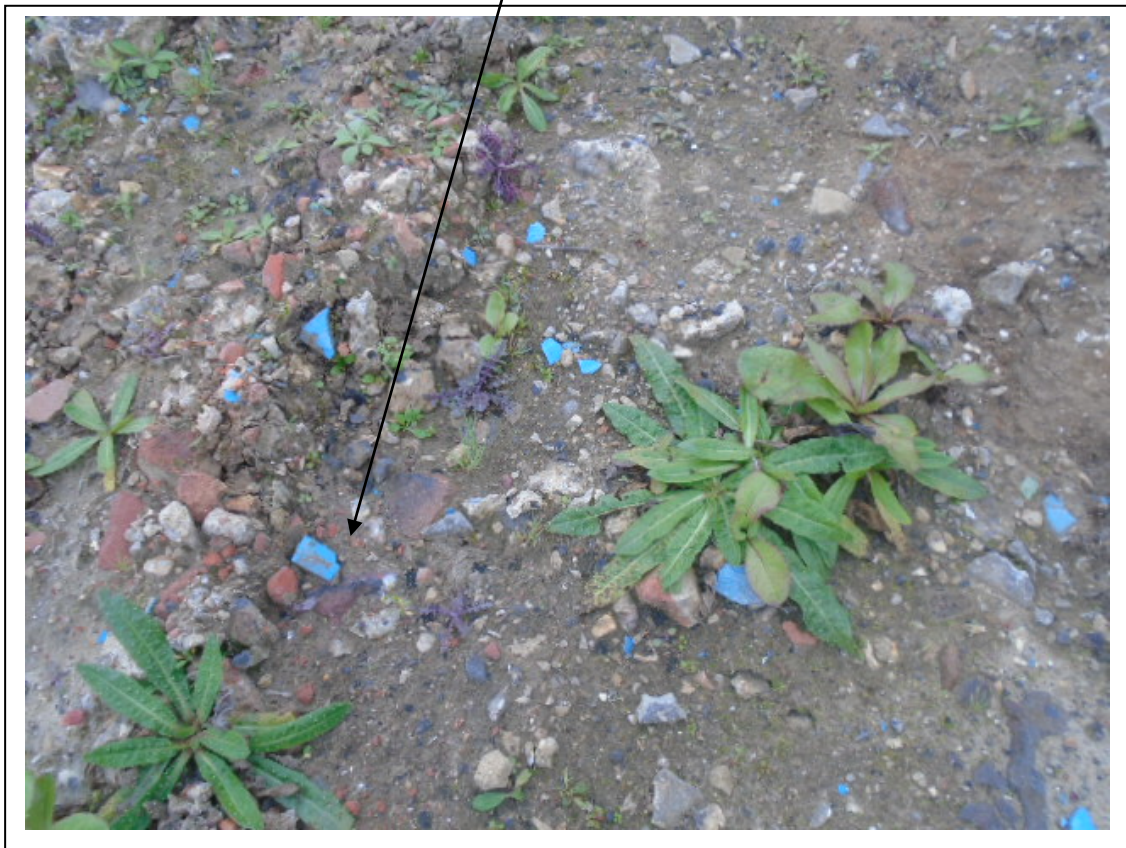
| Sample Reference: GILL/C/02 | Location: On Surface of Crushed Materials |

| Material: Vinyl Debris | Extent: Not Quantifiable (presumed throughout) |
| Condition: High Damage | Surface Treatment: Bare |
| Asbestos Type: No asbestos detected in sample. | Material Assessment Score: 0 |

| Recommendation: Non asbestos material | |

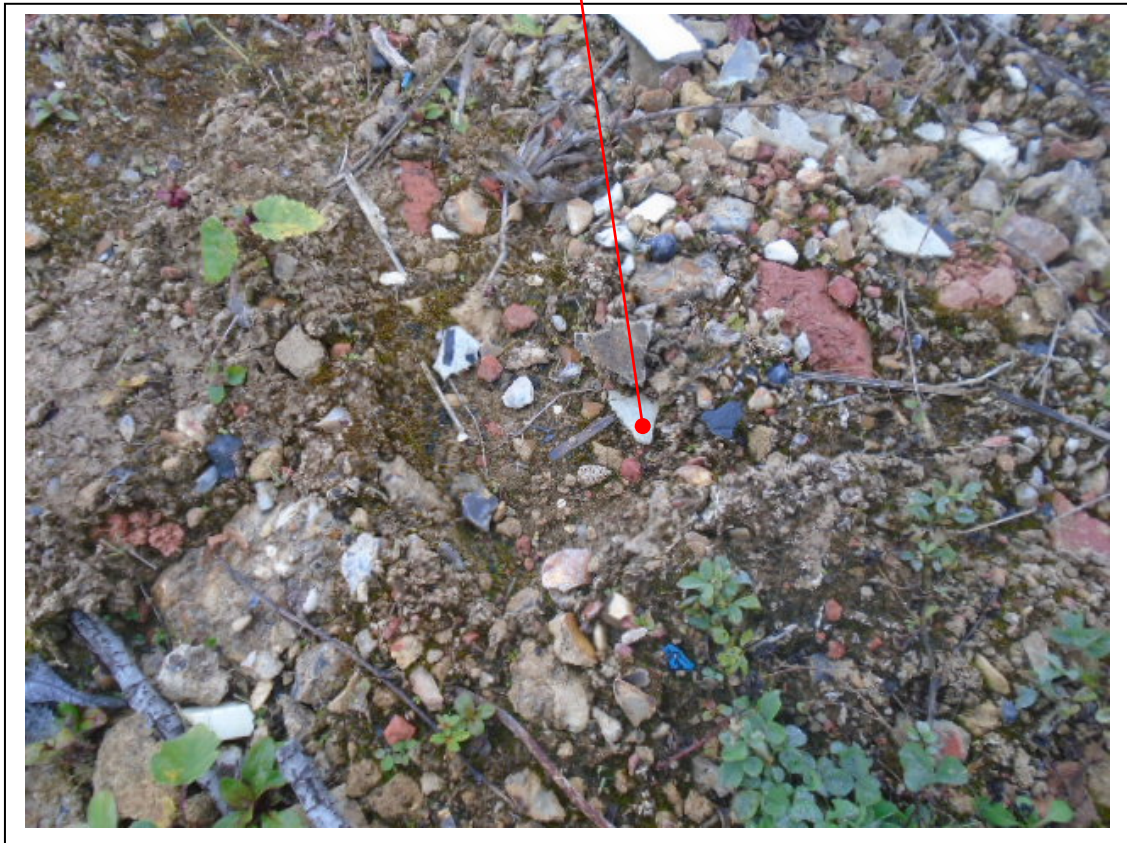
| Sample Reference: GILL/C/03 | Location: On Surface of Crushed Materials |

| Material: Floor tile and adhesive | Extent: Not Quantifiable (presumed throughout) |
| Condition: High Damage | Surface Treatment: Bare |
| Accessibility: Routine Disturbance | Friability: Medium |
| Asbestos Type: Chrysotile (white asbestos) fibres detected in sample. | Material Assessment Score: 6 |

| Recommendation: Remove using a suitably trained and competent contractor | |

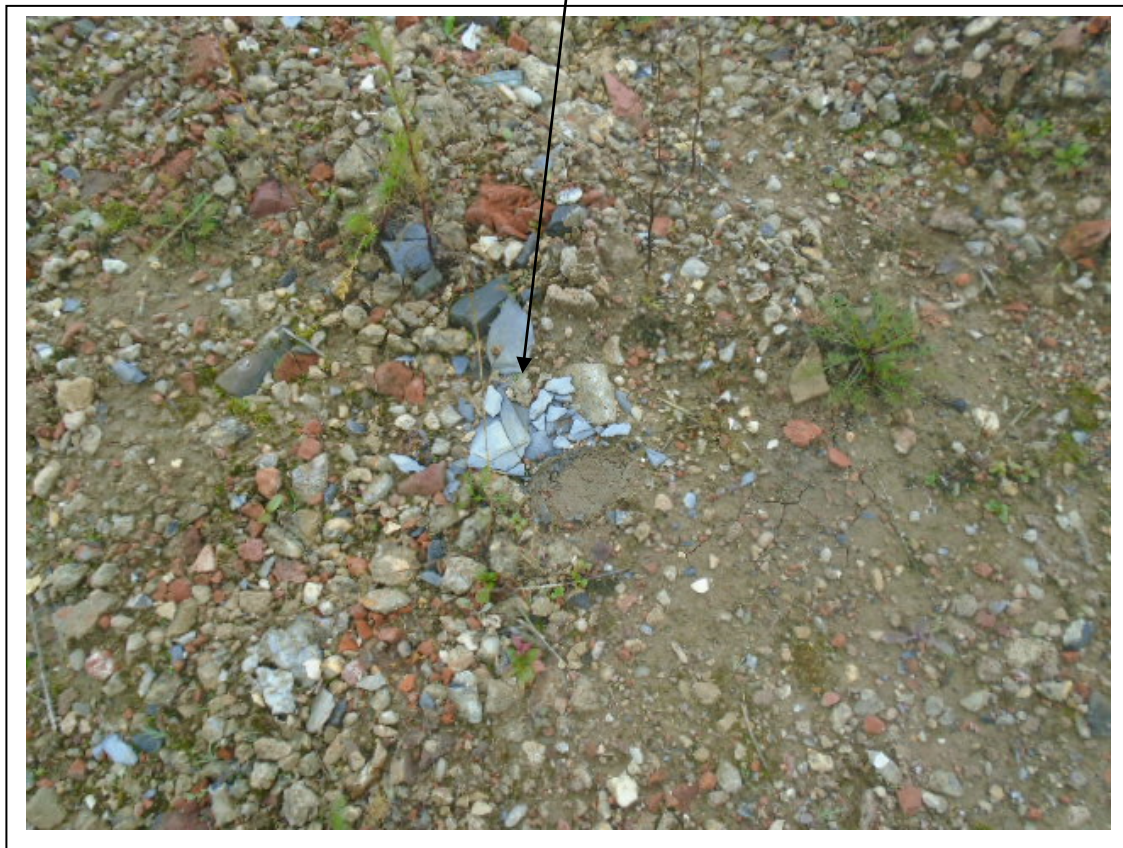
| Sample Reference: GILL/C/04 | Location: On Surface of Crushed Materials |

| Product Type: Slate Debris | Sampled By: Nic Button |
| Condition: High Damage | Surface Treatment: Bare |
| Asbestos Type: No asbestos detected in sample. | Material Assessment Score: 0 |

| Recommendation: Non asbestos material | |

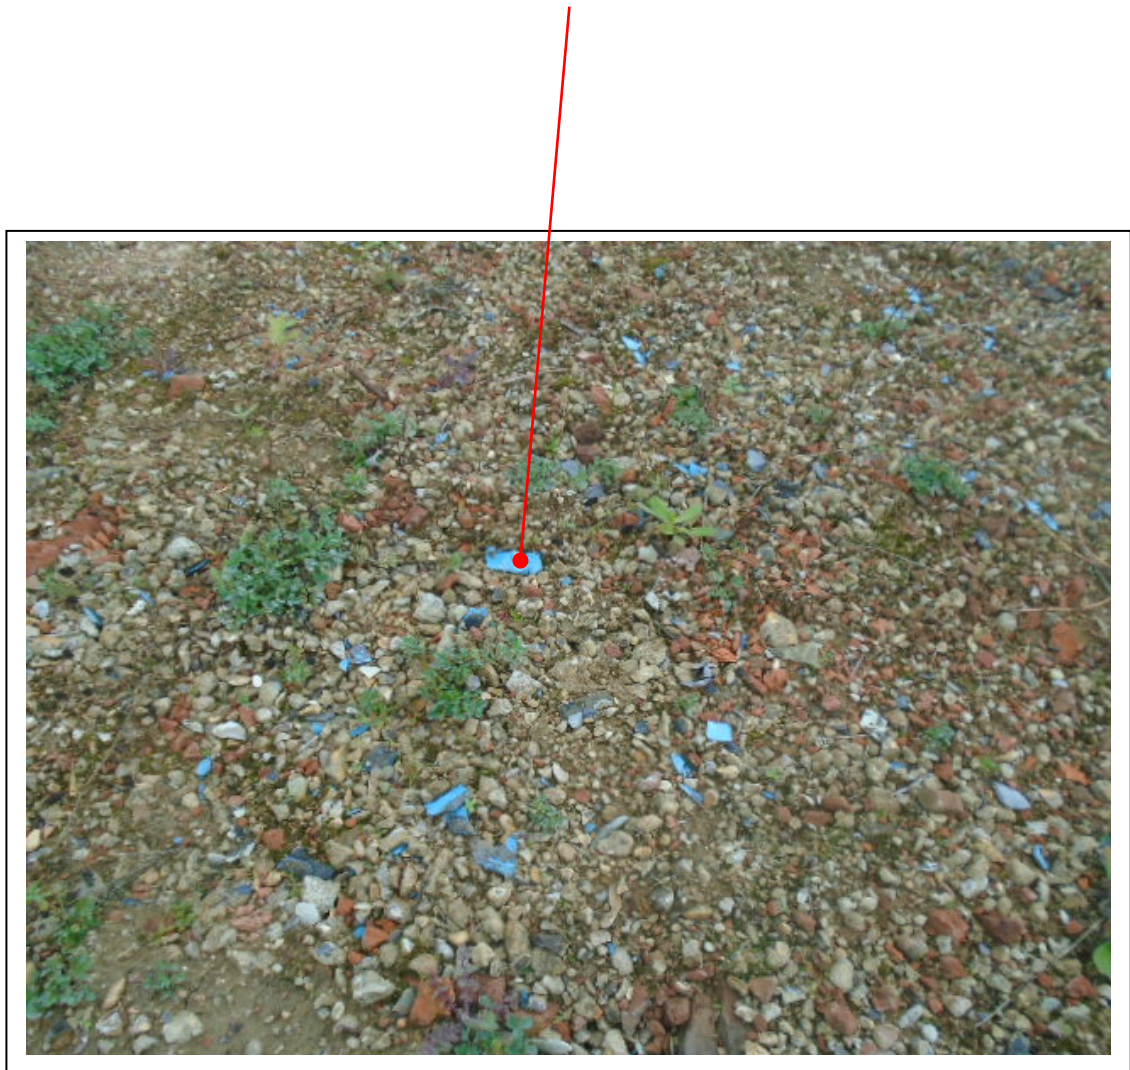
| Sample Reference: GILL/C/05 | Location: On Surface of Crushed Materials |

| Material: Floor tile and adhesive | Extent: Not Quantifiable (presumed throughout) |
| Condition: High Damage | Surface Treatment: Bare |
| Accessibility: Routine Disturbance | Friability: Medium |
| Asbestos Type: Chrysotile (white asbestos) fibres detected in sample. | Material Assessment Score: 6 |

| Recommendation: Remove using a suitably trained and competent contractor | |

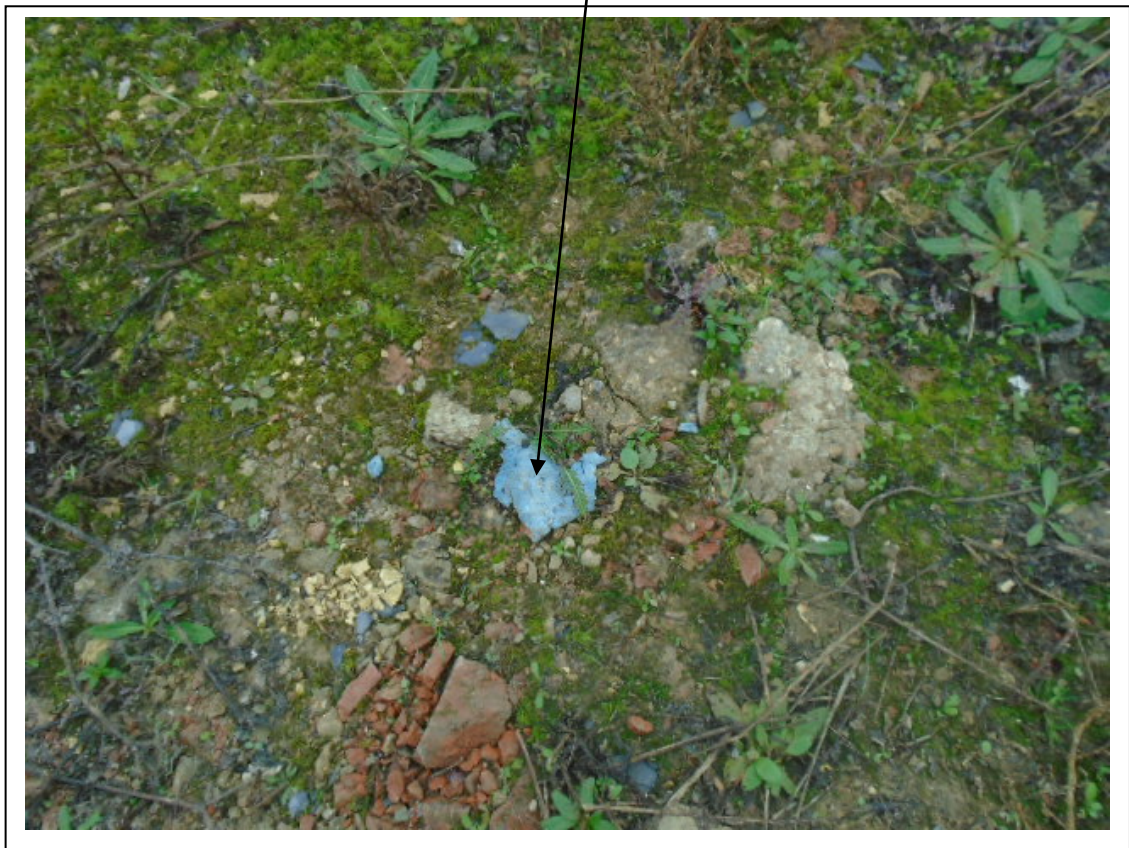
| Sample Reference: GILL/C/06 | Location: On Surface of Crushed Materials |

| Product Type: Blue Linoleum Debris | Sampled By: Nic Button |
| Condition: High Damage | Surface Treatment: Bare |
| Asbestos Type: No asbestos detected in sample. | Material Assessment Score: 0 |

| Recommendation: Non asbestos material | |
