# GEOSHIELD Verification Report

PROJECT: Porcelenosa: Kenwood Construction

MEMBRANE SPECIFICATION: Gas membrane to specification BS8485 2015

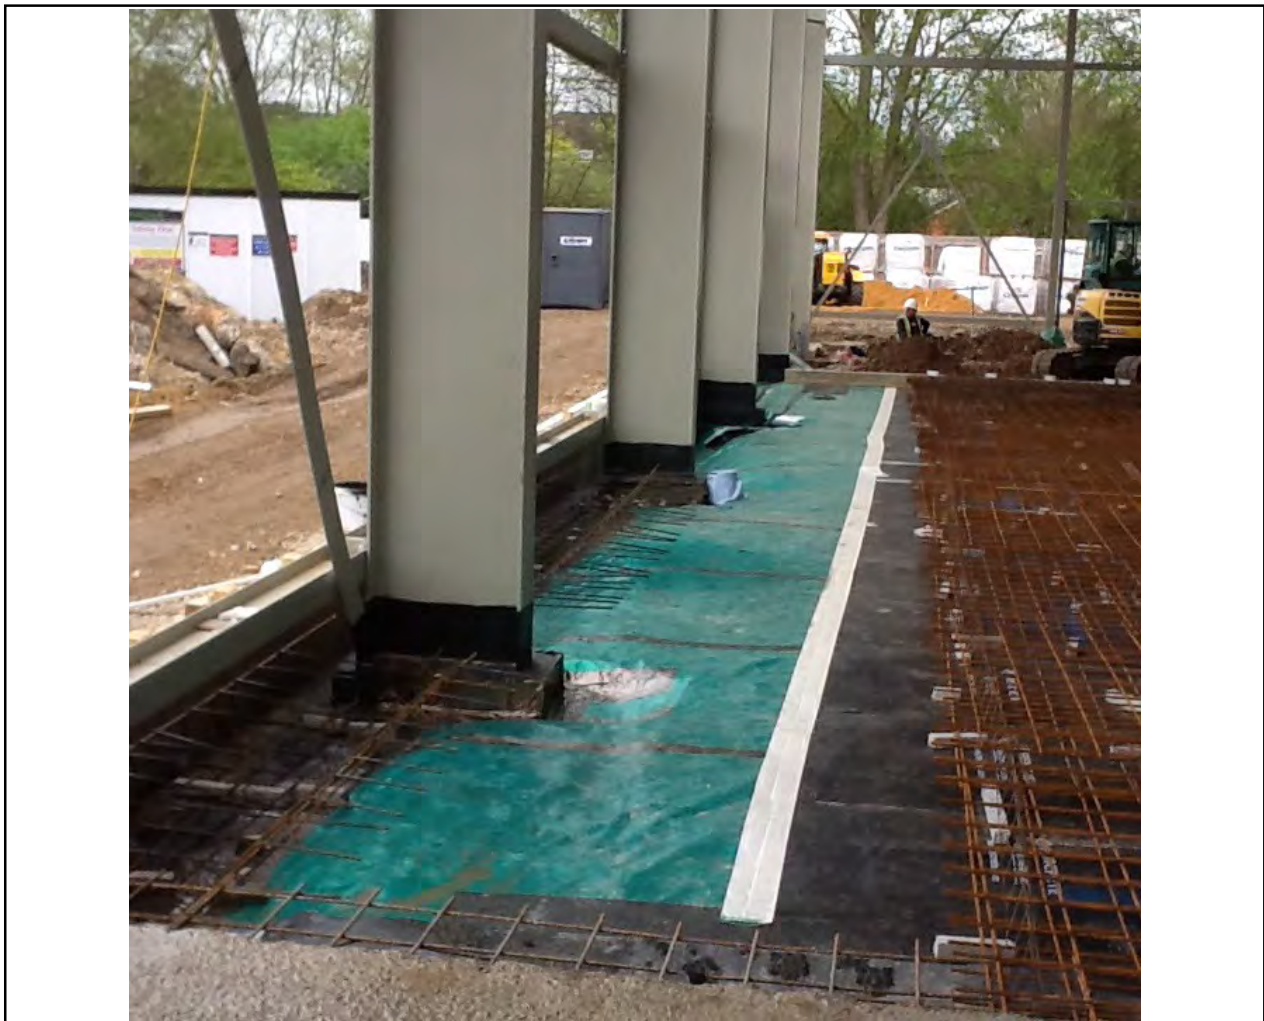
Overview A/B - 4/7

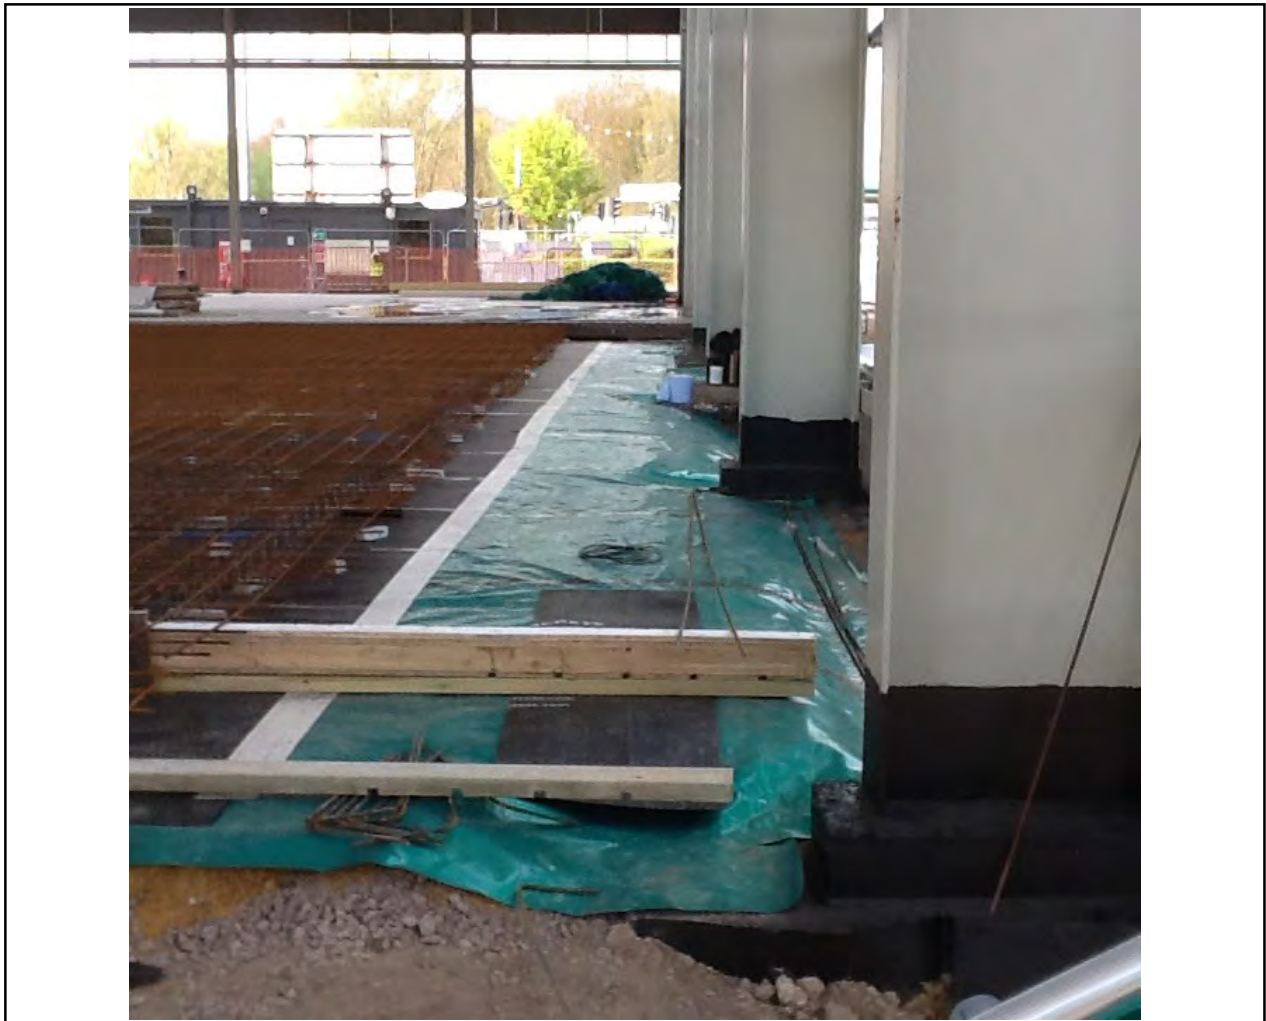
Opposing end view

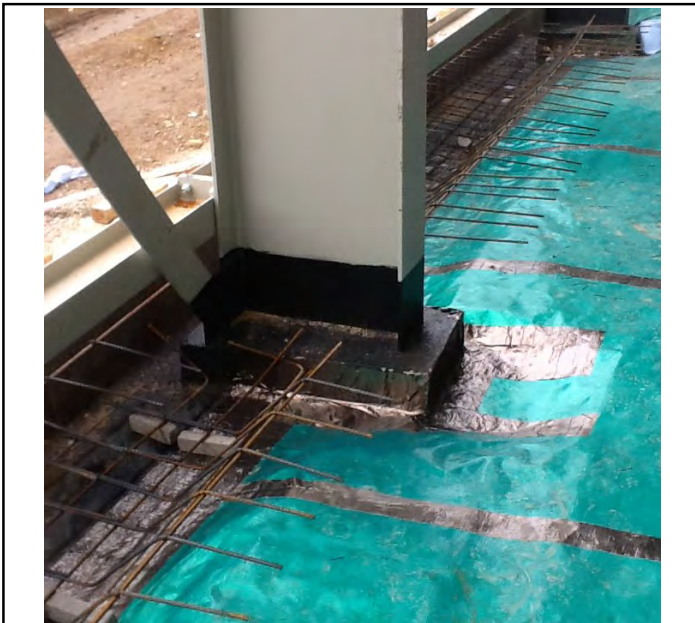
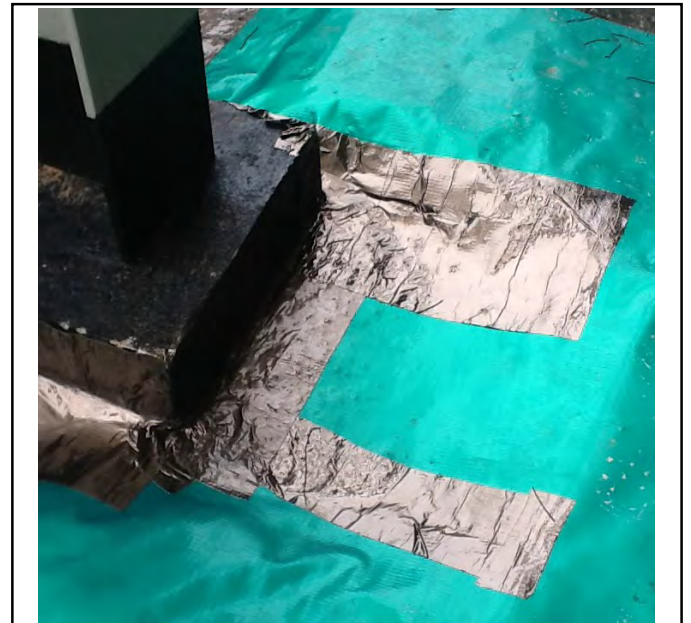
LOCATION/GRID LINE: 5-A

Columns near Edge , detailed to specification

Hydroprufe 9000 linked to edge via GR girth tape and application of Hydroprufe LG to

Columns

| Date | Nr | Remediation Description | Y/N |
|---|---|---|---|
| 3rd Apr | 003 | Columns and edge detailing 5A complete | ✓ |

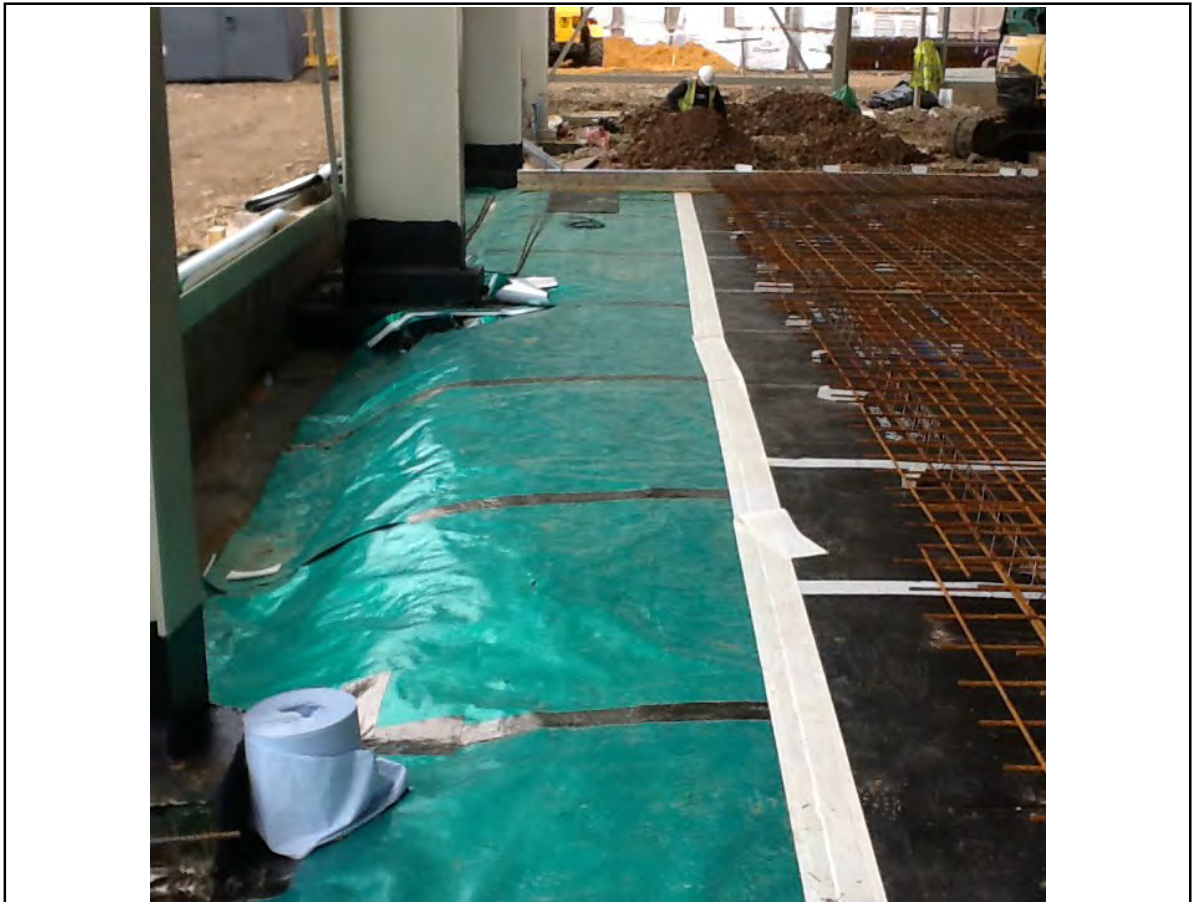
Overview (foreground ) of detailed column

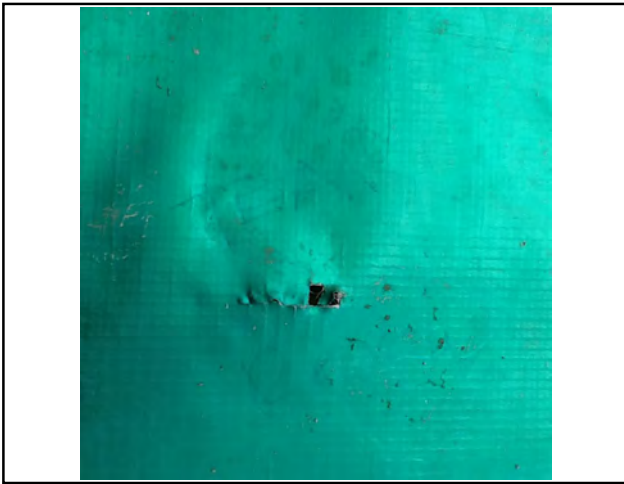
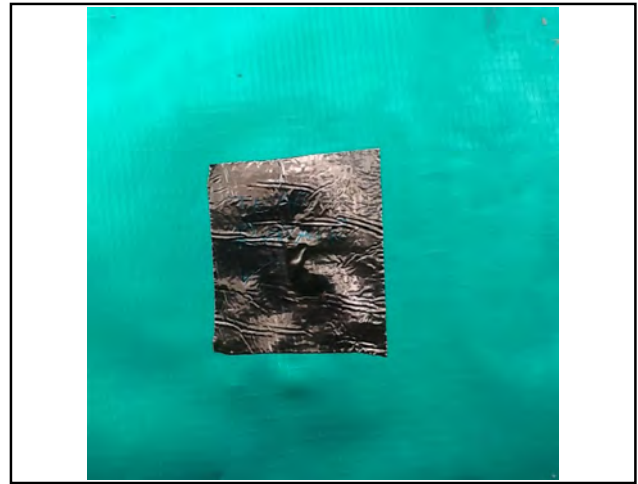
LOCATION/GRID LINE: 4A

NOTES: Tear in membrane caused by steel fixers dragging

Steels across surface , before and after pictures shown below I.e

Tear repaired during visit

| Date | Nr | Remediation Description | Y/N |
|---|---|---|---|
| 3rd Apr | 003 | Repairs in membrane 4A | ✓ |

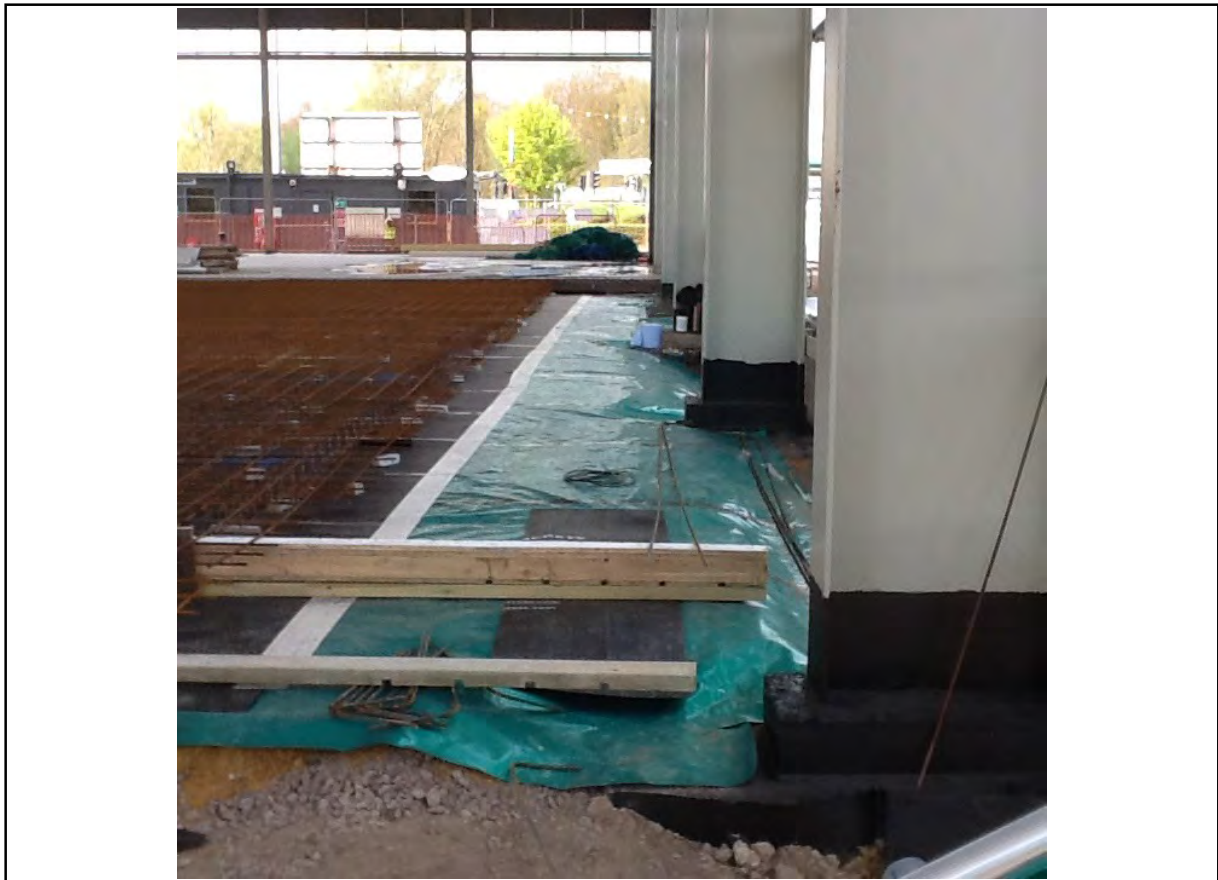
Overview area of repairs required in membrane

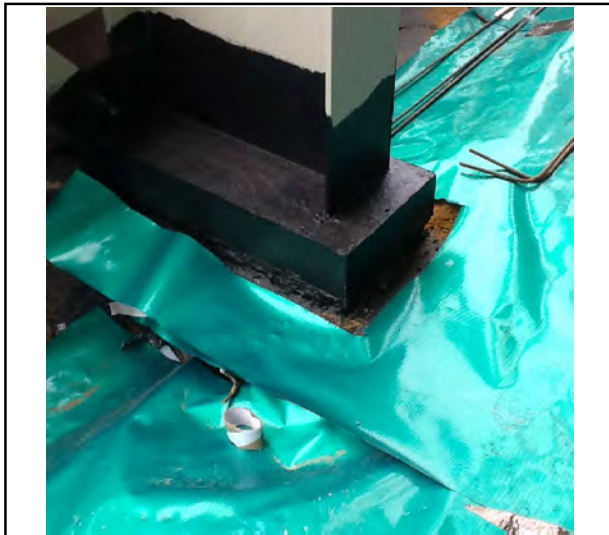
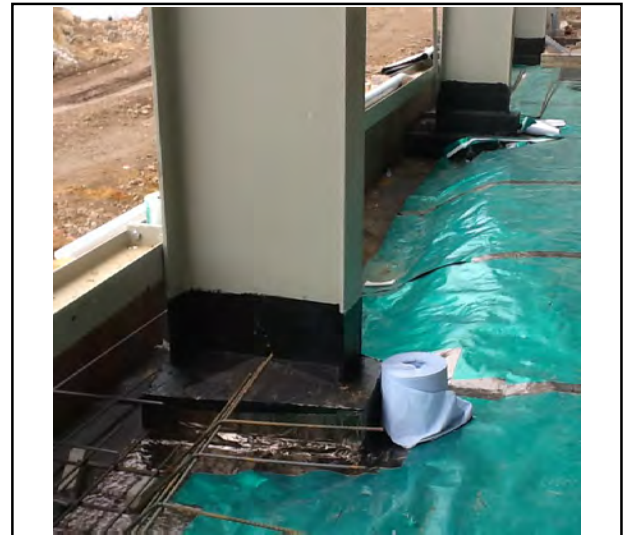
LOCATION/GRID LINE: A-B - 6-7

NOTES: This area waits detailing tape on edge ( outer wall A)

and columns , to complete installation of membrane

| Date | Nr | Remediation Description | Y/N |
|---|---|---|---|
| 3rd Apr | 003 | Outstanding detailing to columns and edge A/B -6/7 | |

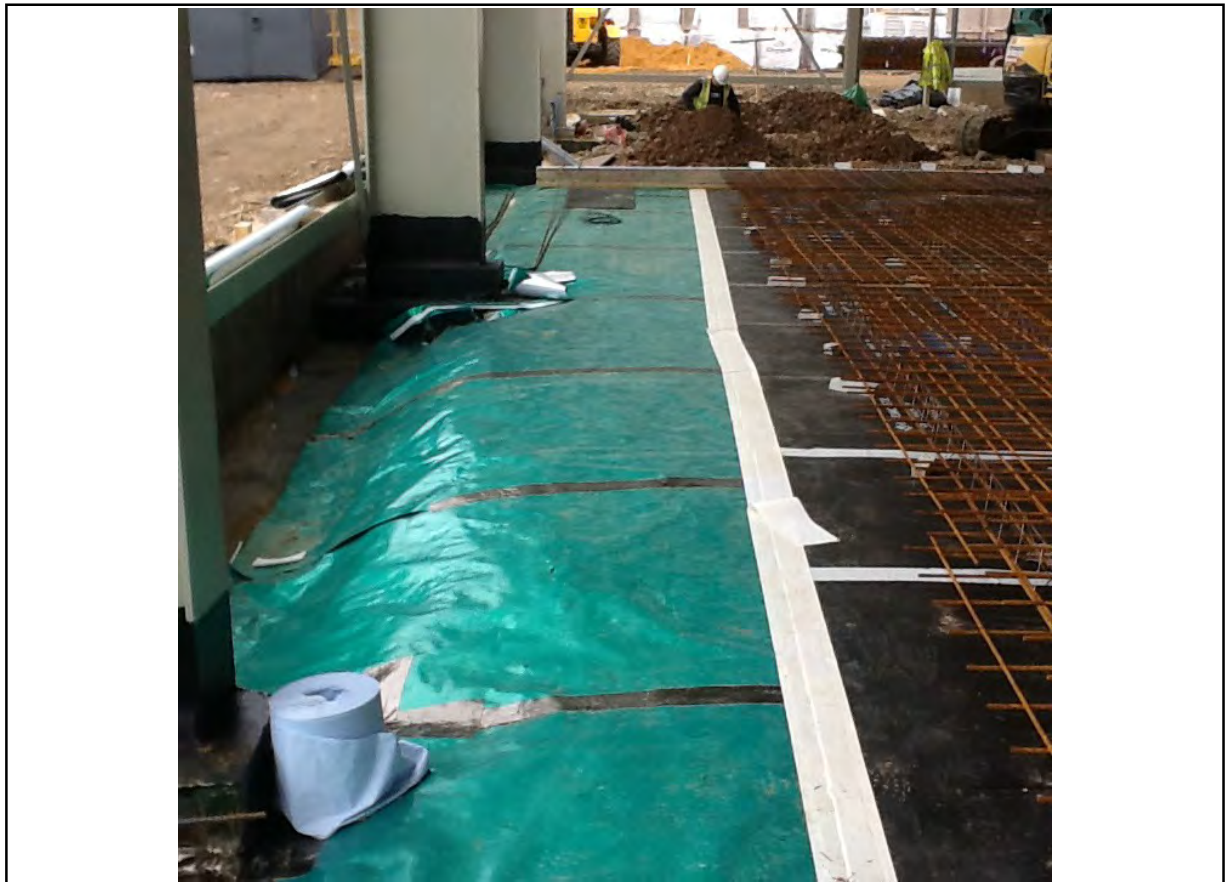
Overview outstanding area to be completed

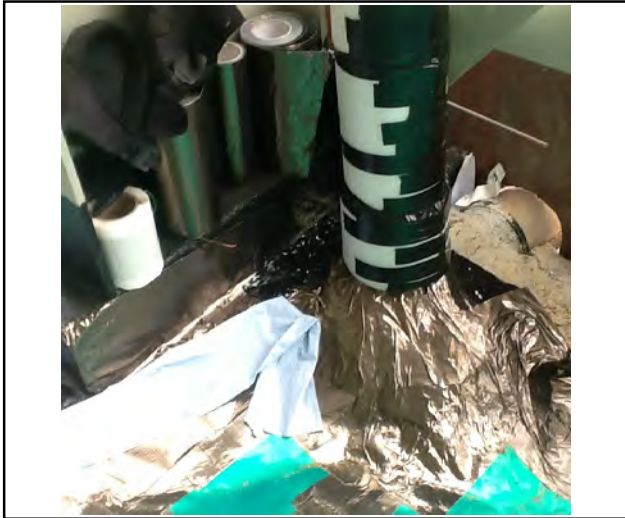
Pipe penetration complete

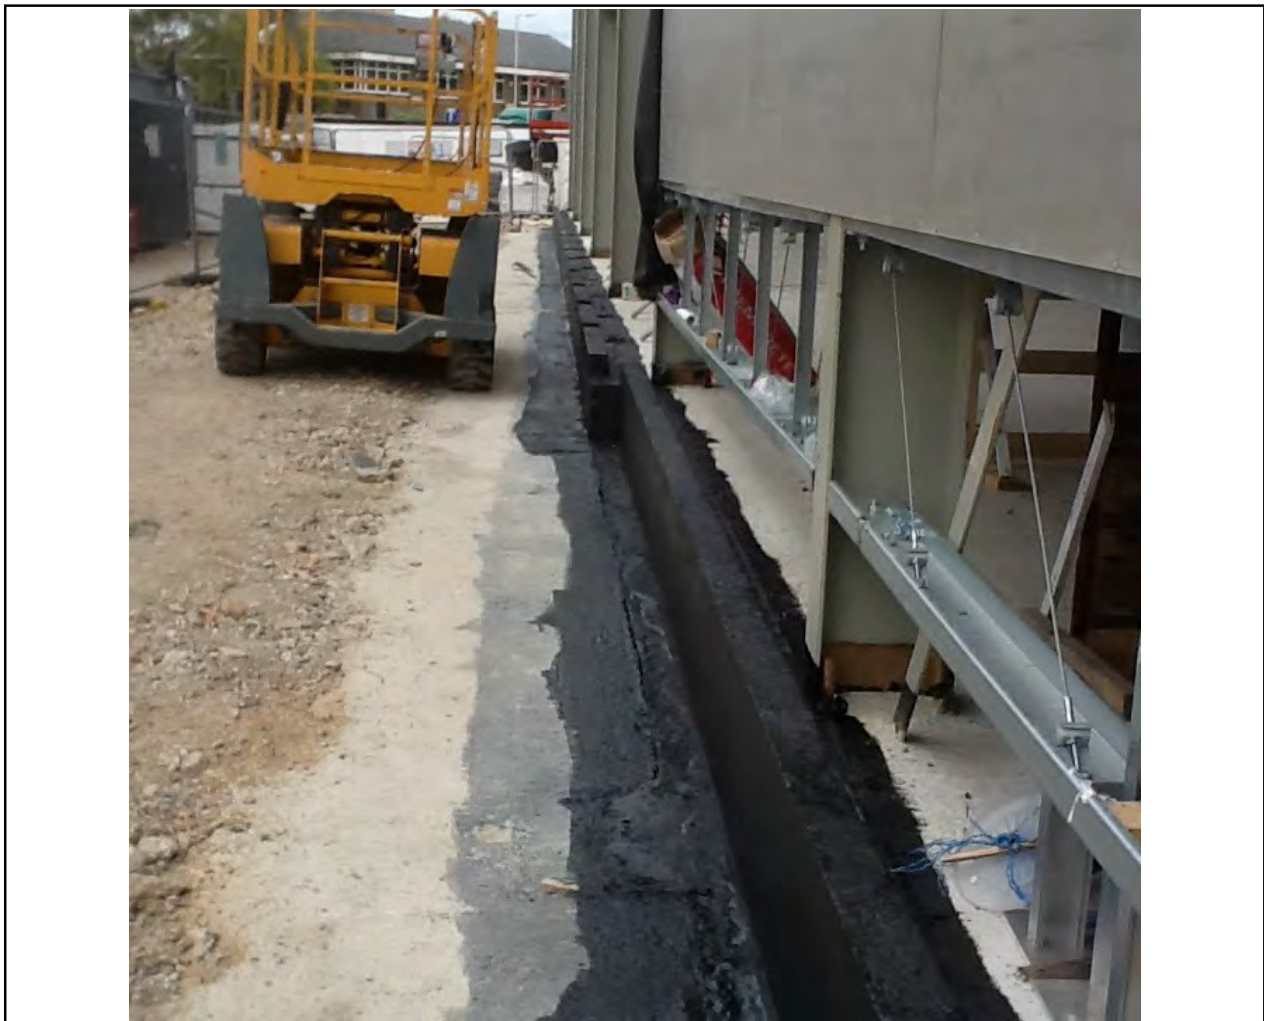
Overview wall 1

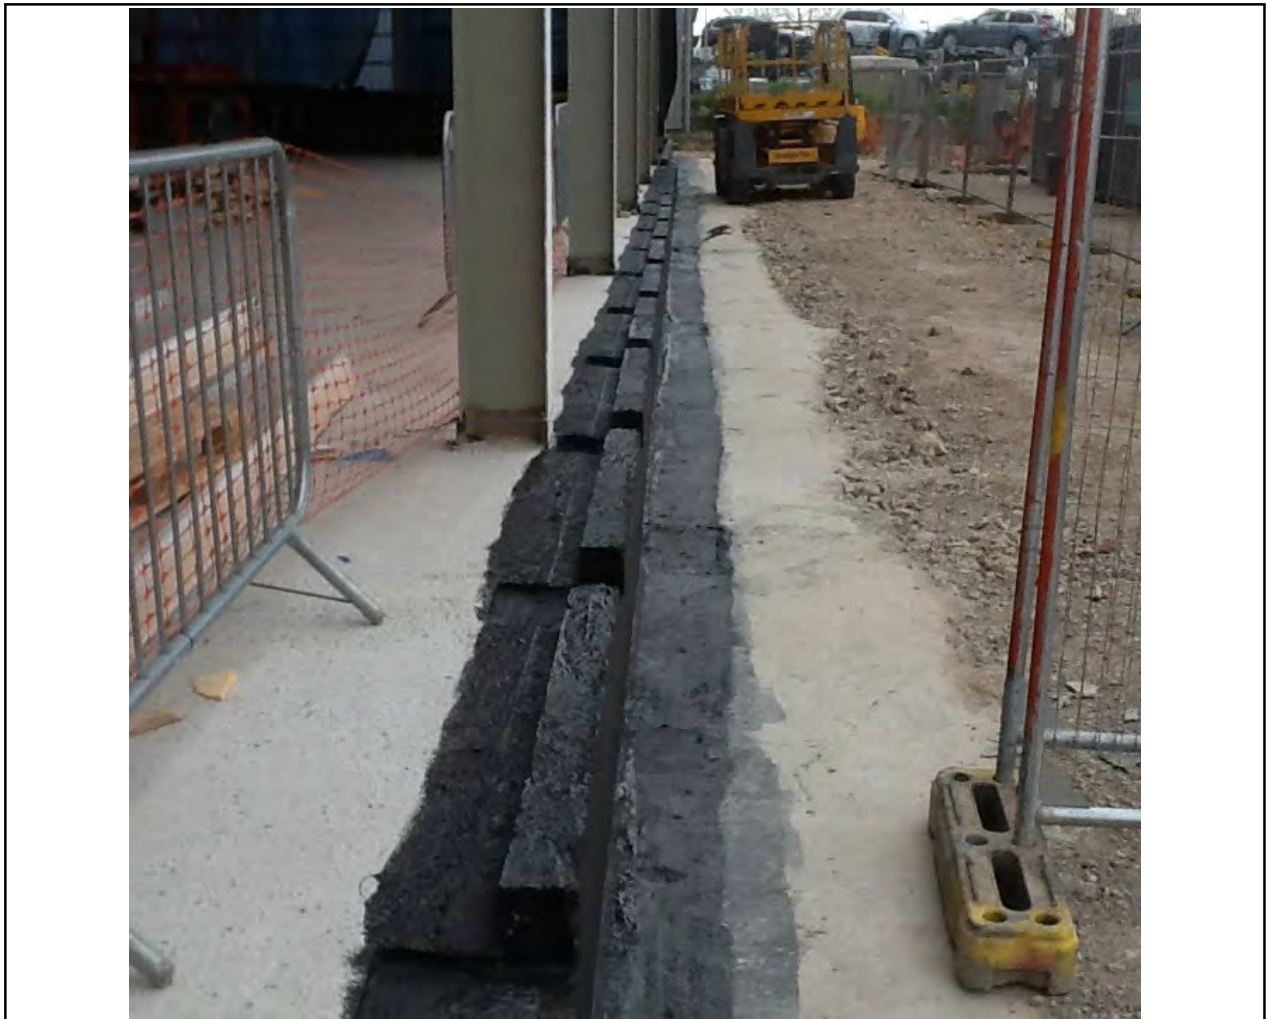
Wall 1 , viewed from corner of intersection with wall A

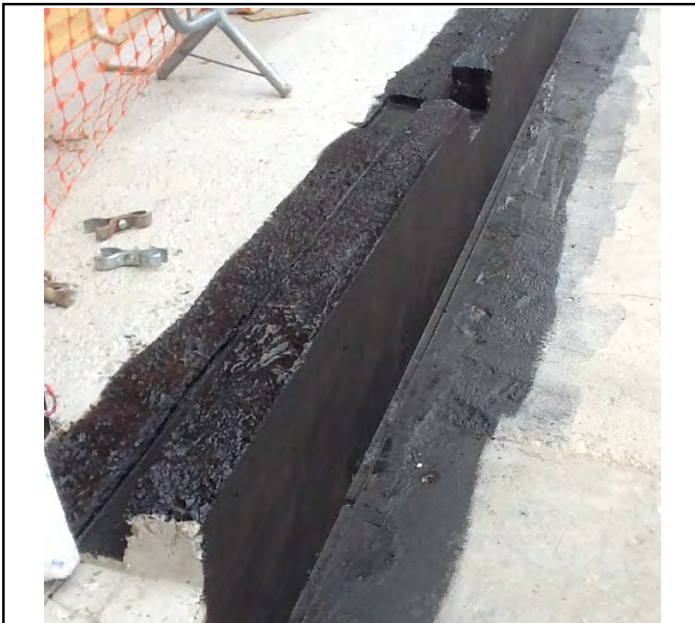
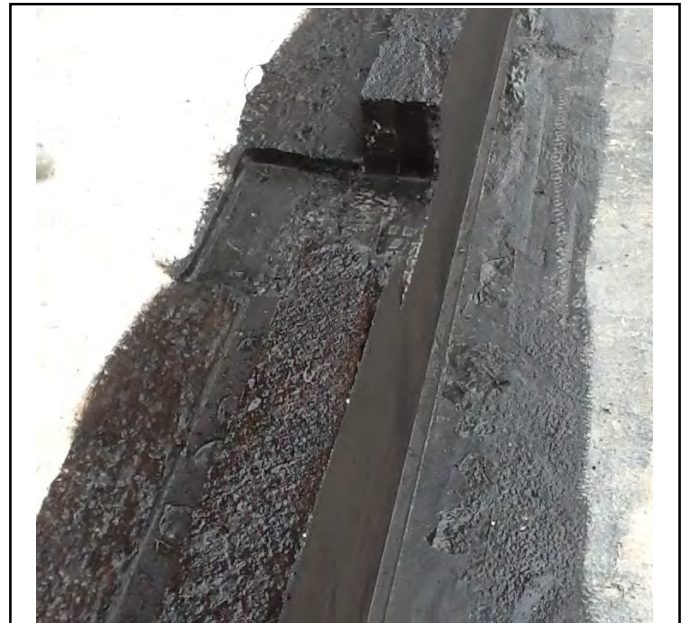
LOCATION/GRID LINE: Wall 1

NOTES: Two views showing primed wall 1 ready for application of

Membrane

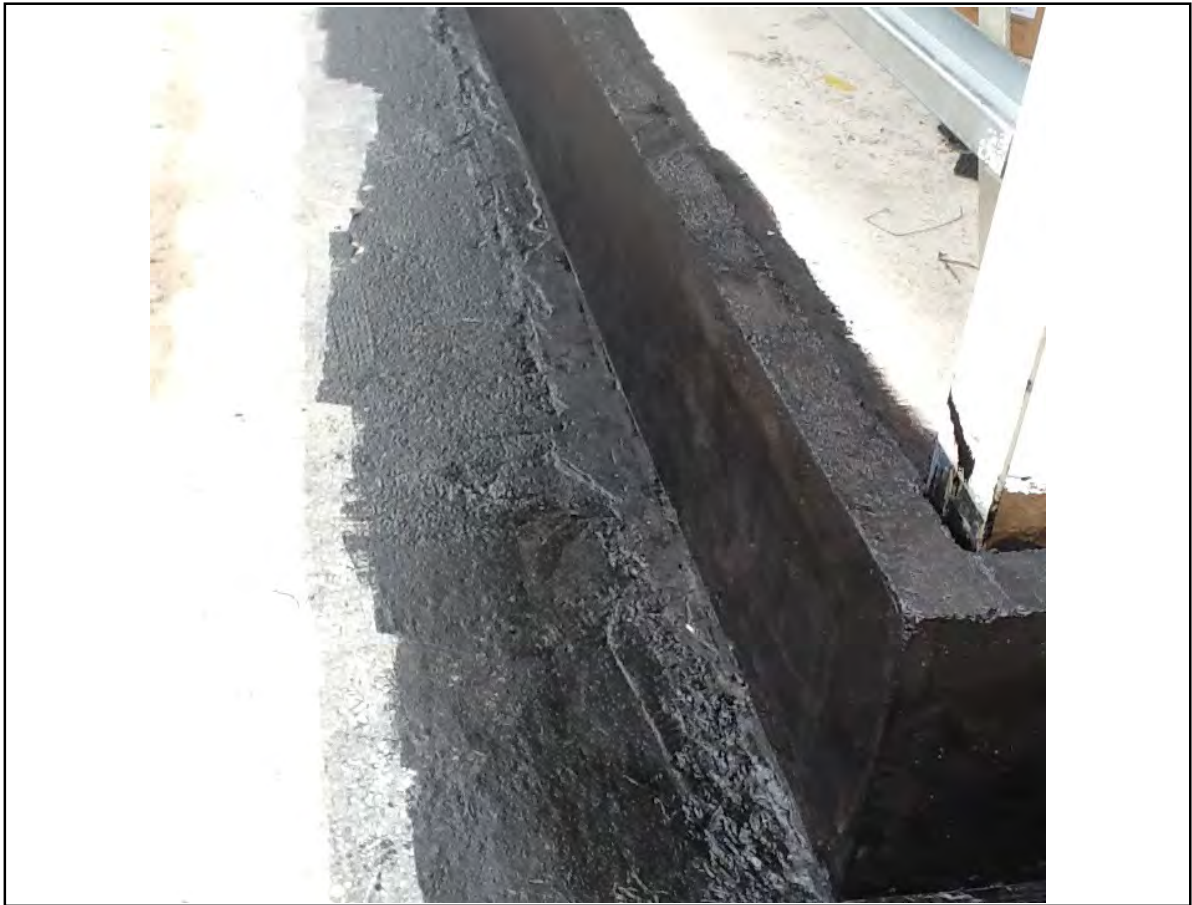
### Overview primed wall 1

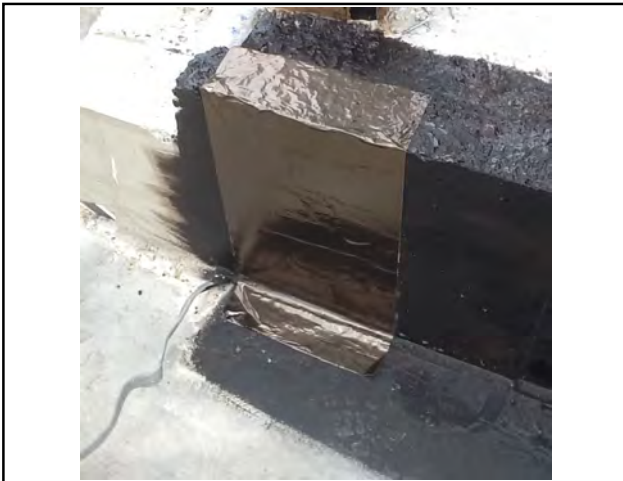
LOCATION/GRID LINE: Wall 1 , near corner of wall A ,

NOTES: Photo 1 incorrectly applied GR detailing( remediation)

Tape to wall perimeter

| Date | Nr | Remediation Description | Y/N |
|---|---|---|---|
| 10th Apr | 004 | Incorrect application of detailing/ remedation tape | ✓ |

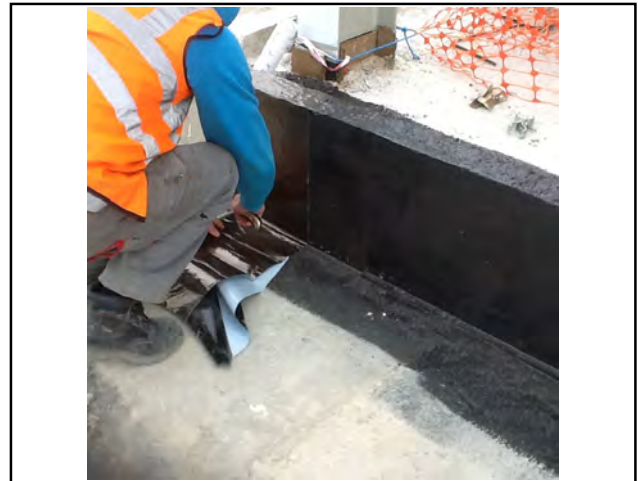
Photo 2 : incorrect tape being removed

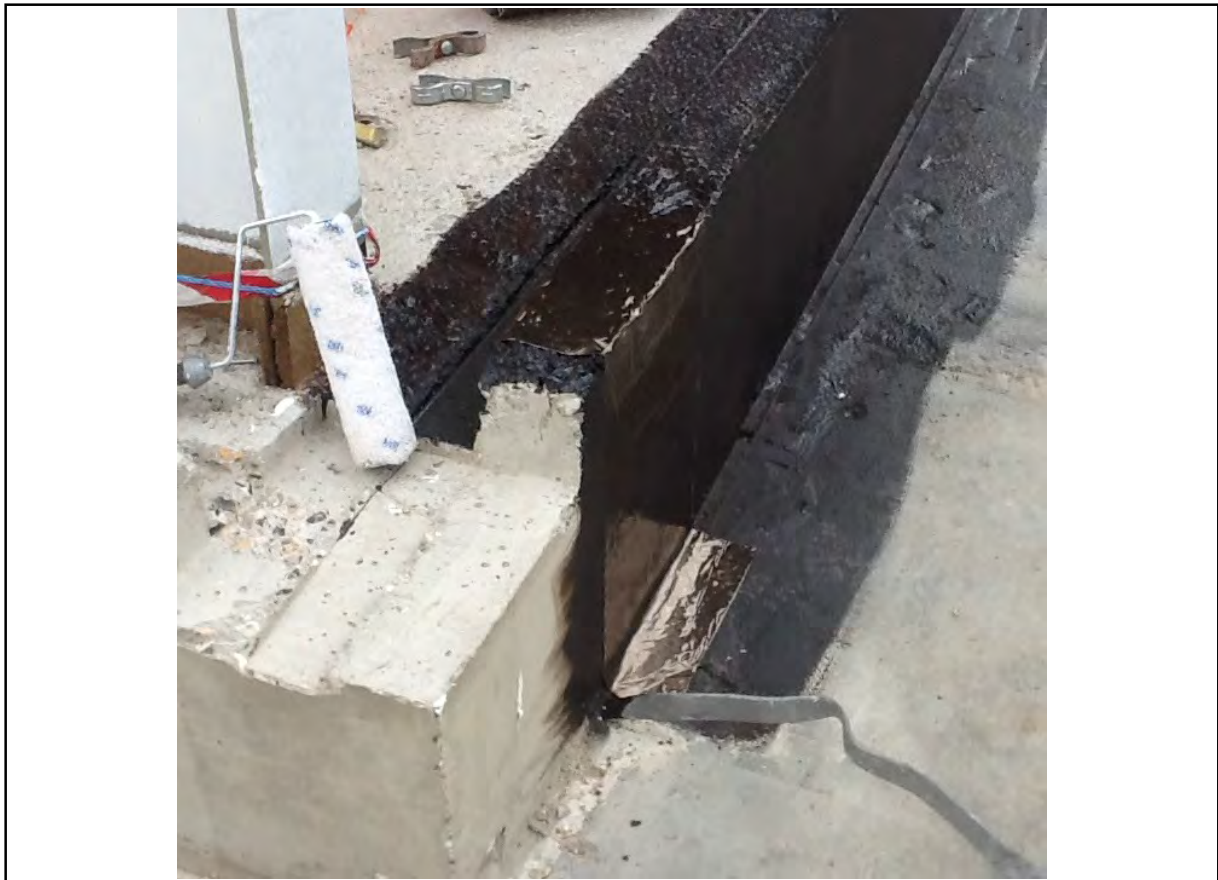
Overview of incorrectly applied remediation/detailing tape

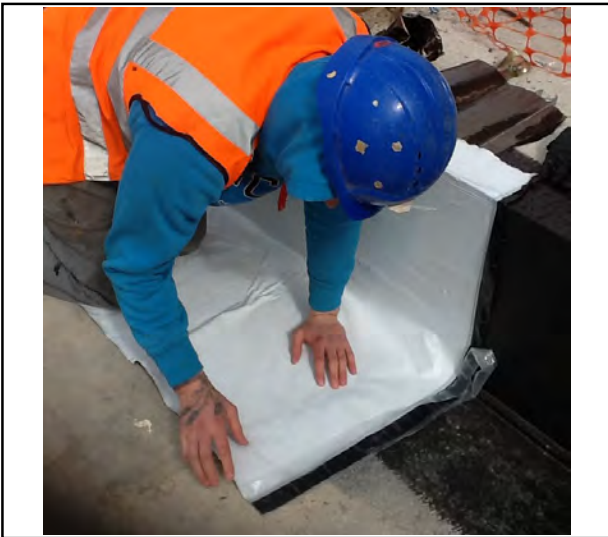
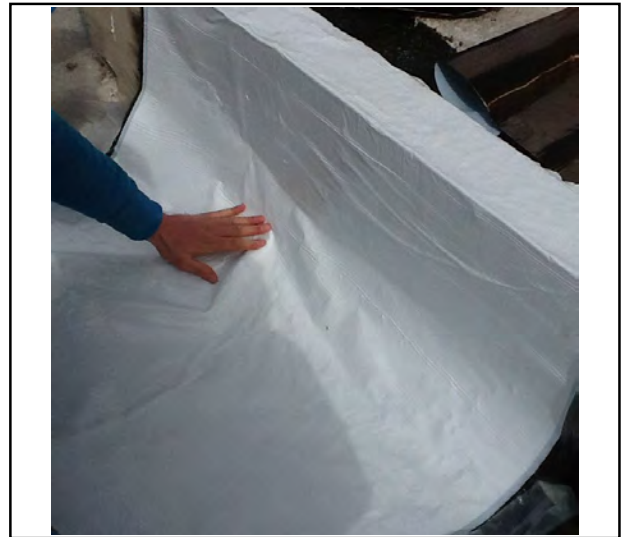
LOCATION/GRID LINE: Wall 1 near corner wall A

NOTES: Two views showing progress of Hydroprufe 8000

application , ( after the incorrect tape had been removed )

| Date | Nr | Remediation Description | Y/N |
|---|---|---|---|
| 10th Apr | 004 | Correct application of Hydroprufe 8000 on perimeter | ✓ |

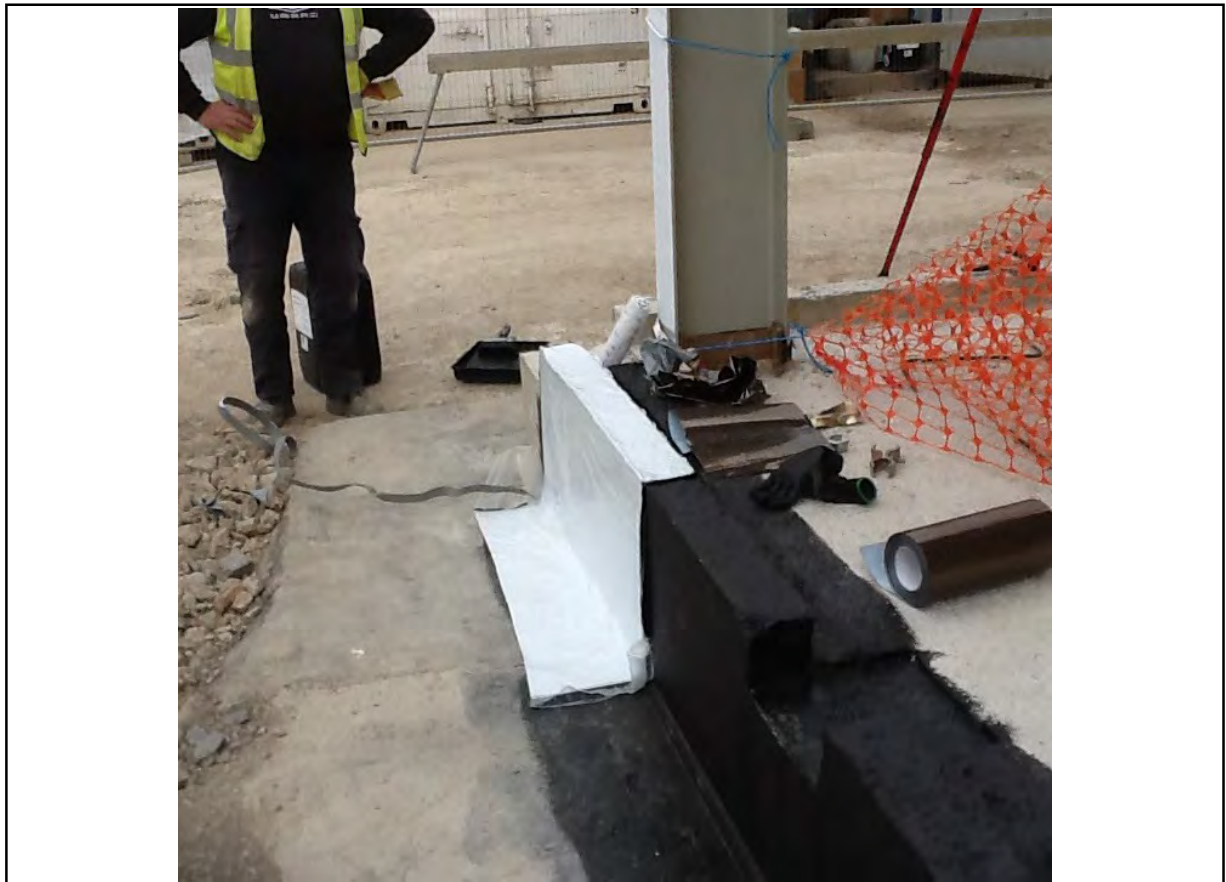
Overview first section of Hydroprufe 8000 application

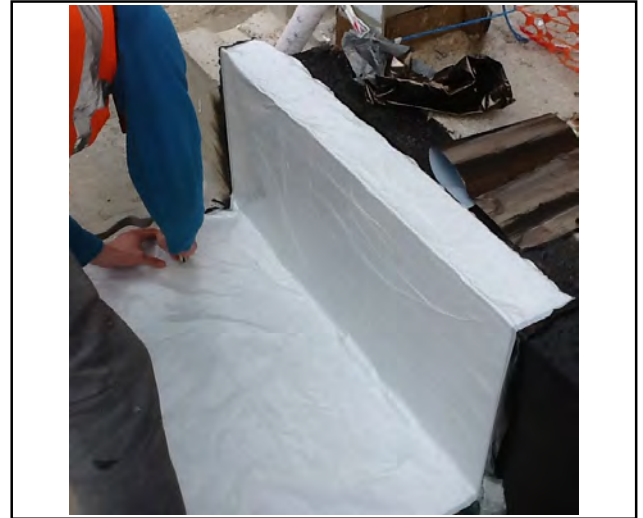
Correct Application

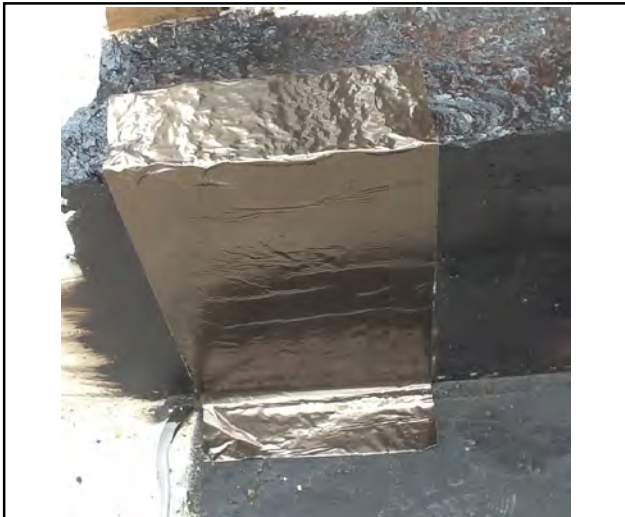
Incorrect product

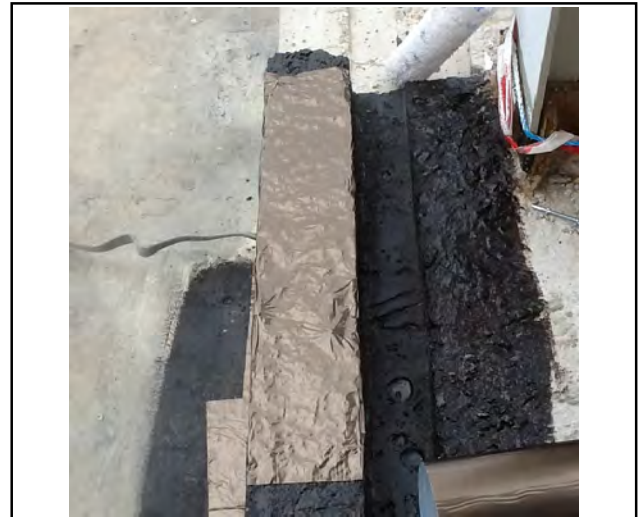
Incorrect application

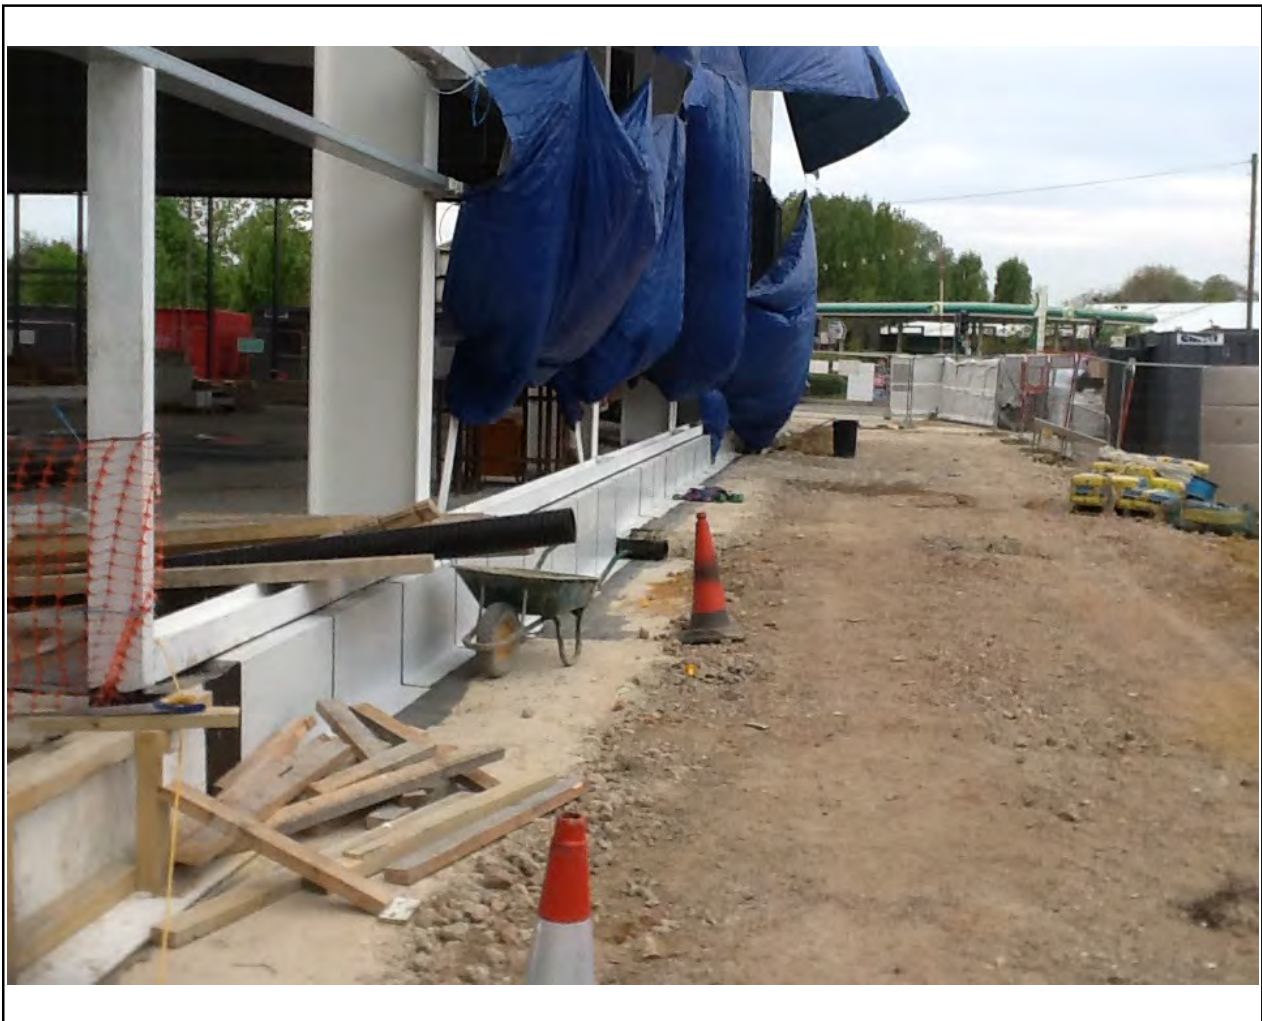
Overview wall A

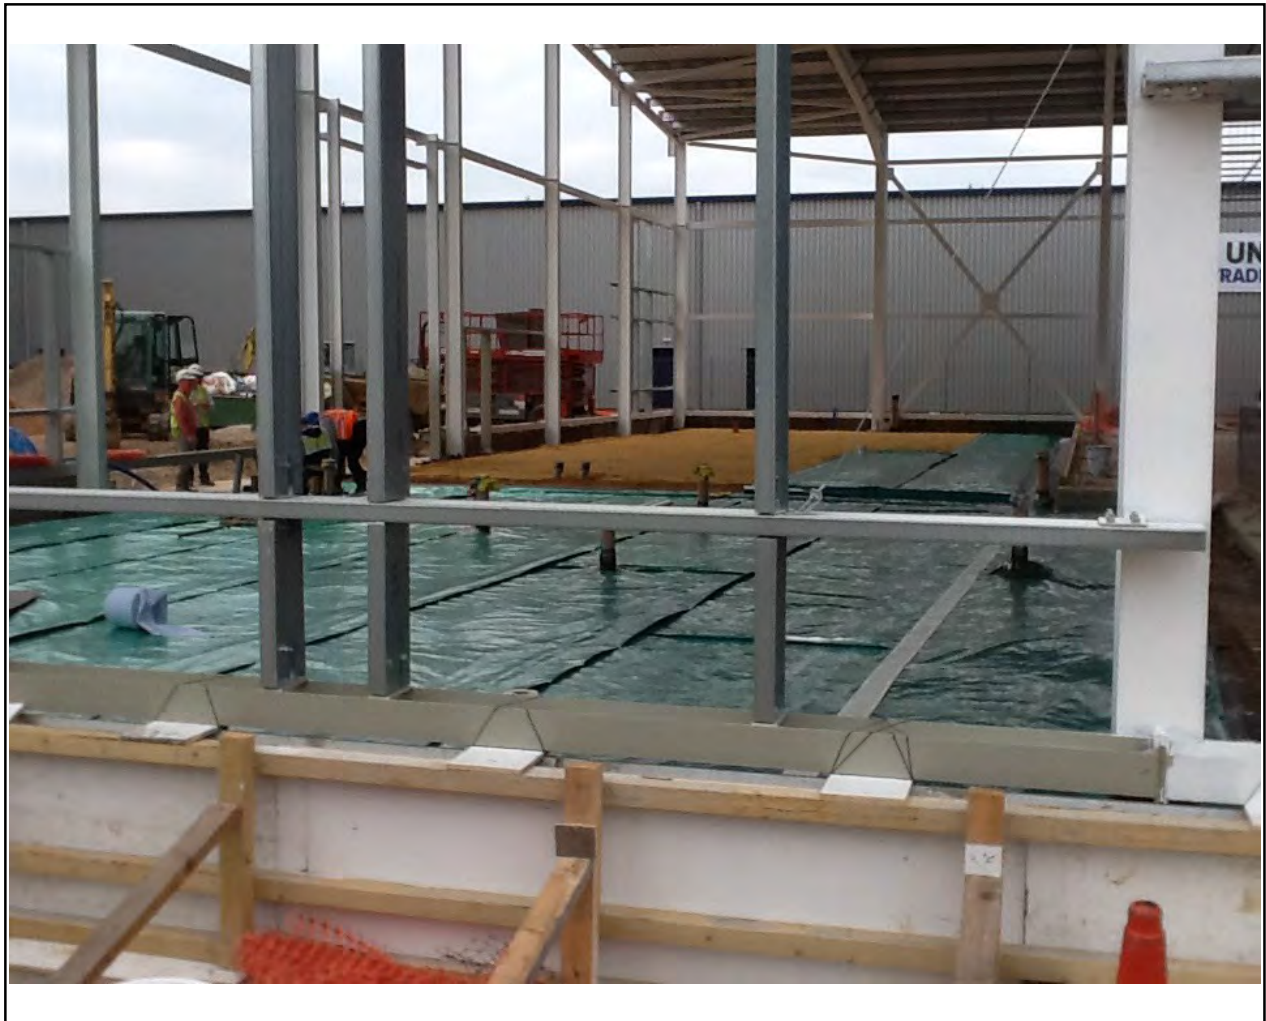
Overview area 7/9 - A-H

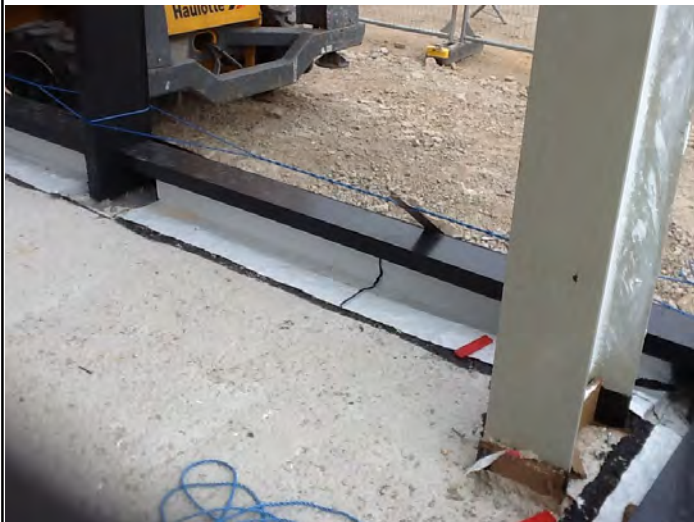
Photo 1 : Shows application over the top and then secured on the inner surface

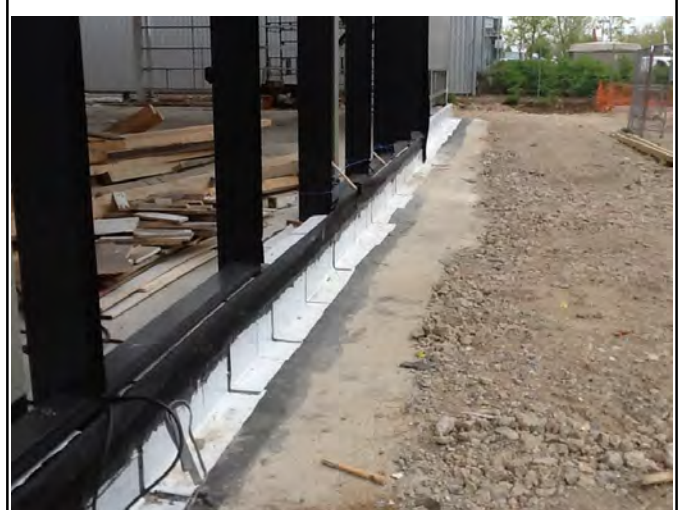
Photo 2 : outer view of wall 1

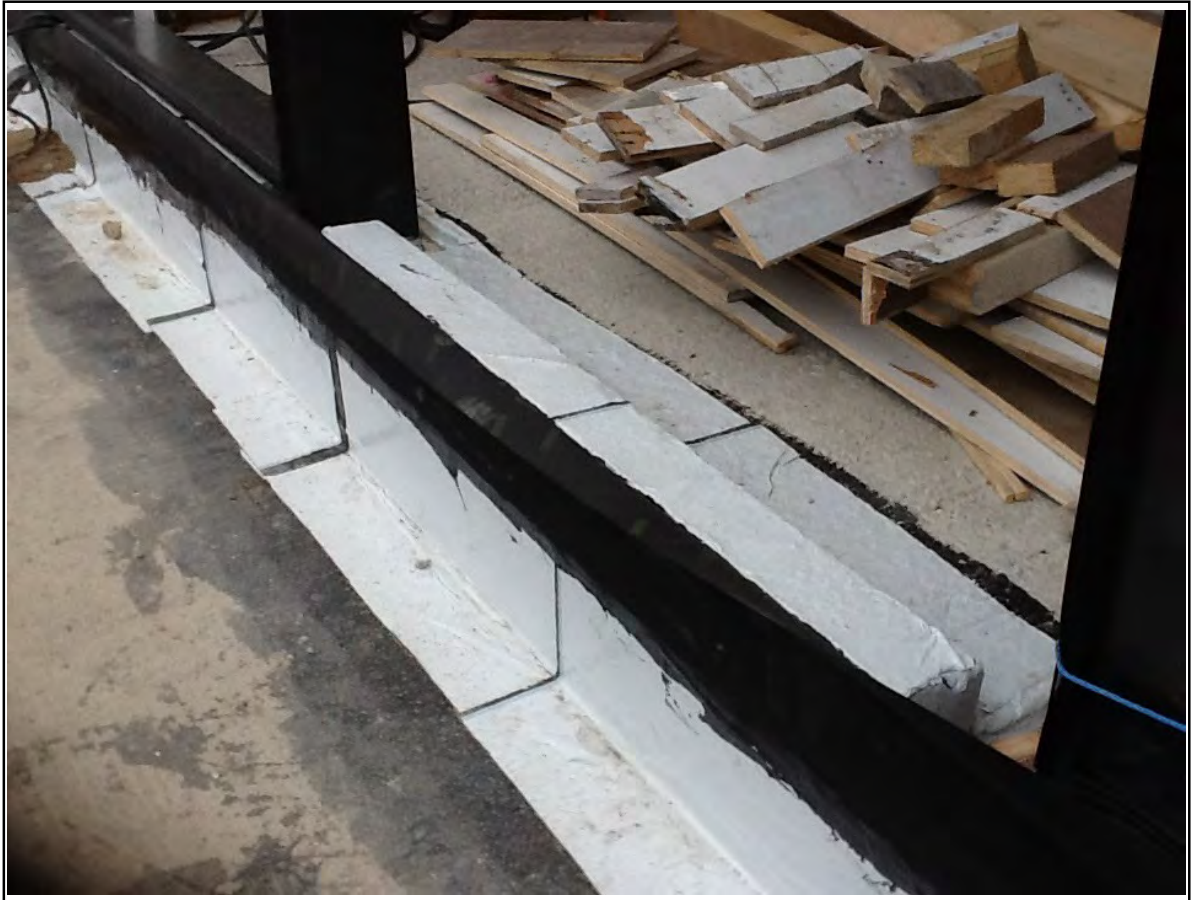
Overview wall A

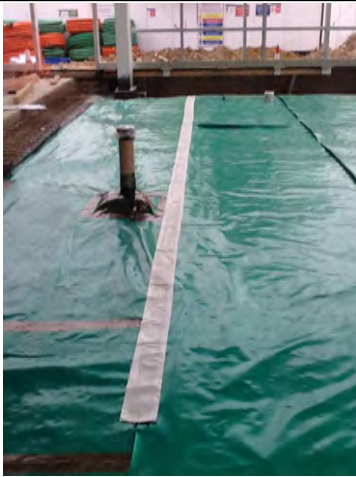
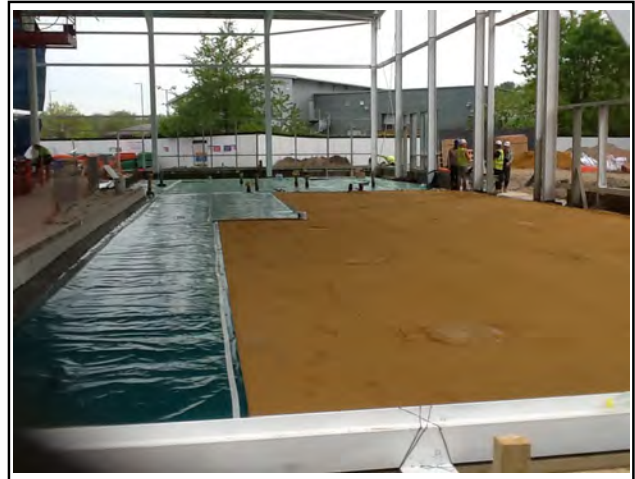
GR detailing tape ( had run out , more ordered ) tried the wrong tape for a small

Section
