# GEOSHIELD Verification Report

PROJECT: Porcelenosa: Kenwood Construction

MEMBRANE SPECIFICATION: Gas membrane to specification BS8485 2015

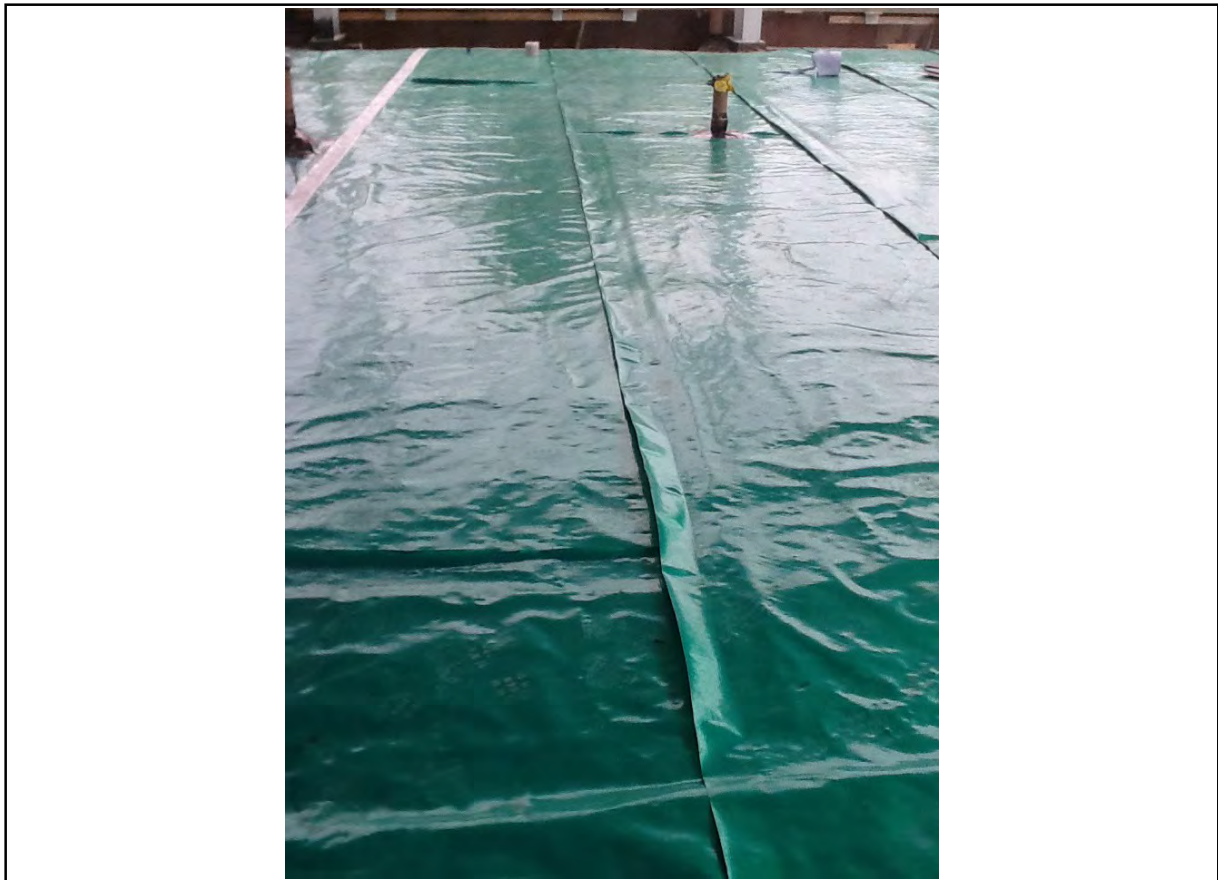
Overview , laps outstanding to be taped ( ongoing)

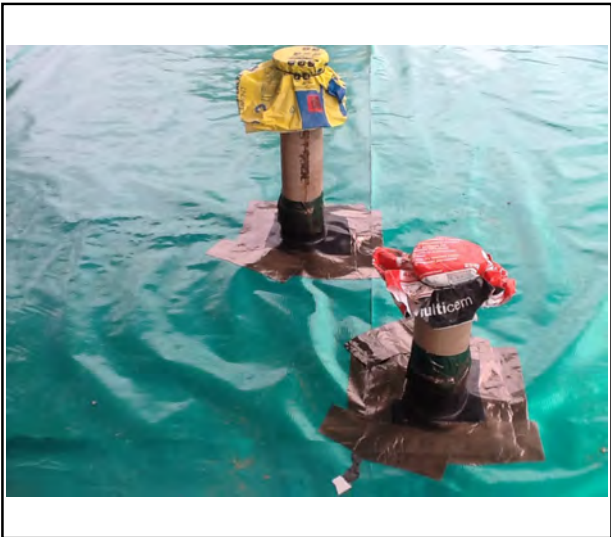
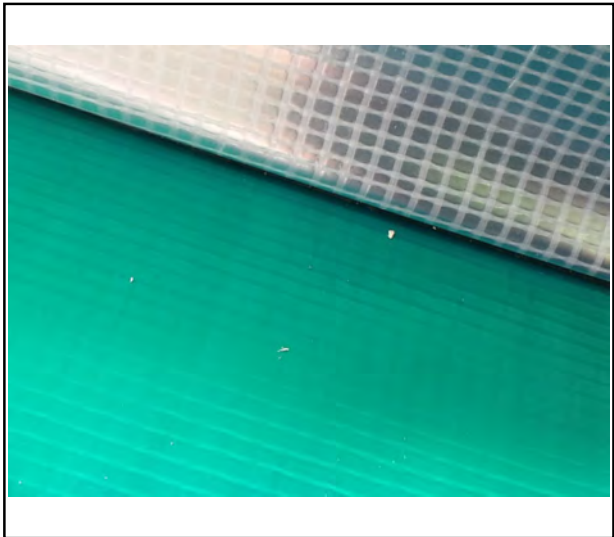
NOTES: Pipe penetrations correctly detailed and laps

In this area correctly applied with double sided tape

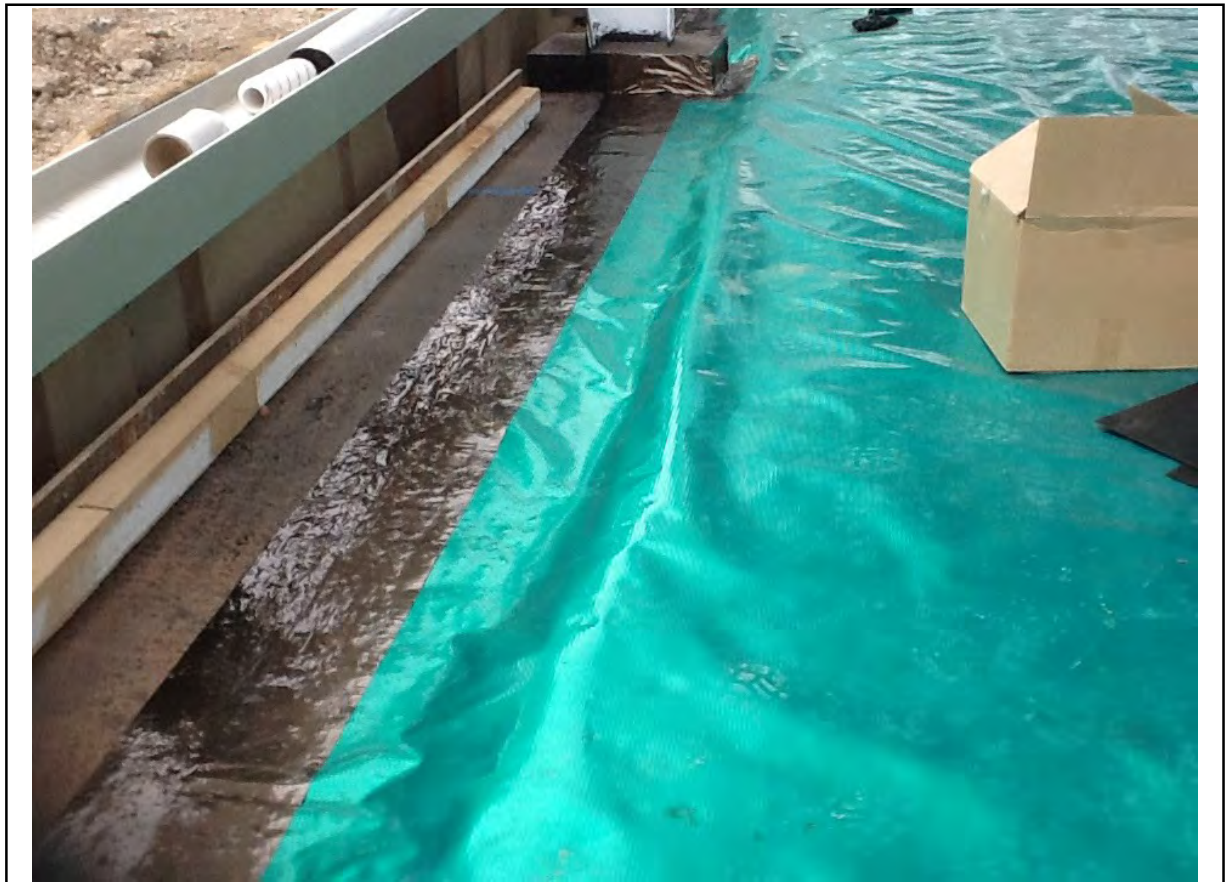
Edge correctly applied with detailing tape

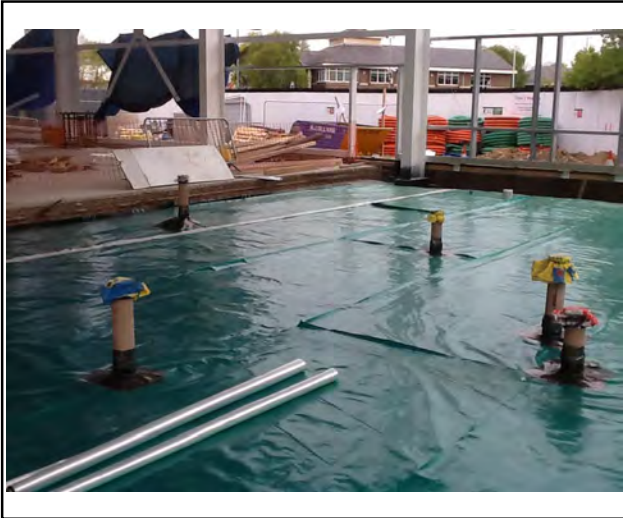
Application overview

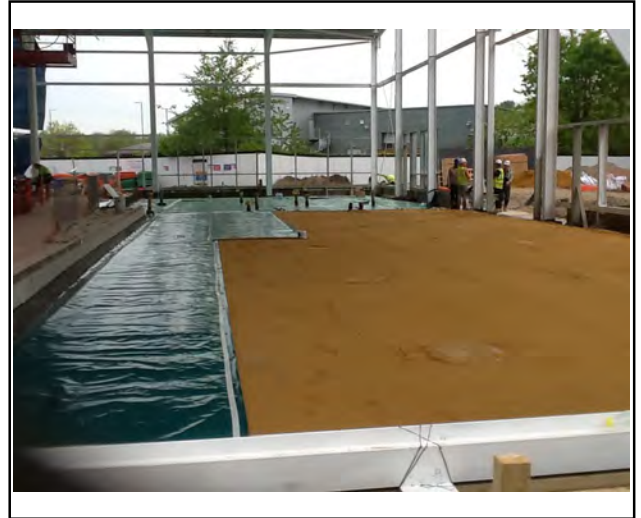
Application on sand blinding

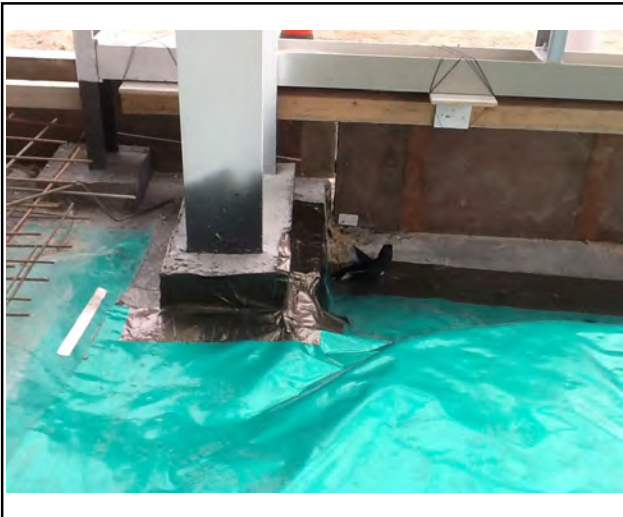
Column detailing

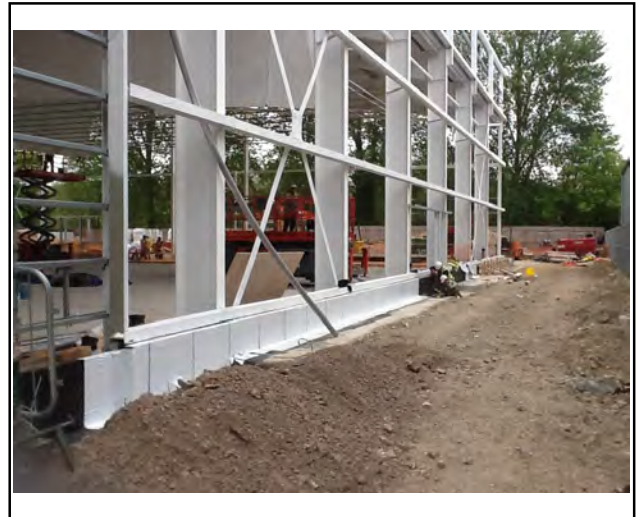
Wall perimeter
