**2 Ferndale Close  
Tilehurst  
Reading  
Berkshire  
RU31 6UZ**

# **Preliminary Bat Roost Assessment**

**Ref: R2012/a**

**August 2018**

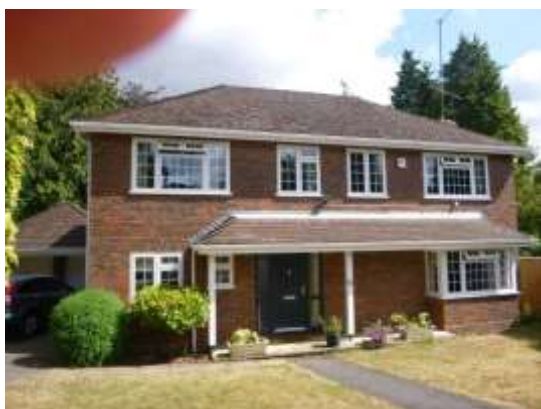
**3.2.1** The house was of modern, brick cavity wall construction with a hipped roof covered in flat clay tiles; a hipped roof garage was attached at the rear (northern) corner (**Photographs 1 & 2**).

**1. Front of house viewed from south-west.**

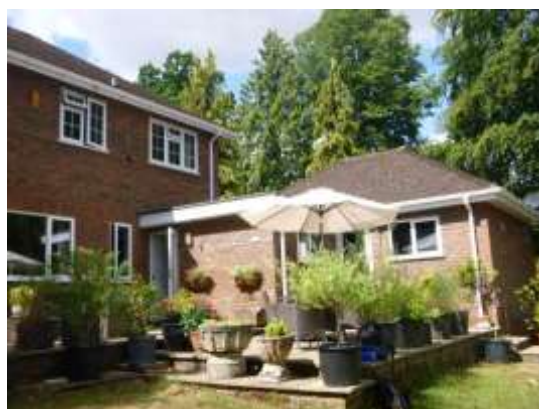
**2. Rear of house with attached garage viewed from east.**

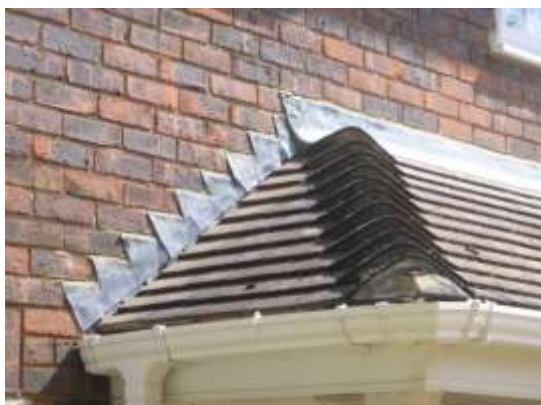
**3.2.2** Viewed from the front, the roof and ridge tiles were fitted tightly, offering no visible roosting opportunities for bats, with the lead flashing around the canopy over the porch also fitted tightly (**Photograph 3; Target Note 1**). At the rear, the moss covered roof tiles were also tight and in place, offering no visible gaps suitable for bats (**Photograph 4; Target Note 2**). The hips were mortared tightly with uPVC soffits lining the eaves of the main building (**Photograph 5; Target Note 3**).

**3. Lead flashing fitted tightly around canopy.**

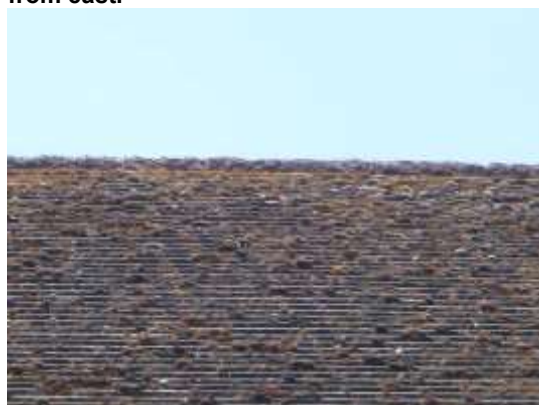
**4. Tiles at rear covered in moss and fitted tightly.**

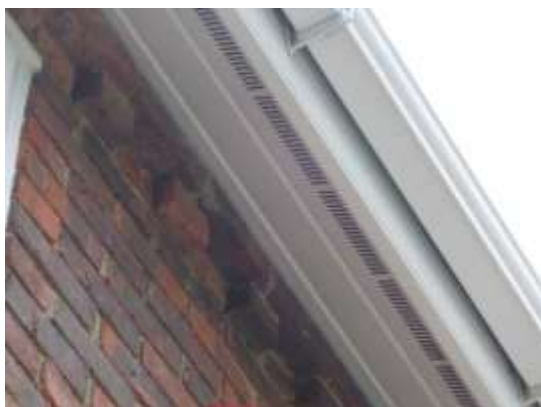
**5. UPVC soffits at rear tight to brickwork.**

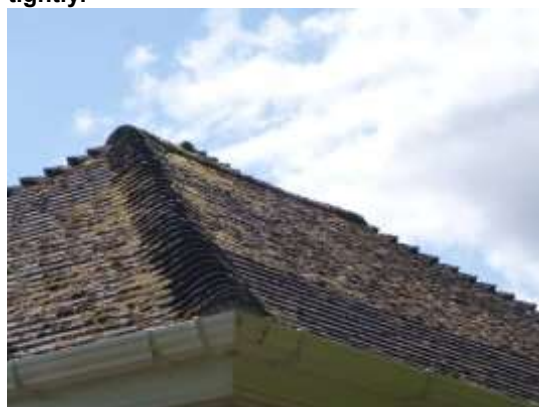
**3.2.3** Similarly to the house, the garage was lined with flat roof tiles that were occasionally covered in moss (**Photograph 6; Target Note 4**). The hips of the garage were mortared completely (**Photograph 7; Target Note 5**) and the eaves were formed by UPVC soffits, which were sealed tightly to the brickwork (**Photograph 8; Target Note 6**). At the side (south-east) elevation, the lead flashing at the base of the chimney was fitted closely to the tiles (**Photograph 9; Target Note 7**).

**6. Tightly fitted moss covered tiles on garage.**

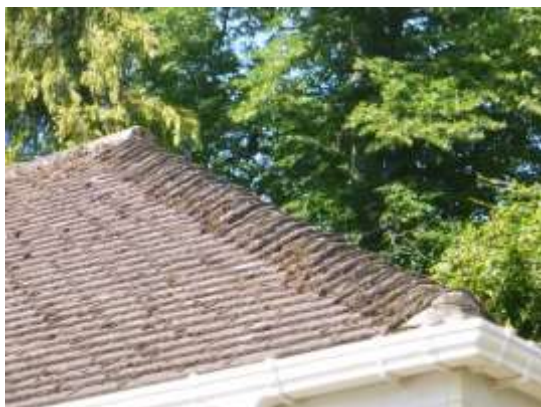
**7. Mortar under hips complete.**

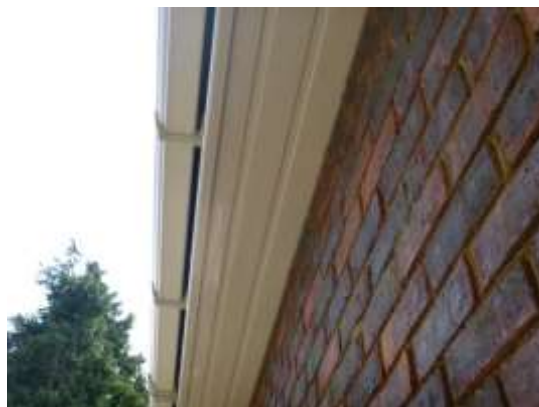
**8. UPVC soffits on garage tight to brickwork.**

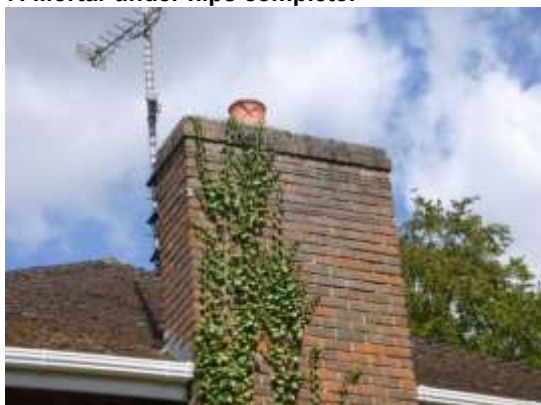
**9. Lead flashing at base of chimney tight to tiles.**

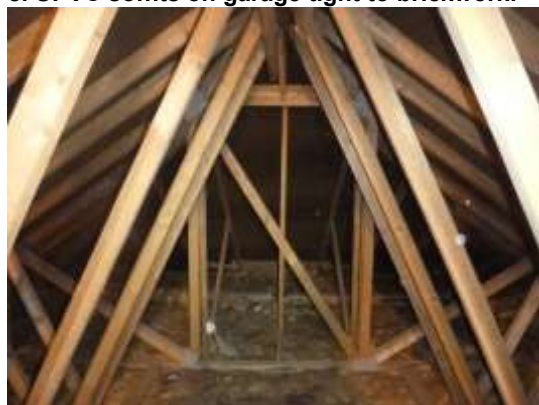
**3.3.1** The house had a hipped roof with trussed rafters, accessed via a loft-hatch located in the middle of the void towards the north-western end. The roof had a height of between 2.25 metres to 2.5 metres at the lightly cobwebbed ridge and the floor was covered with fibreglass insulation (**Photograph 10; Target Note 8**) with a small section of boarding by the hatch.

**10. Floor of roof void covered with fibreglass.**

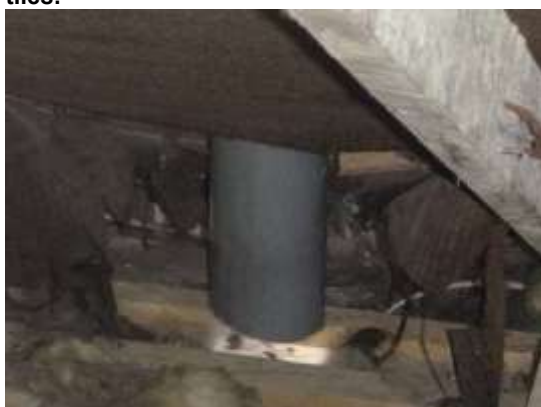
- 3.3.2** The roof was lined with bitumen felt, which was mostly intact and fitted tightly apart from two large gaps: one at the hipped section of the ridge to the south-east, behind which roof tiles were exposed (**Target Note 9**); and another gap on the rear elevation towards the north-west around a ventilation pipe (**Photograph 11; Target Note 10**). Daylight was visible through a hole in the soffit located nearby (**Photograph 12; Target Note 11**). A smaller, cobwebbed tear in the felt was present towards the south-eastern end (**Photograph 13; Target Note 12**). The presence of cobwebbing suggests a lack of recent bat activity in this section. The roof was open at the eaves, which also contained a brickwork chimney on the south-eastern side.

**11. Tear in felt around pipe.**

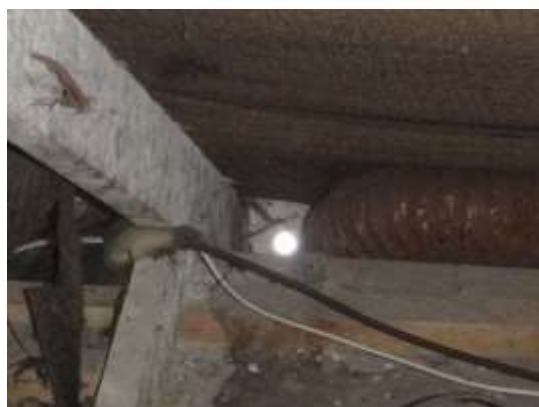
- 4.1.1** The house showed no evidence of the presence of bats, with no features on the exterior with the potential for use by crevice-dwelling bats, such as the pipistrelles (*Pipistrellus* spp.), to roost. The loft space contained a few features such as the hole in the soffit box that could be used as access by void-roosting species such as the long-eared bats (*Plecotus* spp.); however, no evidence of their presence or activity was observed.

**12. Hole in soffit; daylight visible.**

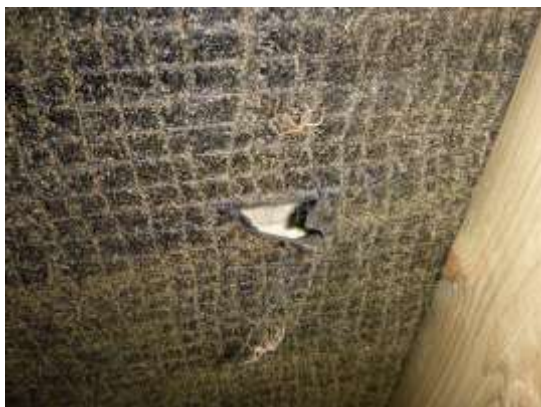
**13. Cobwebbed tear in felt.**

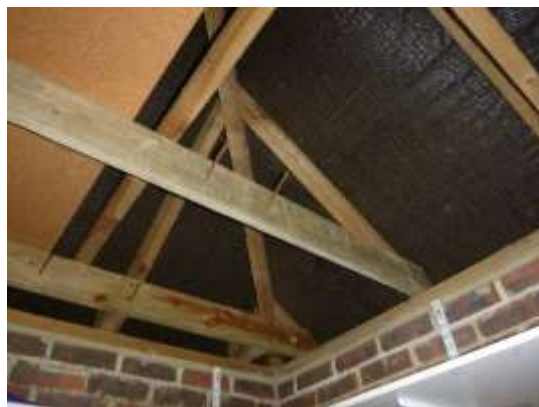
- 3.3.3** The garage was open to the roof and lined with bitumen (**Photograph 14; Target Note 13**). The lining was intact in most places with the exception of a couple of small tears (**Photograph 15; Target Note 14**). The roof was heavily cobwebbed at the corners, and lightly cobwebbed at the ridge, suggesting a lack of recent disturbance within the garage.

**14. Garage lined with bitumen and ground floor open to roof void.**

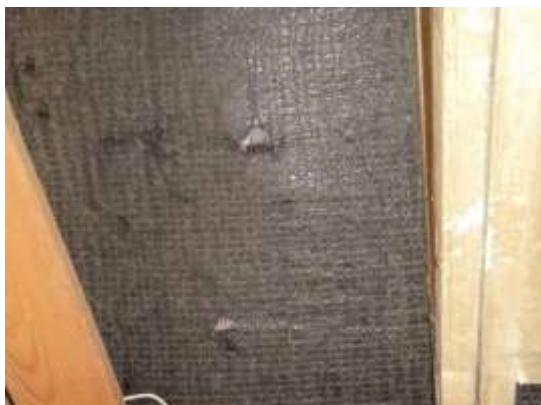
**15. Superficial tears in bitumen felt in garage.**

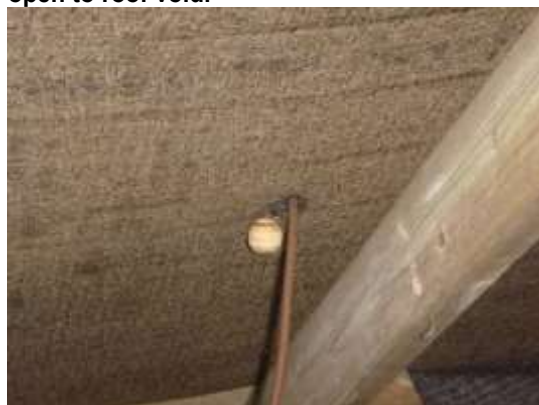
- 3.3.4** There was no evidence of roosting bats observed in the loft space of the house or the garage at the time of the survey. A small wasps' nest was found at the south-eastern side of the roof near the chimney (**Photograph 16; Target Note 15**).

**16. Small wasps' nest in south-western side of roof.**
