# GROUND LEVEL AND VISUAL INSPECTION OF ONE PINE TREE Rev:0,

**St Joseph's College,  
Upper Redlands Road,  
Reading,  
RG1 5JT,**

**Rachel Sheridan,  
Estates Bursar.**

Job no. MJC-18-0181

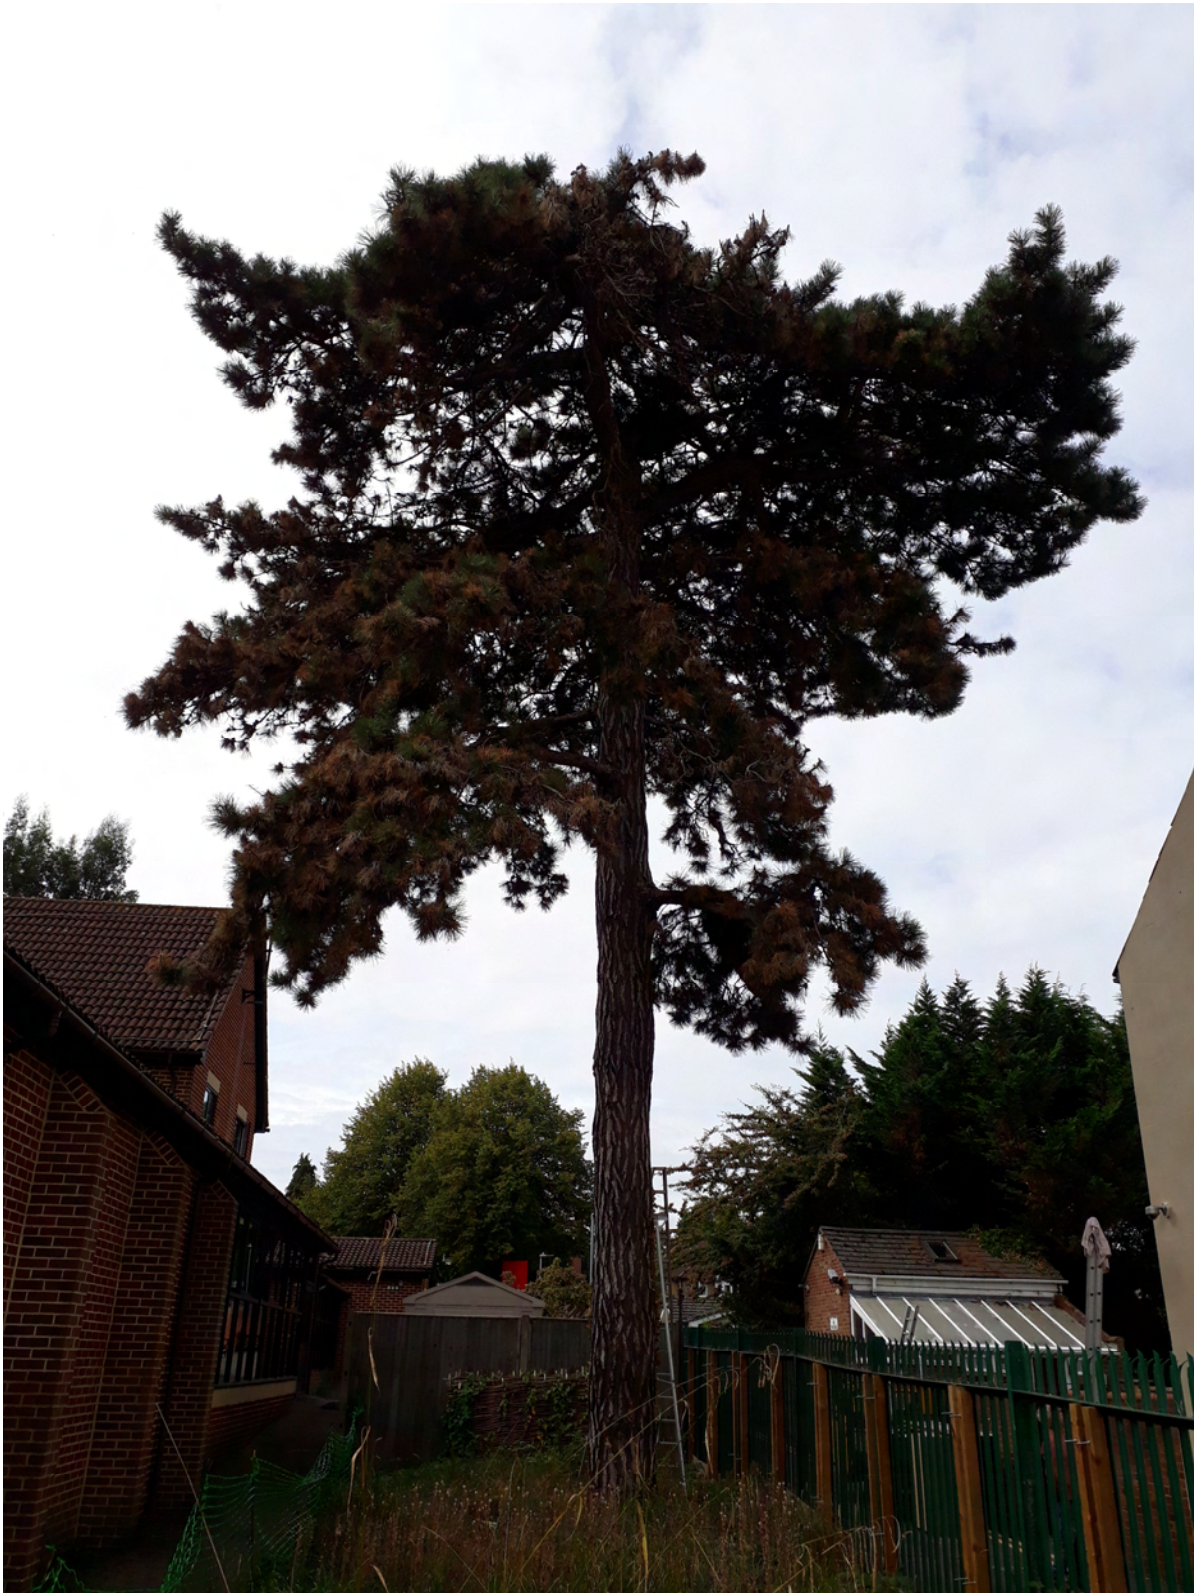
- 4.1 The tree in question is a Corsican pine *Pinus nigra var. laricio*.
- 4.2 The tree is an early mature to mature specimen (BS5837:2012), and has extensive crown dieback as illustrated in Figures 1 and 2 of Appendix 2. This dieback is killing the distal or outer parts of the crown in the mid and lower parts of the crown. This pattern of distal foliage killing is illustrated in Figure 3 of Appendix 2.
- 4.3 The crown contained large quantities of small diameter deadwood as a result of this ongoing crown dieback. However, these all seemed to be sufficiently small in diameter and light in weight to pose very little risk of causing significant harm to persons or property as a result of them falling from the crown.
- 4.4 The larger diameter crown branches and the trunk did not seem to be decayed or otherwise unstable.

- 5.2 The crown dieback is the result of the distal parts of the shoots and the buds being killed by a boring insect. The symptoms of this dieback are similar to those caused by Pine Shoot Moth *Rhyacionia buoliana* (Strouts & Winter 2004) although they are not completely consistent with the symptoms described in that text. I believe that this insect can only be confidently identified by taking and sending samples for laboratory analysis, however, this expense may not be justified on the basis that the dieback is being caused by the larval stage of either this, or a similar insect, and that the results of this infestation and the treatment options available are very likely to be identical.

Figure 1 – view of the tree from the east, illustrating the crown dieback.

- 6.1 Apply to the LPA for permission to remove this tree on the grounds that it is in terminal decline as a result of insect damage of the shoots and buds, and agree to replace this tree with a new tree, the species and location of which to be agreed with the LPA following discussion.
- 6.2 If the tree is to be retained, have a competent arboriculturist inspect and risk assess the tree on an annual basis, starting twelve months from the date of this inspection.
- 6.3 All tree work should be carried out to British Standard 3998:2010 'Recommendations for Tree Works' as a minimum standard.

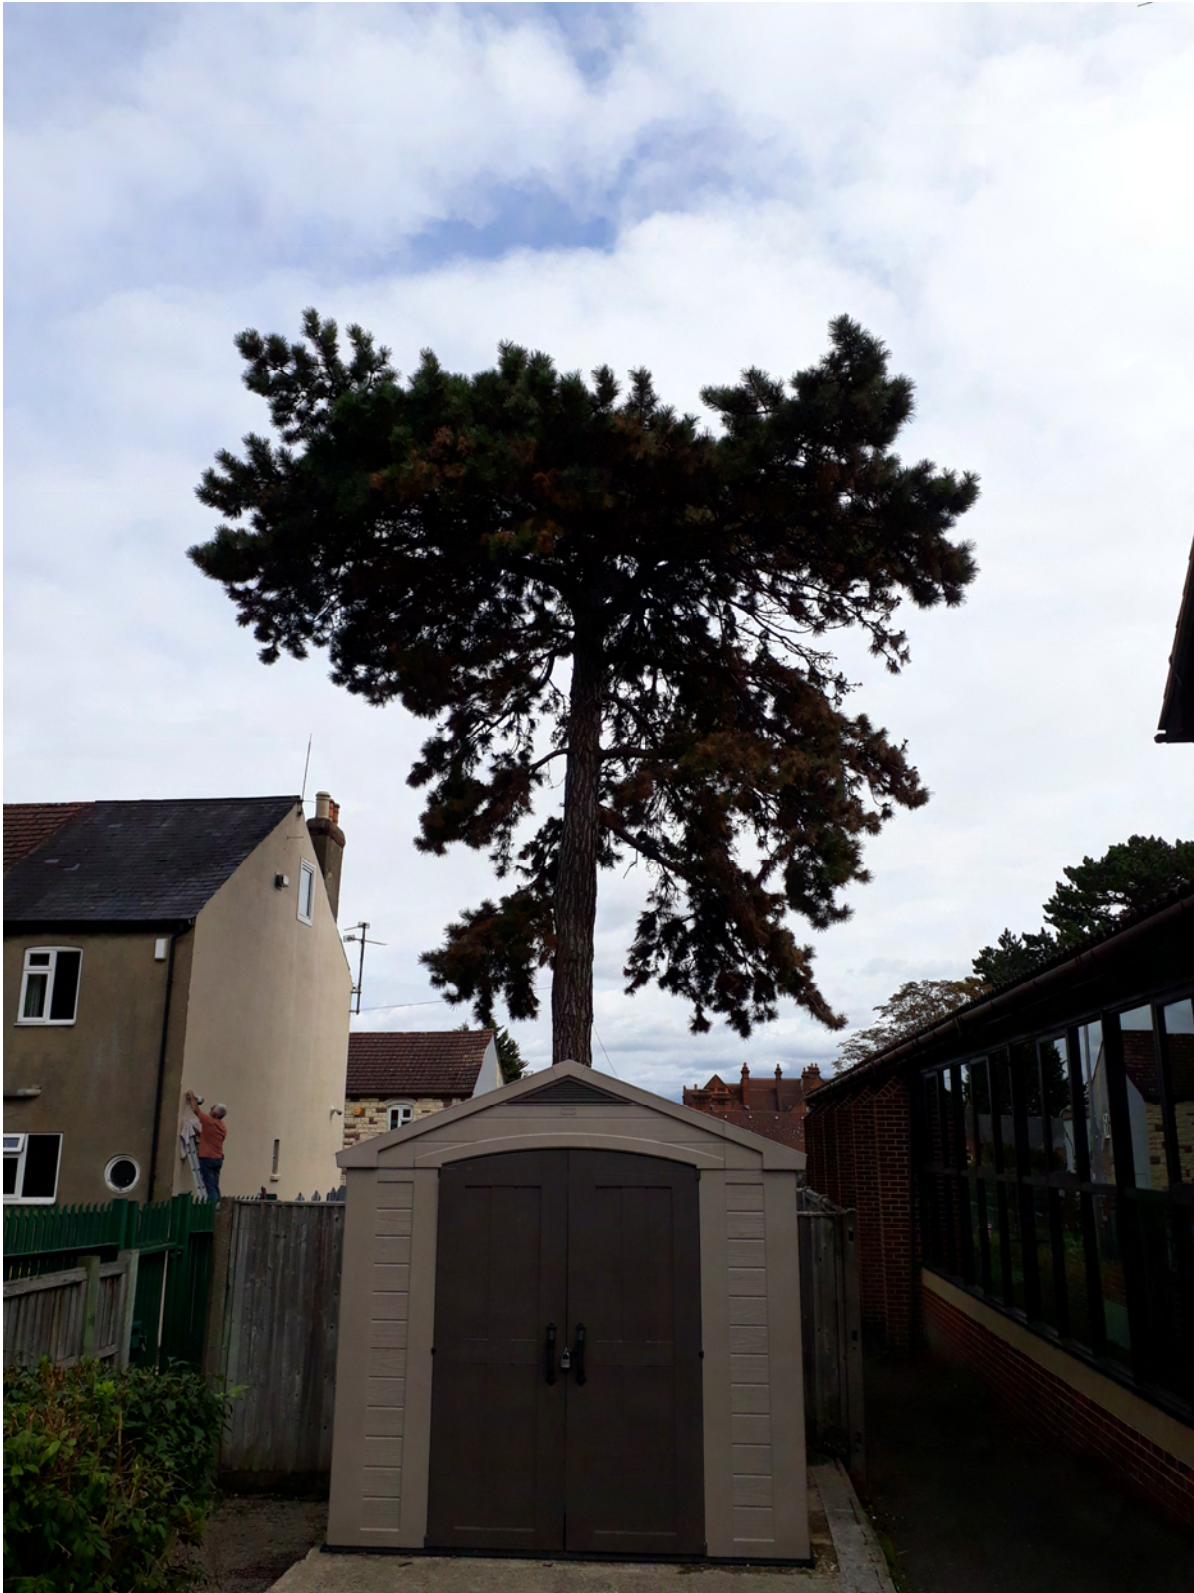
Figure 2 – view of the tree from the west, illustrating the crown dieback.

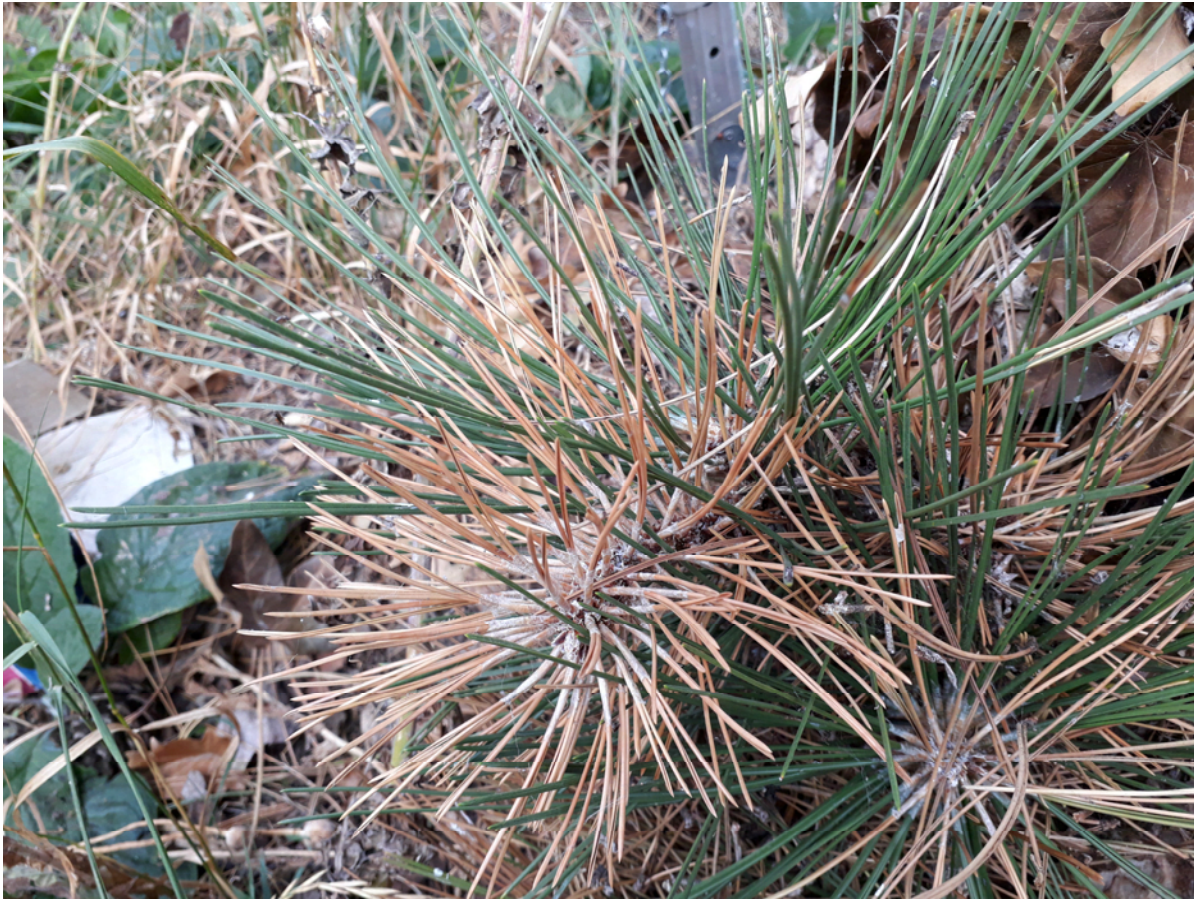
- 4.6 A small lower crown branch was removed from the tree to allow a closer inspection of the dieback. Technically this branch removal required the permission of the LPA, however I took the liberty of authorising its removal as I needed to inspect the dieback closely to carry out my instructions, and the removal of the branch had no appreciable detrimental impact on the public visual amenity of the tree.

Figure 3 – close up of lower crown branch removed for the purpose of the inspection. Note that the distal part of the shoots are killed, whereas older foliage further back along the branch are still alive.

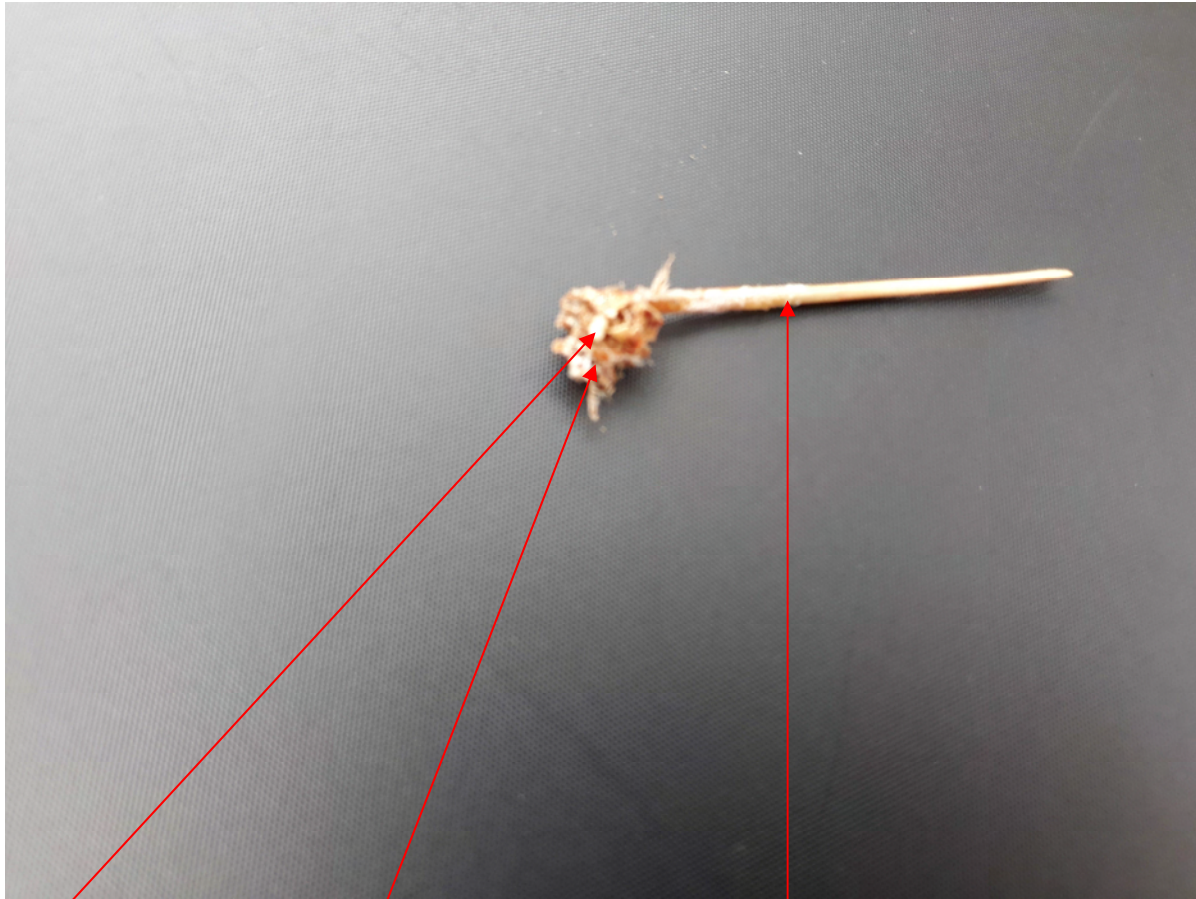
- 4.7 Inspection of the removed branch confirmed that the distal parts of the shoots are being killed. Dissection of the killed shoot buds revealed dry buds filled with a brown frass, and containing small white/pale grey grubs approximately 1mm in diameter and 2-3mm in length. Figure 4 at Appendix 2 of this report illustrates the dissected bud and the grub in question. Unfortunately this picture is not very clear as the camera struggled to focus correctly when so close to the subject.

Grub

Killed & dissected bud

Killed needle

Figure 4 – Close up of dissected bud.
