## SITE MONITORING REPORT

| <b>Instruction</b> | Upper Redlands Road |
| <b>FLAC Instruction ref</b> | CC31-1036 |
| <b>Client</b> | Reading University |

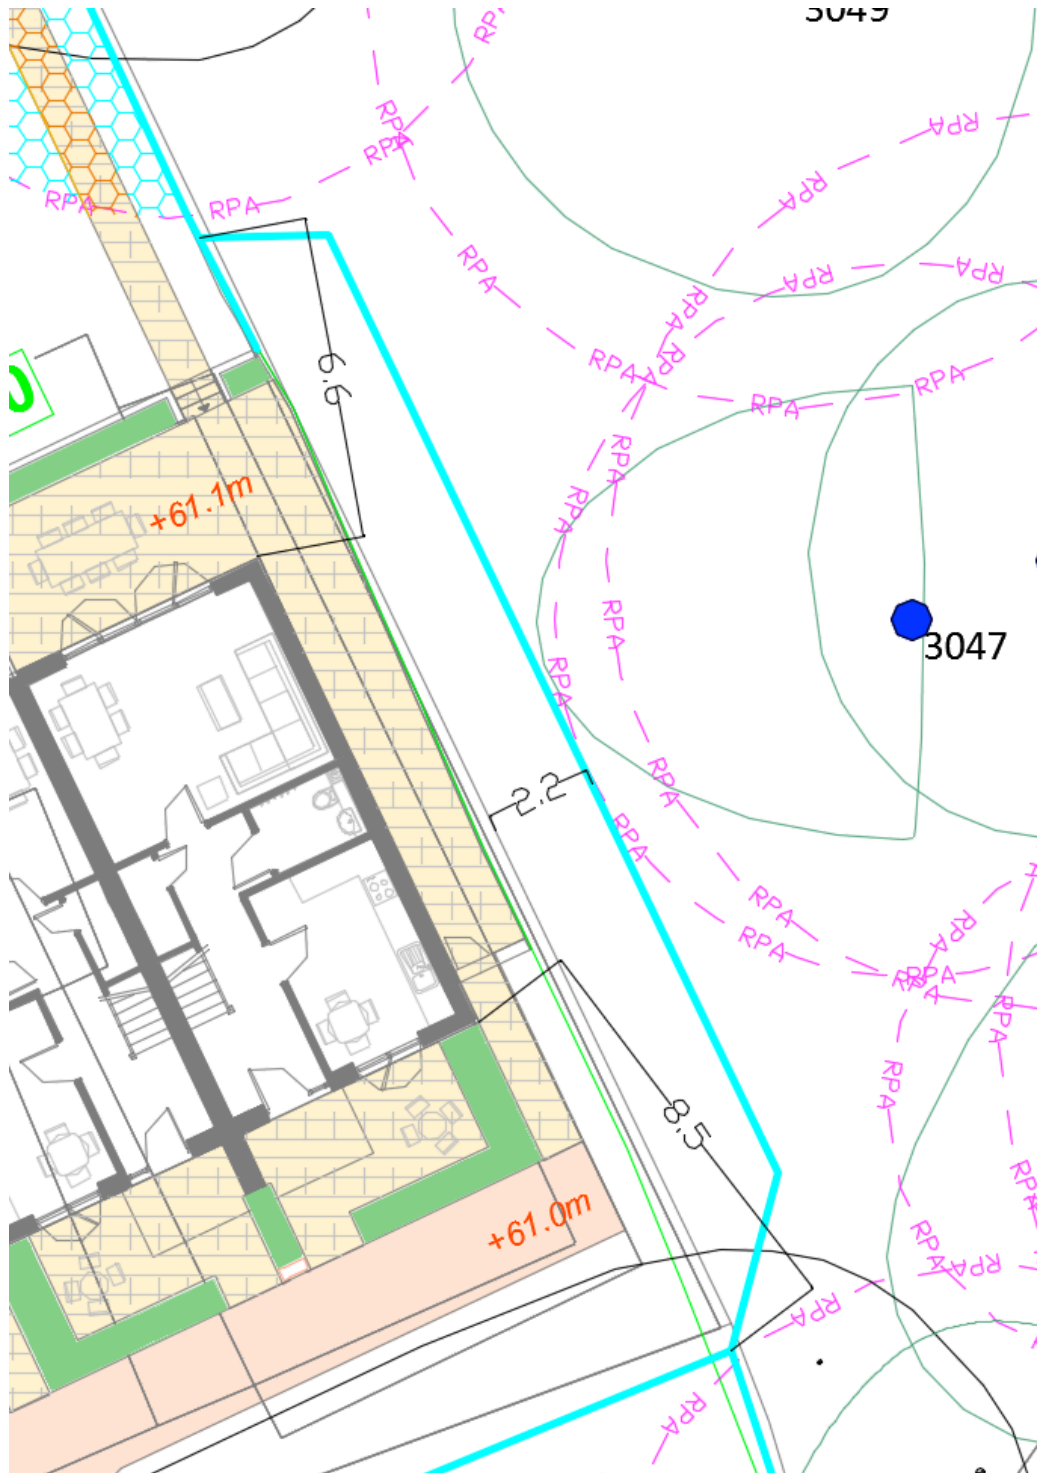
4. In any event the protection of trees to the east will require a more substantial barrier to be installed prior to work for either a wall or batter commencing. The current situation is that with the scaffolding in place access down the east flank is greatly restricted so orange mesh on lamp irons has provided a visual demarcation of the limits to access since the old chain link fence was removed

*Marked-up TPP to show alignment of enhanced tree protection fencing for works associated with either retaining wall or batter construction*

5. The current alignment of the mesh is likely to be satisfactory in terms of access facilitation for the wall/batter if extended to the north but proximal activities will require a suitably robust barrier replacement, to that end I recommend: herras panels on boots, pinned into the ground; panels clipped together and braced horizontally; supported by individual back braces, also pinned into the ground
6. This is not the typical fully driven scaffold framework but I consider it to be suitably robust with consideration of the location, close scrub vegetation and the level of construction activity. NB please would Knowles contact FLAC a week before the new fencing so that we may record the replacement tree protection fencing once installed

8. I would advise that the new fence alignment is pegged out, noting the maximum offset as shown on the mark-up above, to determine if any access facilitation pruning is required. If pruning of the scrub is necessary I advise that an arboricultural contractor is instructed to undertake this, per the arboricultural method statement. They could also undertake the removal of the sycamore (see item 10 below) and the outstanding pruning works per the specification provided on the tree protection plan 31-1036.06-C dated 26.01.17

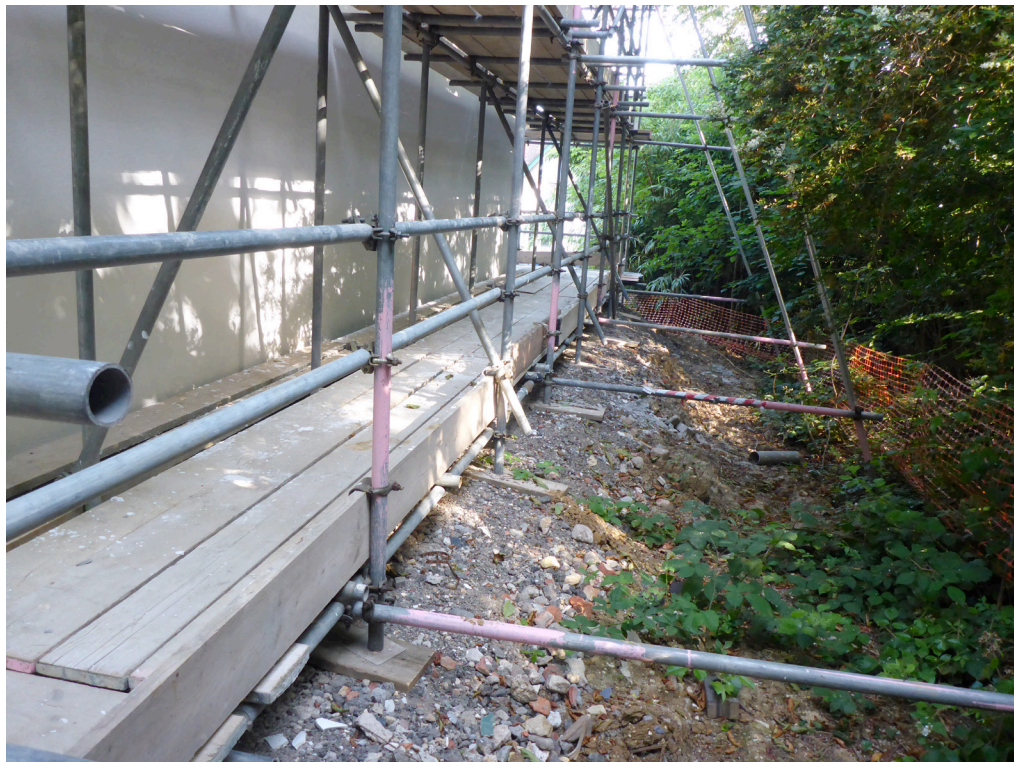
*Photograph to show the east flank of unit 10, scaffolding outriggers required old boundary fence to be removed but framework impedes access, orange mesh visually demarcates limits to access. Wall to be constructed approximately where scaffold toe board is, removal of framework requires enhanced tree protection fencing to replace orange mesh per mark-up above*

9. The new tree protection fencing must remain in situ until the boundary fence is installed because without the scaffolding, access along the flank of the unit is feasible consequently access beyond the site must be prevented
