**49 Briants Avenue  
Caversham  
Reading  
Berkshire  
RG4 5AS**

## **Daylight Bat Survey**

**Ref: R1475/a**

**September 2016**

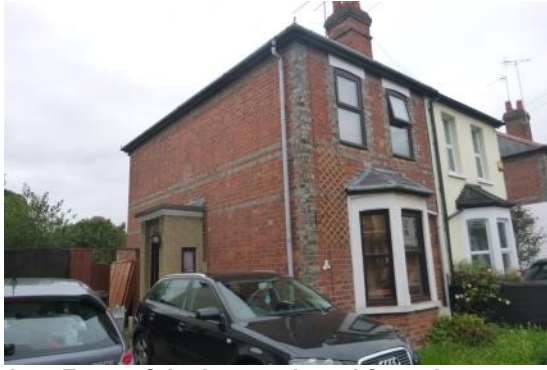
- 3.2.1** The house was of brick, cavity wall construction with a hipped roof covered in flat slate tiles (**Photograph 1**). There was a flat-roofed extension attached to the rear of the house (**Photograph 2**).

1. Front of the house viewed from the northwest.

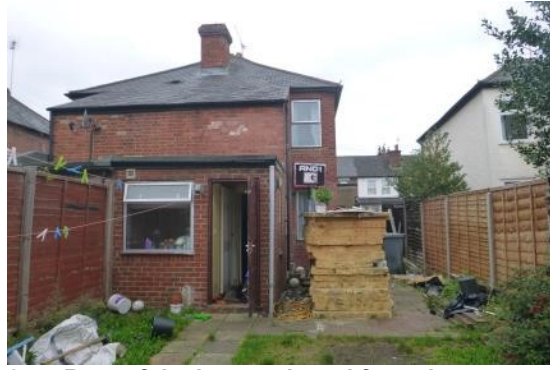
2. Rear of the house viewed from the west showing the flat-roofed extension.

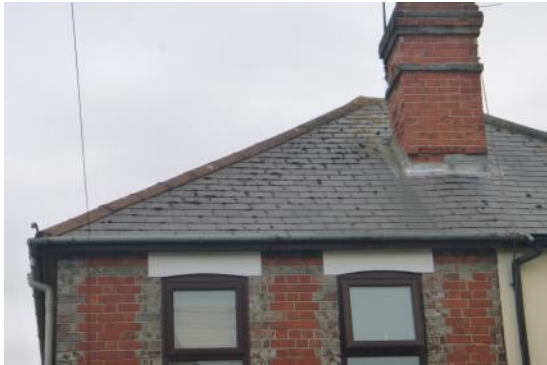
- 3.2.2** The roof tiles were fitted very tightly on all parts of the roof offering negligible opportunities for roosting bats (**Photograph 3; Target note 1**). The ridge tiles were intact and mortared tightly (**Photograph 4; Target note 2**). The hip tiles were mortared tightly at the rear (**Photograph 5; Target note 3**); however there were two gaps in the mortar under hip tiles on the northern elevation of the roof (**Photograph 6; Target note 4**).

3. Tightly fitted, flat slate roof tiles.

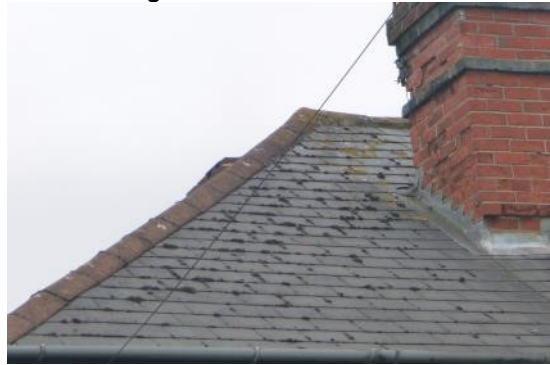
4. Tightly mortared ridge tiles at the front of the house.

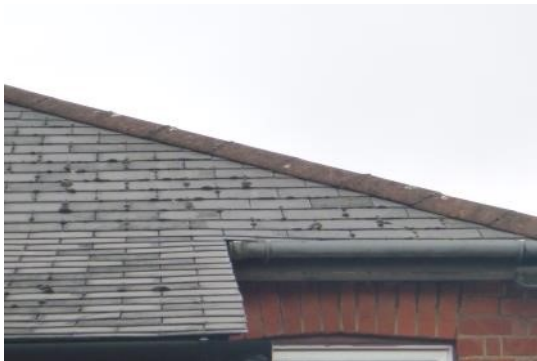
5. Tight hip tiles at the rear of the house.

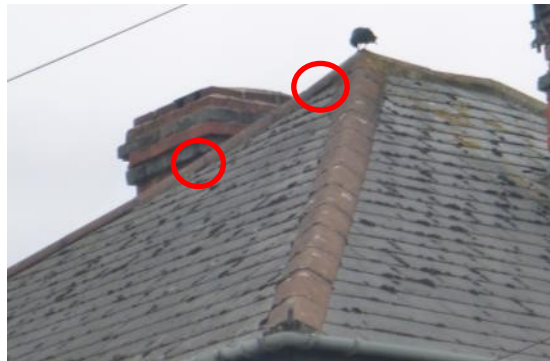
- 4.1.1** There were no signs of bats in the roof space. The hole at the eaves was a potential access point into the roof space but no evidence was found that void-dwelling bats were using this space and it was heavily cobwebbed, which can suggest there has been no recent activity. Externally the house offered potential features that could offer roosting opportunities for crevice-dwelling bats such as the gaps underneath the hip tiles on the northern elevation.

6. Two gaps underneath hip tiles on the northern roof elevation.

- 4.2.2** The potential features that could offer roosting opportunities for crevice-dwelling bats i.e. the two gaps underneath the hip tiles on the northern elevation will not be affected by the proposed works and therefore it is considered highly unlikely that the planned work to extend the property will have any impact on bats or their roosts.

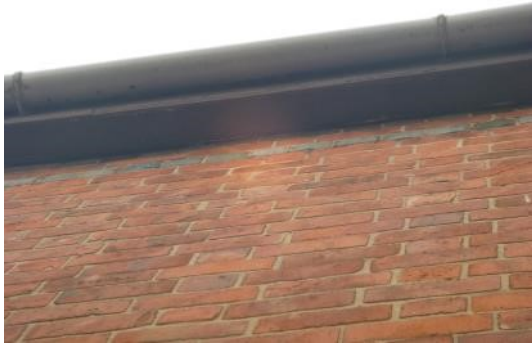
- 3.2.3** The soffit box was tight to the brickwork around the house (**Photograph 7; Target note 5**). The wooden bargeboard on the rear extension had a narrow gap behind it but it was heavily cobwebbed (**Photograph 8; Target note 6**). There was tightly fitted lead flashing around the chimneys at the front and rear of the house (**Photographs 10 & 11; Target notes 7 & 8**). The flat bitumen felt roof on top of the rear extension had no gaps beneath also (**Target note 9**).

**7. Tightly sealed soffit at the side of the house.**

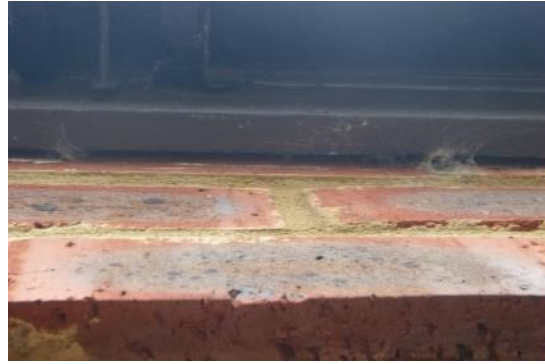
**8. Cobwebbed gap behind bargeboard of rear extension.**

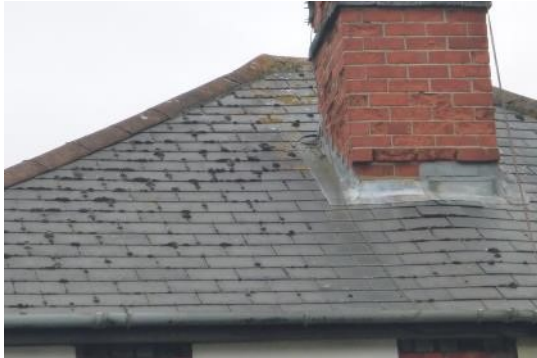
**9. Tight lead flashing around chimney at front of the house.**

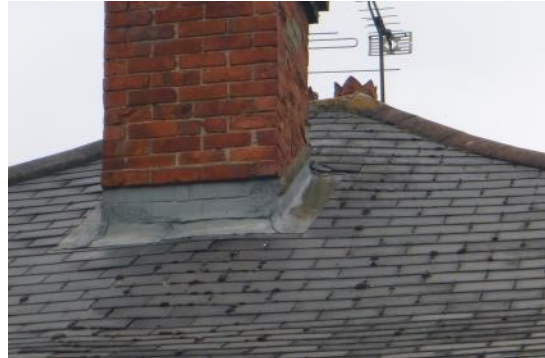
**10. Tight lead flashing around chimney at rear of the house.**

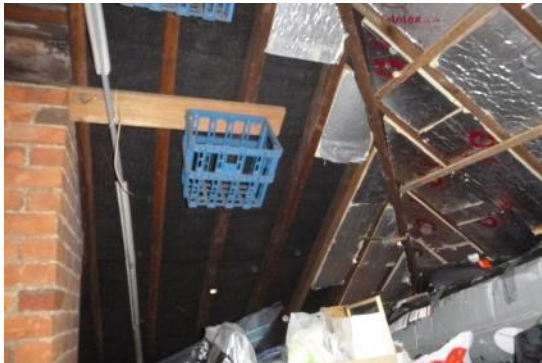
**11. Roof partly insulated with bitumen felt and partly with foil covered insulation panels.**

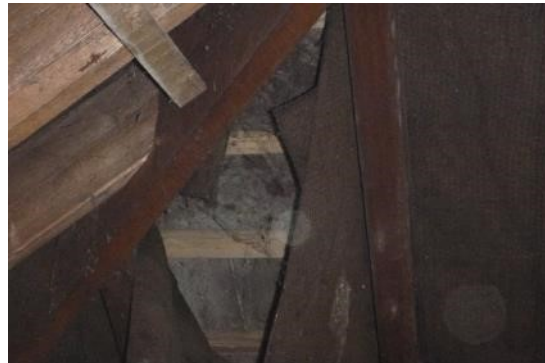
**12. Tear in felt exposing tiles underneath at rear of house.**

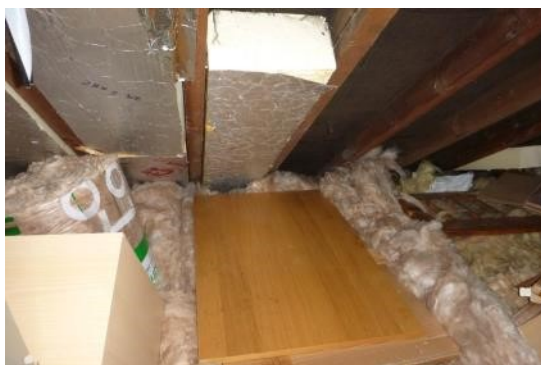
**13. Fibreglass insulation extending to eaves in some places.**

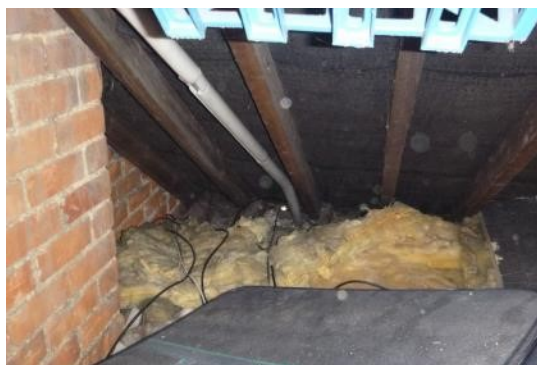
**14. Hole at eaves at front of house where cables were running through.**

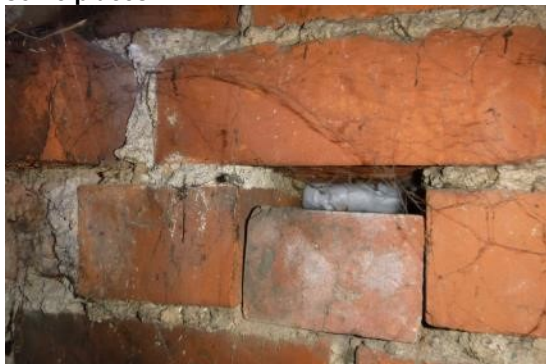
**15. Gap in brickwork of internal gable.**

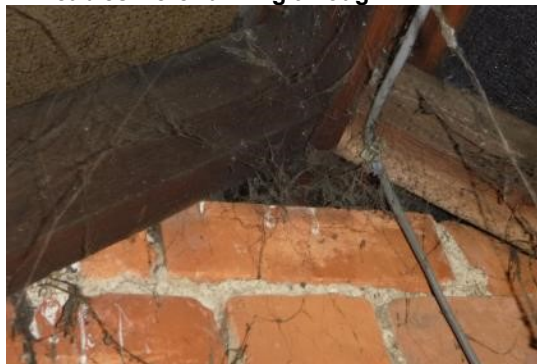
**16. Heavily cobwebbed gap at apex of internal gable.**

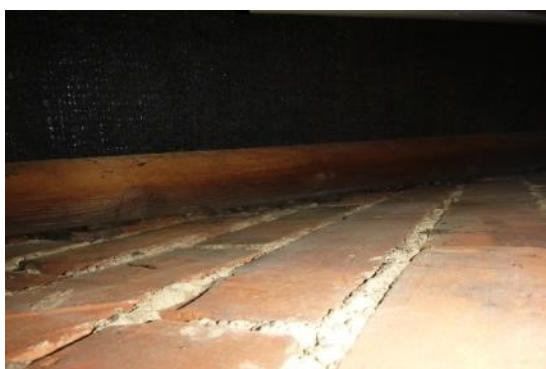
**17. Cobwebbed gap between rafters and brickwork of chimney.**

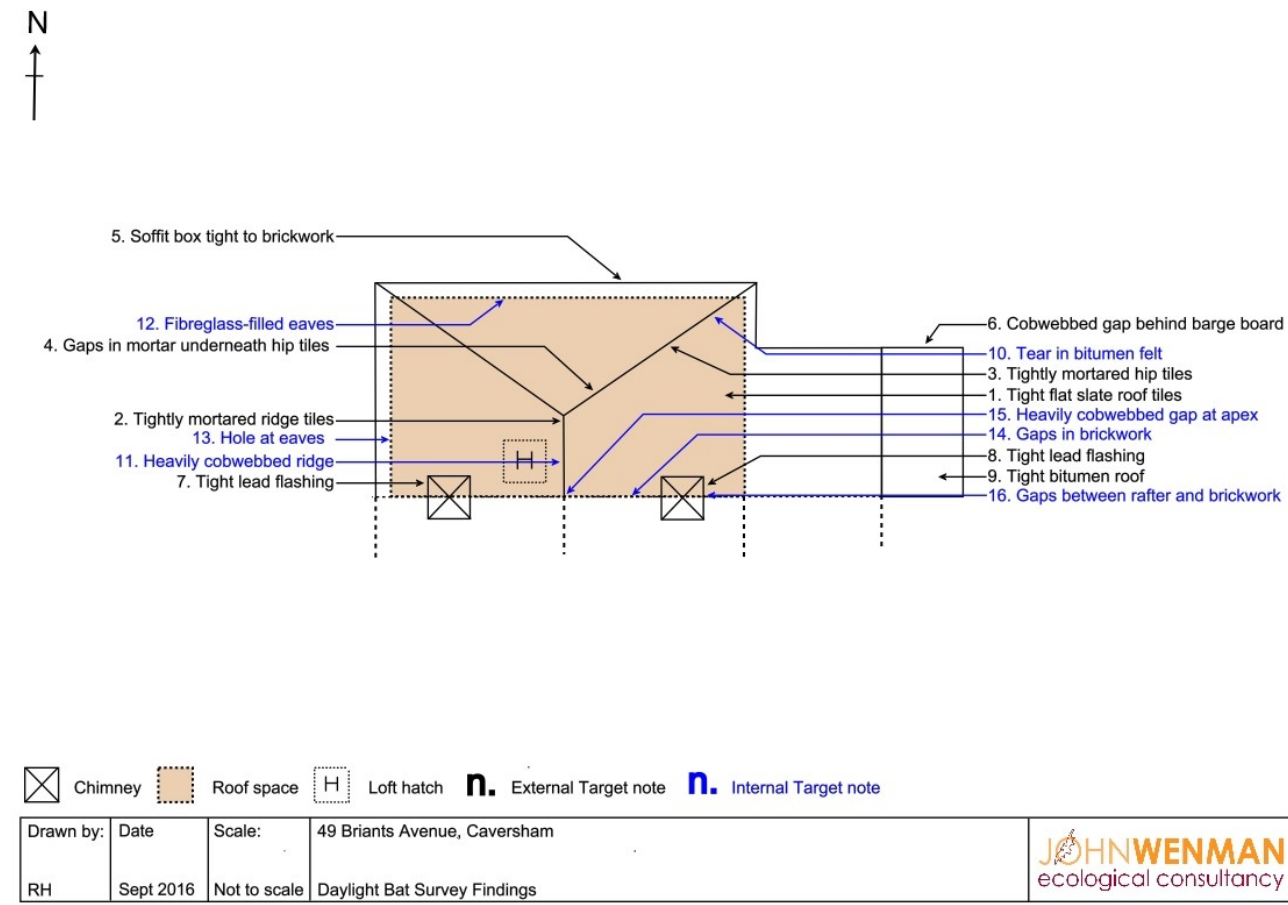
APPENDIX 2 - DAYLIGHT BAT SURVEY FINDINGS

- 3.1.1** The external and internal bat survey findings are detailed on a plan with target notes in **Appendix 2**; photographs of the site are shown in **Appendix 1**. There follows a description of the external and internal survey findings:
