Brock Keep, 571 Oxford Road, Reading

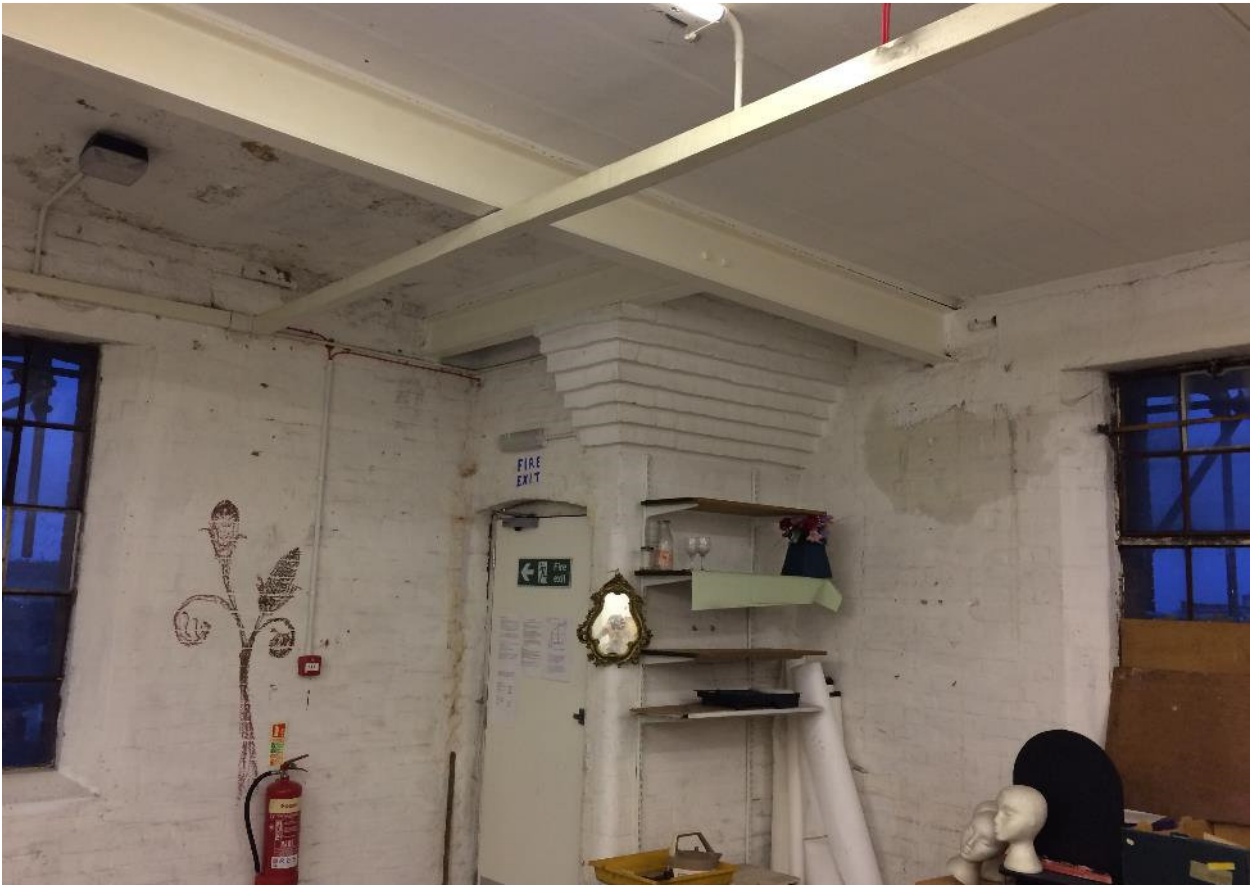
**Photograph 12 - Damp marks and deterioration of ceiling finish below eye bolts NE turret**

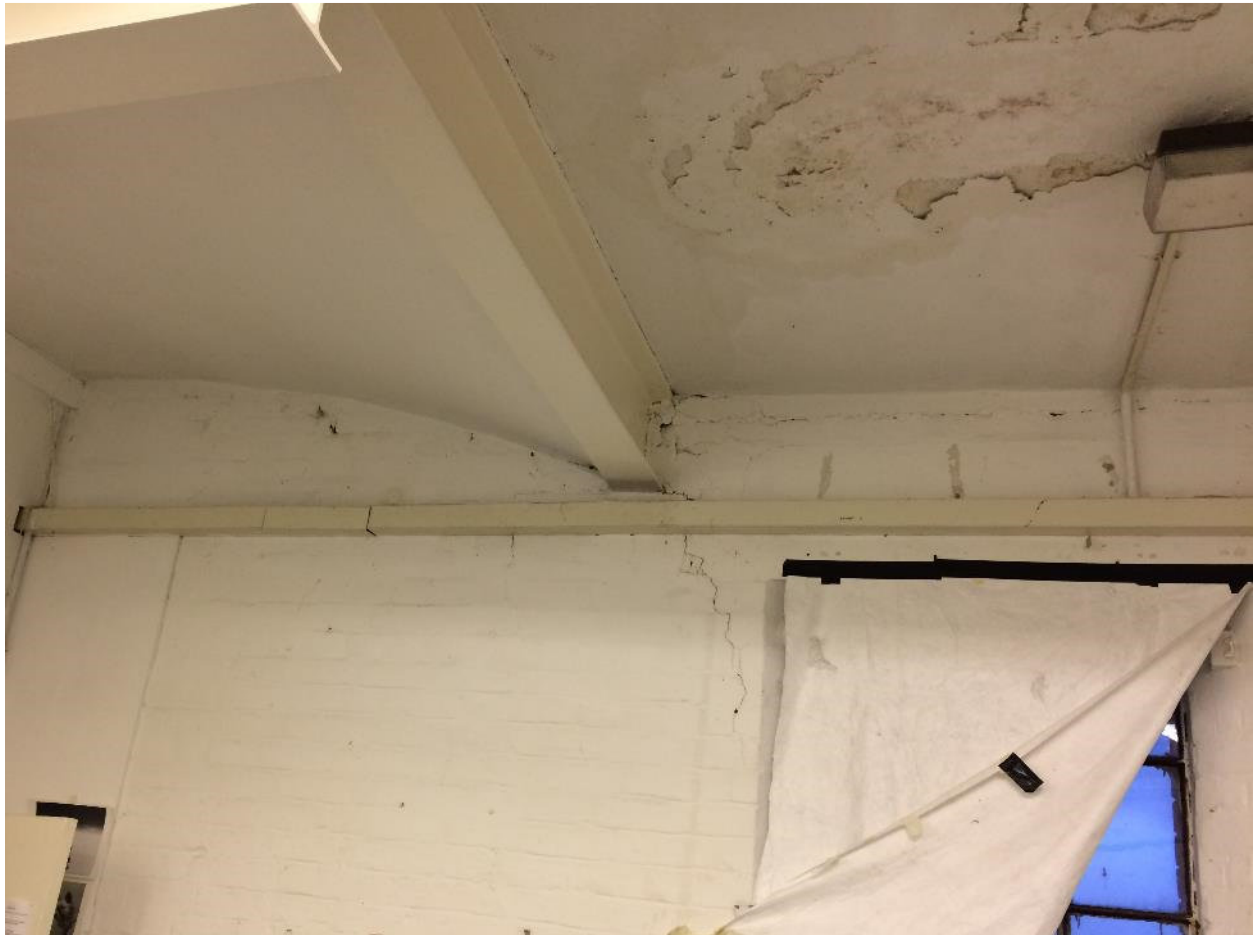
**Photograph 13 - Damp marks and deterioration of ceiling finish below eye bolts SW turret**

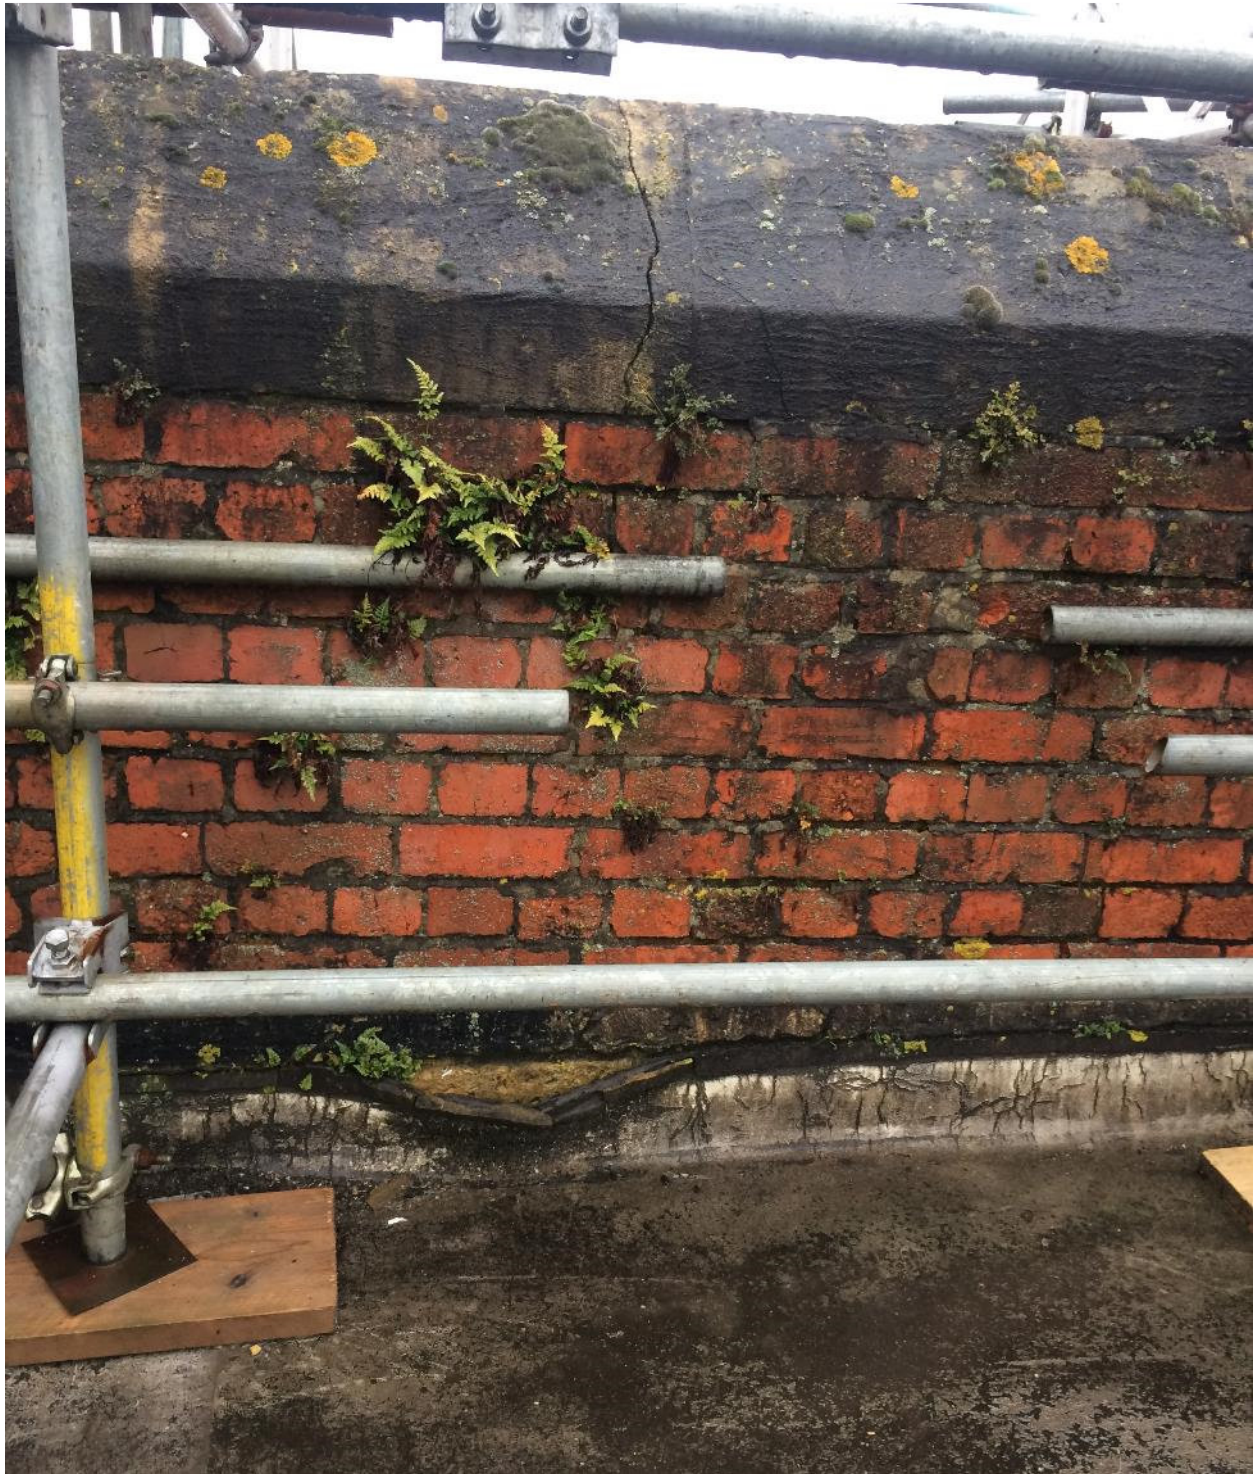
Photograph 14 - Asphalt upstand detached from wall, exposing bath stone

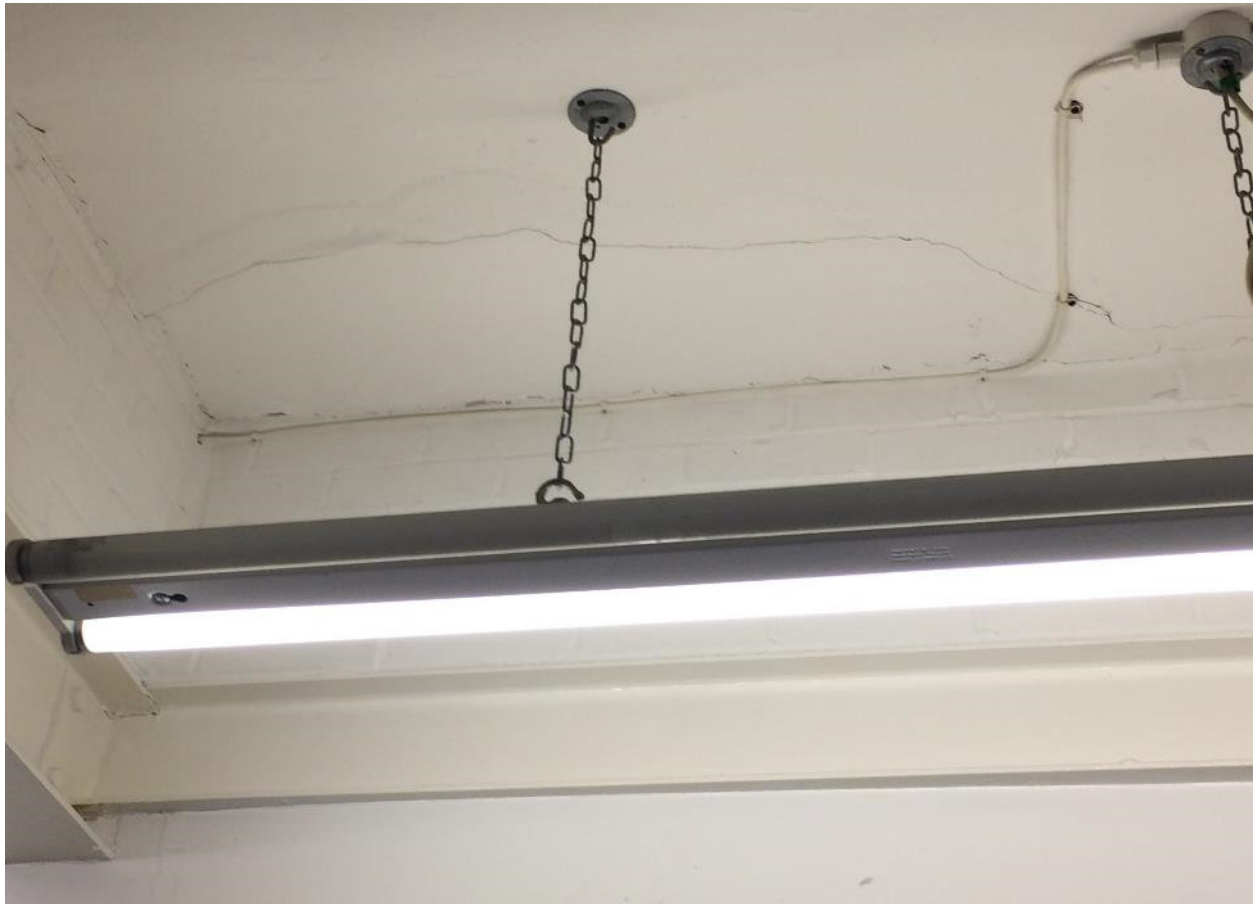
**Photograph 15 - Cracking to underside of barrel vaulted roof slab**

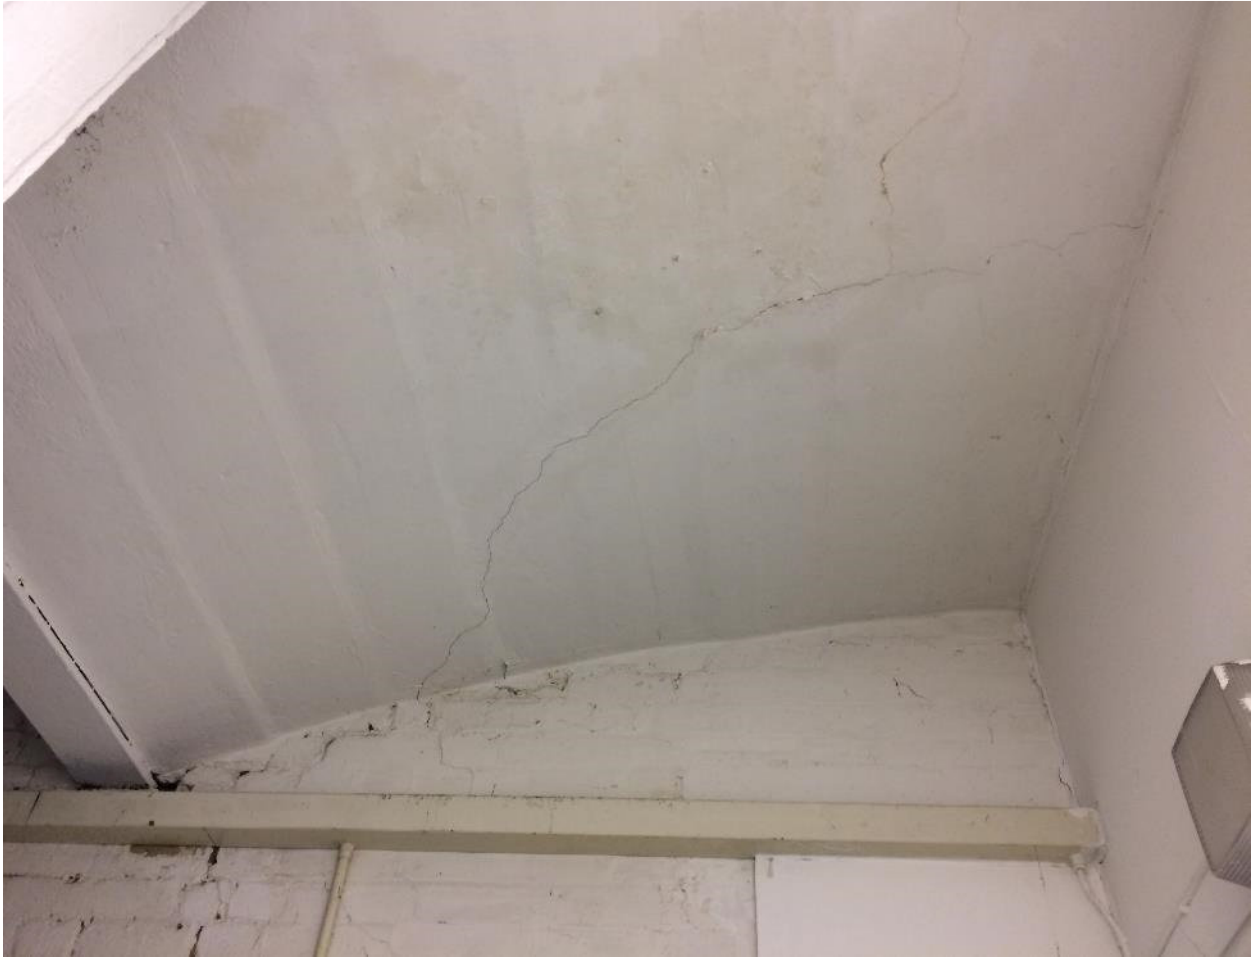
**Photograph 16 - Cracking to underside of barrel vaulted roof slab**

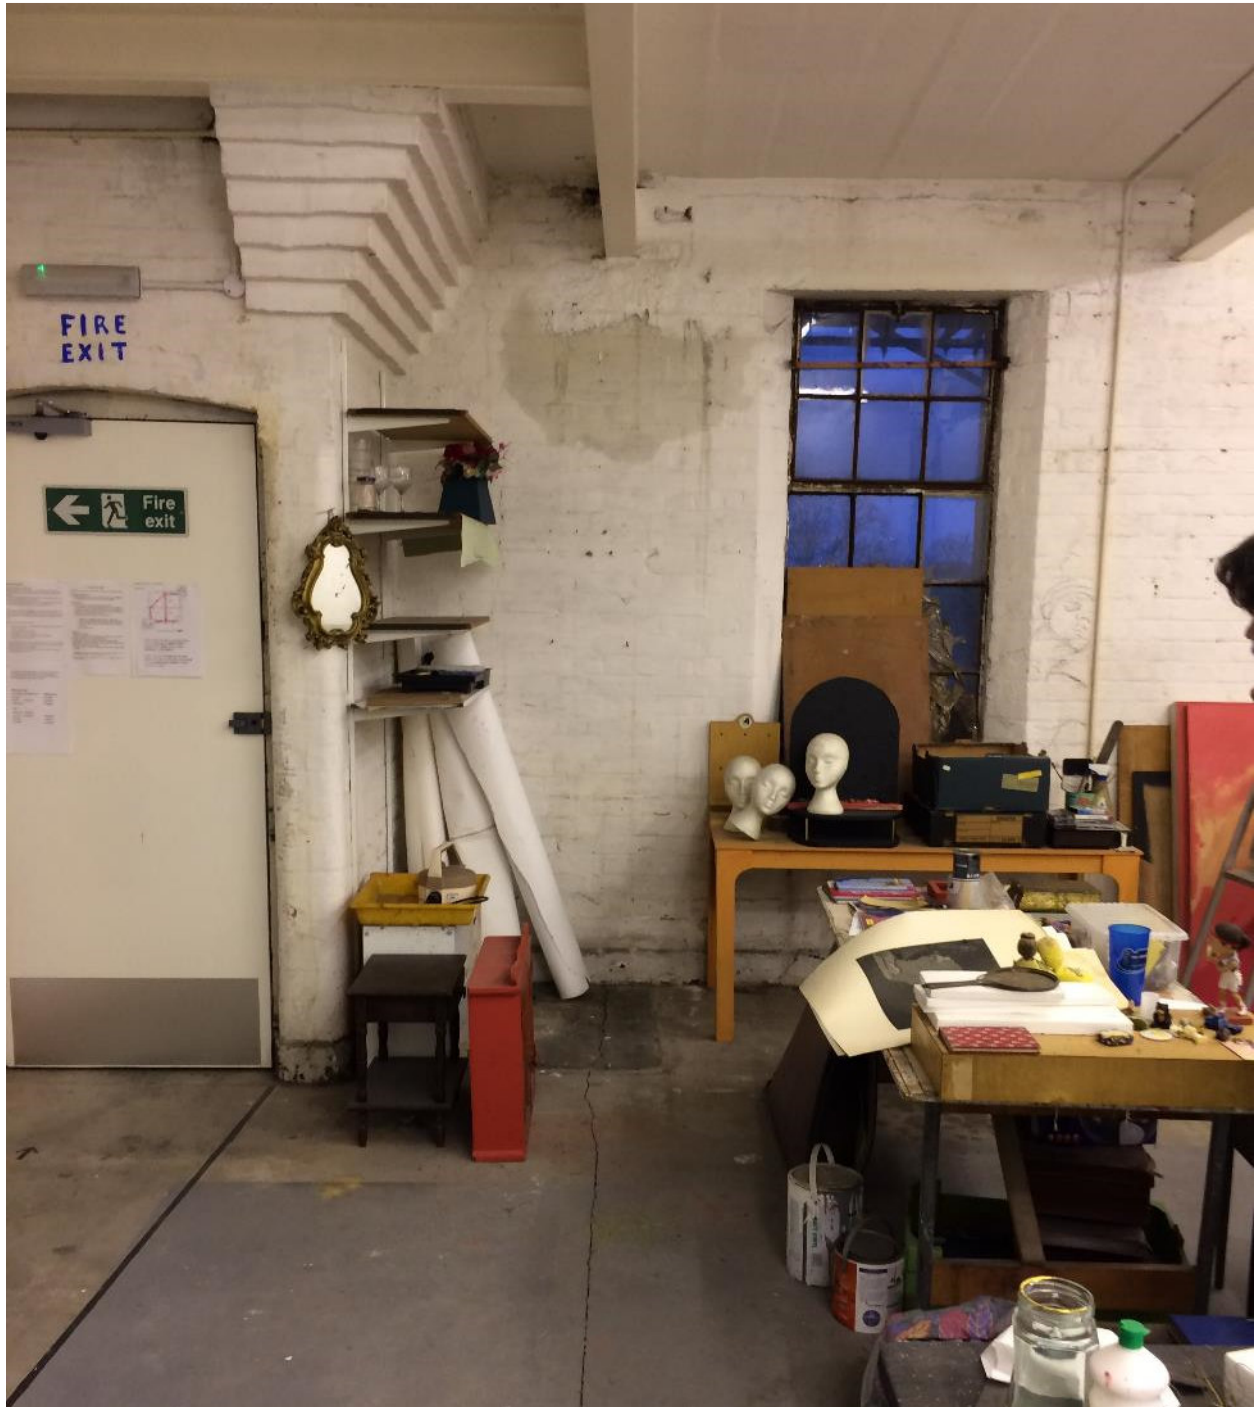
Photograph 17 - Damp brickwork beneath beam bearing on East elevation, 3<sup>rd</sup> floor

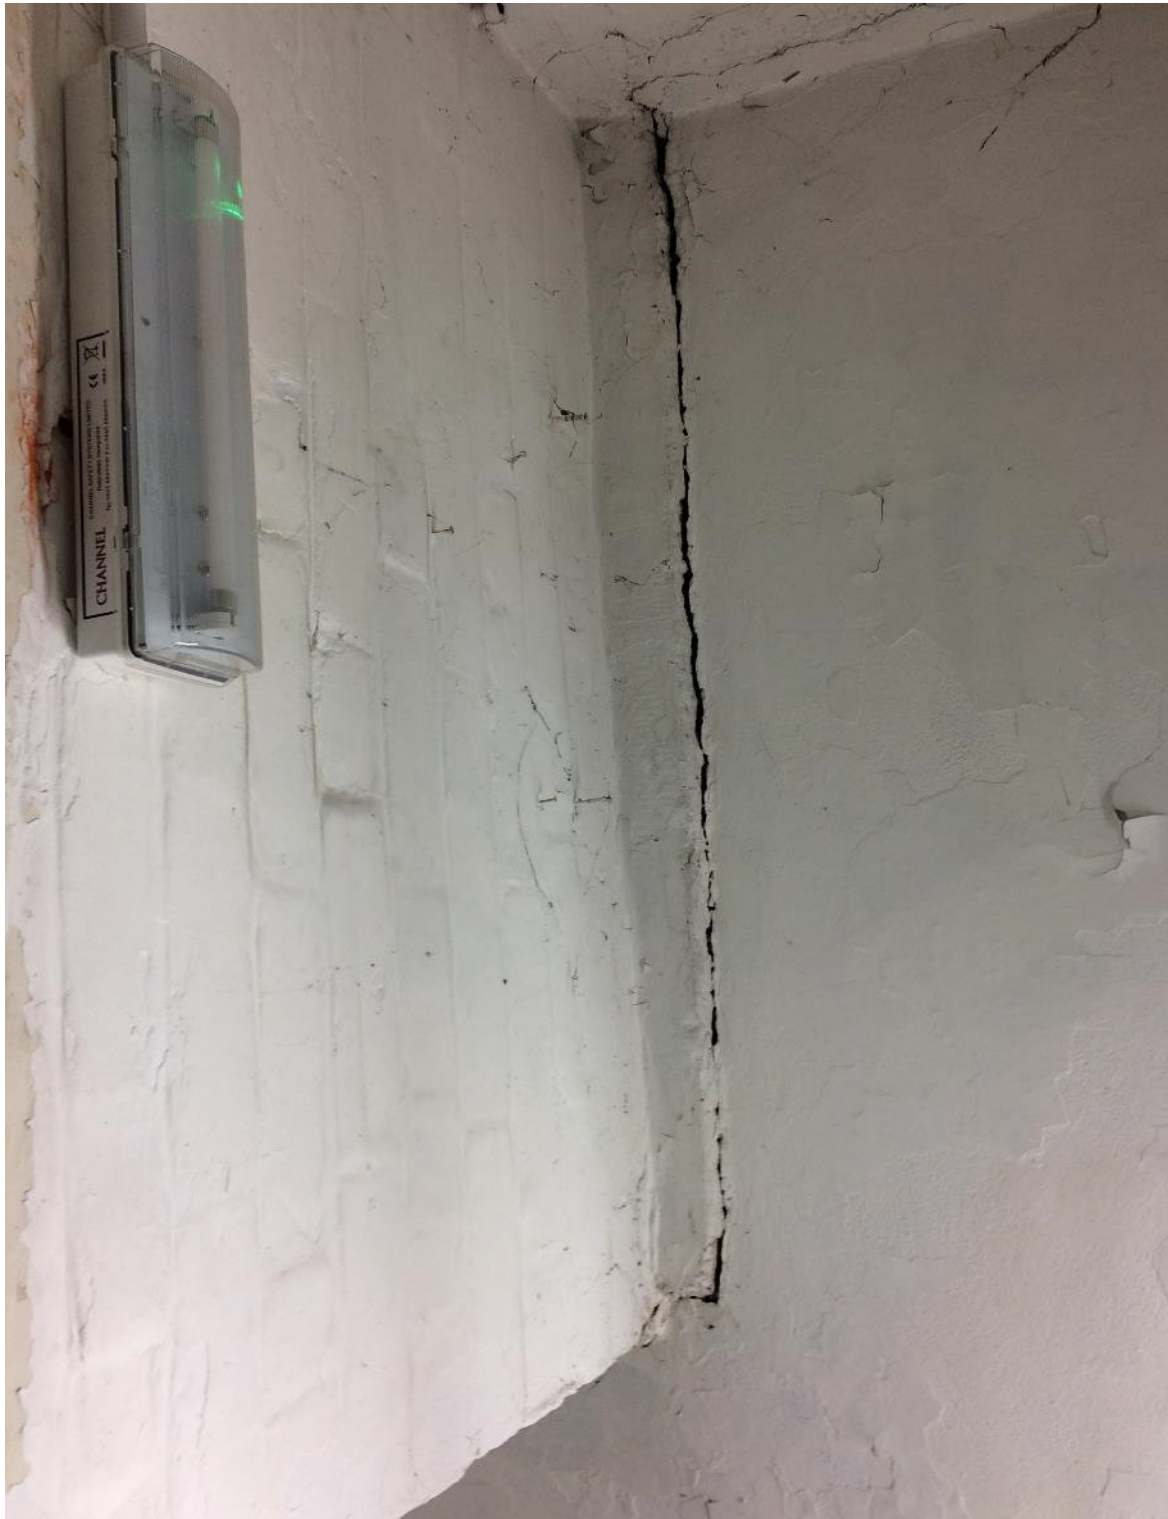
Photograph 18 - Crack to underside of 3<sup>rd</sup> floor slab, above doorway to the North East tower

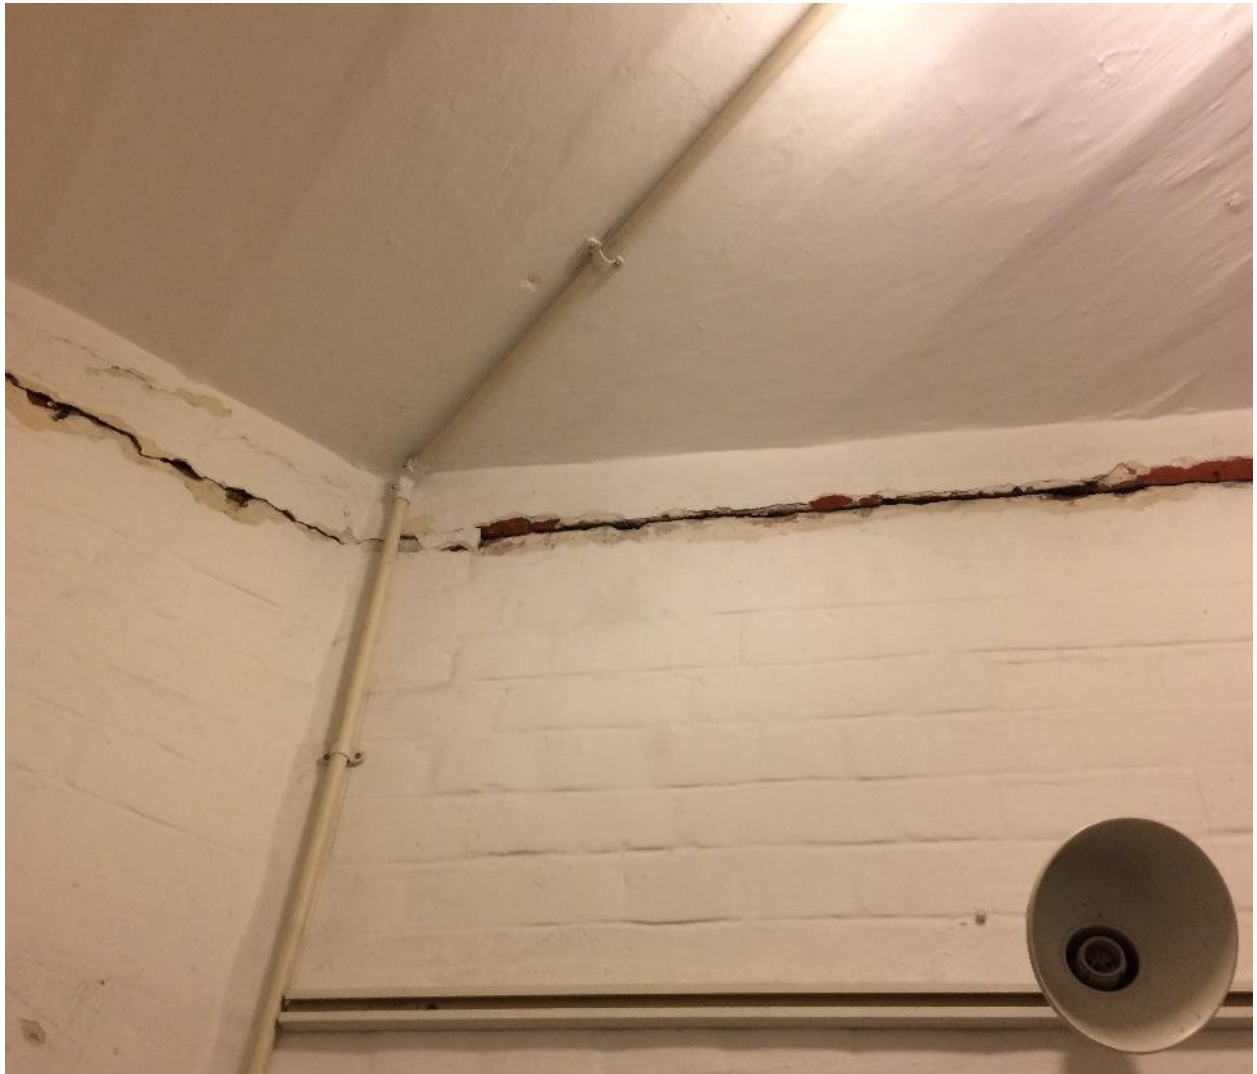
**Photograph 19 - Crack to bed joint beneath 2<sup>nd</sup> floor slab over NW chamfered corner**

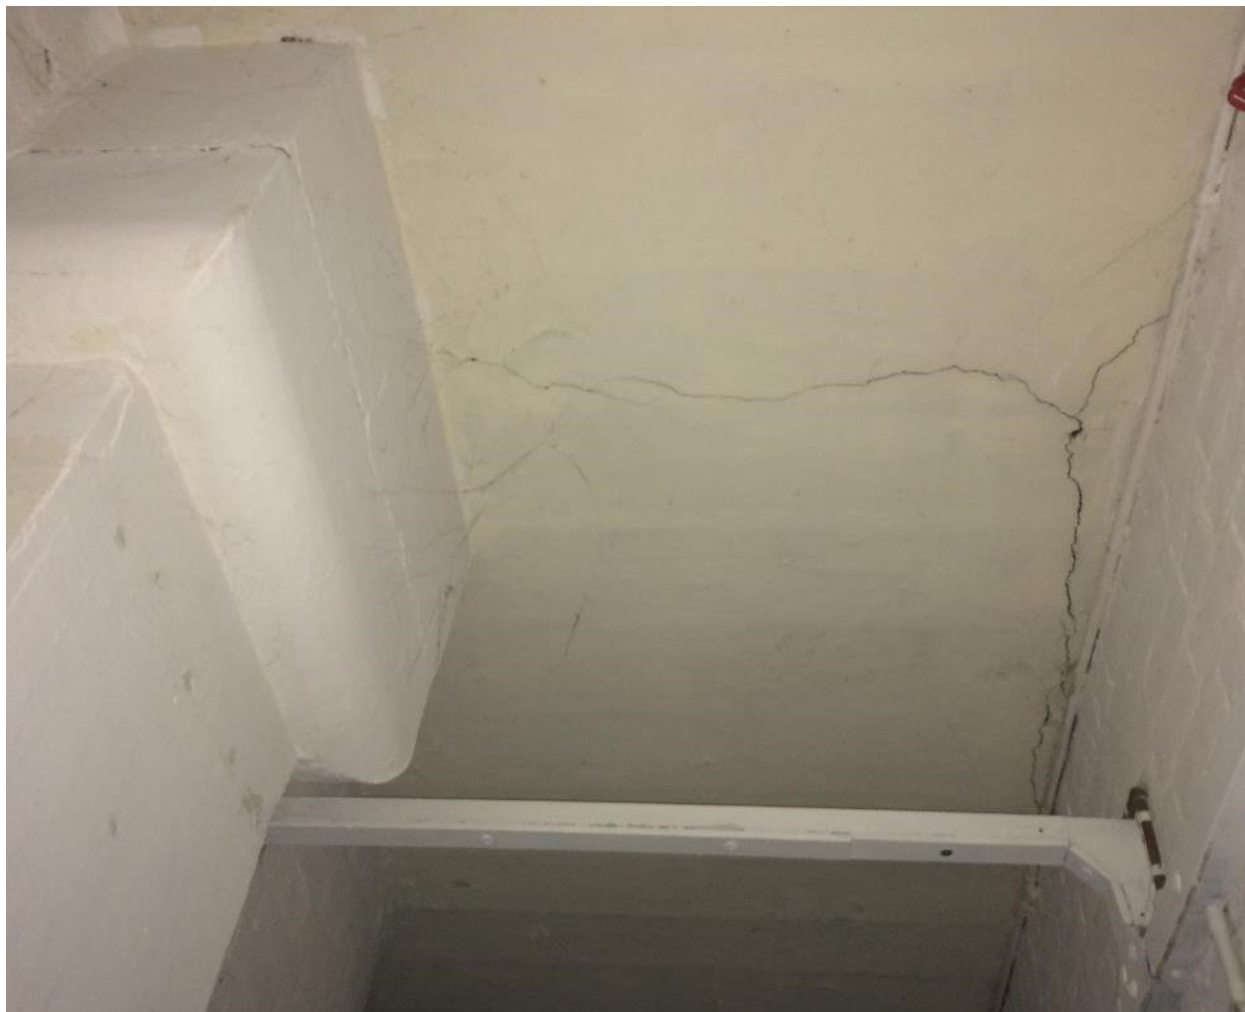
**Photograph 20 - Cracking to the underside of the First-floor slab**

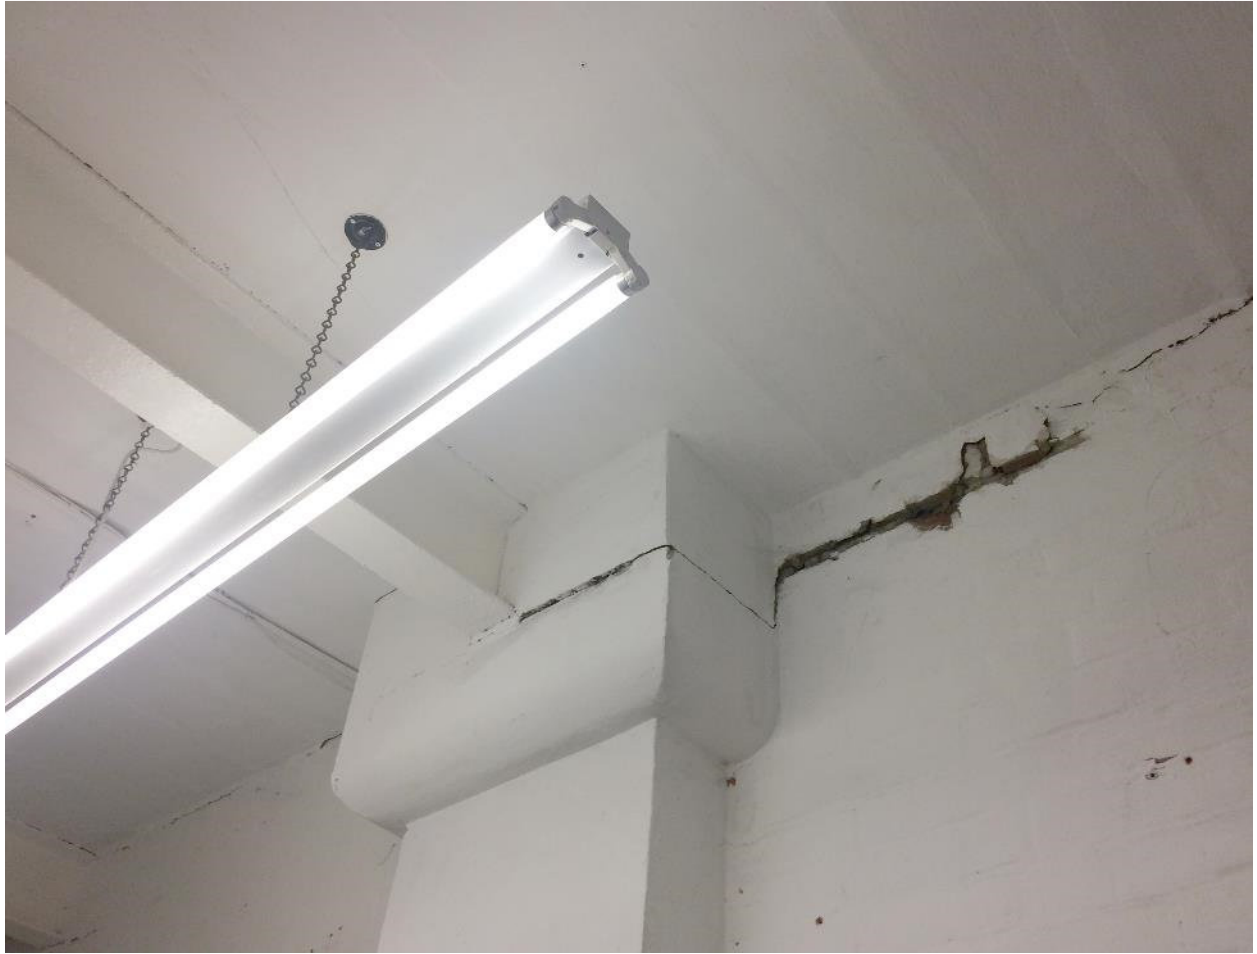
**Photograph 21 - Cracking to the stone capital around the beam bearing**

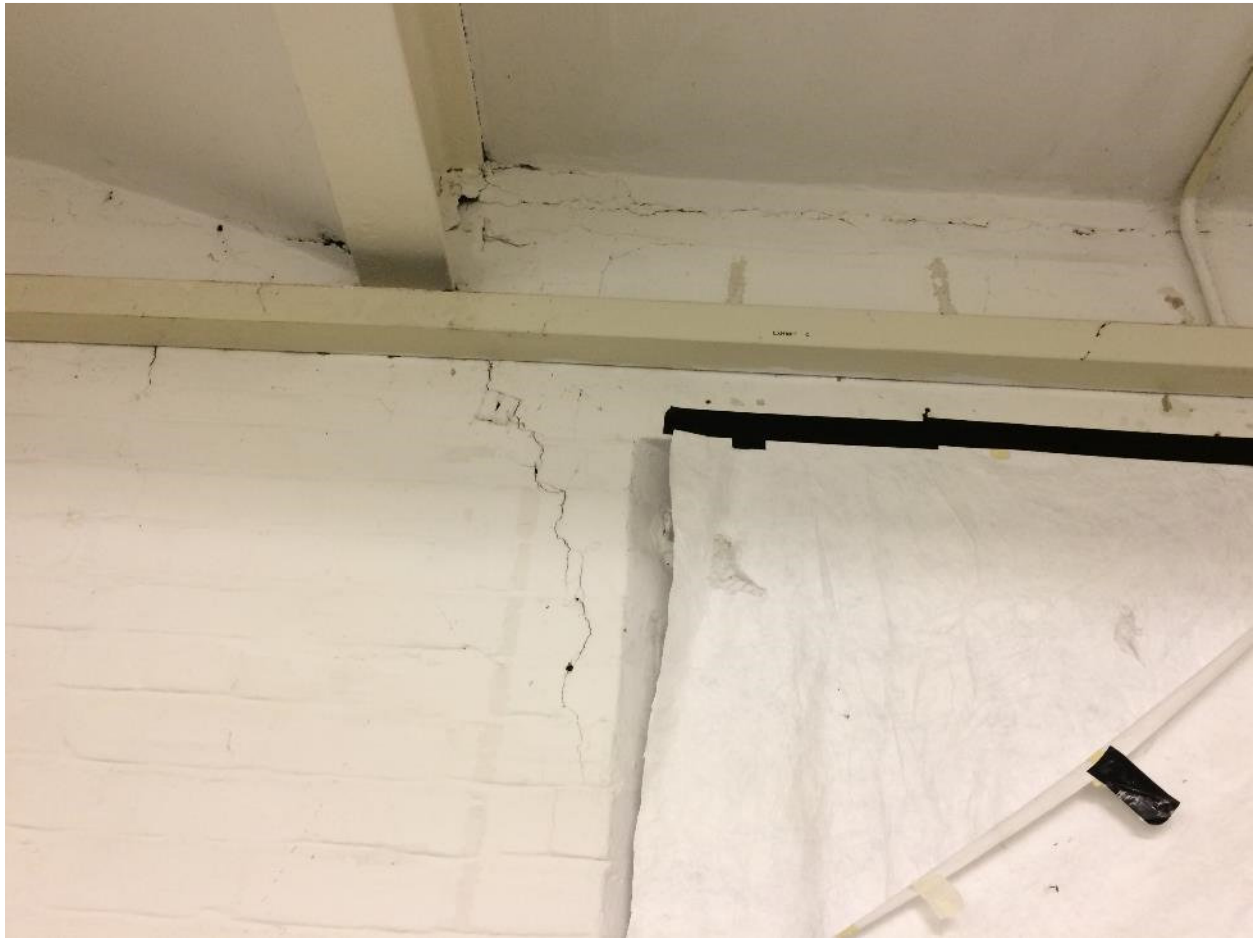
**Photograph 22 - Cracking to walls beneath beam bearing**

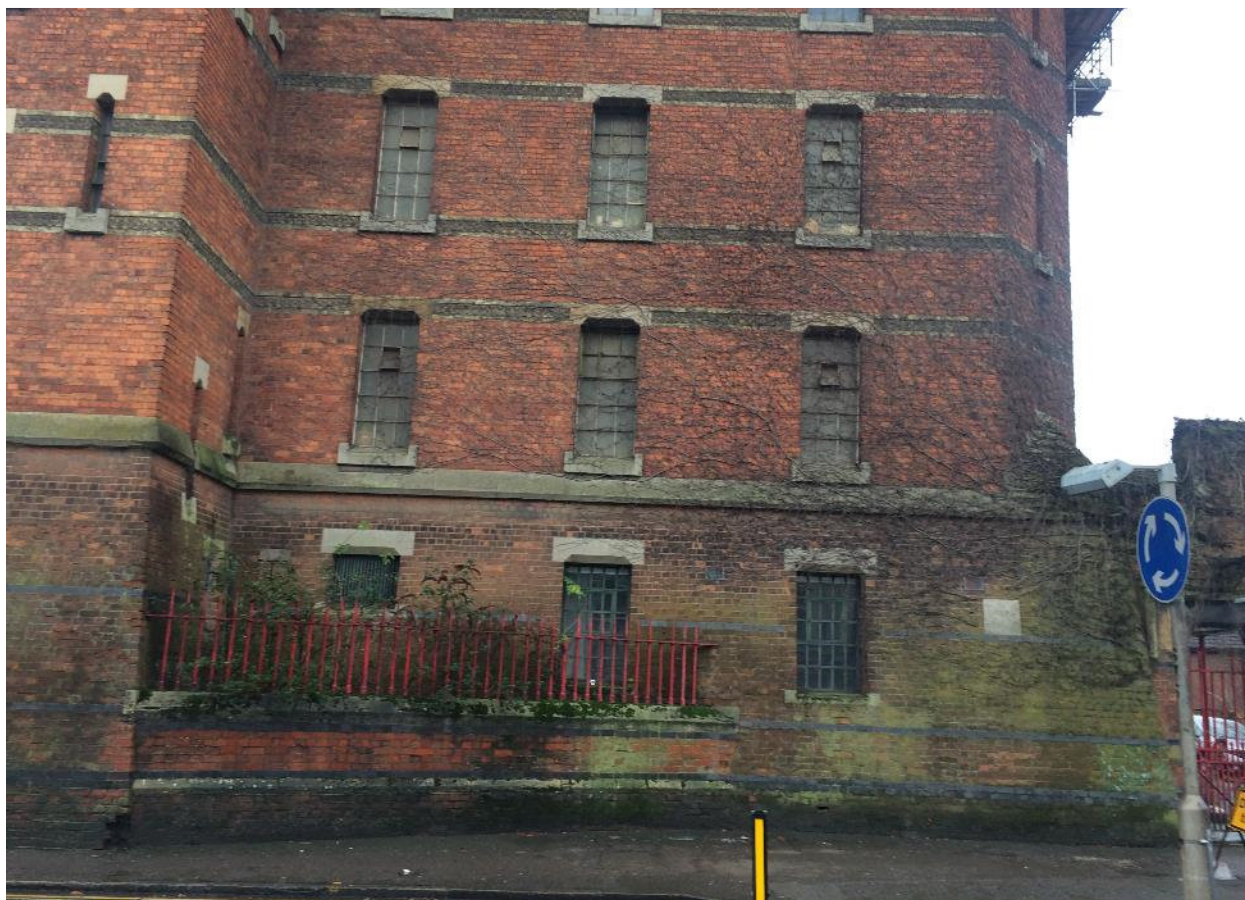
Photograph 23 - Damp external wall below first floor

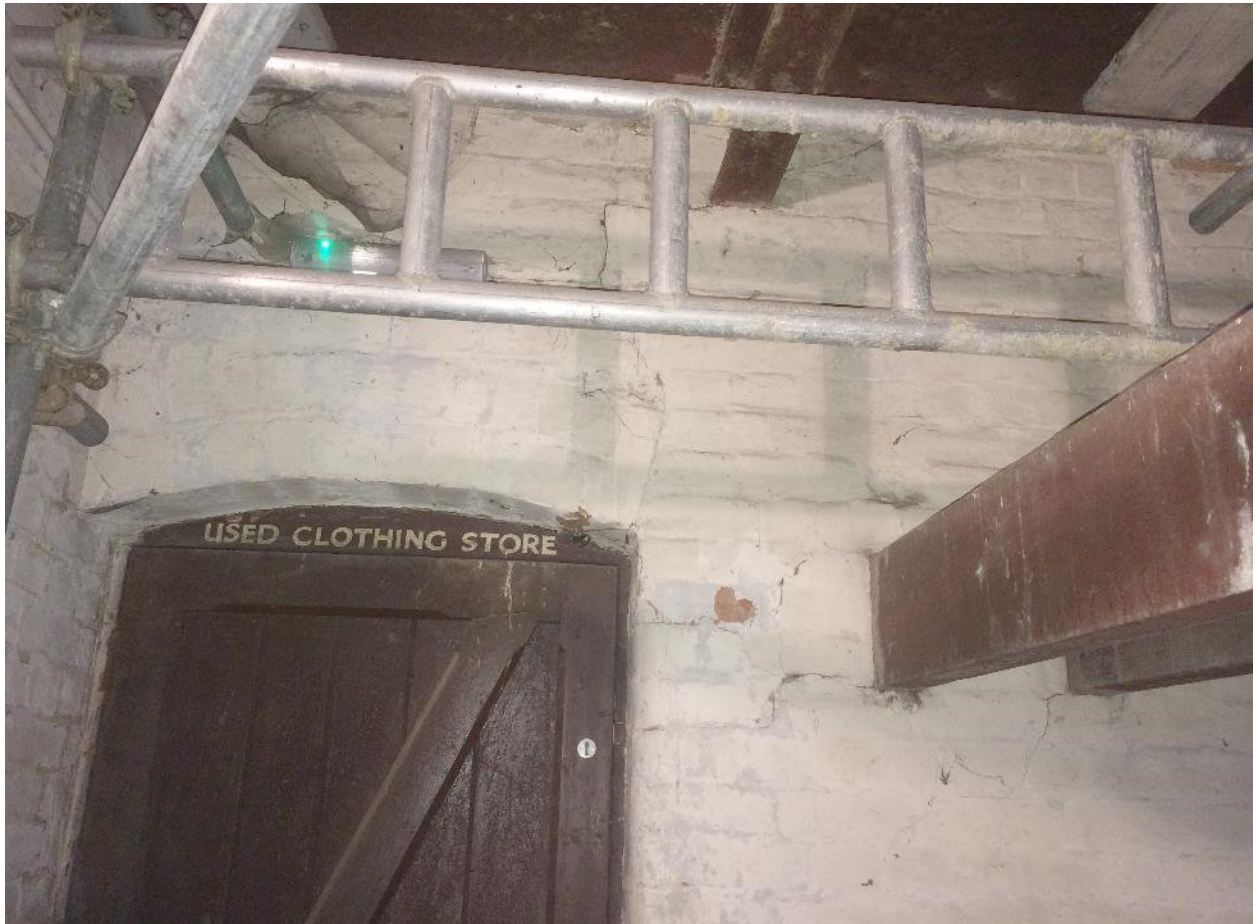
Photograph 24 - Cracking to tower wall beneath water tank beam

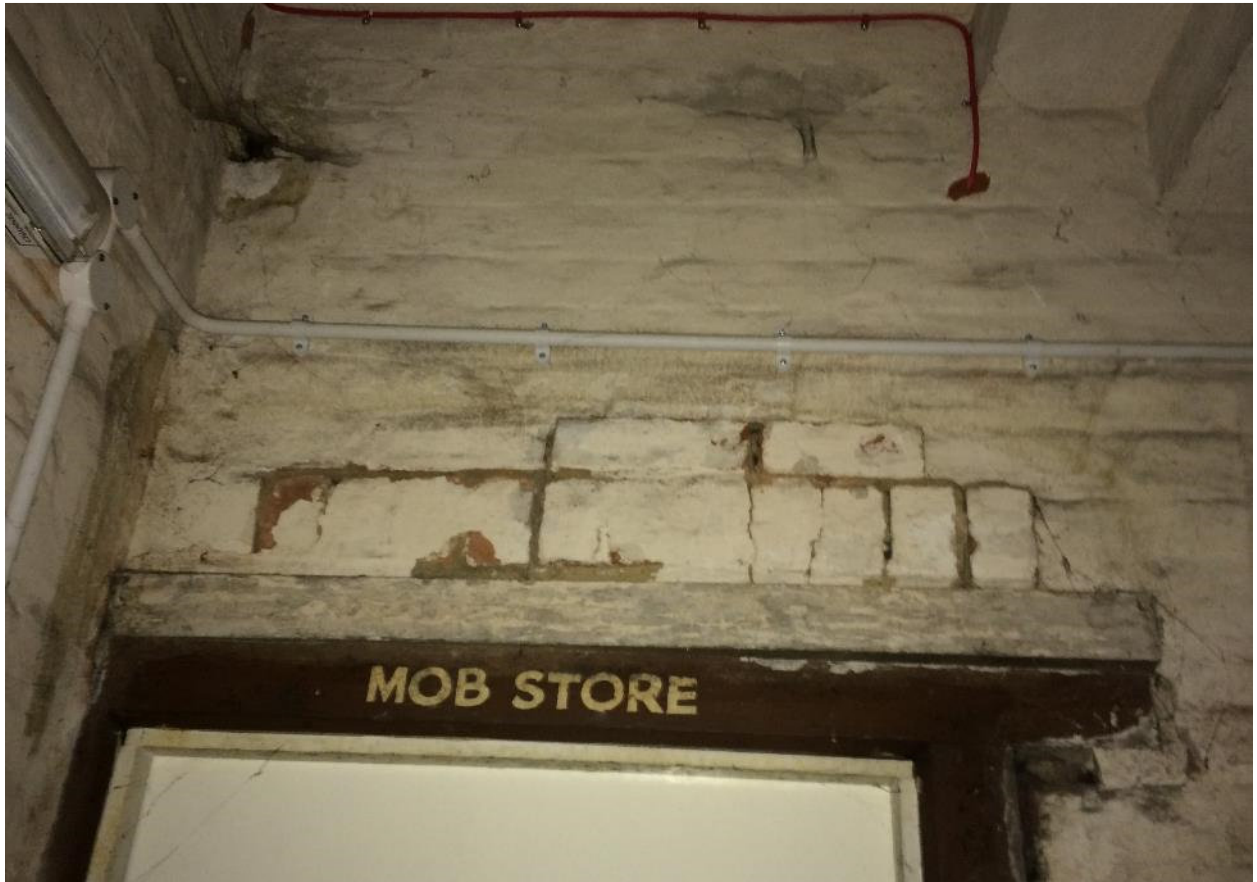
Photograph 25 - Brick dislodged over door lintel from NE tower

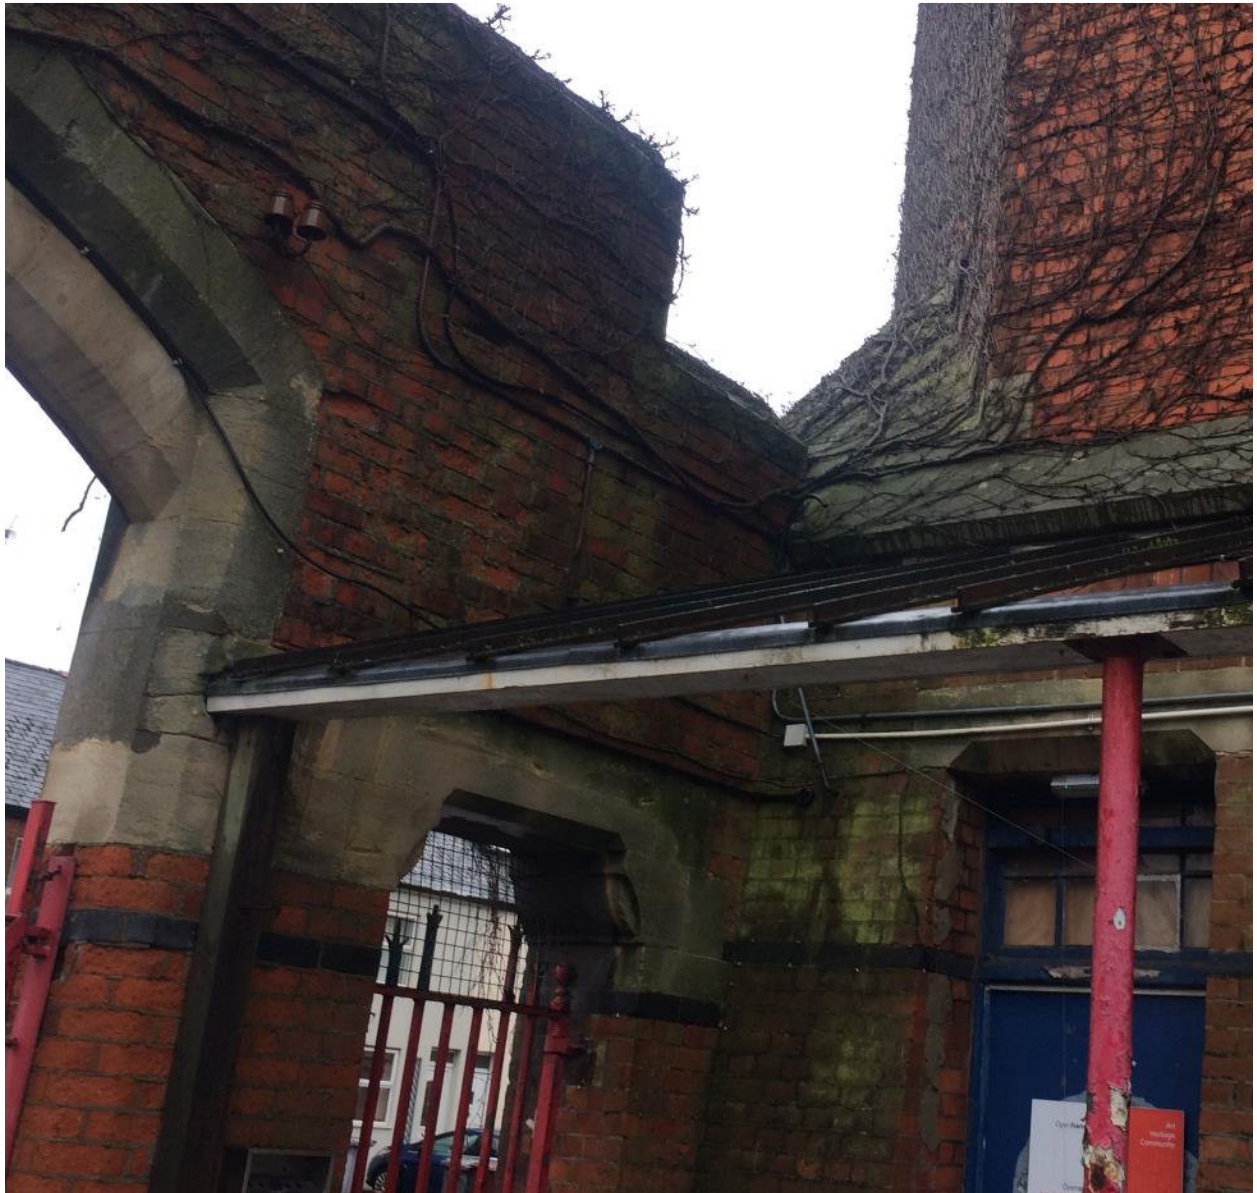
Photograph 26 - Timber post supporting the veranda is damp.

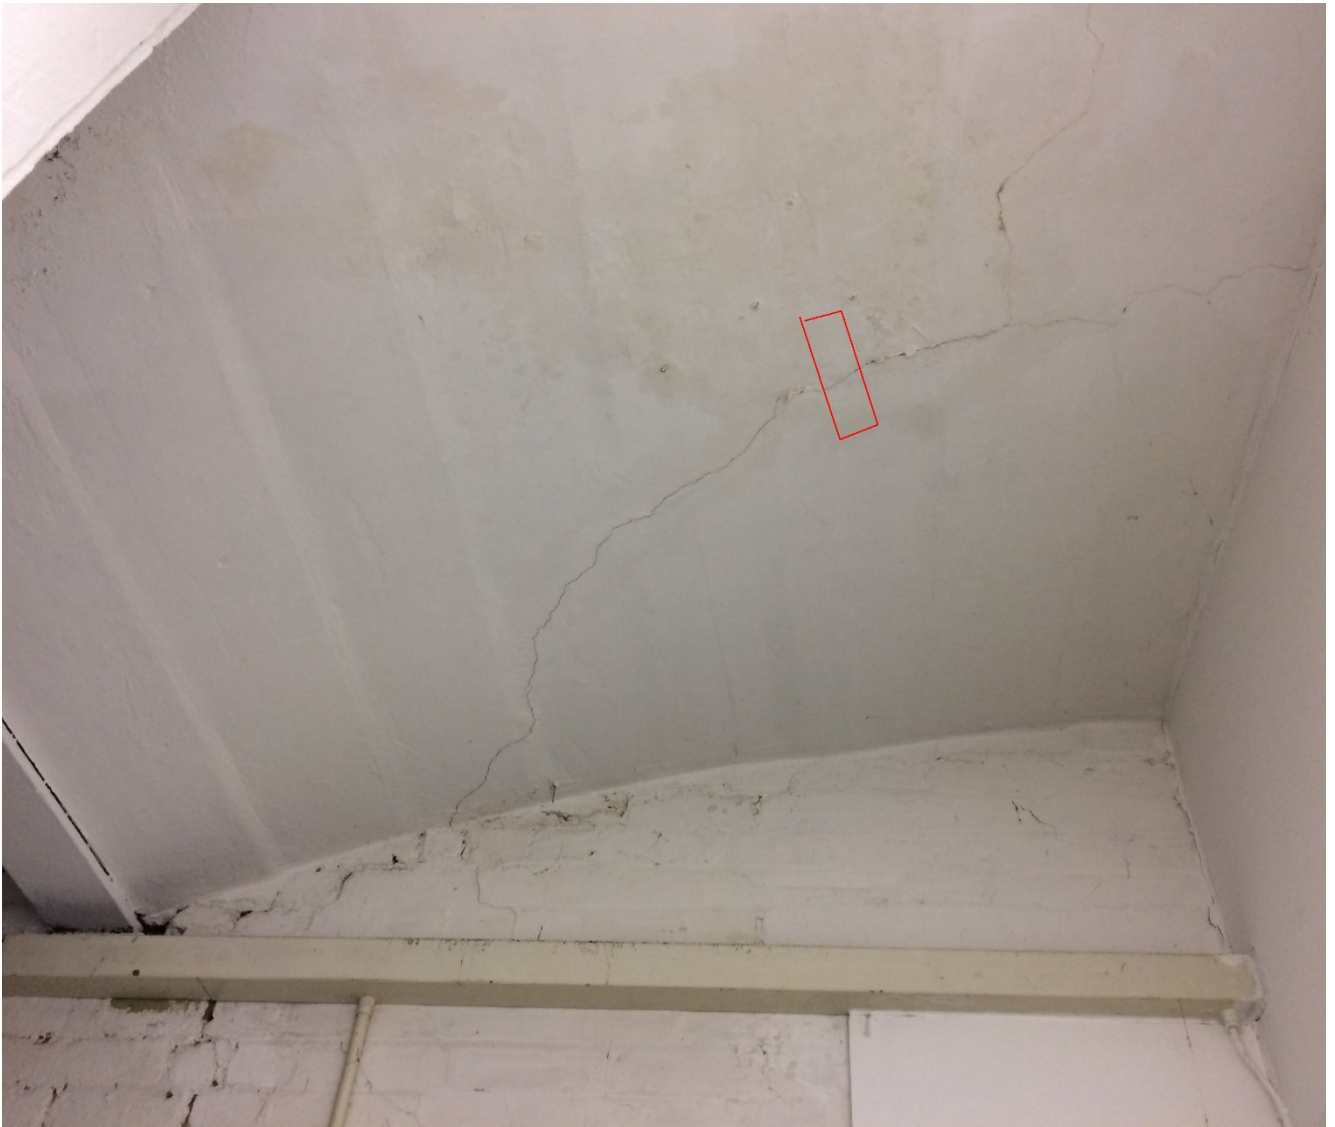
- 1) Underside of the Barrel-vaulted roof slab, over the North West art studio on the third floor

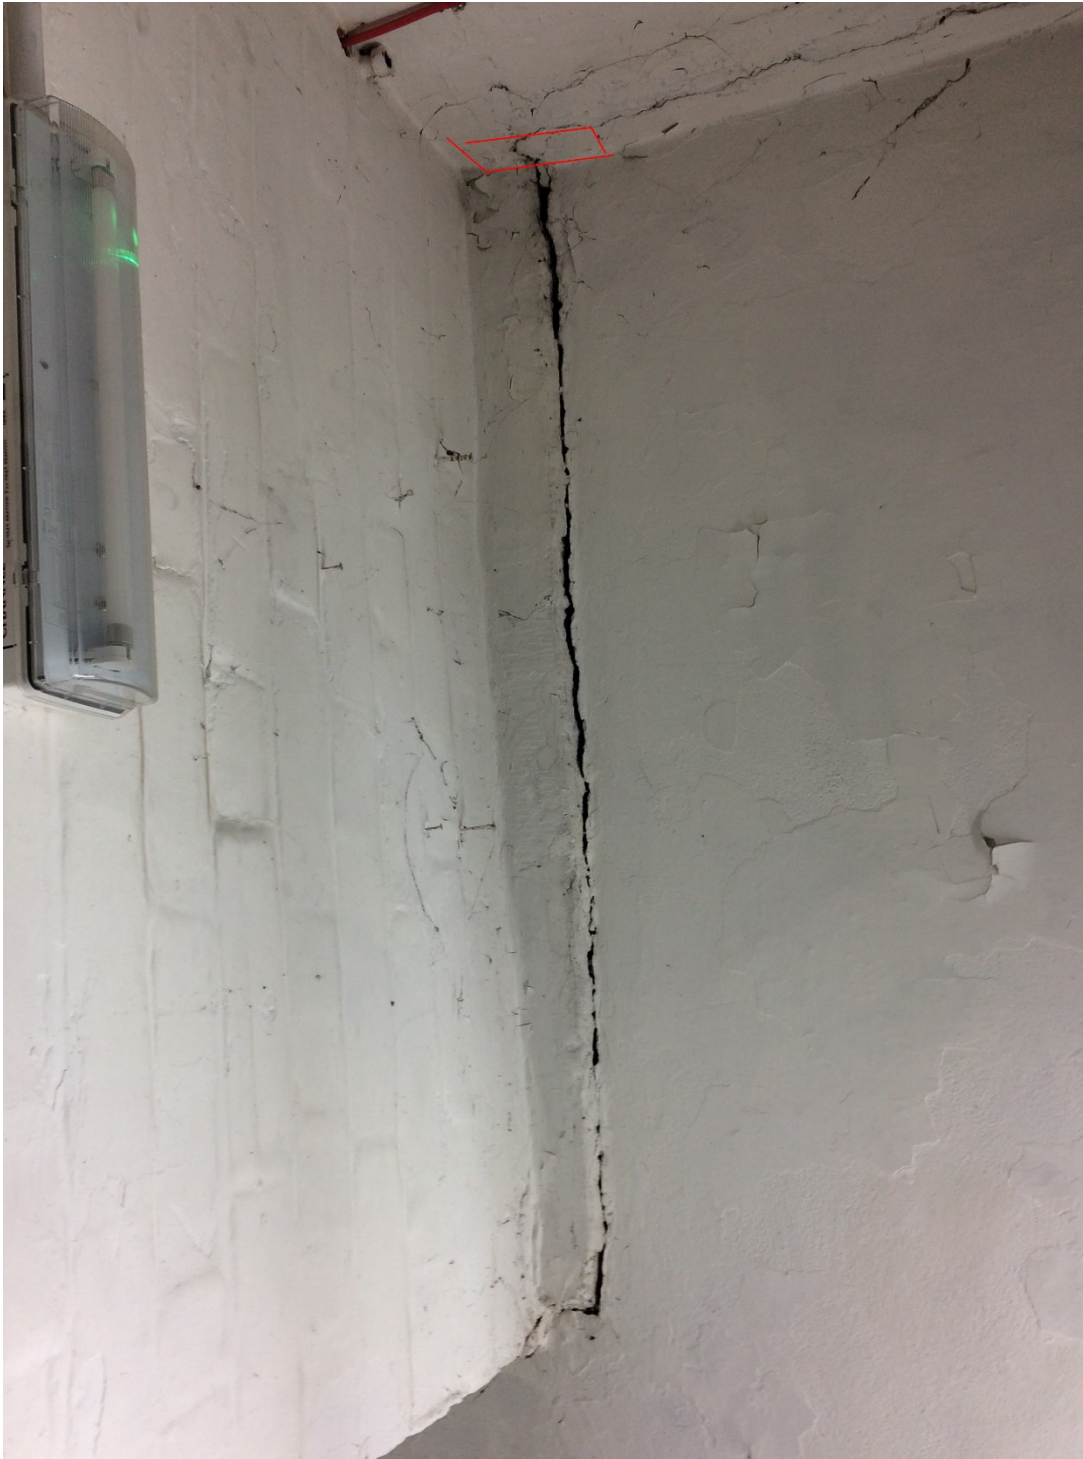
- 2) Crack in external wall near underside of 3<sup>rd</sup> floor slab. Over doorway going through to the North east turret at 2<sup>nd</sup> Floor, on the art studio side
