Brock Keep, 571 Oxford Road, Reading

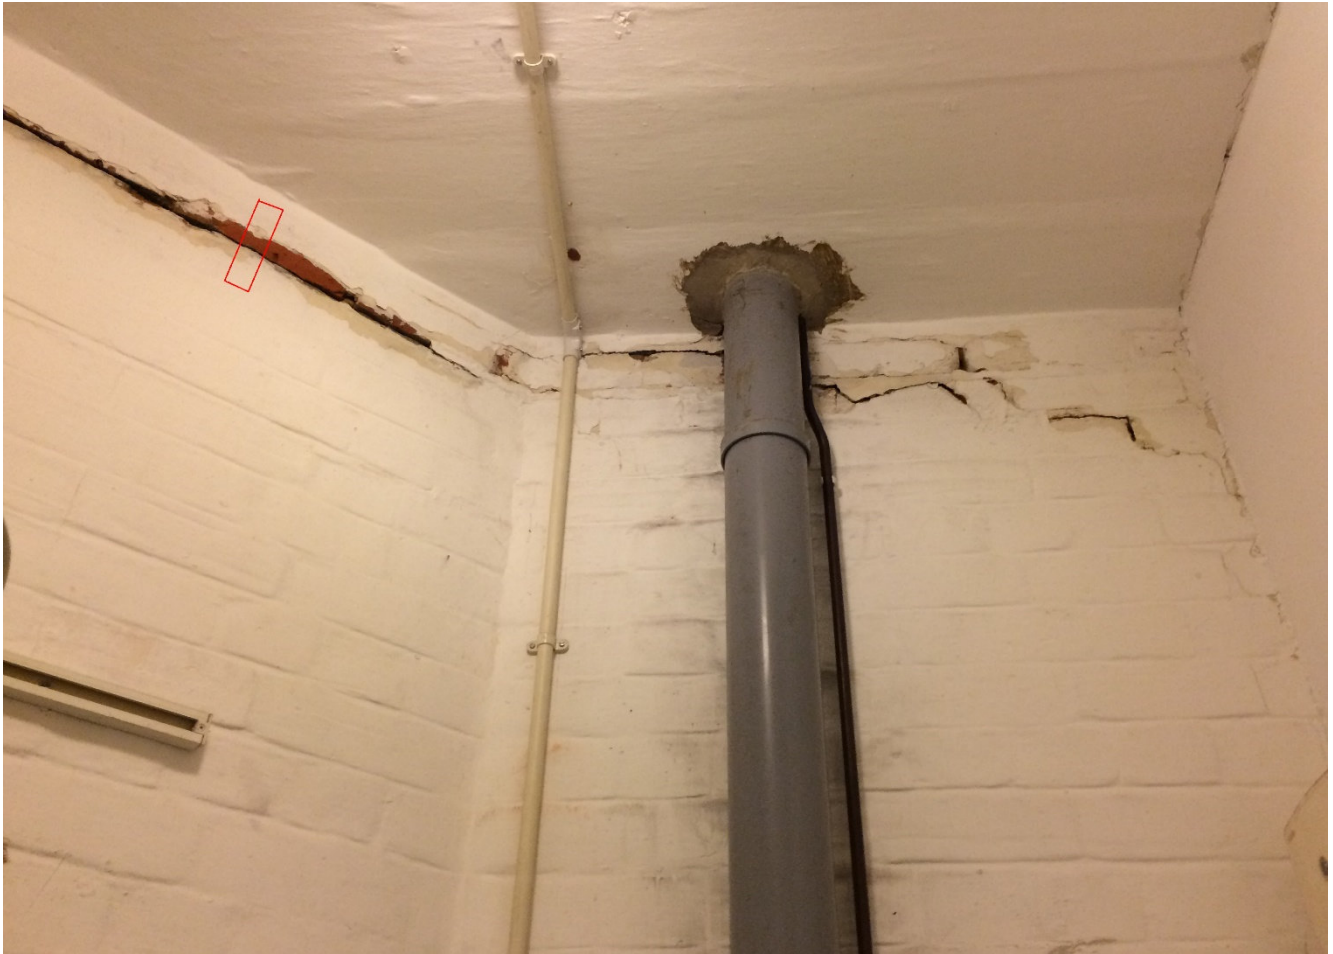
- 3) Monitor applied to crack in chamfered section of wall on the first floor, in the North east corner (Cleaning store/WC)

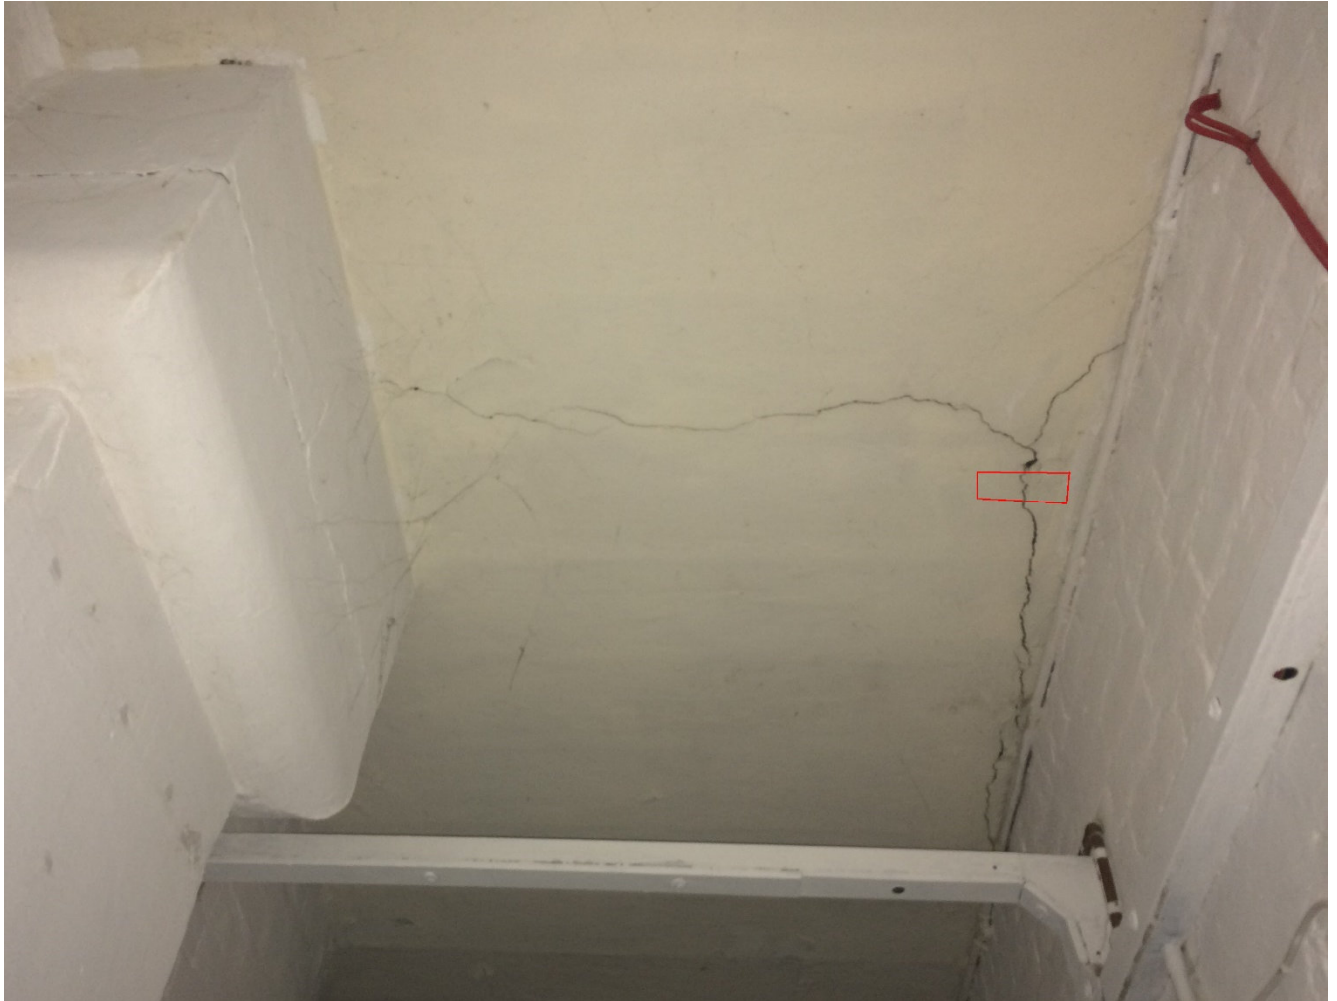
- 4) Crack to underside of first floor slab corner over the corridor

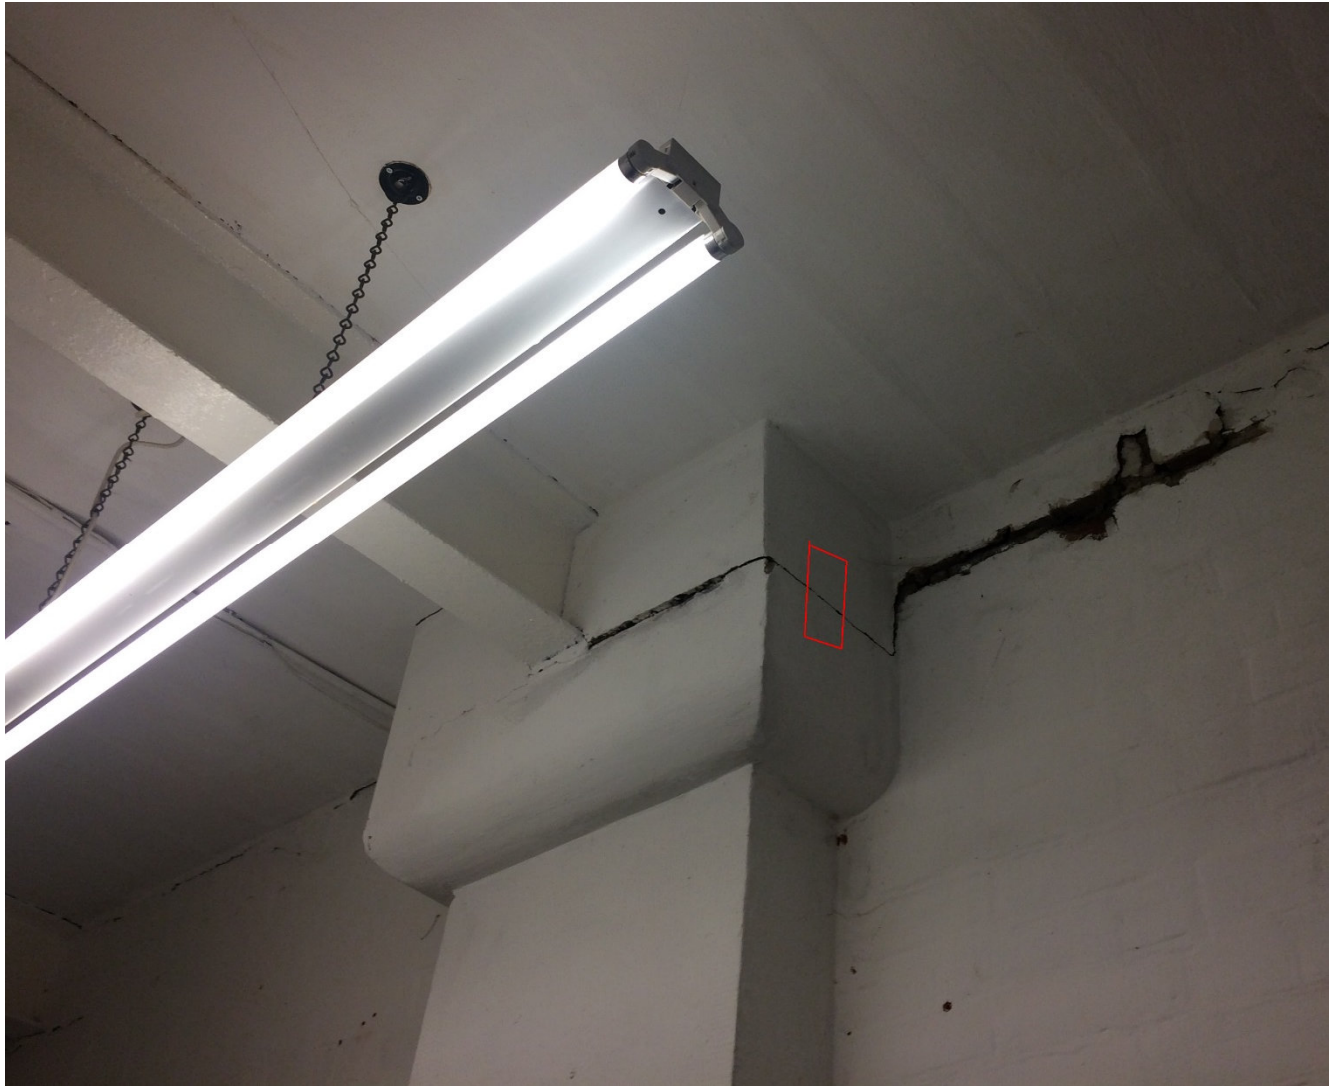
5) Crack to stone capital first floor, in the ground floor corridor
