## The Waterhouse Building: Repairs and Maintenance Works to Chimneys, Roofs &amp; Rainwater Goods

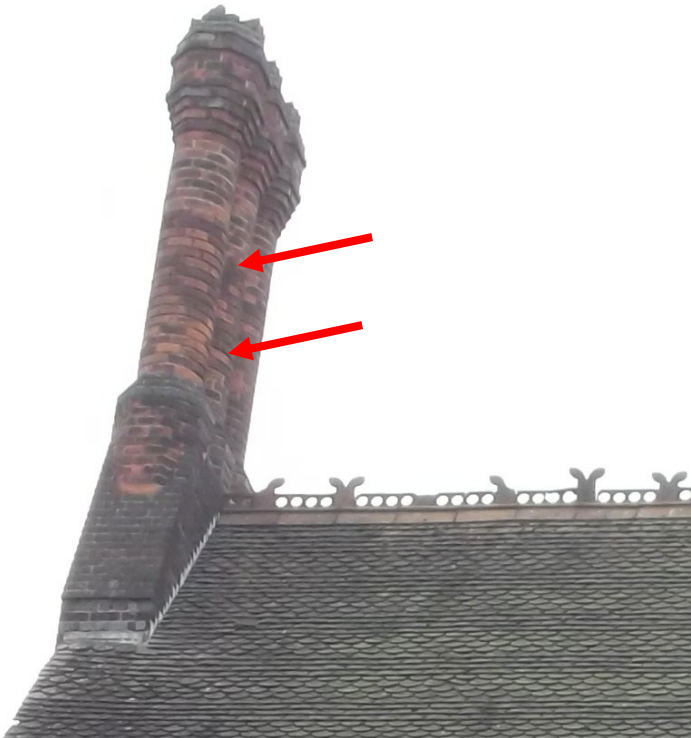
| Item | Location / Element | Description | Condition | Work Required | Tender Figure | Comments |
|---|---|---|---|---|---|---|
| 9.1 | Chimneys | Circular brick-built chimneys at both east and west ends of Central Main Building. Lead flashings. | East chimney stack: Fair. Moderate erosion to brickwork and pointing at low level and to base of stack. | Repair eroded brickwork and pointing (allow 1m <sup>2</sup> of brickwork and 4m <sup>2</sup> of pointing). | | |

| | <p>3) Central Main Building: East Chimney Stack</p> <p>Note erosion to mortar joints.</p> |

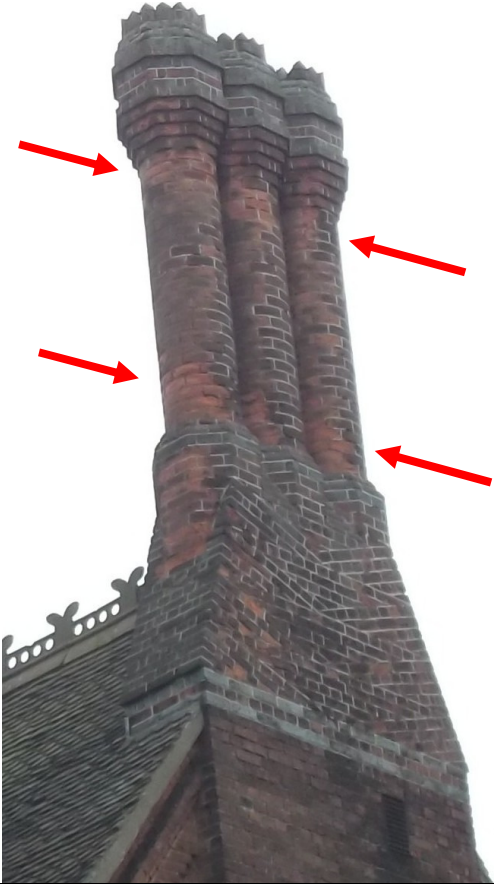
| Item | Location / Element | Description | Condition | Work Required | Tender Figure | Comments |
|---|---|---|---|---|---|---|
| 9.2 | Chimneys | Circular brick-built chimneys at both east and west ends of Central Main Building. Lead flashings. | West chimney stack: Fair. Moderate erosion to pointing at low level and to base of stack. | Repair eroded brickwork and pointing (allow 2m <sup>2</sup> of brickwork and 4m <sup>2</sup> of pointing). | | |

| | <p>4) Central Main Building: West Chimney Stack.</p> <p>Note erosion to brickwork and pointing.</p> |

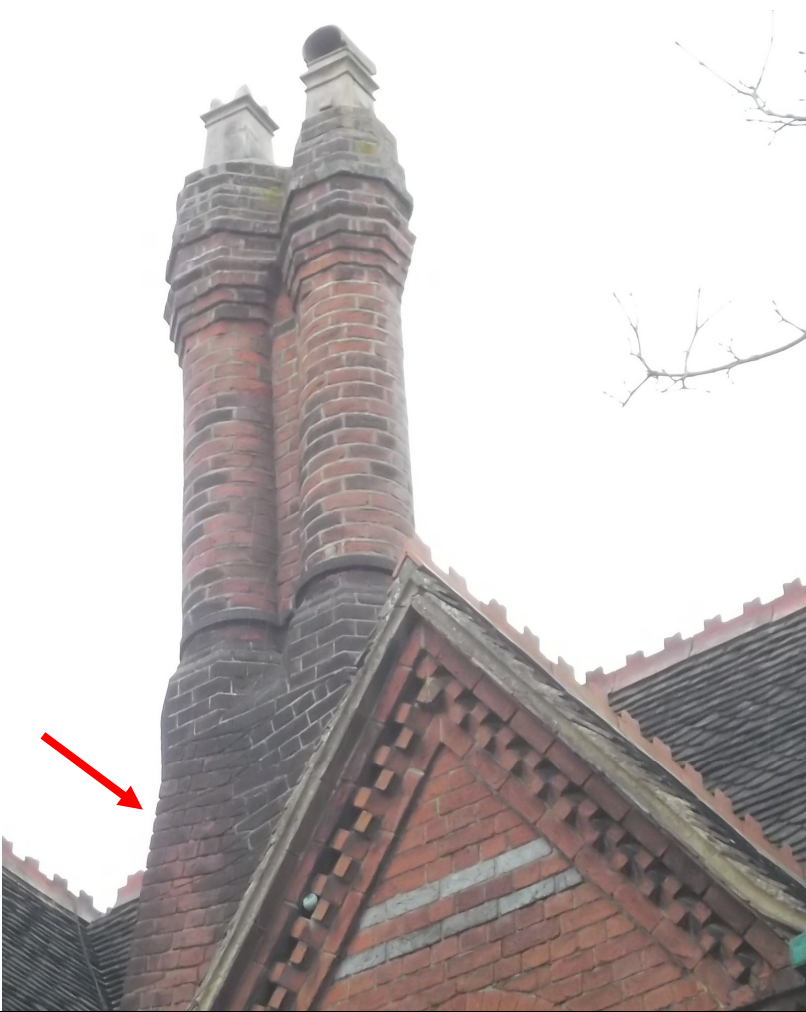
| | <p>5) East Wing, East End Elevation.</p> <p>Note erosion to mortar joints at low level.</p> |

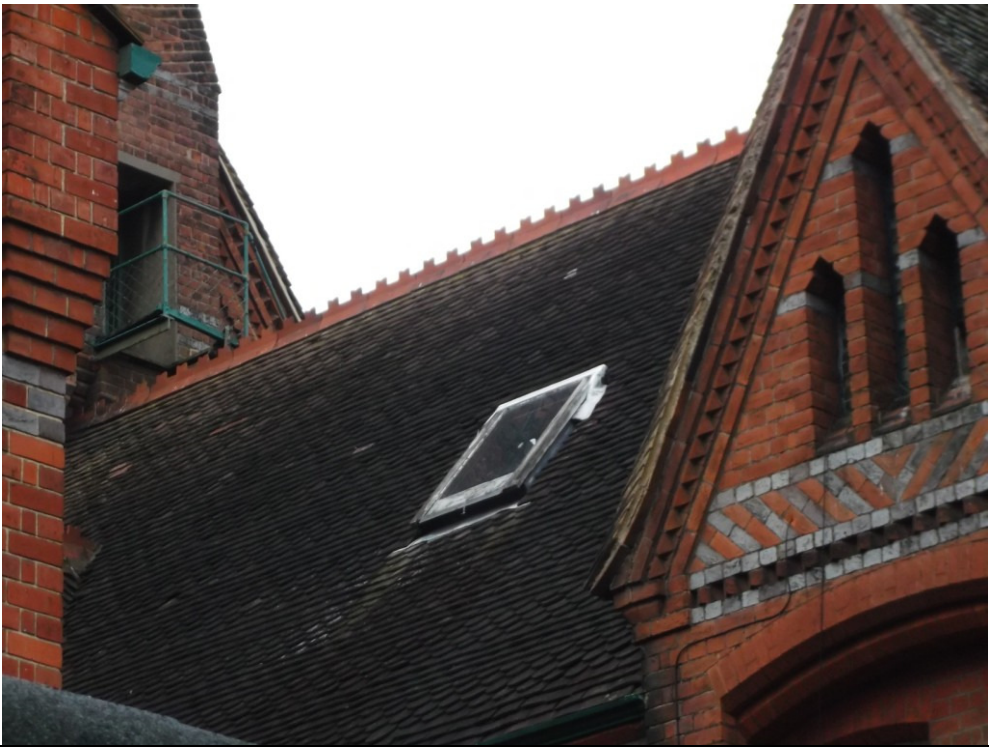
| Item | Location / Element | Description | Condition | Work Required | Tender Figure | Comments |
|---|---|---|---|---|---|---|
| 2.2 | Rooflight | Painted timber rooflight near centre of building on south-facing roof slope. | Paint finish and condition of timber appear poor. | Repair / overhaul joinery and redecorate. Ensure glazing is adequately retained within framing. | | |

| | <p>7) East Wing, Rear Elevation.</p> <p>Note weathered condition of rooflight.</p> |

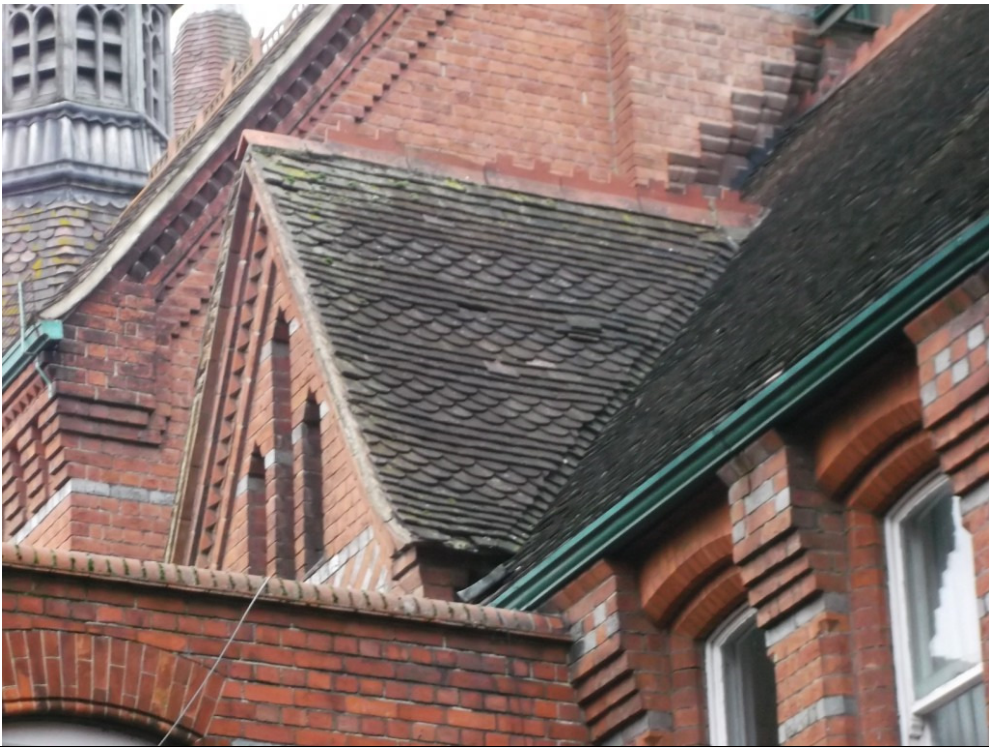
| | <p>8) East Wing, Rear Elevation.</p> <p>Note broken, slipped and missing tiles to dormer roof.</p> |

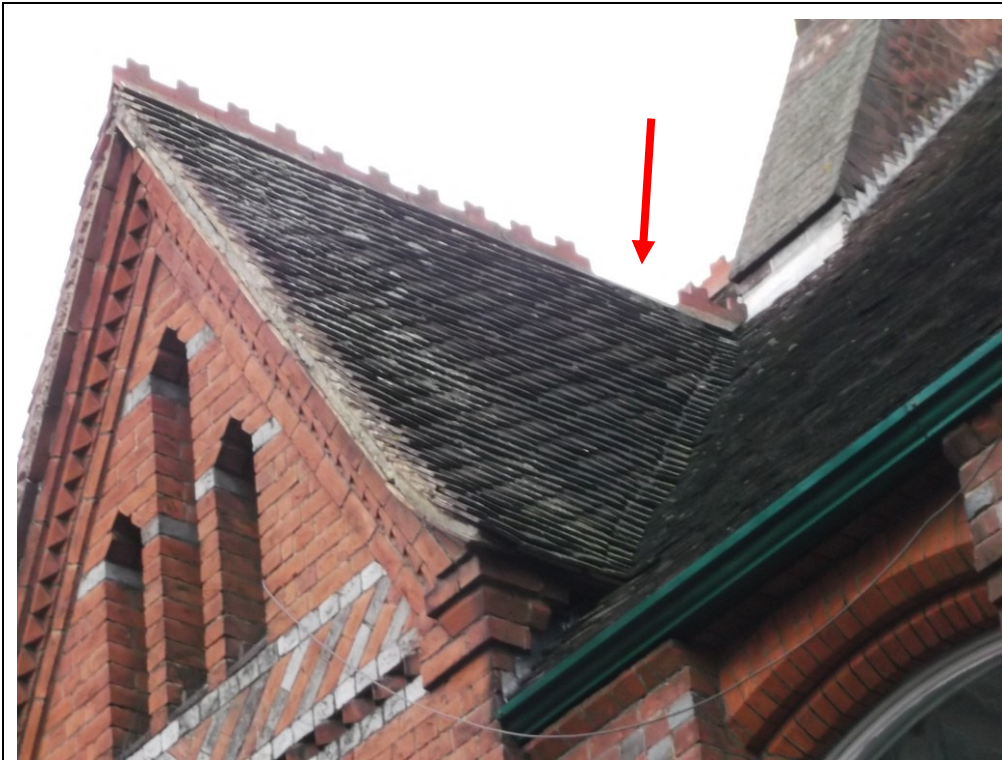
9) East Wing, Rear Elevation.  
Note missing ridge tile to dormer roof.

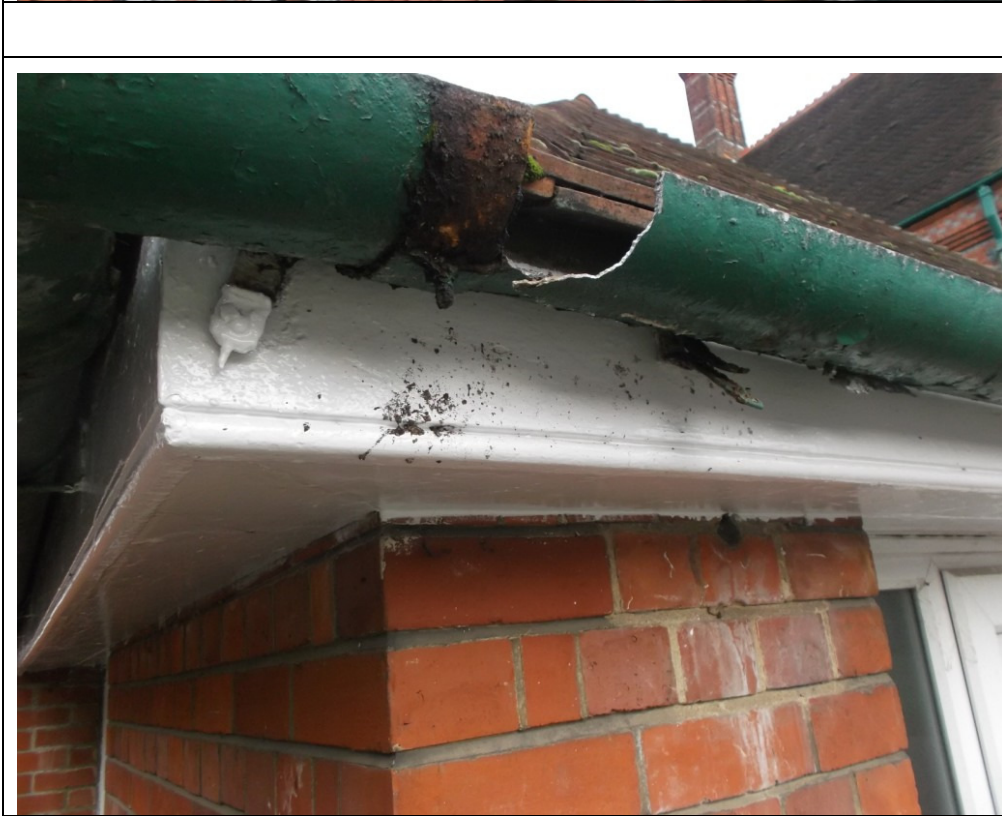
10) East Wing, Rear Elevation Single-Storey Addition.  
Broken cast iron gutter.

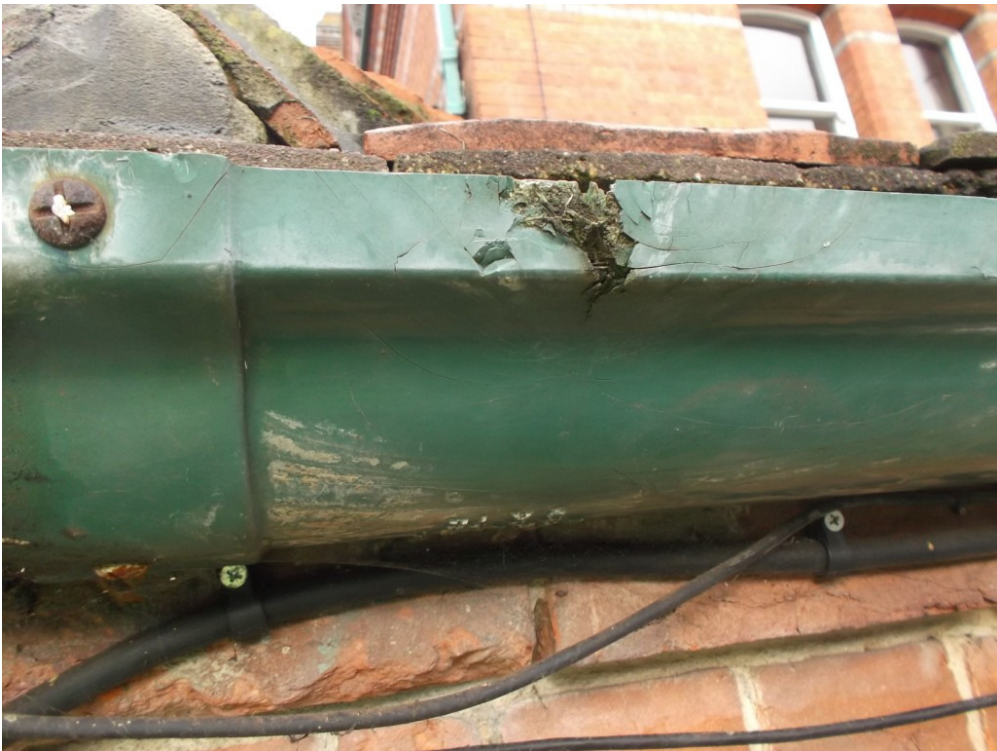
| Item | Location / Element | Description | Condition | Work Required | Tender Figure | Comments |
|---|---|---|---|---|---|---|
| 3.20 | South-facing hipped roof to single-storey rear extension on south face of Rear Projection | Glass Reinforced Plastic (GRP) ogee gutters with bolted joints, installed on corbelled brickwork. | Substantial sagging and distortion to gutter sections which also show signs of fractures and impact damage revealing the fibre matrix within this material. | Replace the gutters with 'Alumasc' or equivalent cast aluminium gutters to match recently installed replacement rainwater goods. | | |

| | <p>11) East Wing, Rear Elevation Single-Storey Addition.</p> <p>Damage and deterioration to glass fibre gutter.</p> |

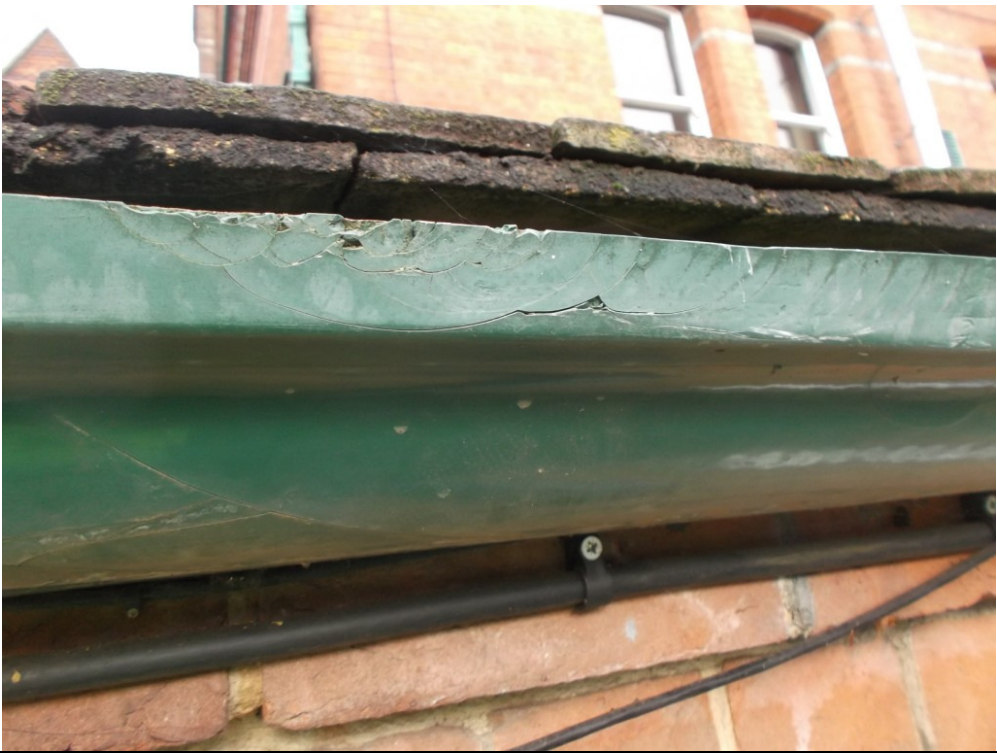
| | <p>12) East Wing, Rear Elevation Single-Storey Addition.</p> <p>Damage and deterioration to glass fibre gutter.</p> |

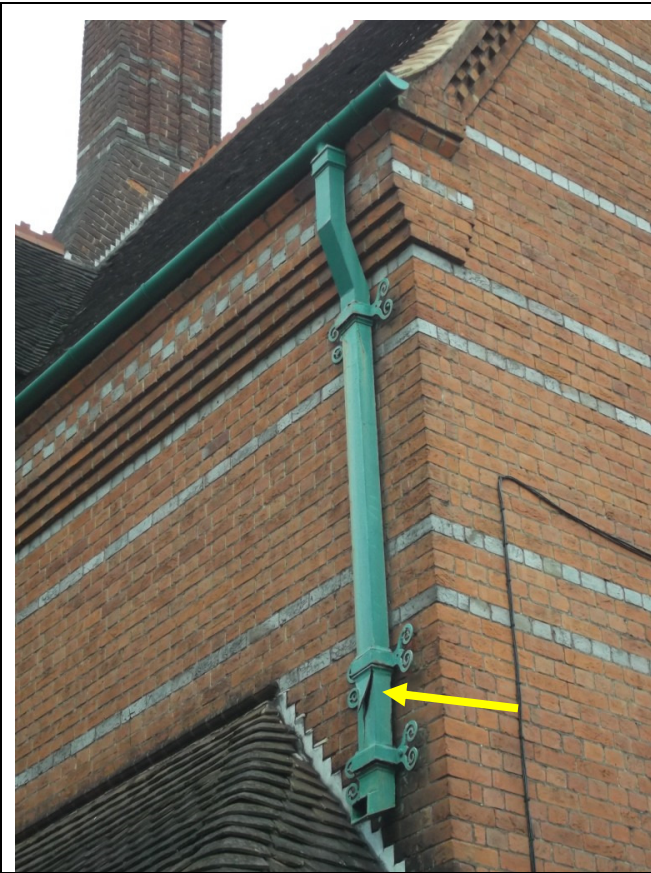
13) East Wing, Rear Elevation Two-Storey Projection.

Broken cast iron downpipe.

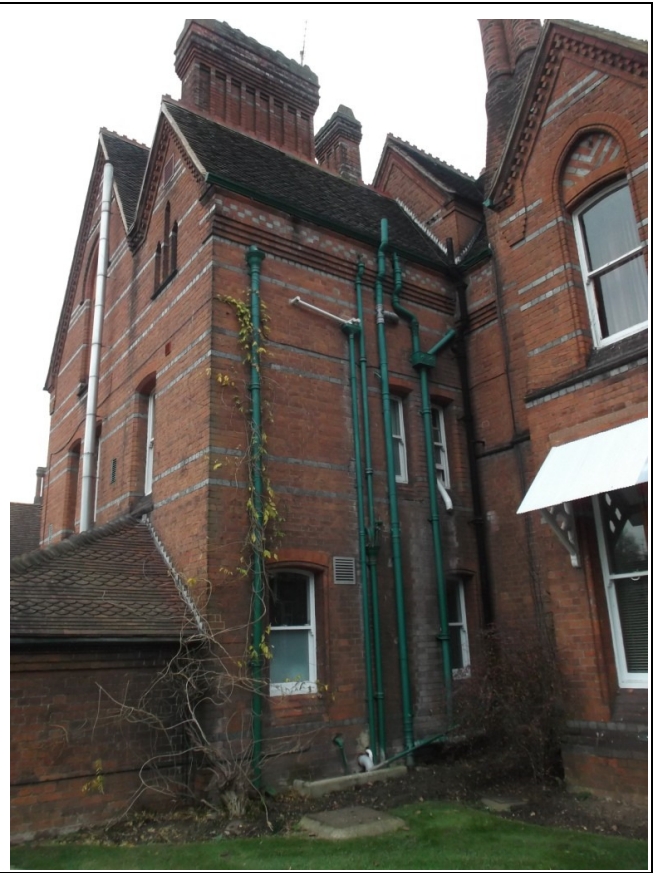
14) East Wing, Rear Elevation Two-Storey Projection.

Collection of rainwater downpipes and waste pipes.

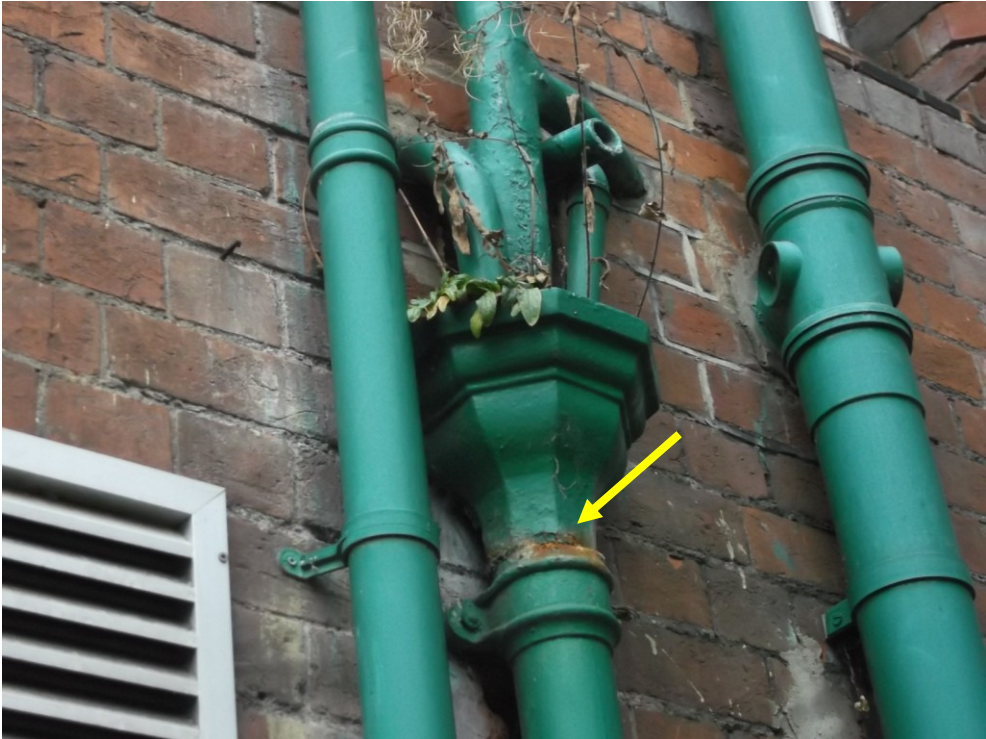
| | <p>15) East Wing, Rear Elevation Two-Storey Projection.</p> <p>Corrosion to cast iron hopper.</p> <p>Note possible lead waste pipework above.</p> |

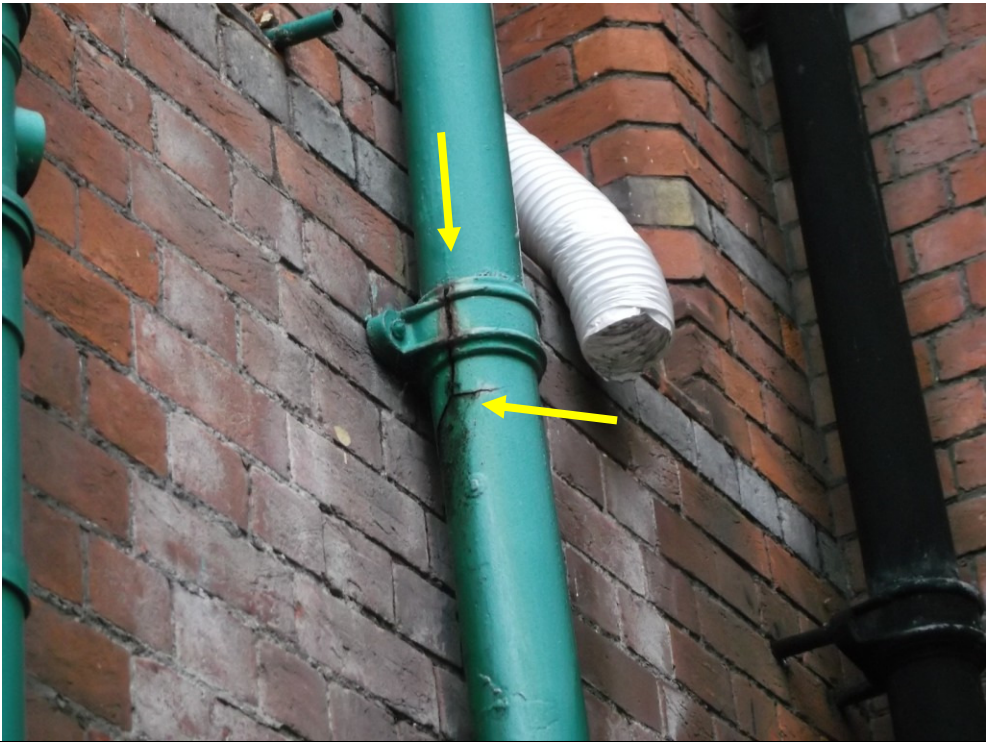
| | <p>16) East Wing, Rear Elevation Two-Storey Projection.</p> <p>Corrosion and cracks to cast iron downpipe and bracket.</p> |

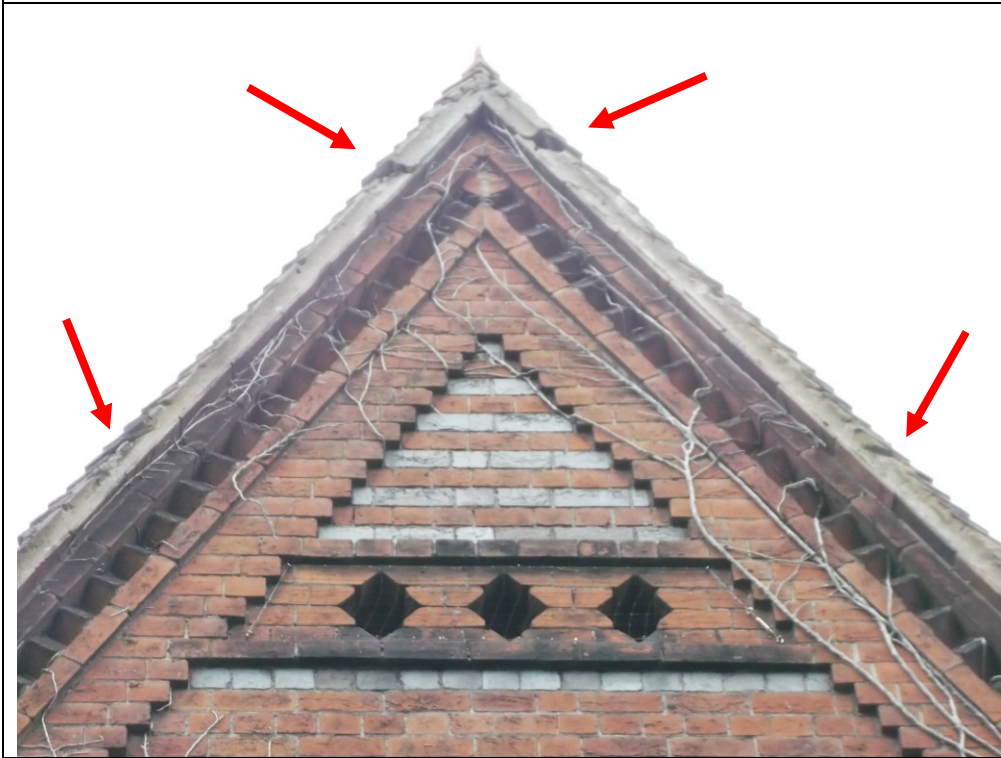
18) East Wing, East End Elevation.  
Note erosion to verge pointing.

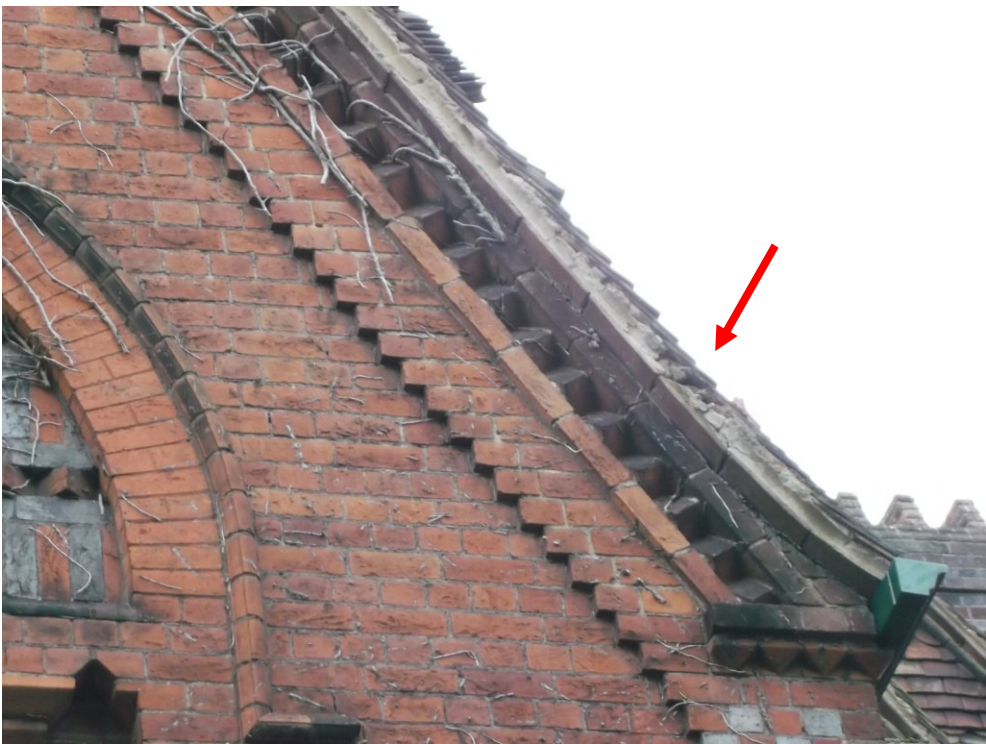
| | <p>19) East Wing, East End Elevation.</p> <p>Note erosion to verge pointing.</p> |

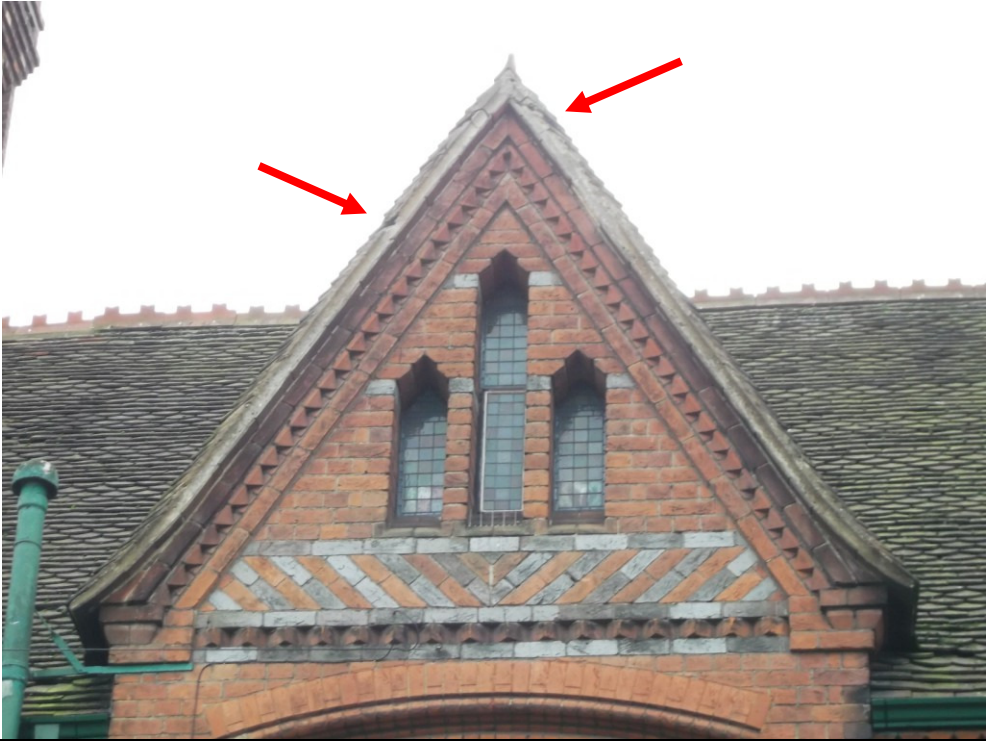
| | <p>20) East Wing, Front Elevation.</p> <p>Note erosion to verge pointing.</p> |

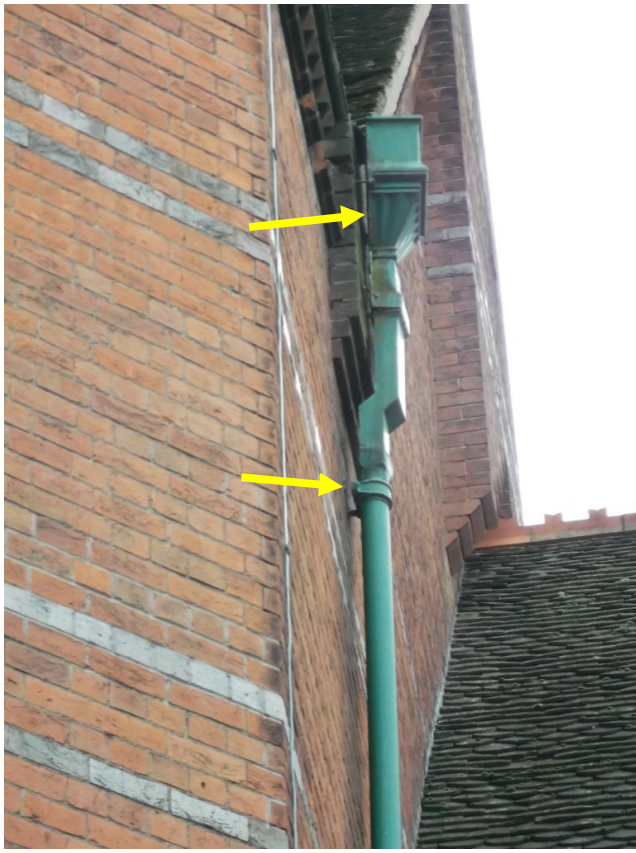
| <p>21) West-facing Elevation of Central Main Building.</p> | <p>22) West-facing Elevation of Central Main Building.</p> <p>Note gap between hopper and brickwork, plus missing fixing to bracket immediately below rectangular section of downpipe.</p> |

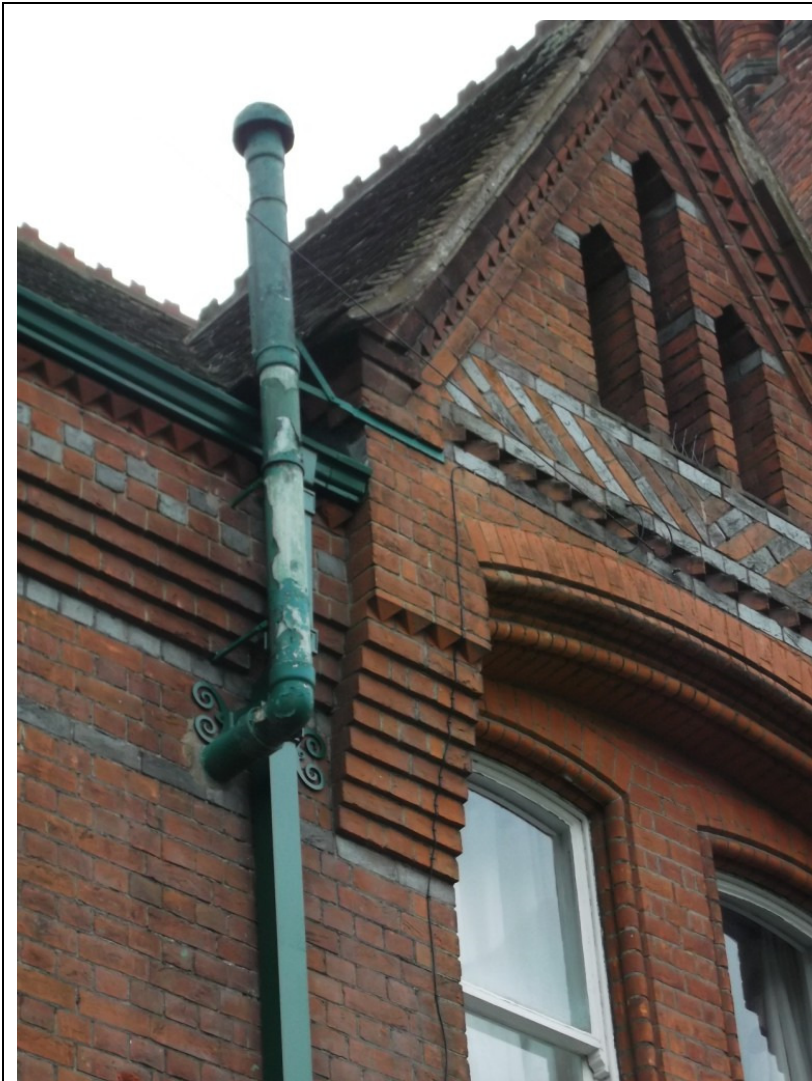
23) West Wing, Front Elevation.  
Flue pipe at high level.
