Visual Survey of 'The Keep', 571 Oxford Road, Reading  
Berkshire

Report: 1902/R01

November 2013

Client : Open Hand Open Spaces Ltd.

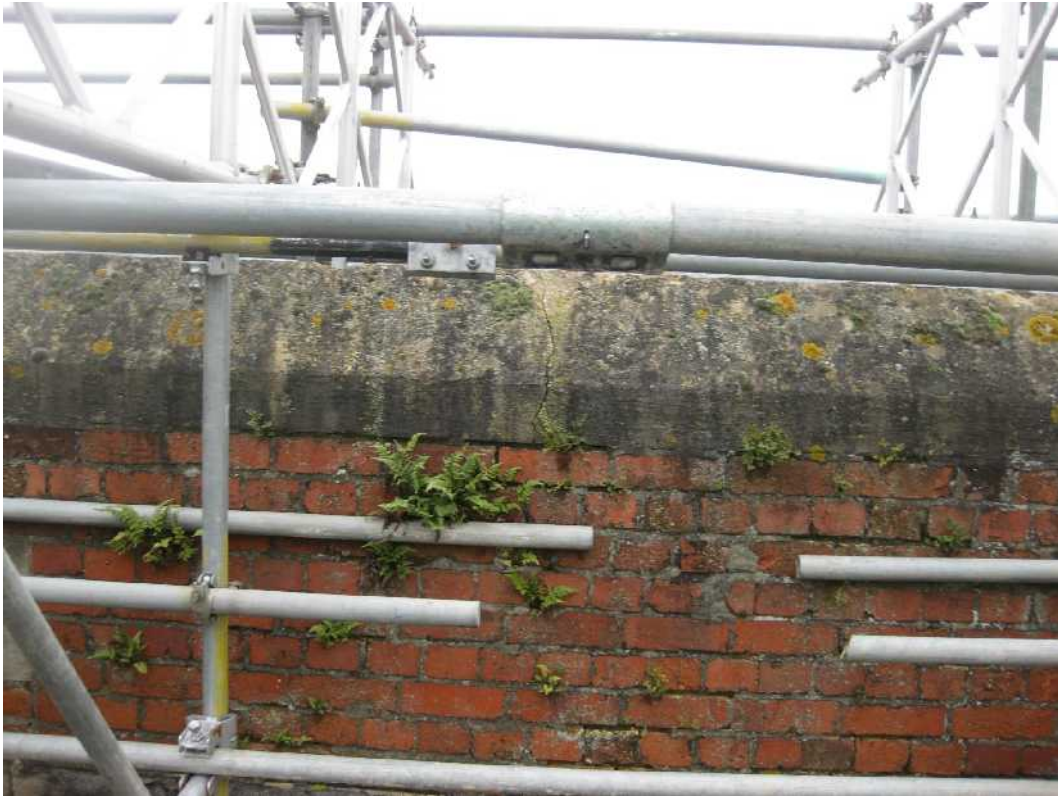
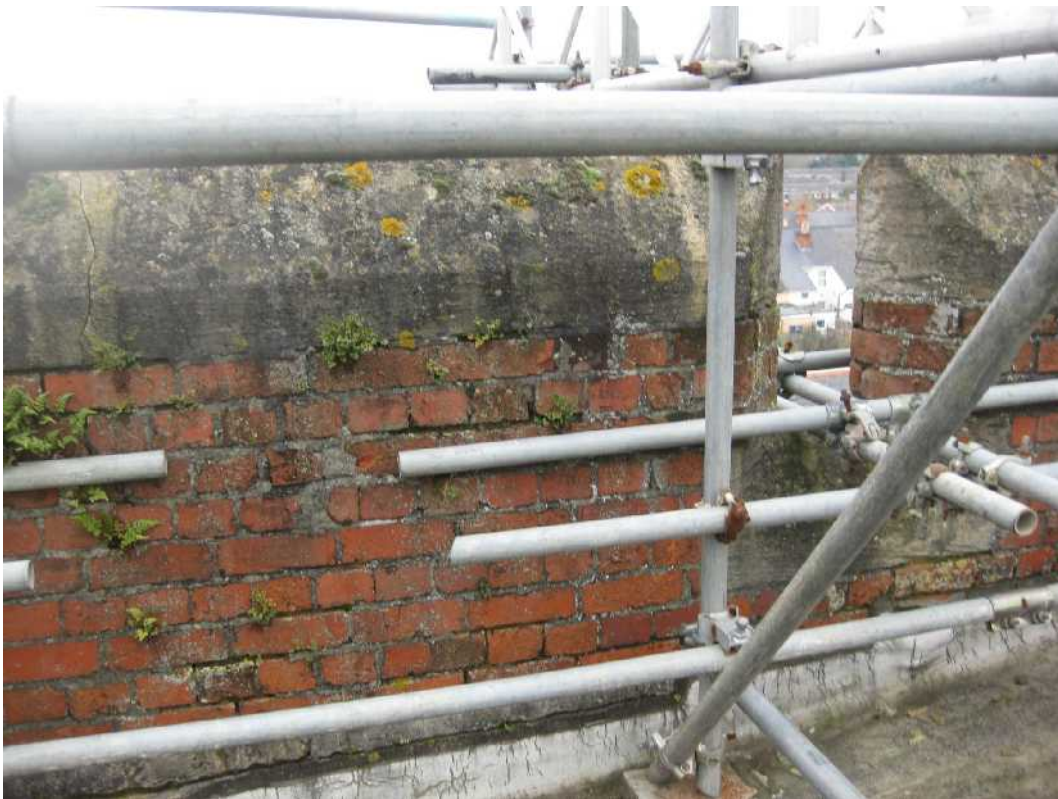
The visual inspection started at roof level. The parapet brick wall at this level was recorded as 328mm thick. Some of the brickwork is weathered and crumbling (5 &6) but generally the overall condition is quite good when considering the age and the limited amount of previous repair. The brickwork needs limited re-pointing with an appropriate and approved matching lime mortar mix (7).

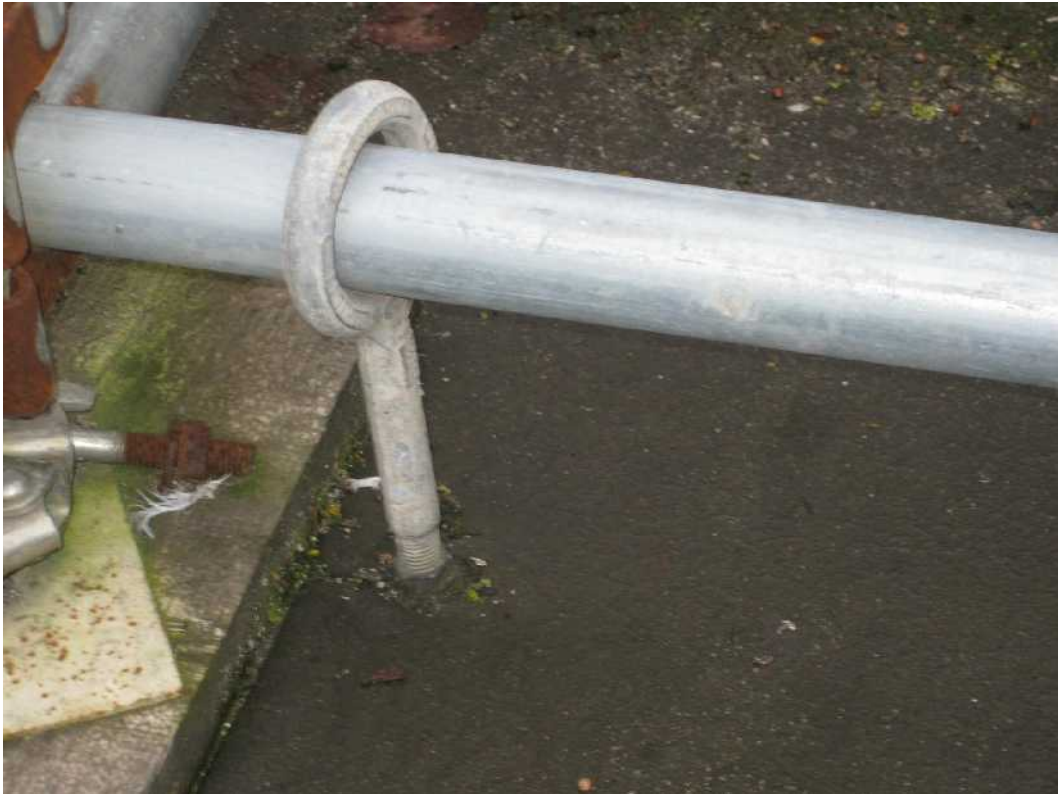
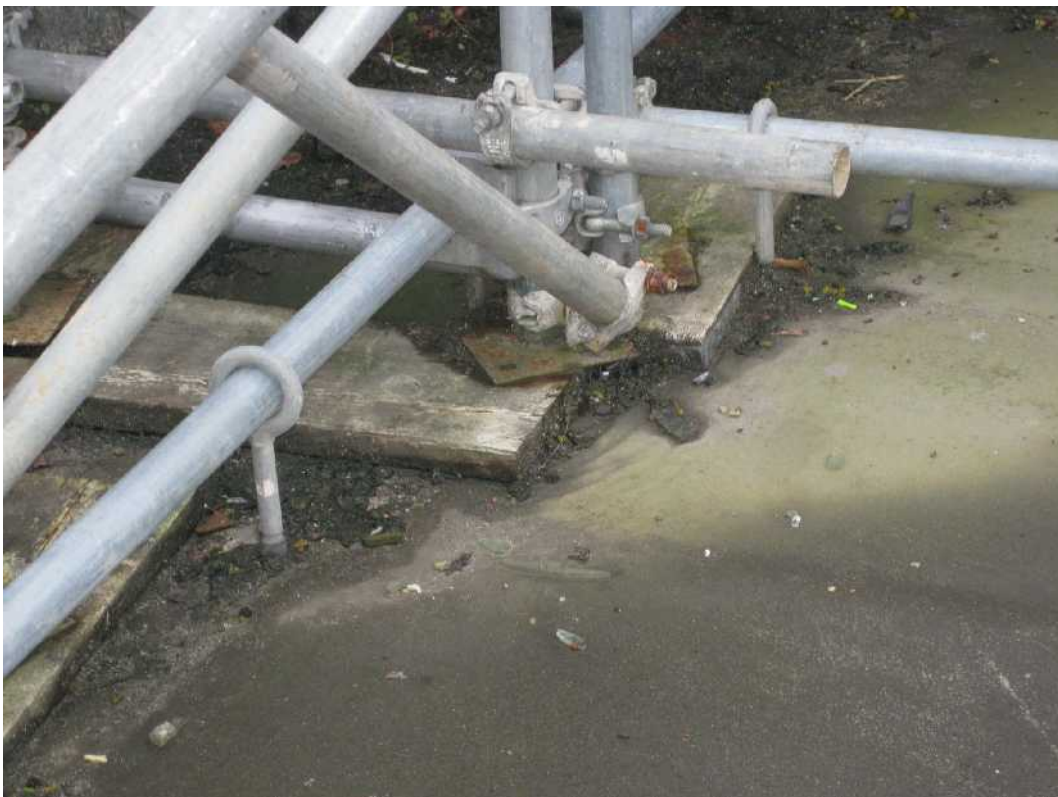
The waterproof asphalt roof covering is laid over the notionally pitched (from the middle) insitu concrete roof slab, the material is traditionally dressed up and into the brick parapet walls joint. Generally the asphalt membrane is in quite good order with only a few tears or cracks and probably dates from the late 1970's (8&9). In a limited number of places the upstand has pulled out from the parapet wall (10) and needs repairing. However, the long term function of the waterproof membrane and concrete roof slab has been very severely compromised by the insertion of numerous eye bolt fixings (11 & 12) installed into the concrete roof slab to secure the scaffolding down to the roof.

It is likely that a completely new and intact membrane will need to be installed as the probability of being able to provide a durable and reliable long term repair at each eye bolt location is unlikely. The eye bolts will need to be removed from the supporting concrete roof slab and the damaged areas carefully repaired in an appropriate manner.

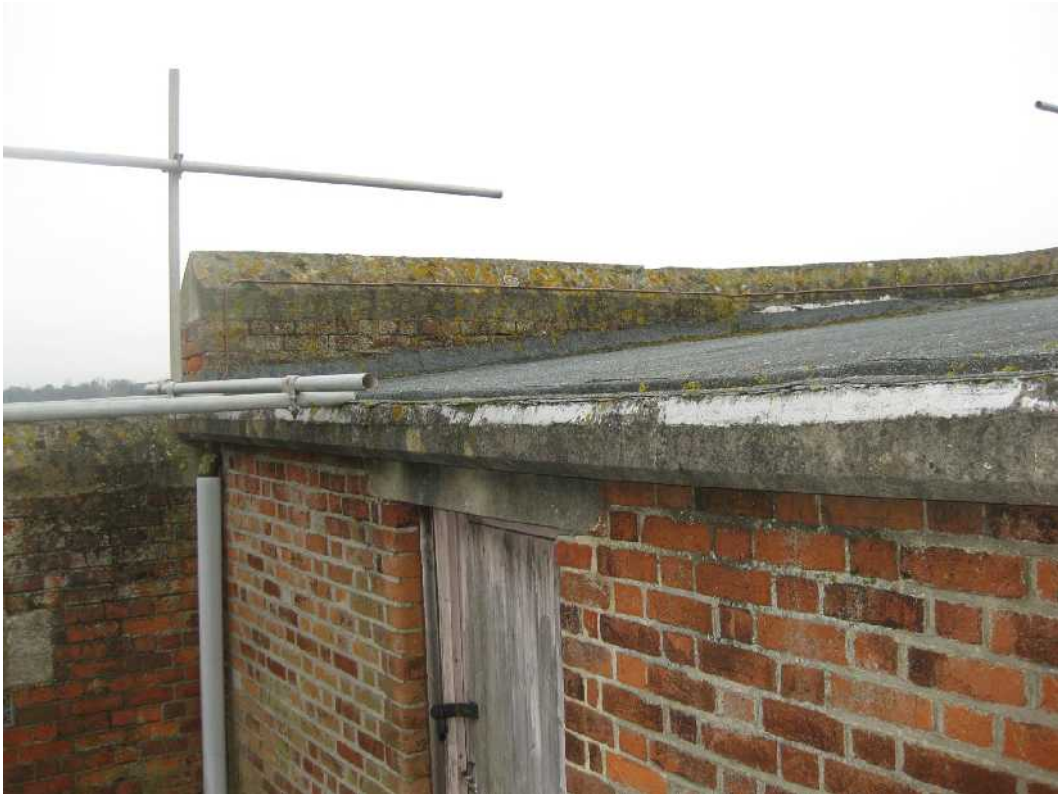
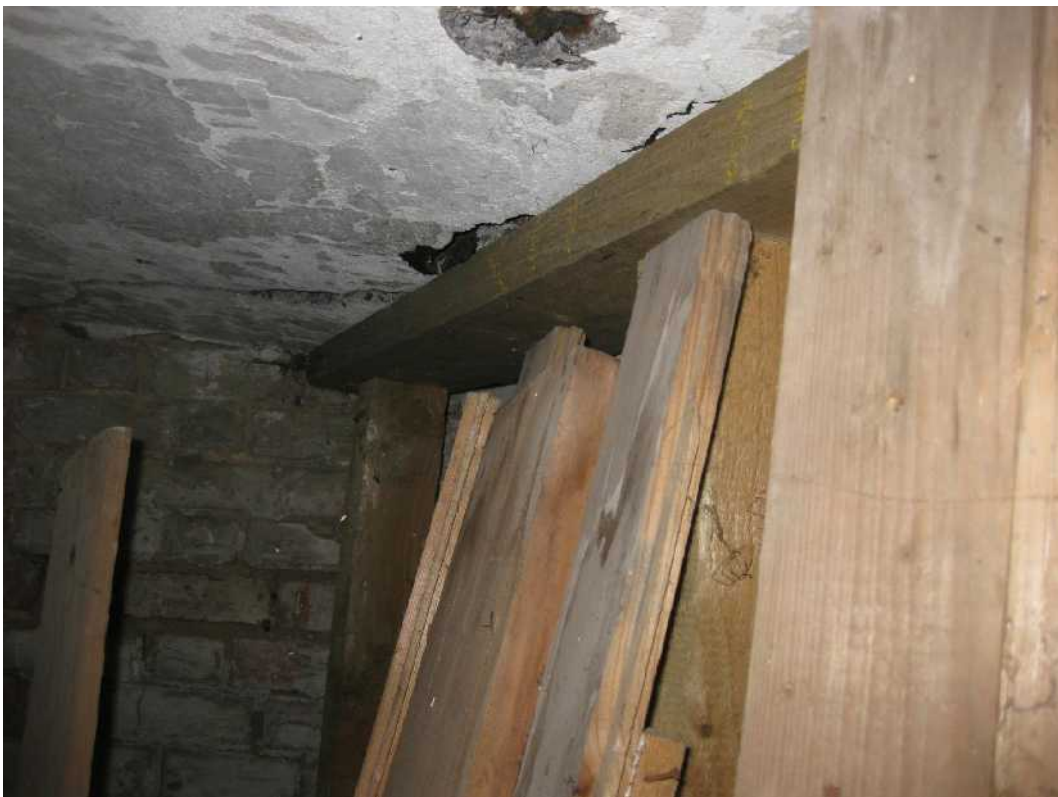
Upon the roof there is a small room formed from 9" brick walls with a monopitch 7" thick concrete slab roof over (13). The concrete slab is constructed from unreinforced concrete and is now badly fractured (14) and is in an unsafe condition. It has been propped with small timber sections in an adhoc manner. General access to this space must be excluded. Any clearing of the space should only take place by a competent builder after first installing a suitably designed internal scaffold or air bag system, which should also be designed to facilitate the replacement of the roof structure once Listed Building Consent is gained for the works.

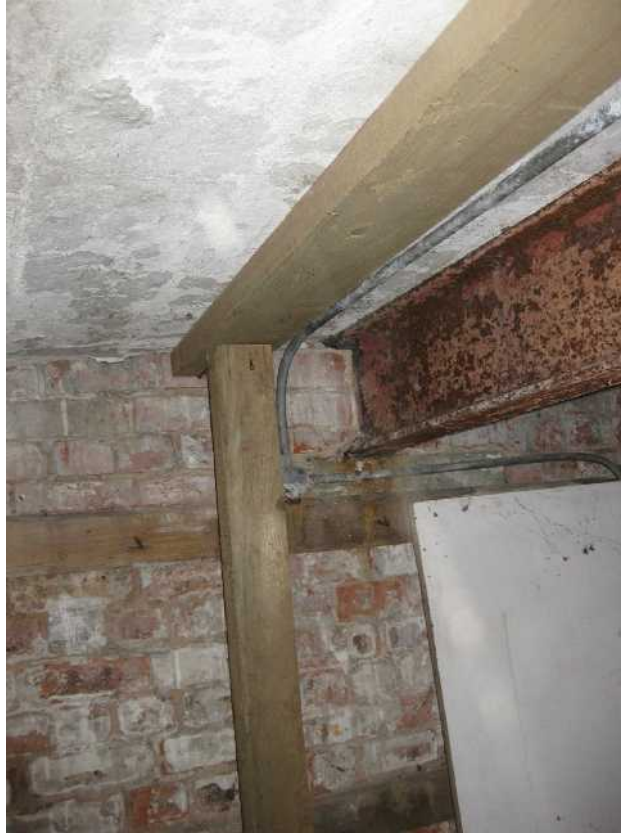
Externally the parapet above this room could be seen to have some weathered joints. Very limited internal inspection of the small room revealed that the roof slab is spanning over corroded wrought iron beams (15) built into the external parapet wall. The corroding bearings of the beam can be seen to be expanding, the expansion forces are jacking the masonry apart.

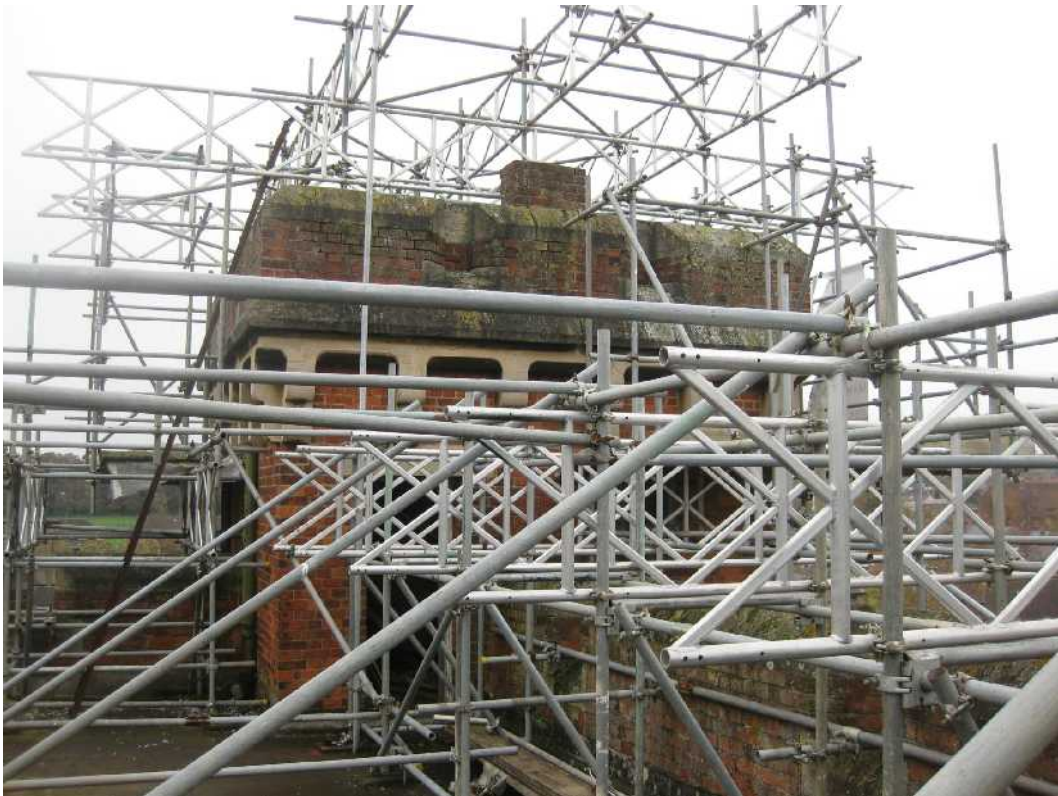
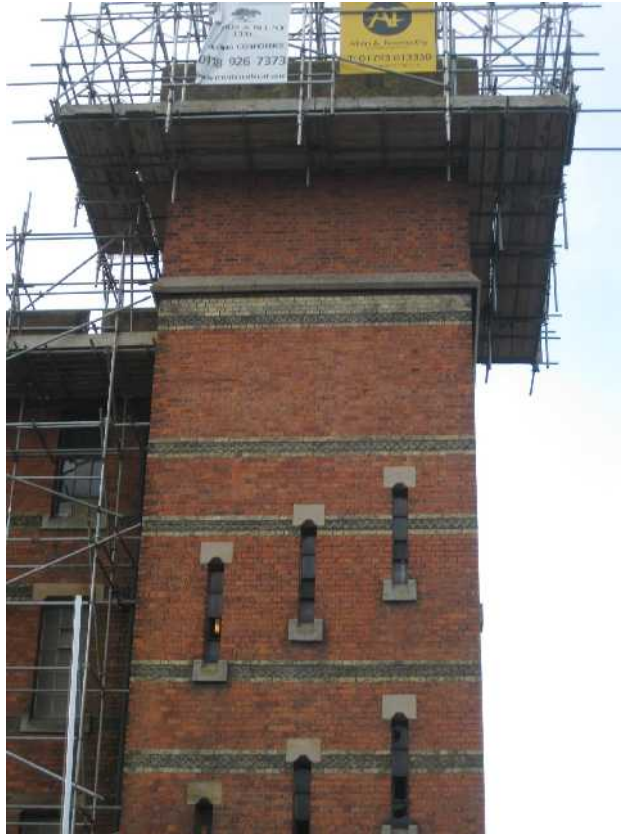
The corner towers (North-East and South-West) could only be partly visually reviewed from the roof and ground level as the installed crash deck obscures inspection, and therefore they could not be comprehensively looked at and will need to be revisited in more detail at a later date, in order to schedule the actual repairs (16 & 17). However, an understanding of the typical condition of the tower structures was gained.

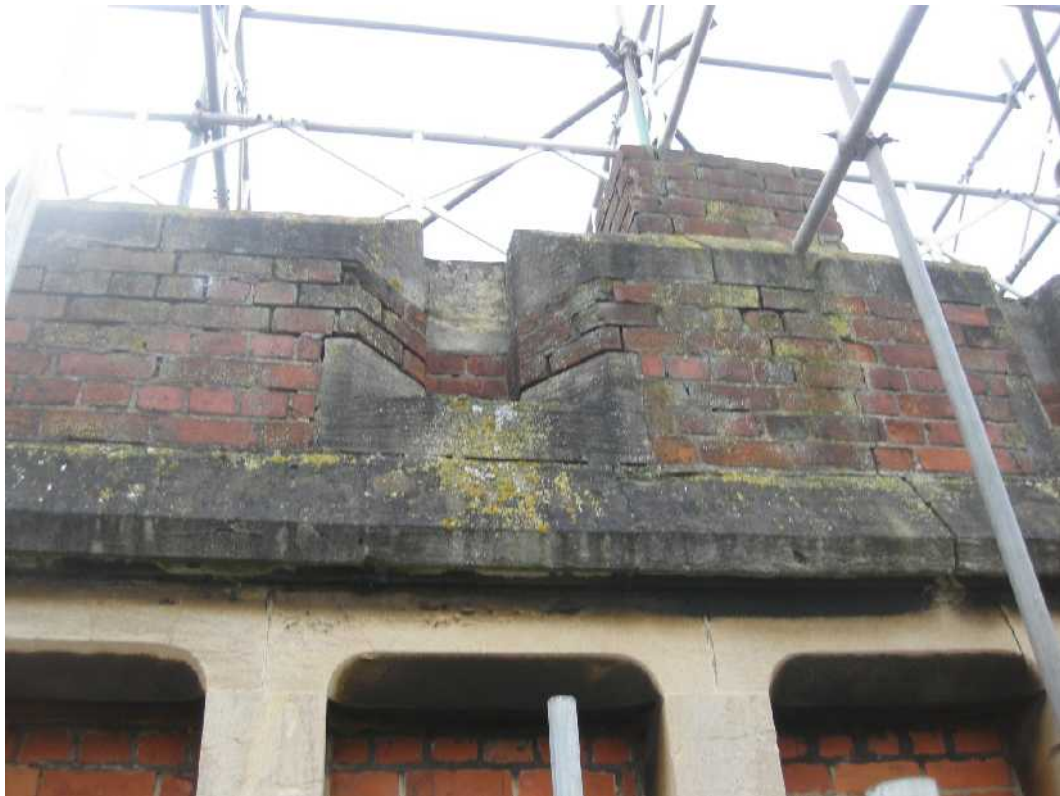
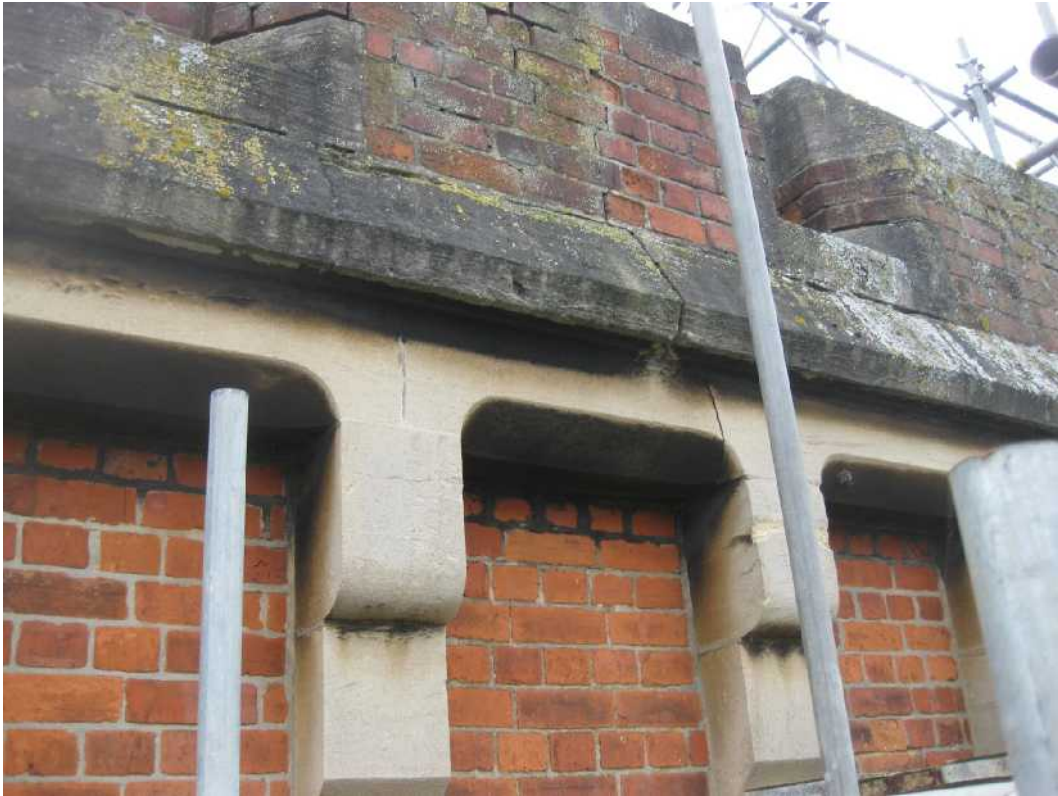
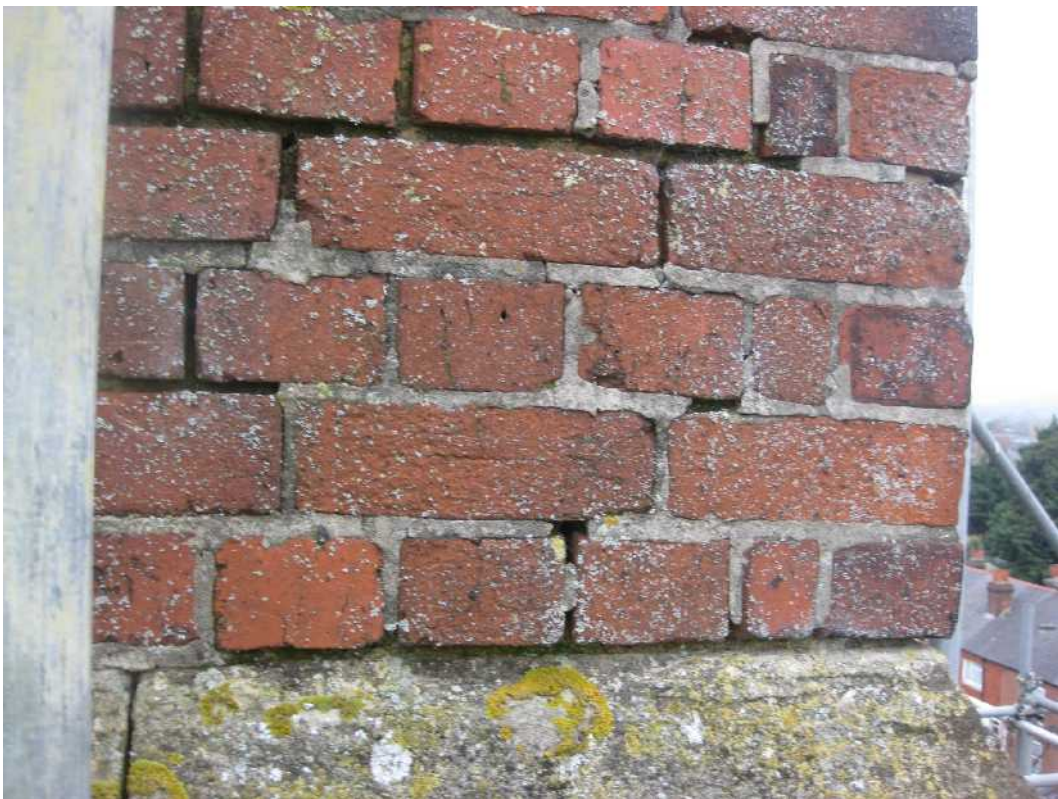
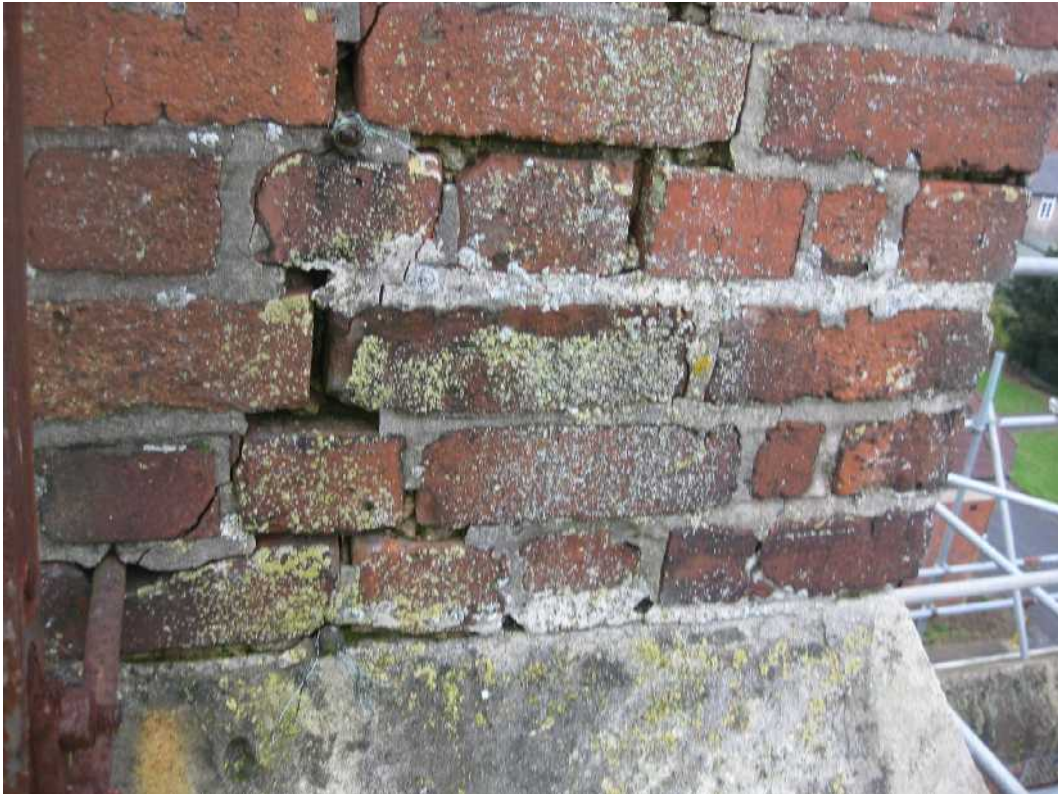
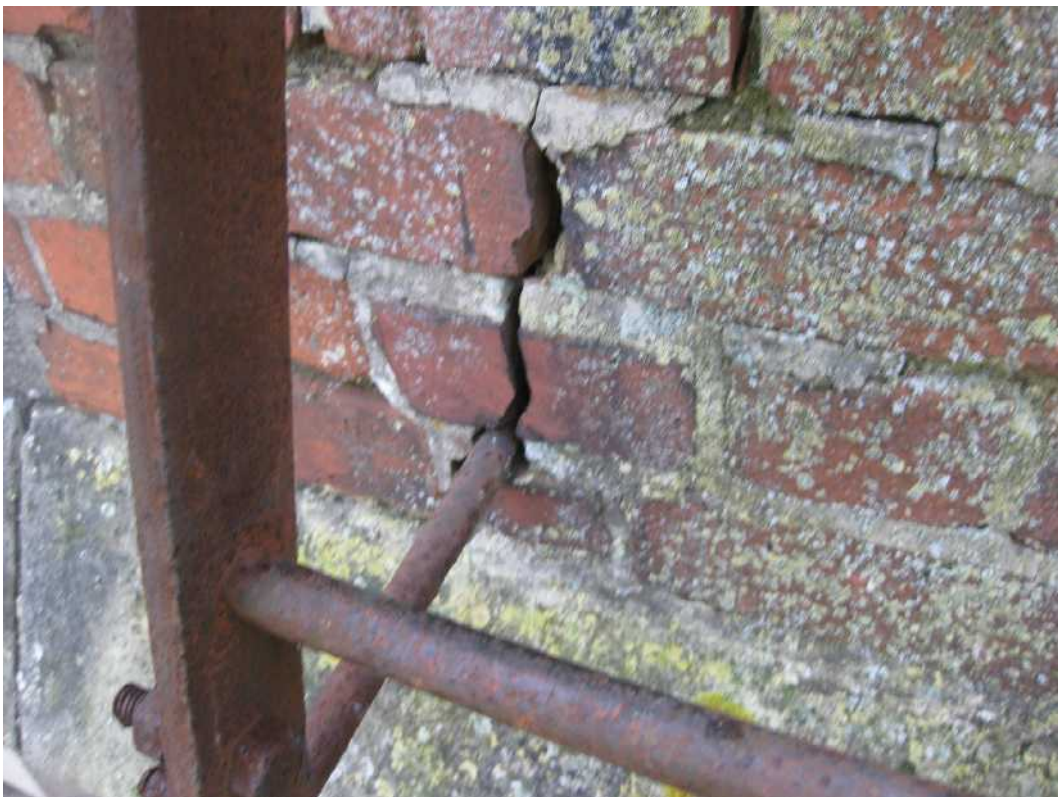
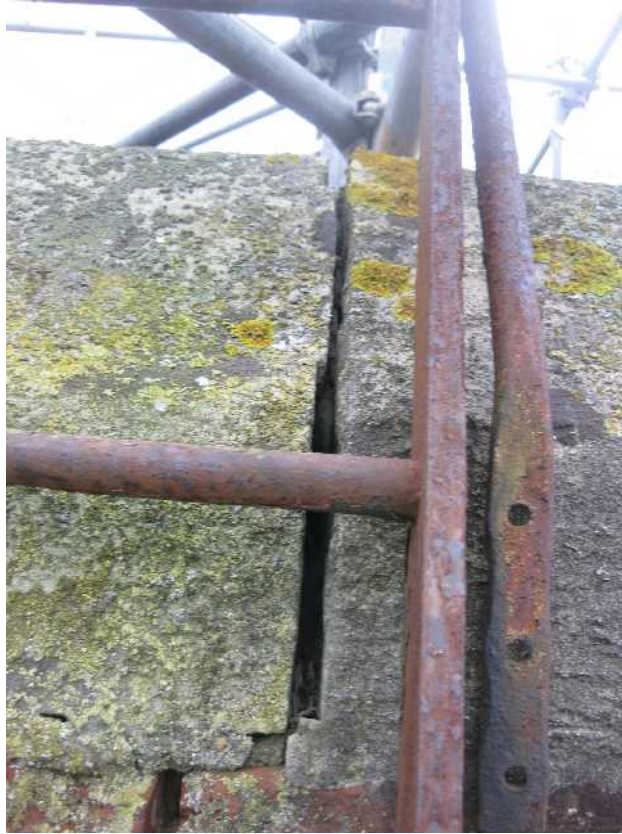
The highly exposed upper top 1.2m sections of the corner towers are in a deteriorated condition (18, 19, 20 & 21) and need extensive deep repointing due to being heavily weathered. Some localised removal of embedded iron elements is needed, and repair of the surrounding damaged areas required (22 & 23). There are some signs of slight amounts of instability of the corbelled corner sections of each tower, these are likely to need to be upgraded with stainless steel ties from corner to corner with external pattress plates.

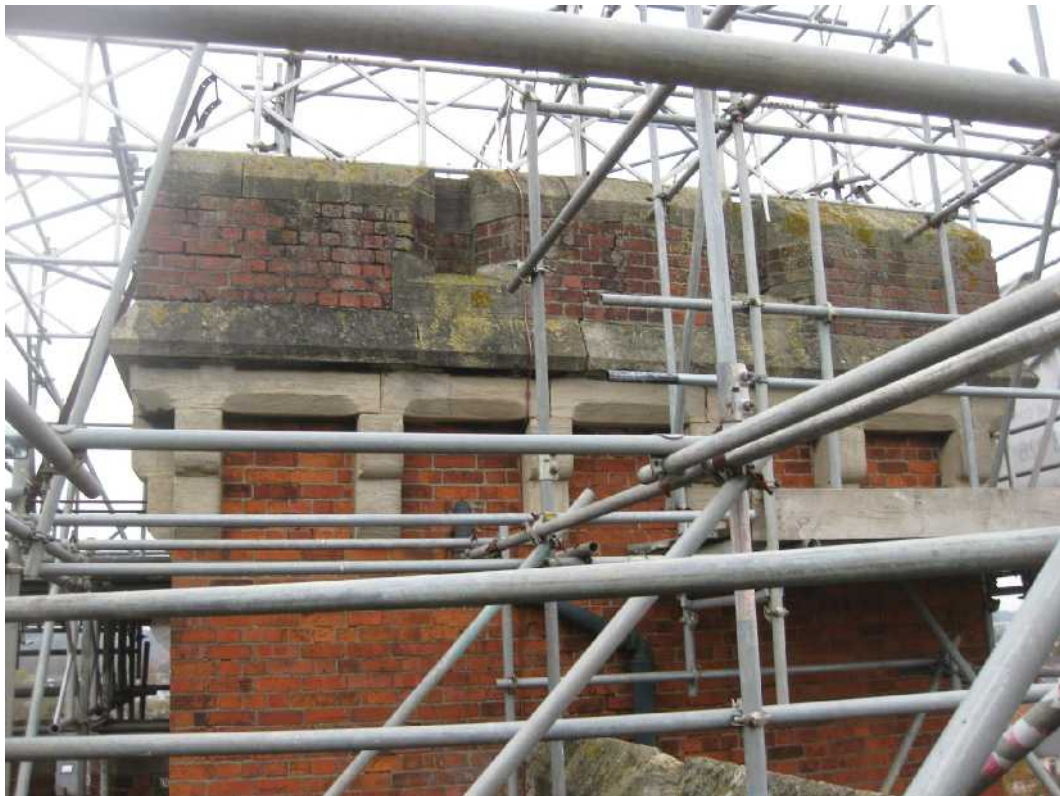
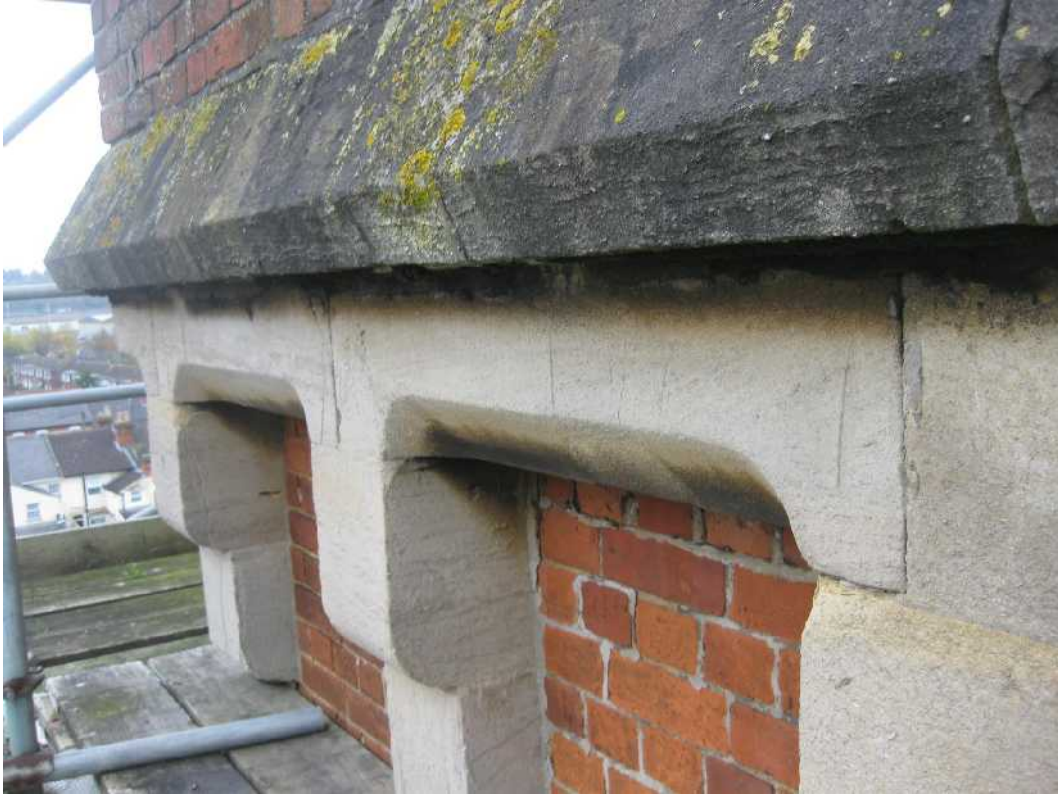
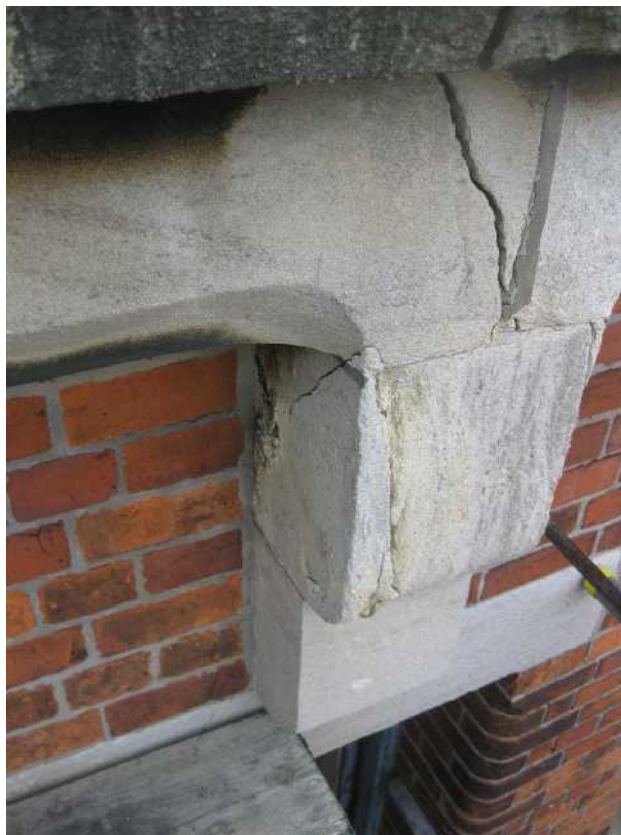
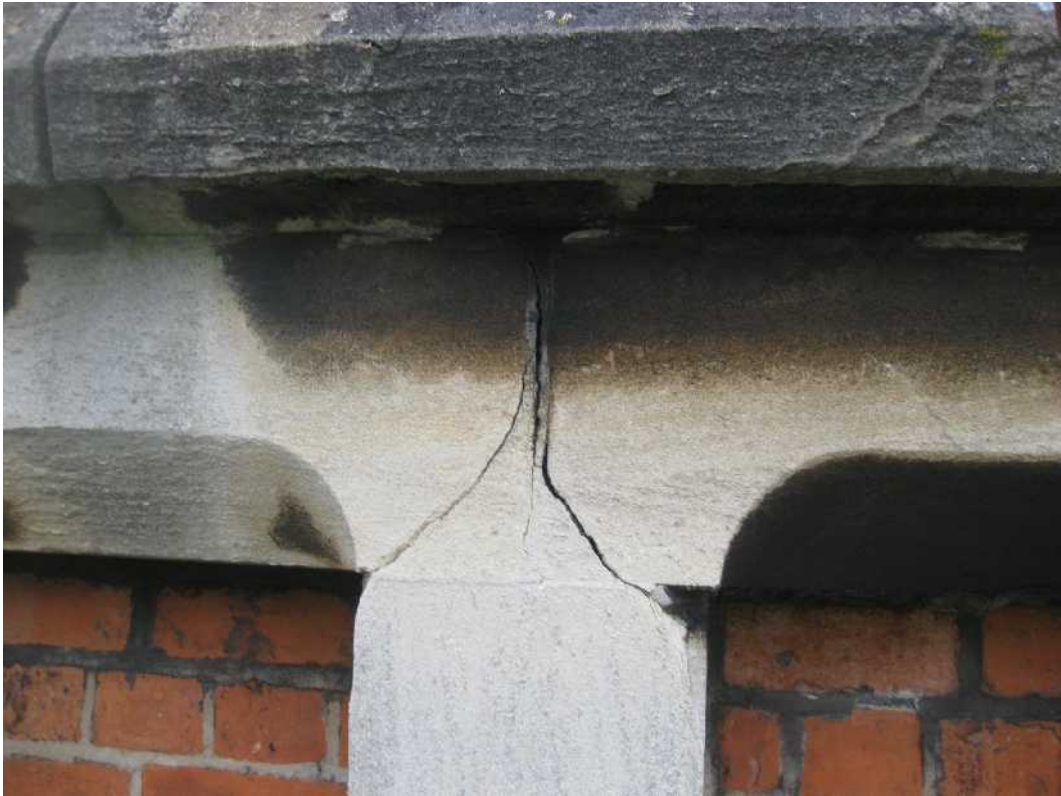
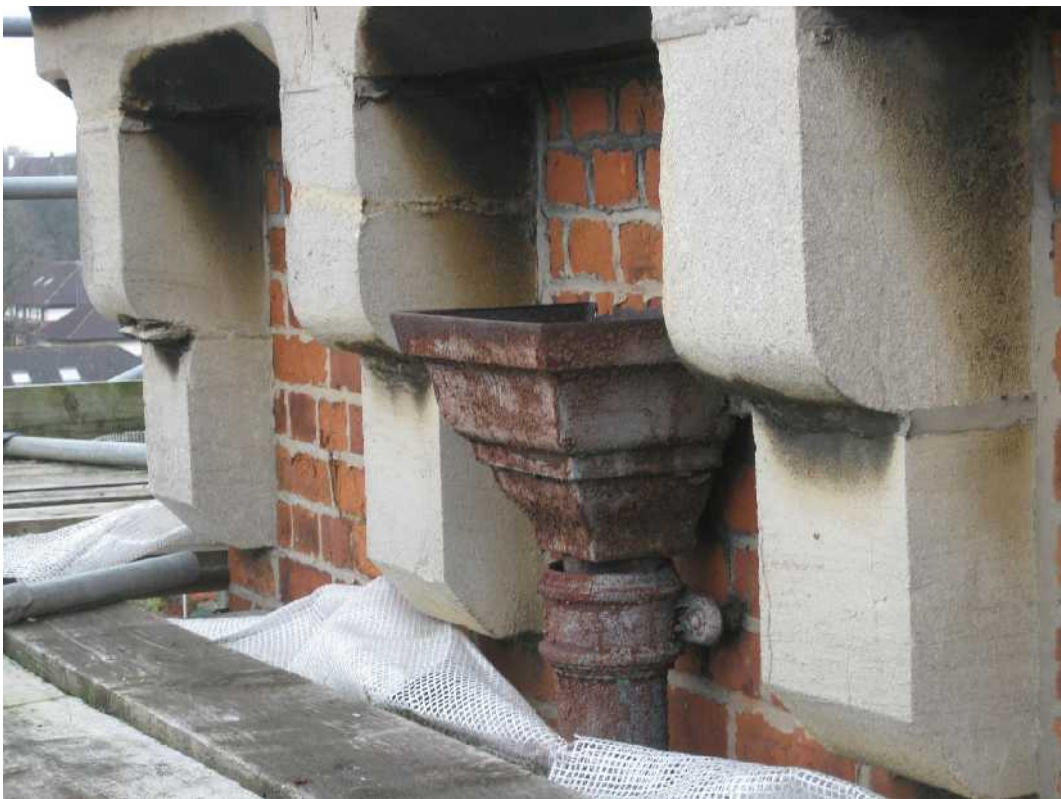
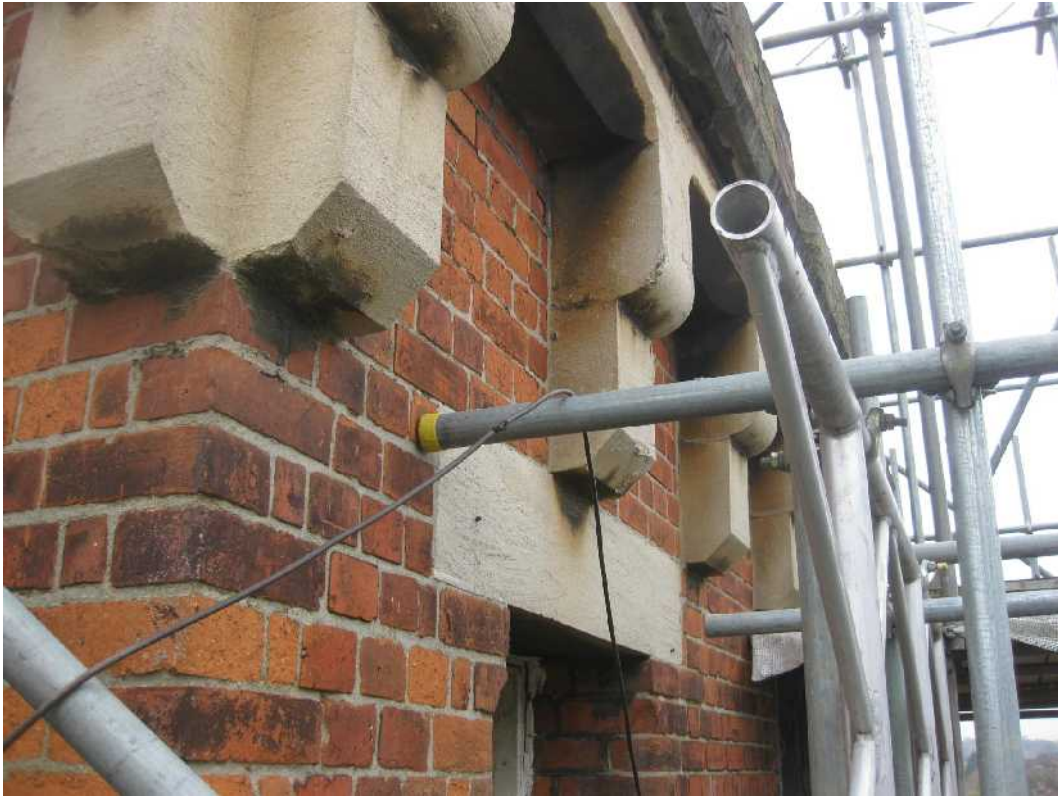
The stone work to the towers is generally in a good condition. However, a few elements are cracked and fractured and need repair or replacement (24,25,26, 27, 28 &29).

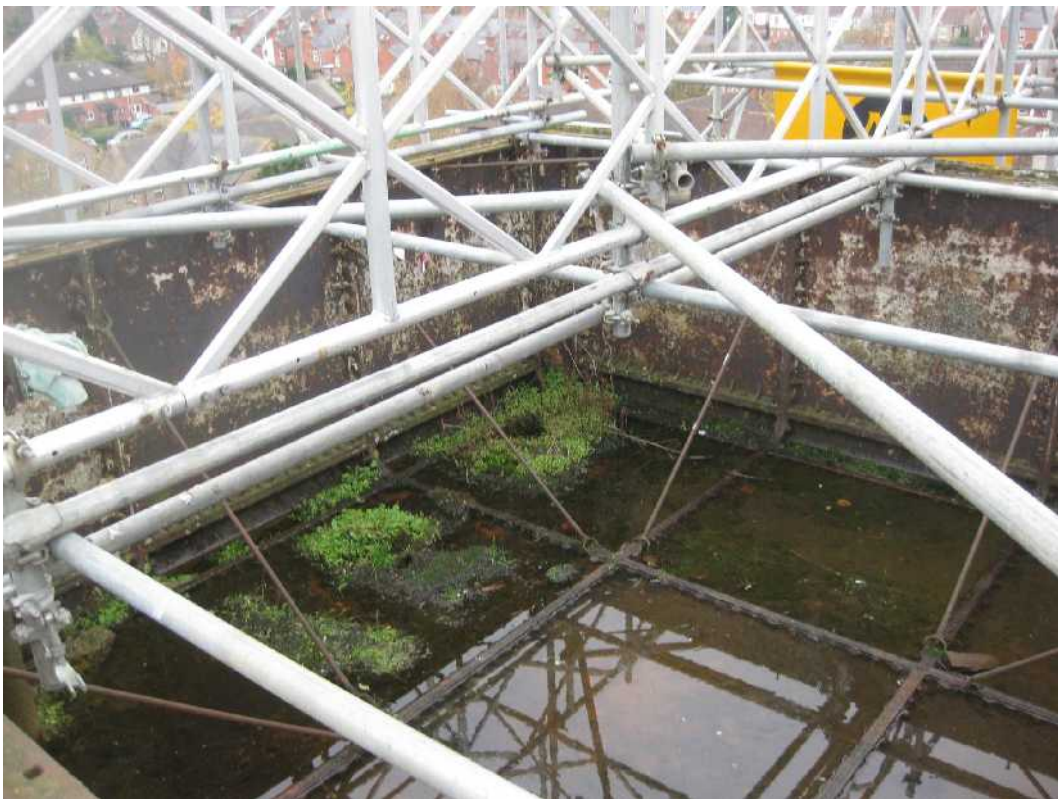
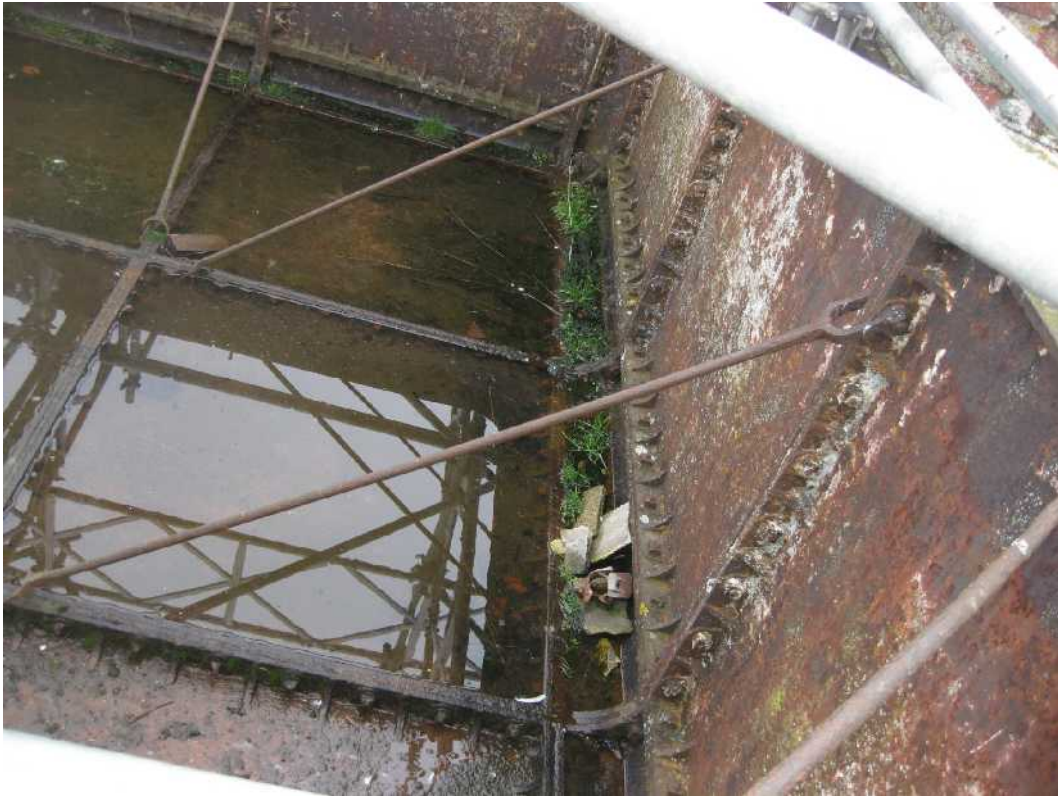
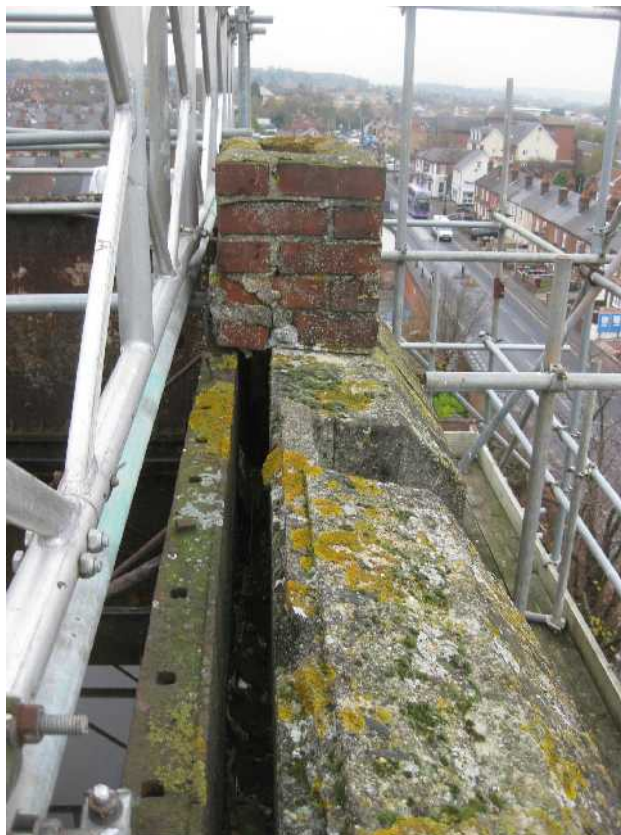
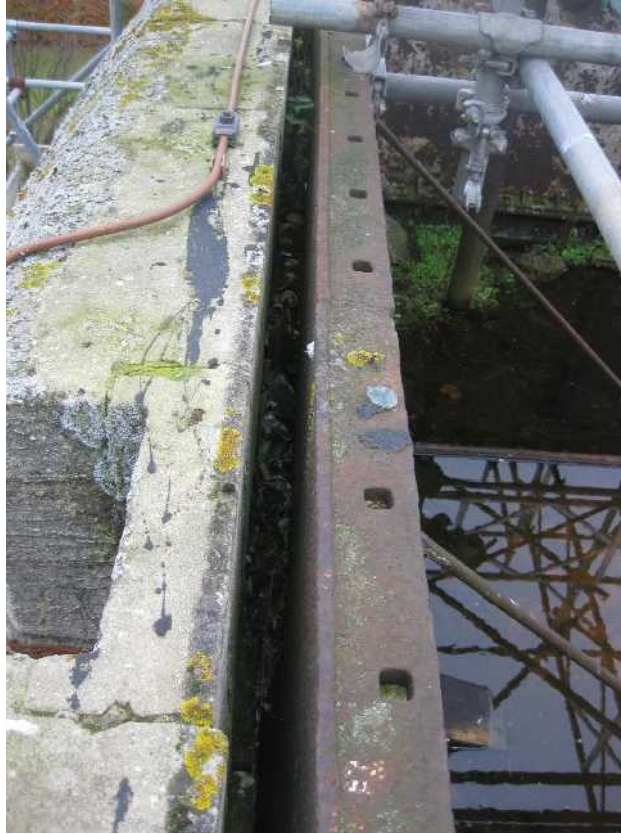
Large segmental cast iron water tanks completely fill the internal tower volume, these are present in the top of each tower (30 & 31). These originally would have been roofed over with a weather proofed timber structure, which are now not present (32 & 33). Due to the level of weathering present within the surrounding structure, the timber structures have probably been missing for the last thirty years.

It is strongly suggested that the tank structures are not replaced back into the tower voids for practical and financial reasons. The tank structures are bolted and riveted together and it is unlikely that they can be taken apart without being damaged. It is potentially quite dangerous to try to lift such heavy and brittle objects out of the towers in one piece. It might be possible to reform and reuse one tank somewhere in the grounds as a grey water recycling vessel which would preserve the Listed fabric on site. The tower voids could be re-roofed and converted into usable space. The south-west tower which does not contain the circulation stair to roof level could create a very serviceable double height cube space.
