Visual Survey of 'The Keep', 571 Oxford Road, Reading  
Berkshire

Report: 1902/R01

November 2013

Client : Open Hand Open Spaces Ltd.

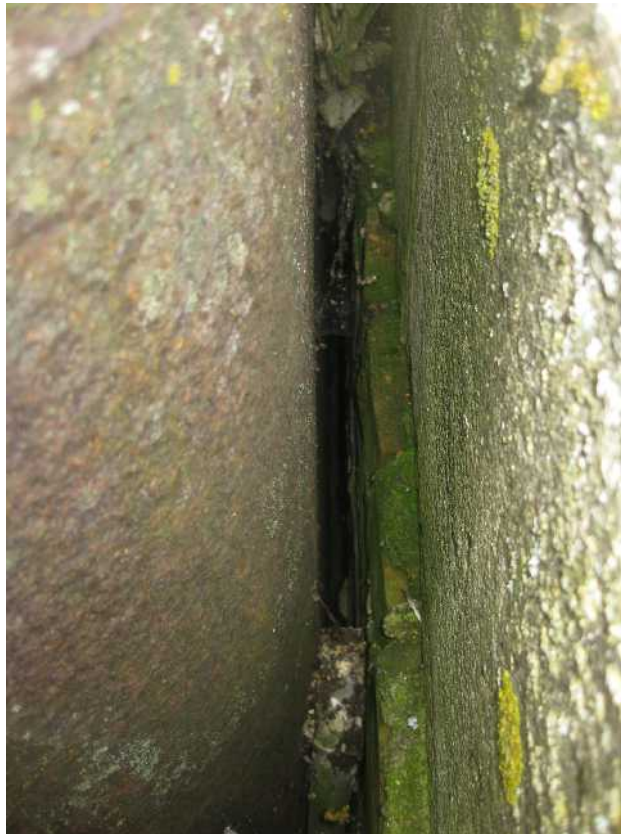
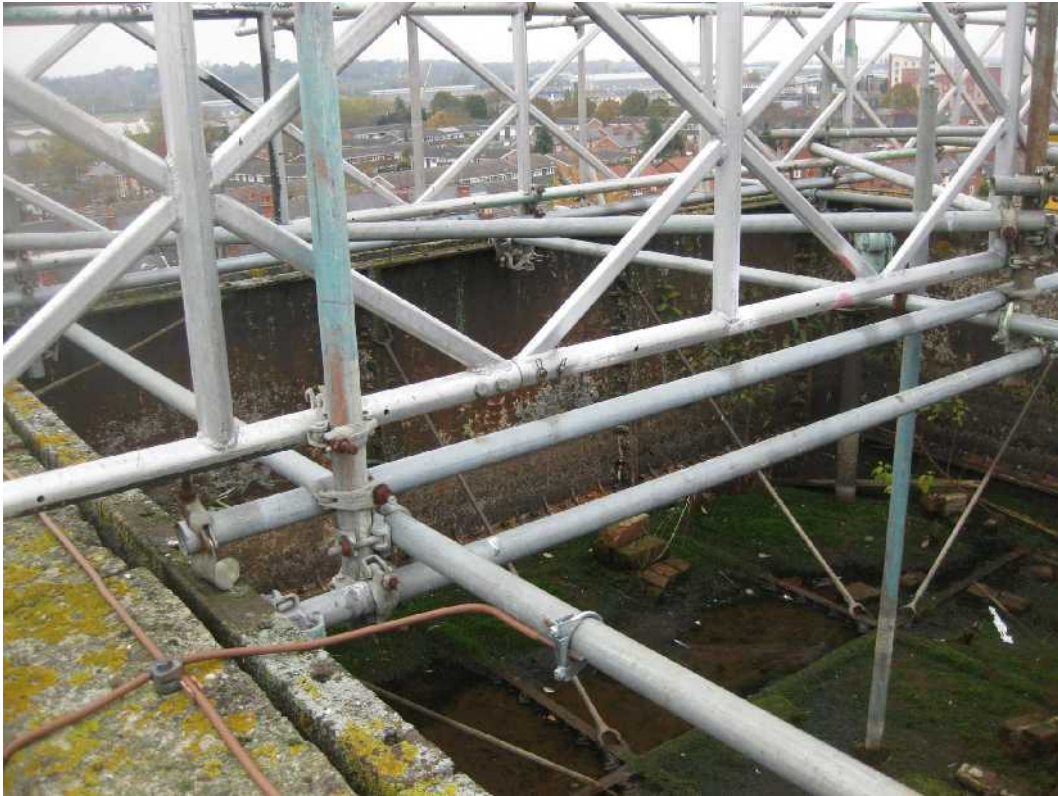
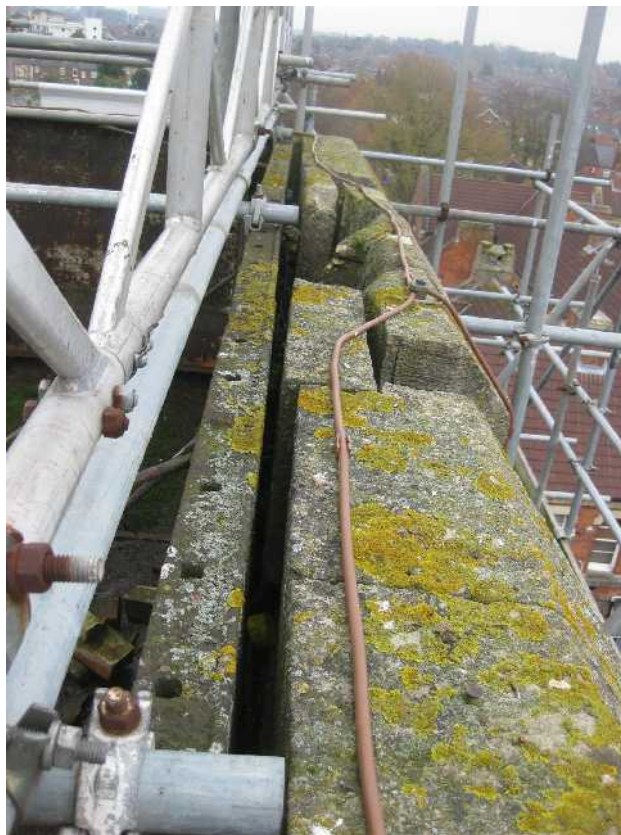
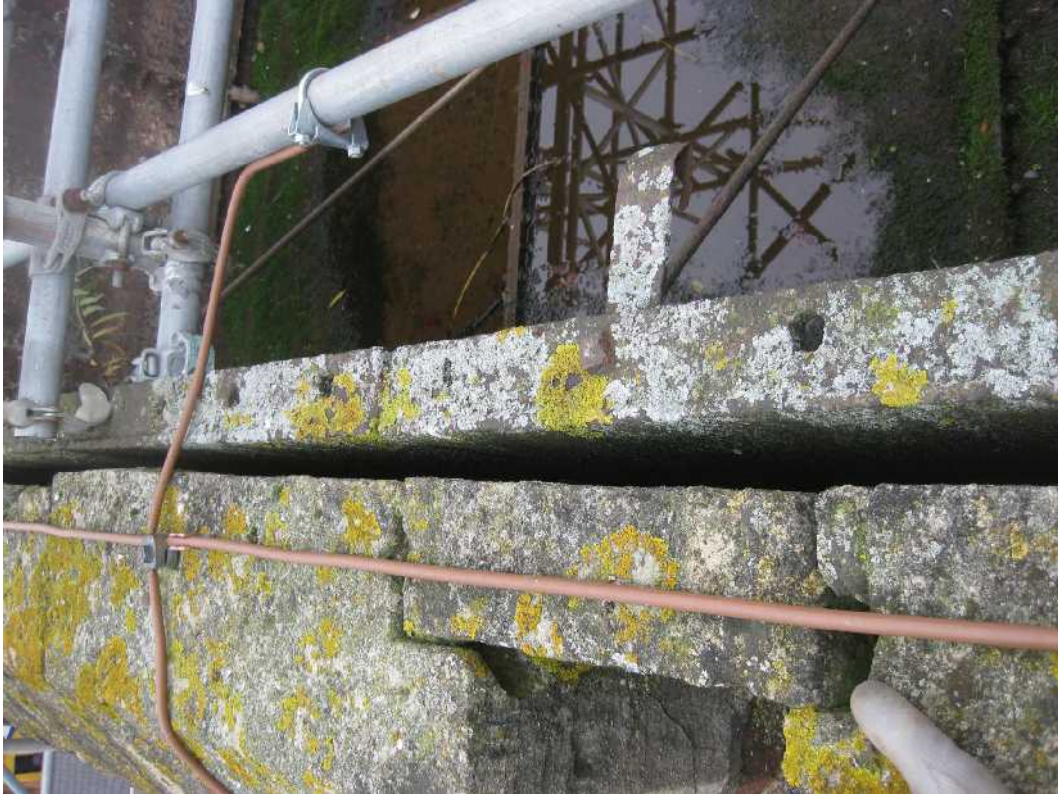
There is a small gap between the tank side and the brick structure. The brick walls are in a weathered condition and need to be repaired (34, 35, 36 & 37). In order to do so, the tank structures will need to be removed. This will also facilitate the repair/upgrading of the supporting concrete slabs below the tanks. It is believed that the tanks and surrounding structure have been exposed to the elements for about thirty years.

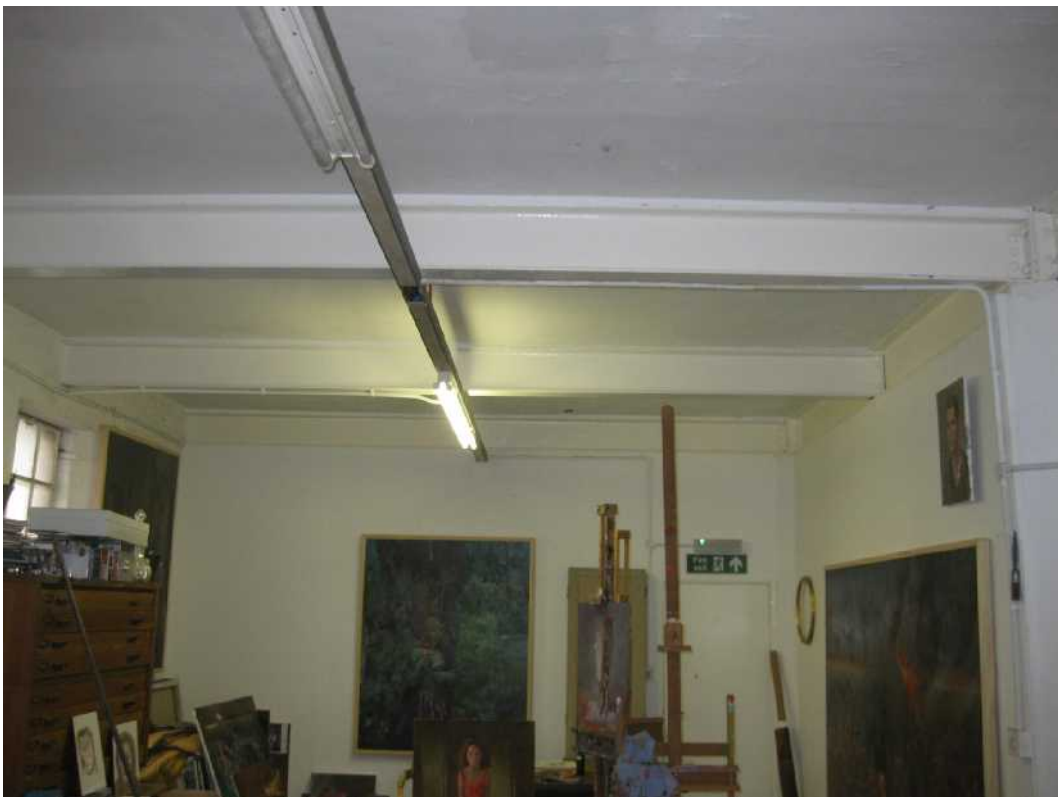
The suspended concrete floor slabs have been cast directly on top of the wrought iron floor beams (38), around the cast iron columns bases/heads and onto the perimeter brickwork. The arched form of the slabs was created by using strips of wood as a temporary bottom shutter. The concrete floor slabs appear to have a thickness of about 125mm. In 1878 the use of site cast concrete within buildings was a very uncommon occurrence and was considered an advanced development for that age.

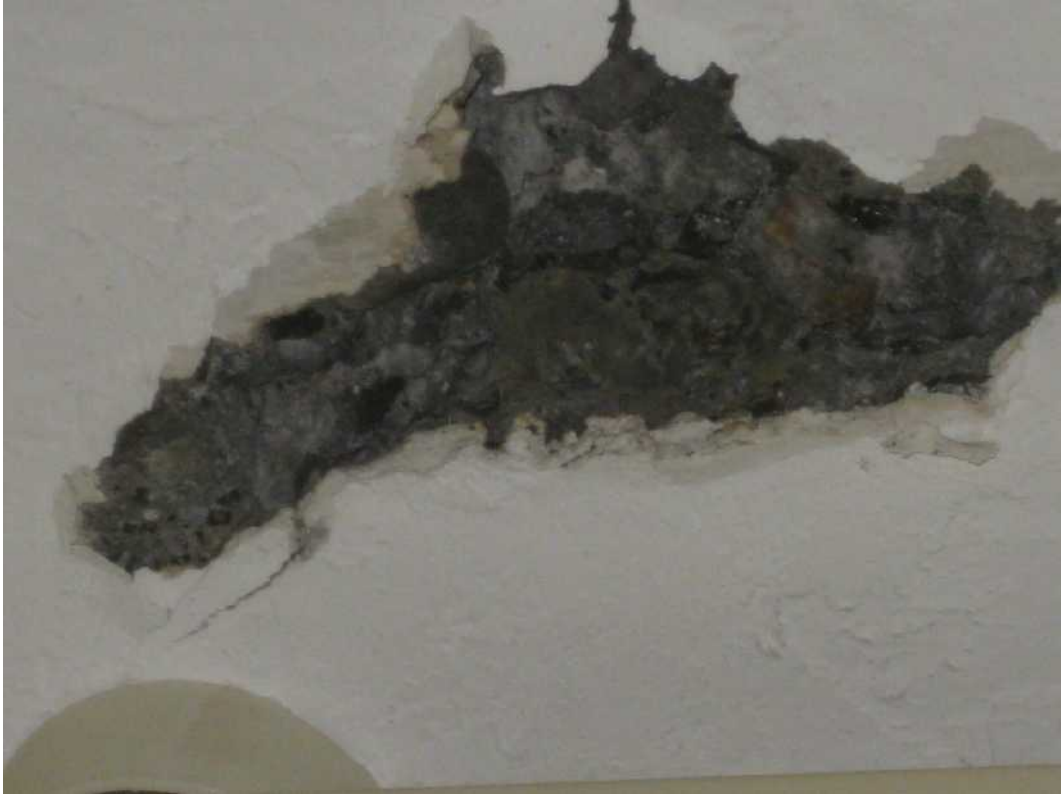
The concrete sections are formed from totally unreinforced material. The concrete is of a dense good quality with some lightweight clinker aggregate (39). The aggregate seems to be limited to a maximum size of 10mm and generally would seem to equate to a 30N concrete such as C30/10. The structural function of the slab depends solely on the intactness and soundness of the section.

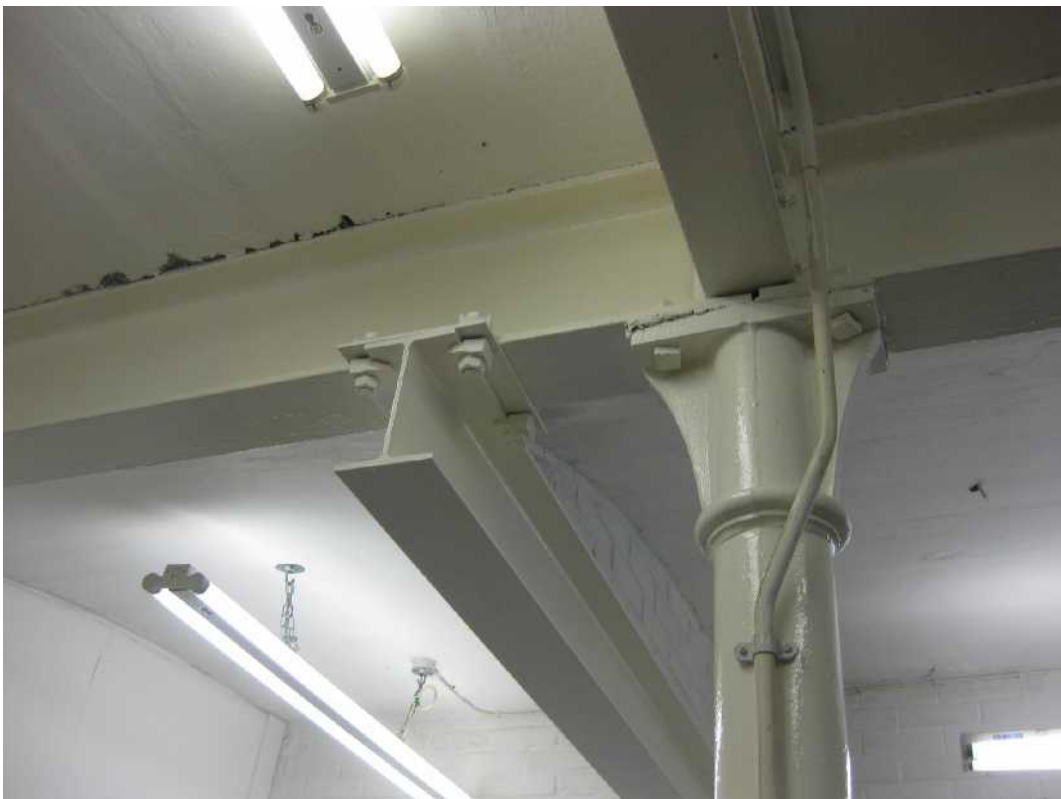
The painted underside of the suspended concrete vaulted roof slab is visible, supported from the original grid of wrought iron beams spanning to the external 450mm thick brick walls. The central portion of the roof slab has been upgraded in the last twenty years by the insertion of some secondary transverse and longitudinal steel and blockwork splitter structures (40).

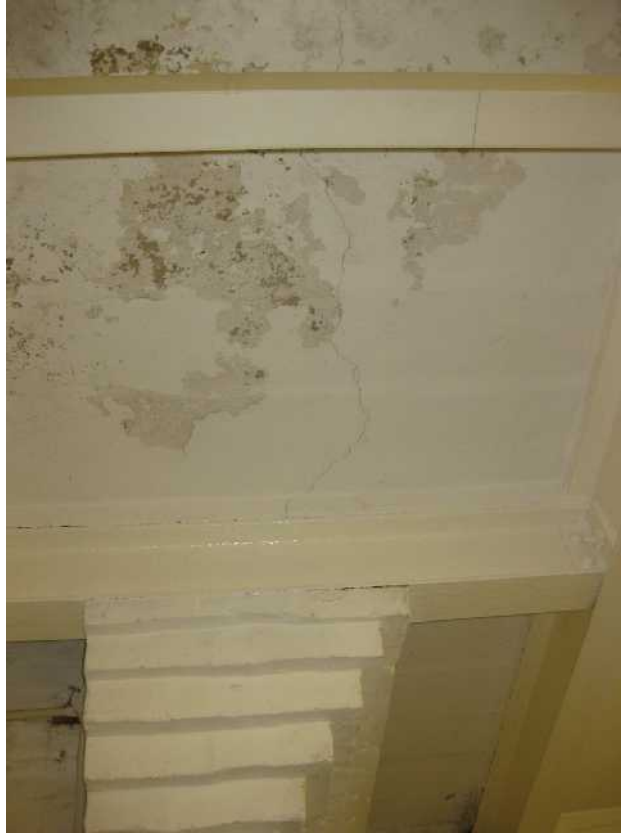
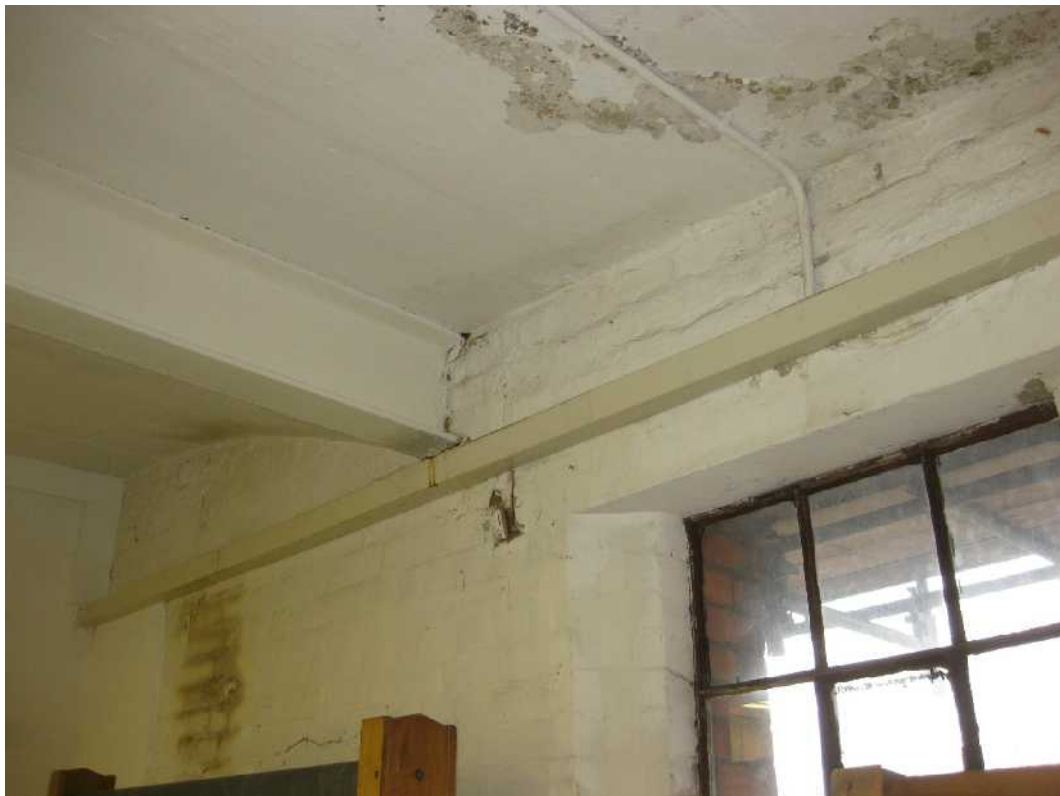
There is evidence of significant water ingress through the roof slab (41 & 42) into the building fabric, that has clearly been taking place over a prolonged period of time. The water has seeped through the failing and punctured asphalt roof water proofing, especially due to the installation of the scaffold fixings through the roof slab, which have resulted in water penetration. There has also been water ingress around pipe penetrations and through wall areas where water run off is concentrated towards the façade.

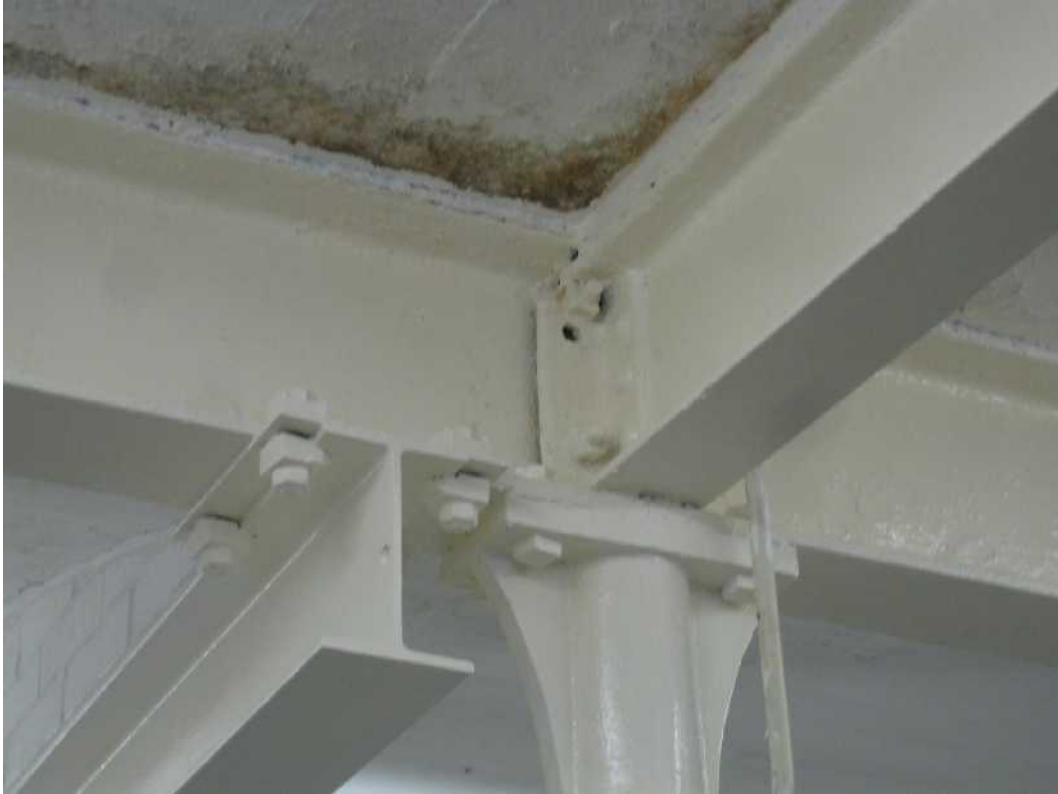
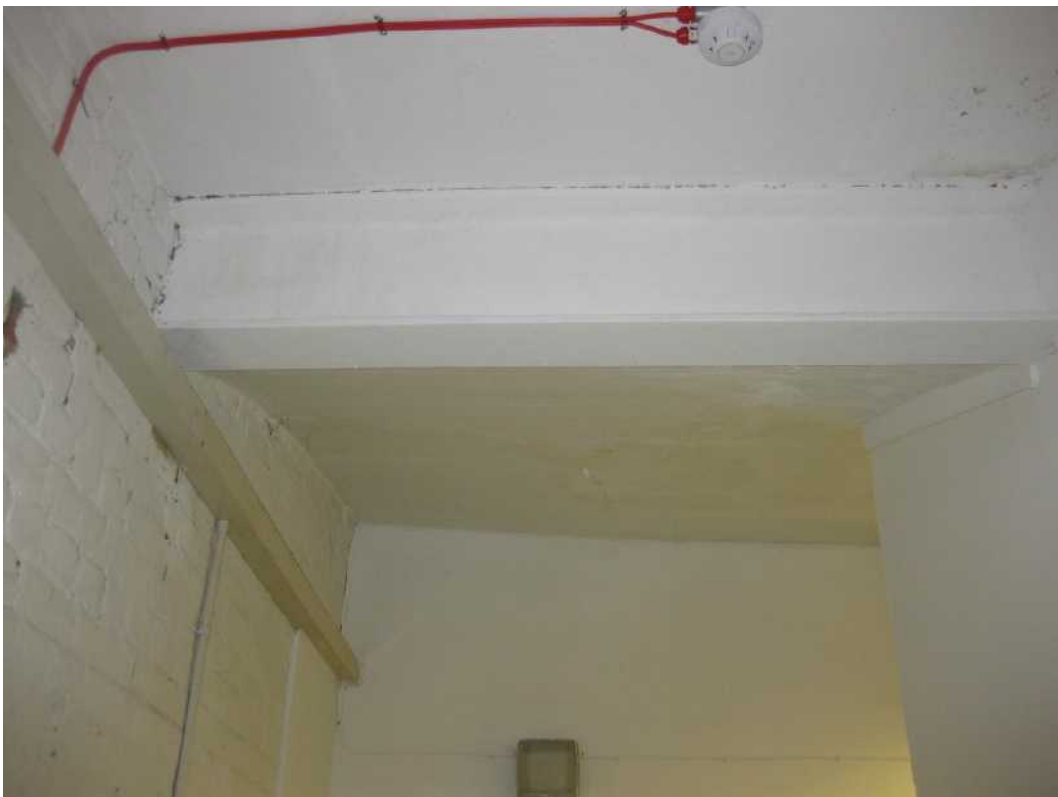
The water ingress has resulted in some corrosion of the wrought iron beam bearings to varying degrees of severity. Surface corrosion is evident and varies from minor surface pitting to the initial onset of local delamination of the body material of the members at their ends (43 & 44).

The full extent of the degradation and condition of the wrought iron and cast iron members will require further investigation by ultra sonic NDT techniques to confirm their quality and soundness.

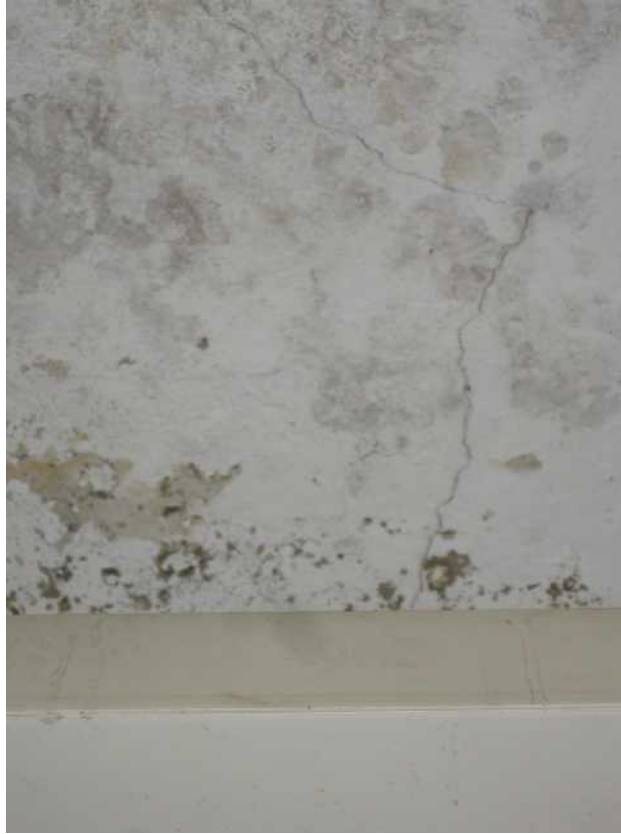
There are numerous cracks visible to the underside of the concrete roof slab (45), signifying that the slabs are in a weakened and degraded condition. The formation of cracks will also mean that the rate of degradation of the slabs will accelerate. It must be remembered that the roof and floor slabs have a general thickness of only 125mm and are totally unreinforced.

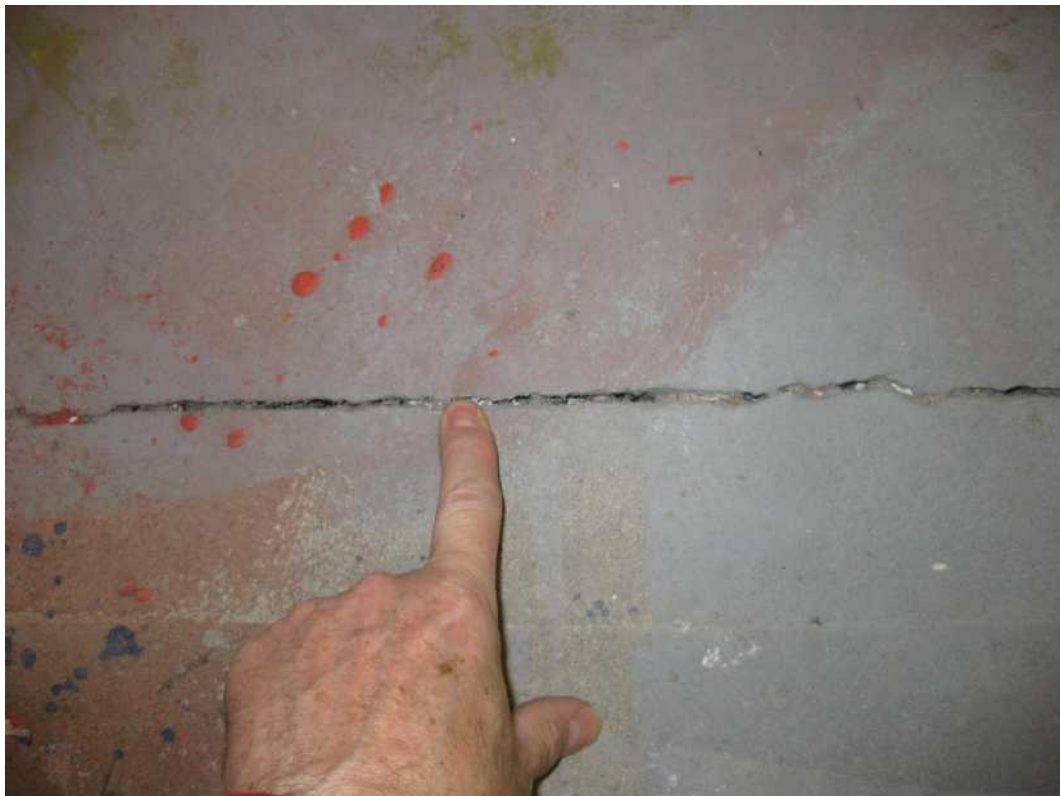
The floor slabs appear in general terms, apart from the first floor slab, to be in reasonable order, being constructed from what appears to be sound concrete with some lightweight aggregates. The unreinforced slabs have developed top joints/cracks along the supporting beam lines (46). There are a few areas of local damage that will need some limited repair.

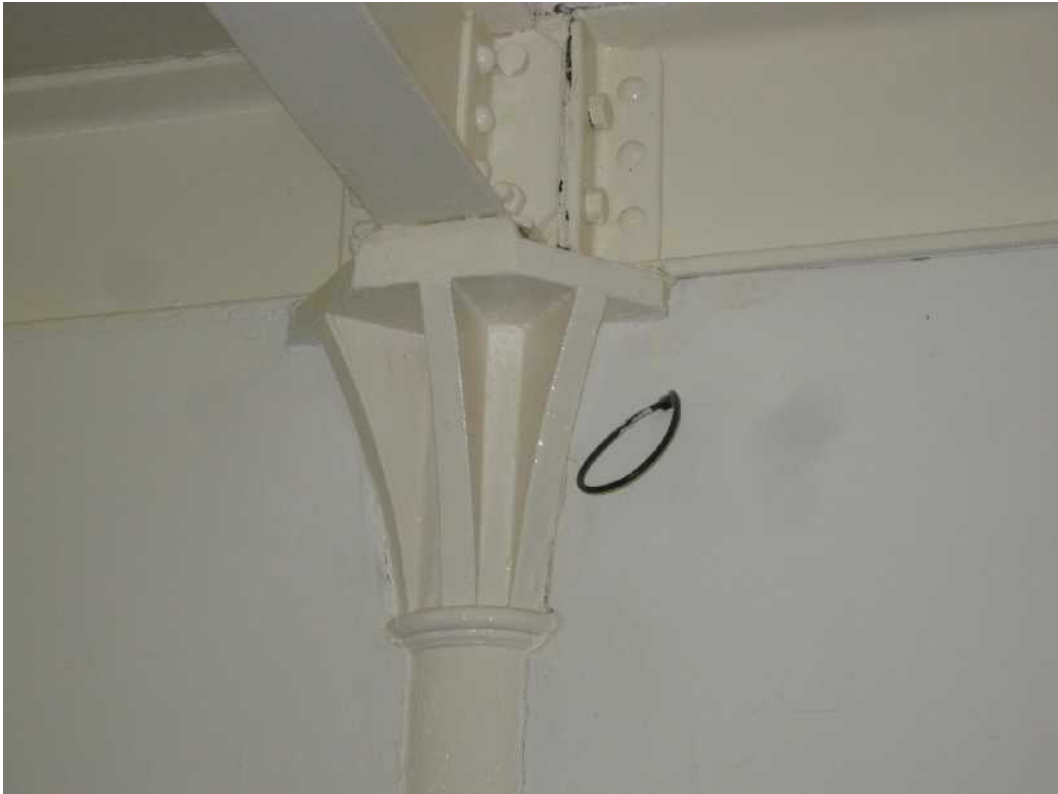
The design service capacity of the supporting structure of the slabs will need to be calculated and reviewed against the applied loading. Further detailed analytical works will need to be carried out in order to consider the theoretical strength of the structure and the level of decay and corrosion which has taken place at each location. The Keep buildings were very efficiently designed by the War Office staff and could be considered for 1877 as "state of the art construction", prefabricated cast iron columns (47) (Pre Tay Bridge Disaster 1879), wrought iron beams and un-reinforced insitu cast concrete slabs.

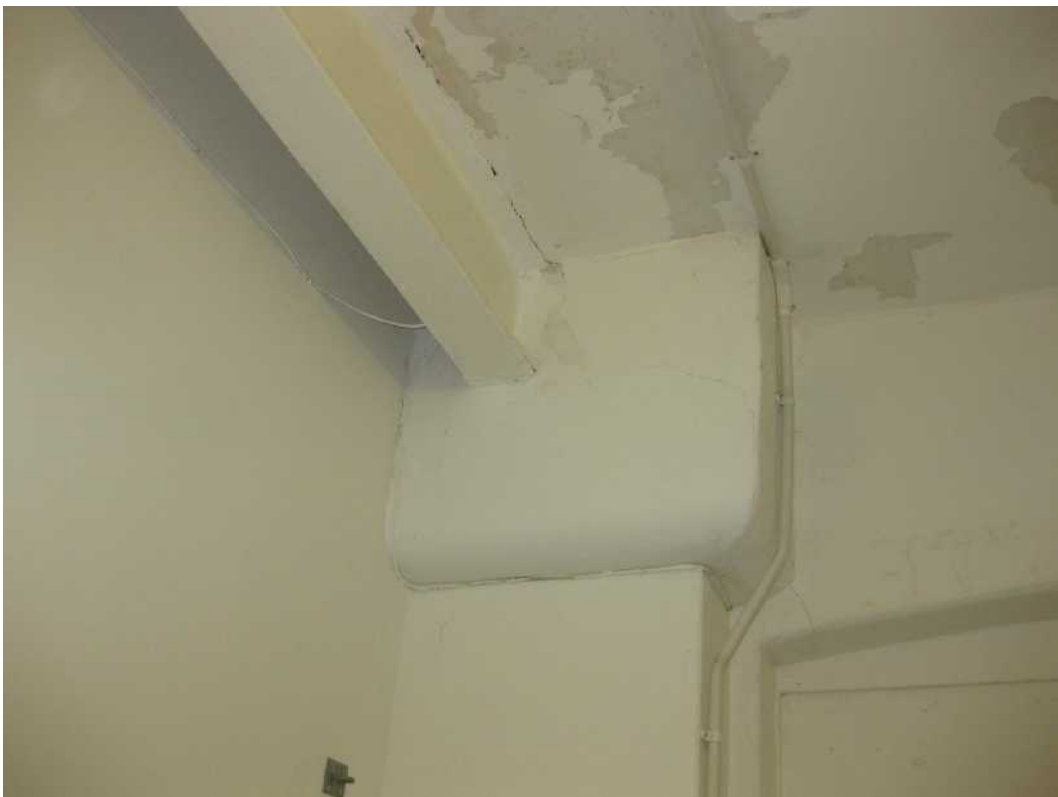
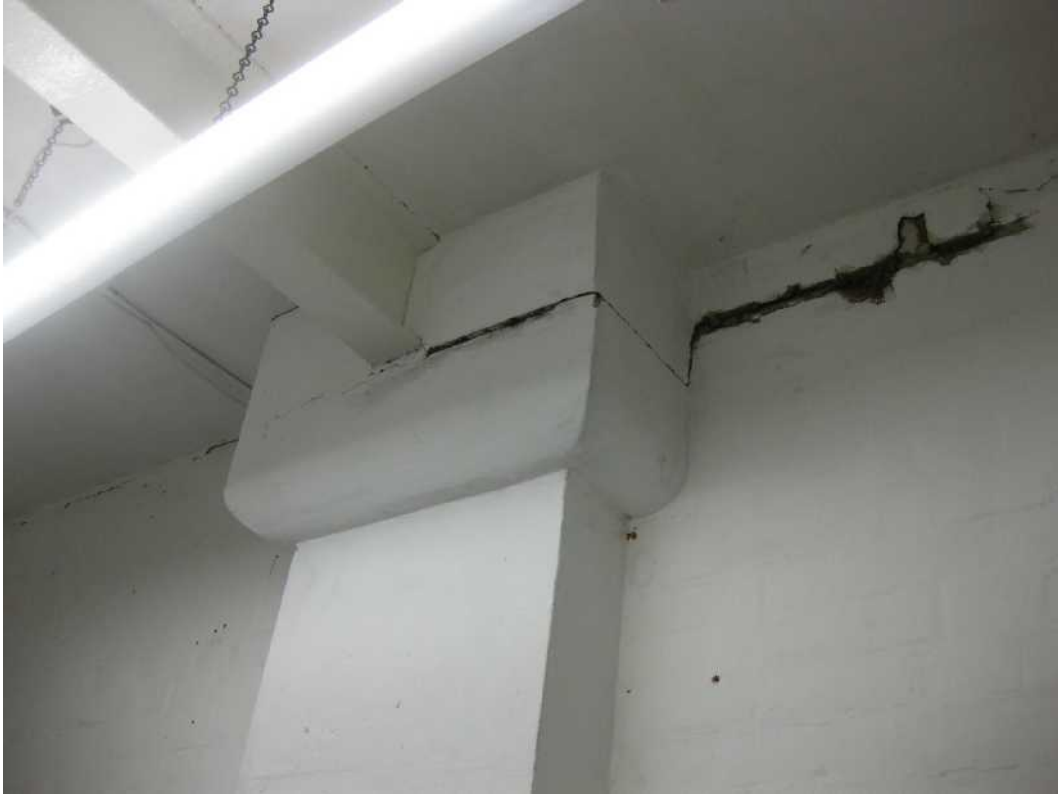
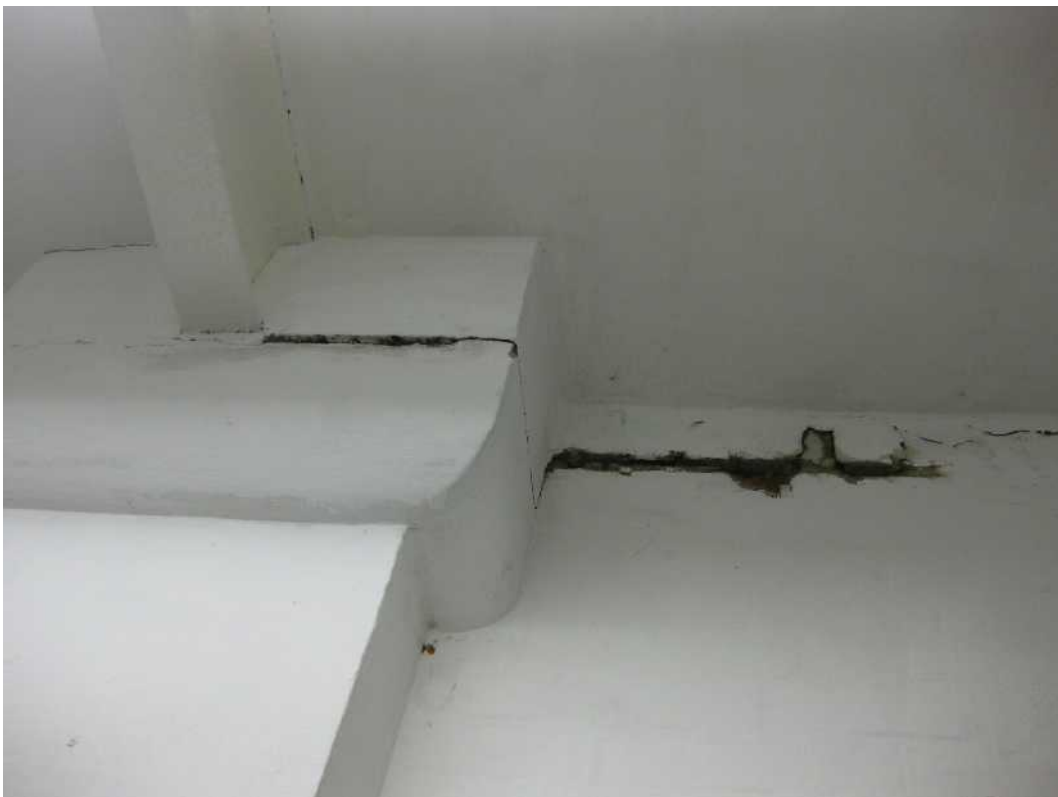
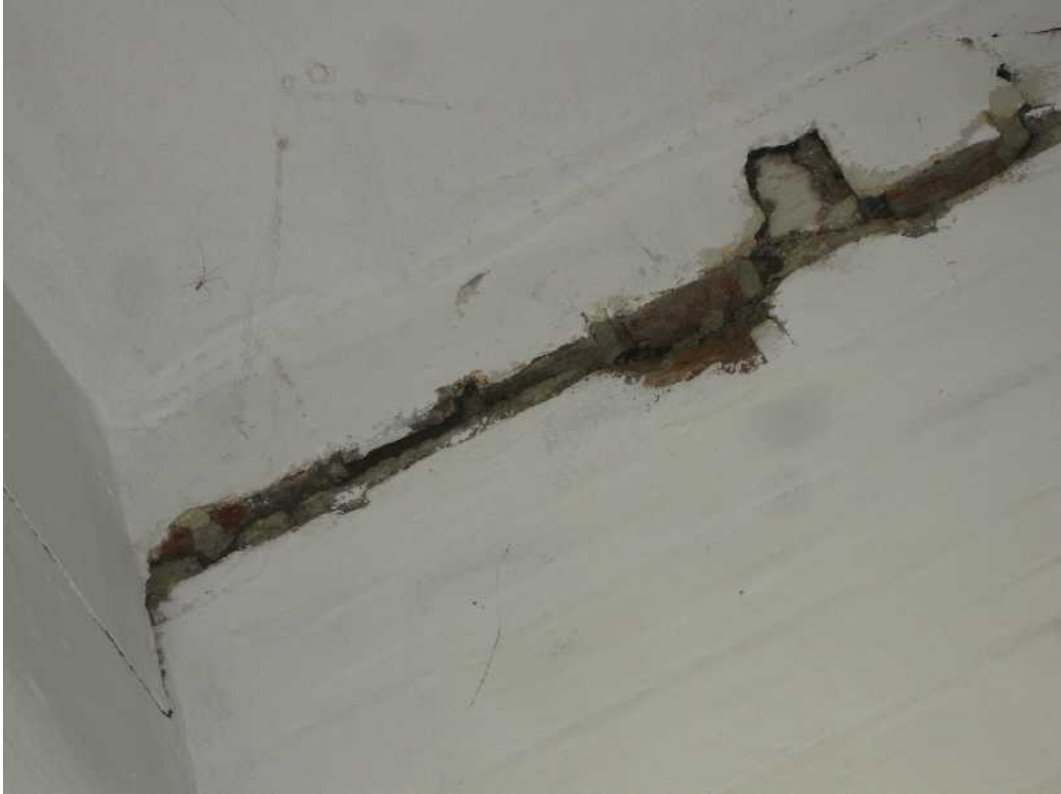
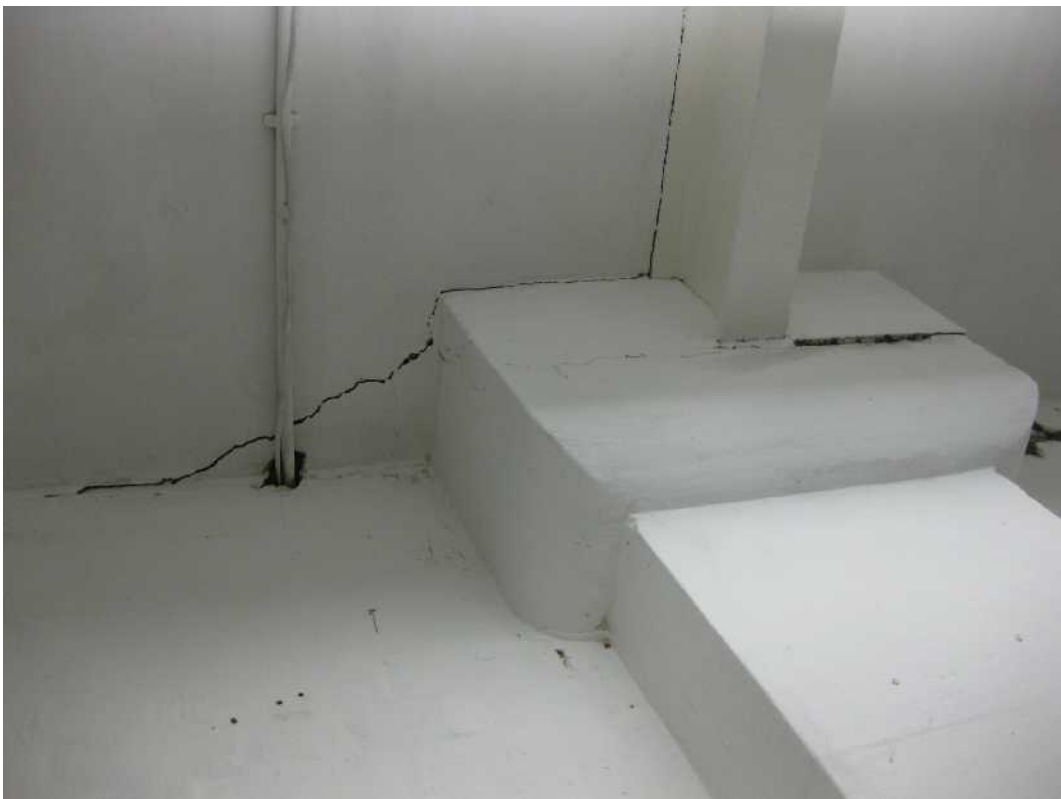
At ground floor level four two feet square stone columns support the main cast iron columns. The capitals to these stone columns which also pick up the wrought iron first floor beams have extensive horizontal cracking which would indicate that some advanced and advancing corrosion jacking of the iron work is taking place (48, 49, 50,

51 and 52). These capitals and the incoming beams will need to have extensive repair and upgrading in due course.

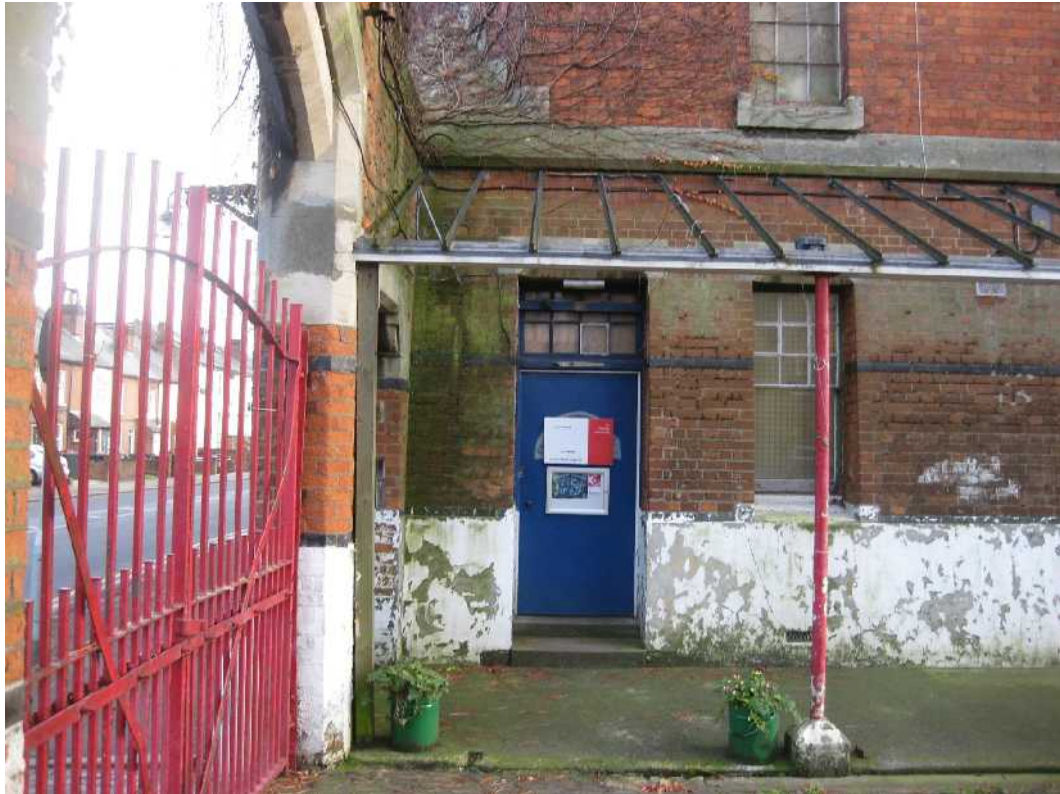
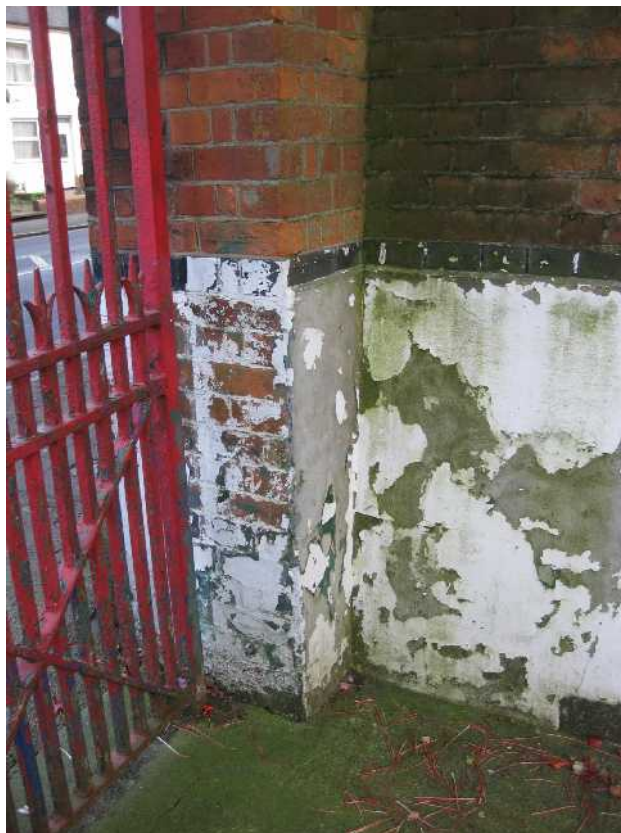
The brick walls at ground floor level are quite damp and damaged, the extent of which has been compounded by the application of cement render (53 & 54). The render needs to be removed and the walls allowed to breathe properly.

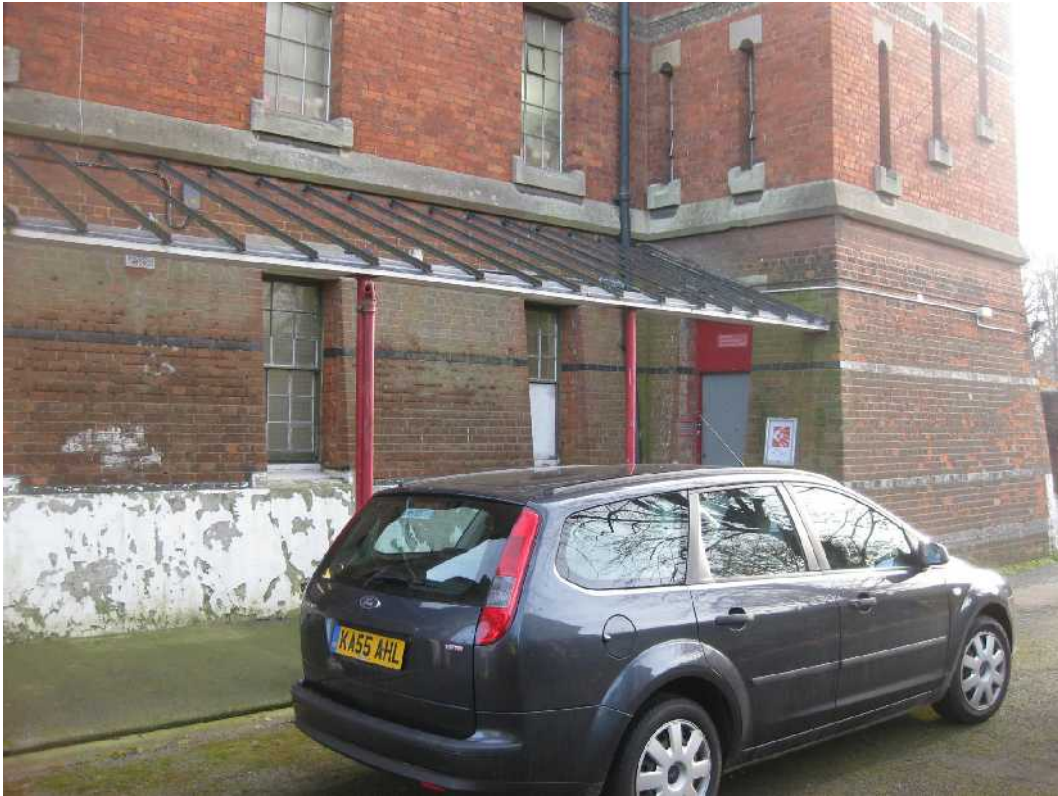
The currently unglazed verandah structure (55) needs to have the iron structure refurbished and repainted, the elements within the walls are likely to need upgrading and once carried out the glass replaced and new lead flashings appended.

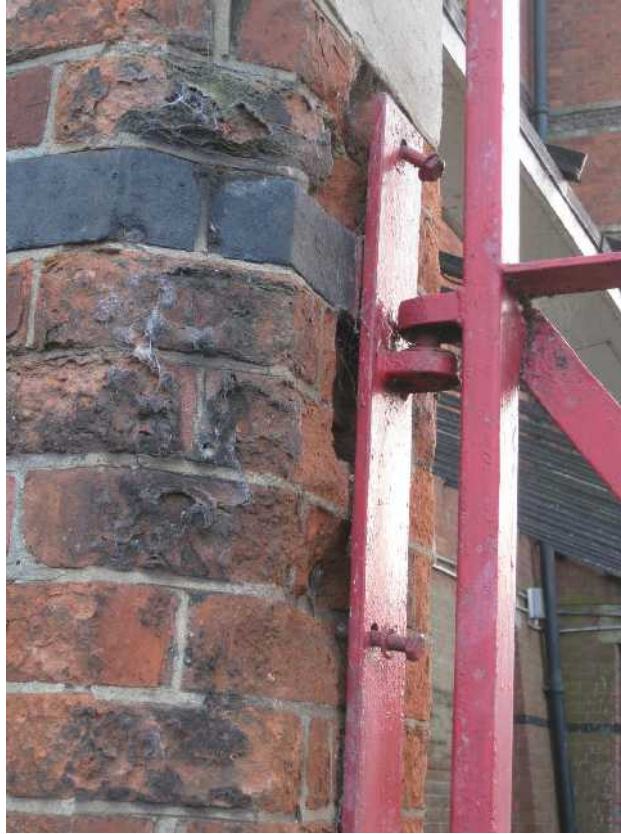
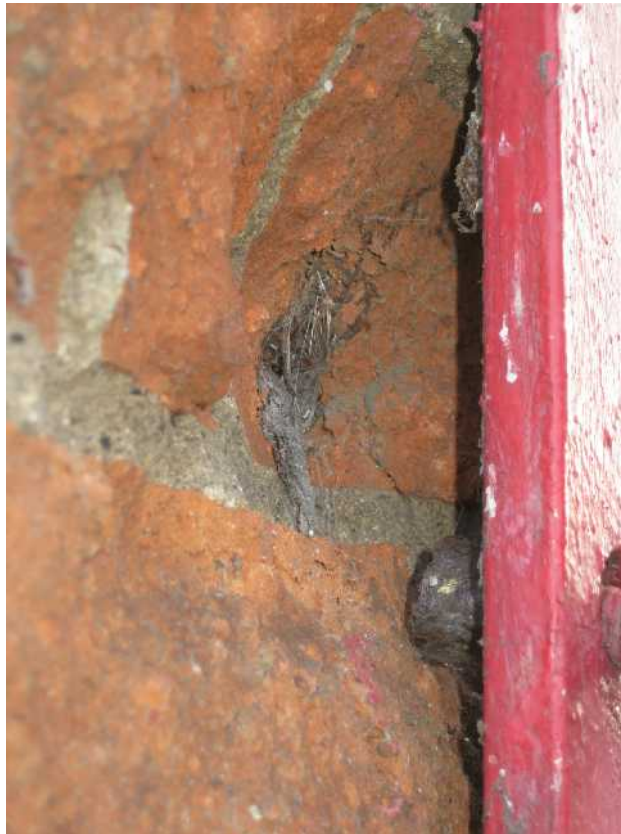
The gate structure needs some minor brickwork repairs. However, the hinge plates need refixing into brickwork once repaired (57 & 58). The gates will need wire brushing back to black metal and then repainting.

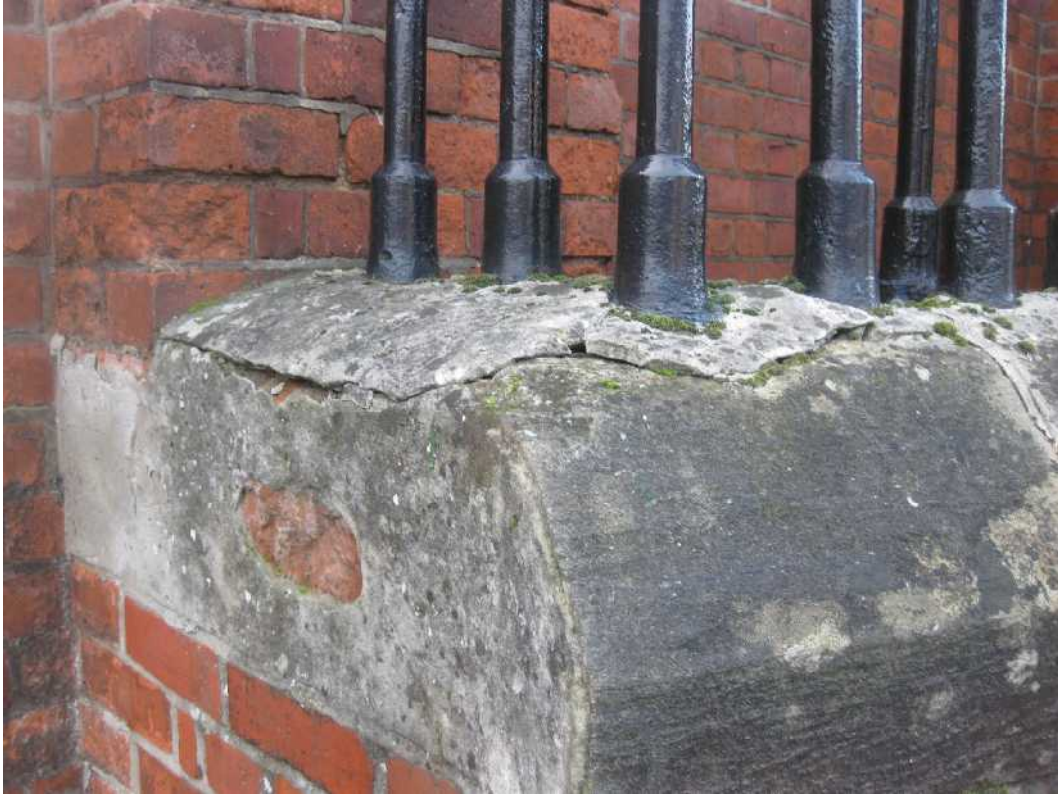
The railings to the two small enclosed spaces against the front of the building also need refurbishment (59).

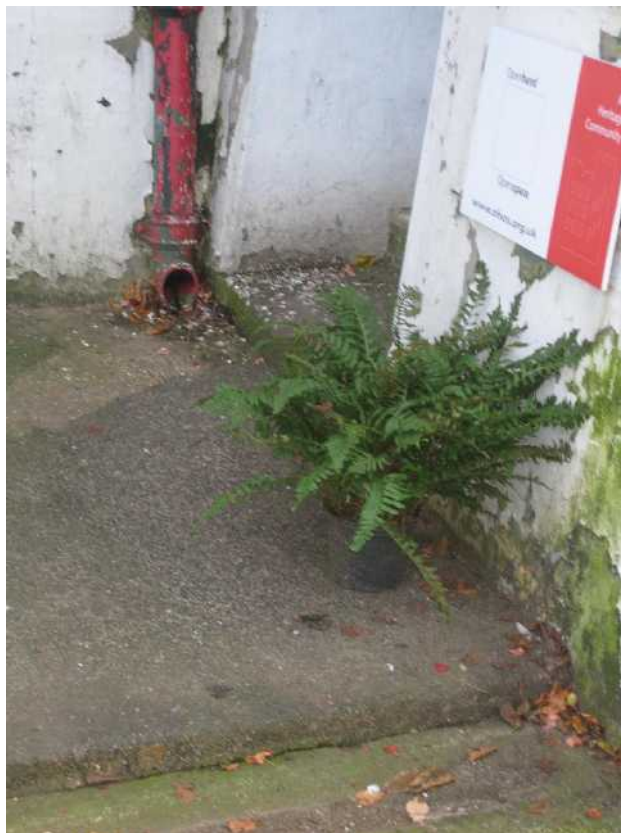
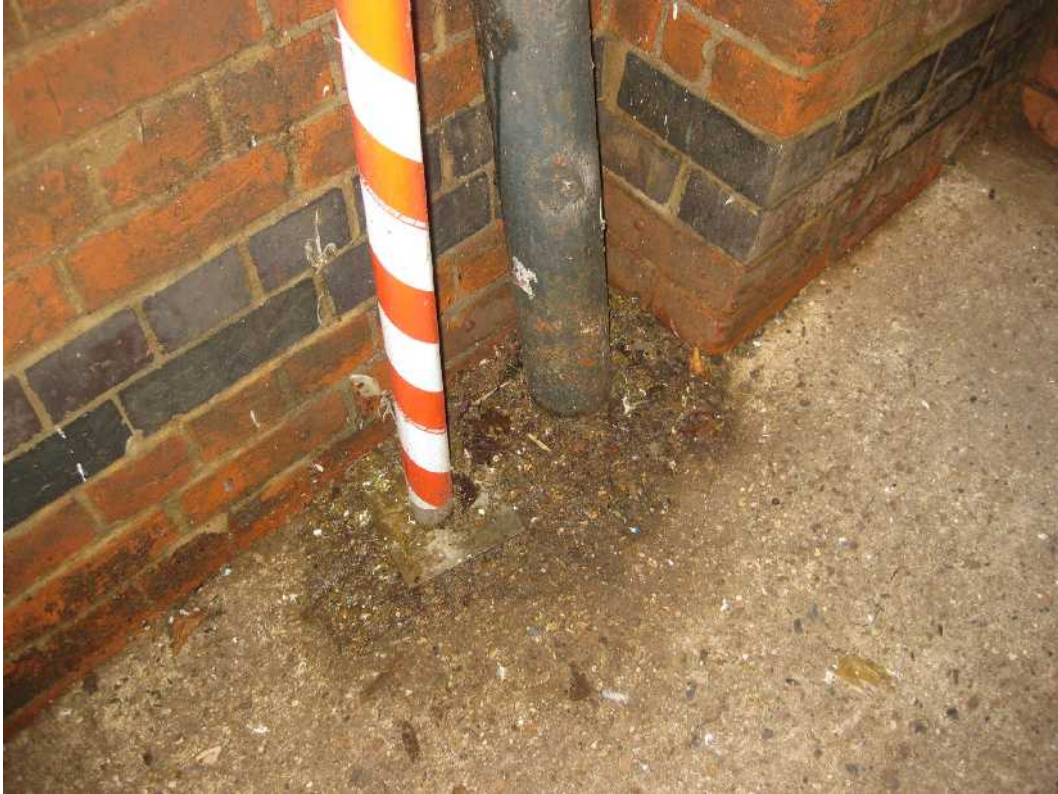
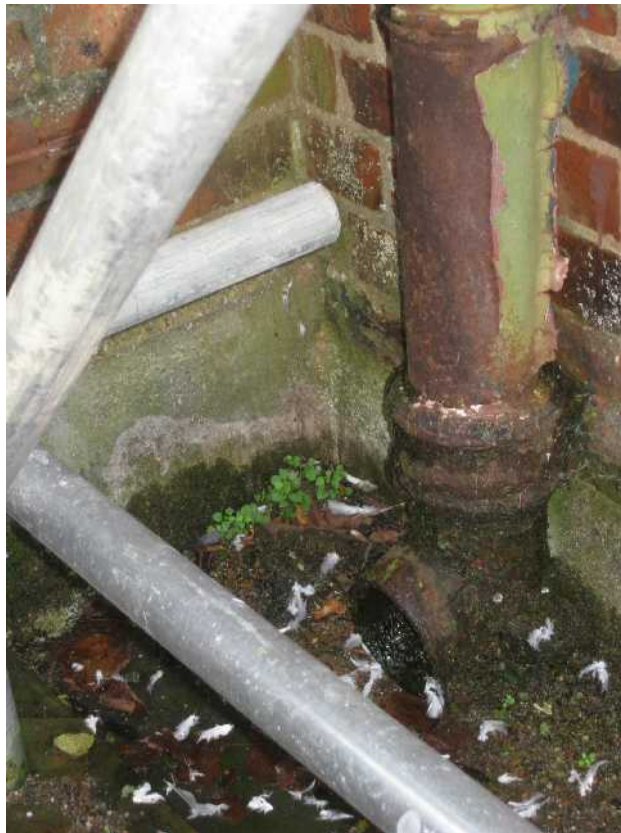
The cast iron rainwater goods need to be completely replaced through the building on a like for like basis and at ground level suitable soakaways need to be formed (60,61,62).
