# Structural Report

## Brock Keep, 571 Oxford Road, Reading

**Author:** Oliver Goodyear MEng(Hons)  
**Job Ref.** C3181  
**Issue:** 1.0  
**Date:** 9<sup>th</sup> March 2018

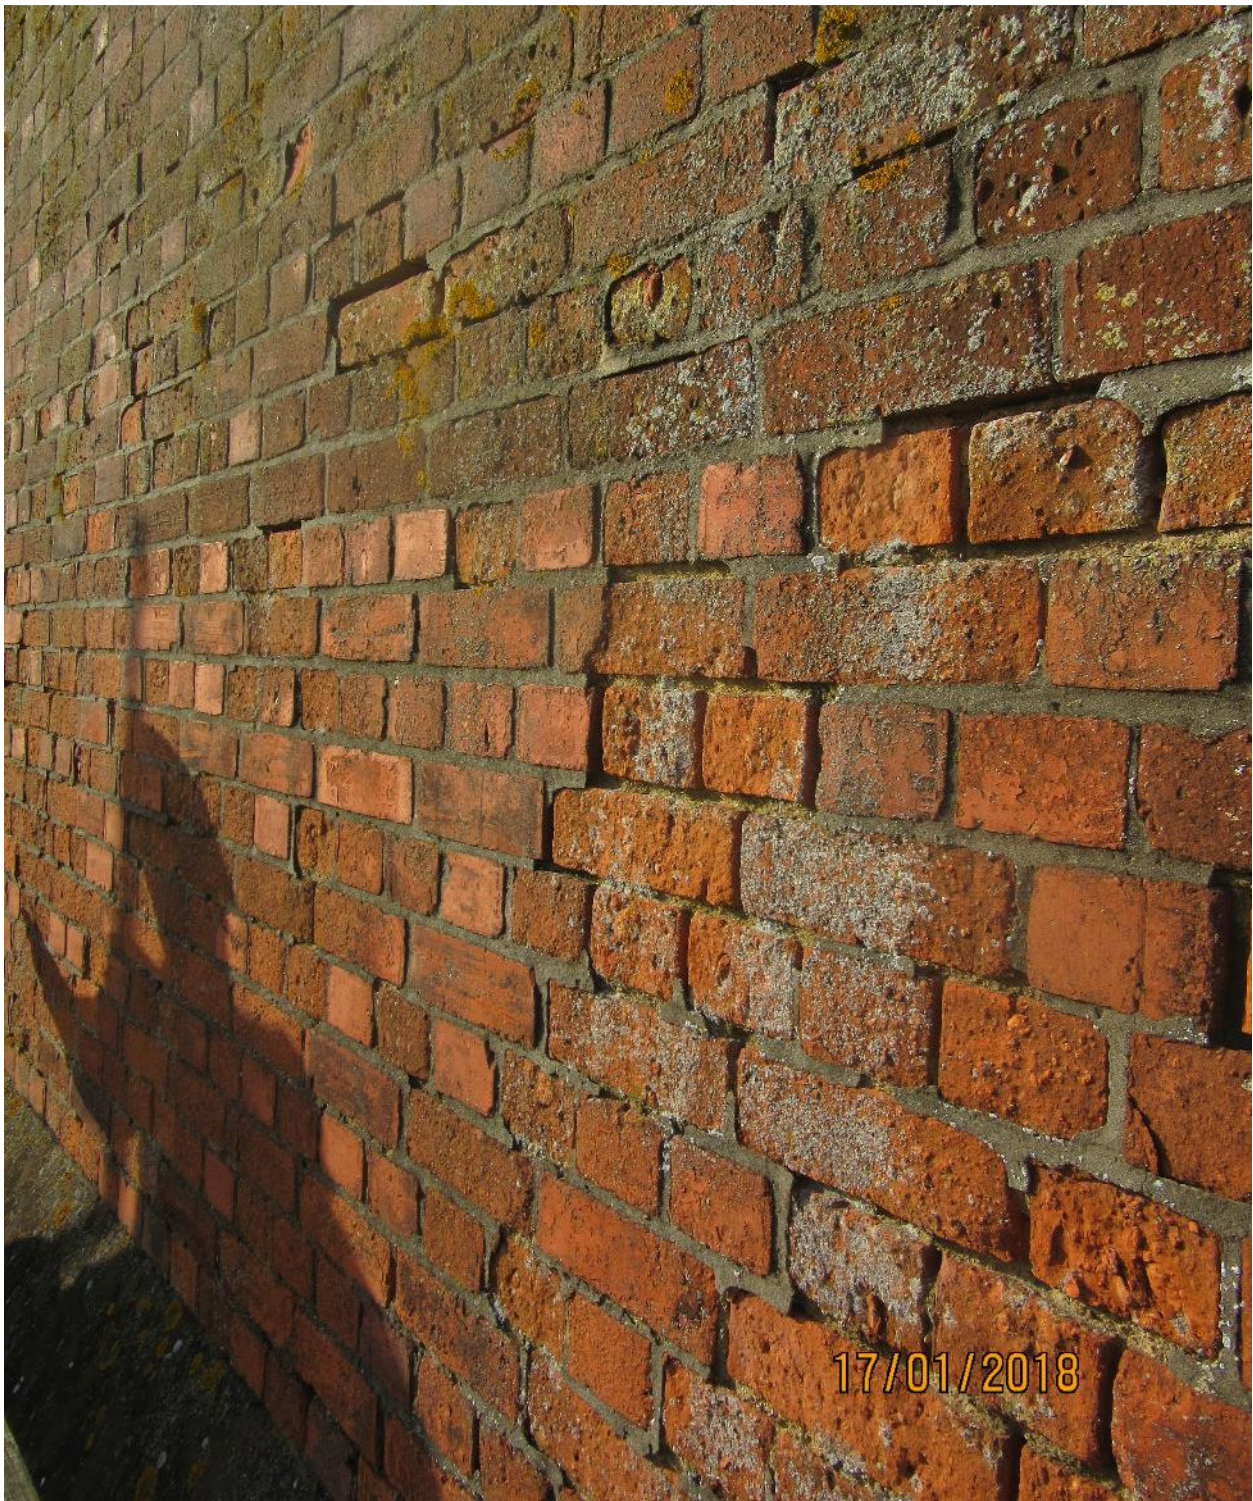
To summarise these defects, it was clear that the top section of the building has been repointed at some point with cement mortar. This building would have initially have been built using a traditional lime mortar, which would have been more suitable for the types of bricks used. Traditional brick walls rely on the lime mortar to breathe and let moisture out of the wall, cement mortar in comparison is less permeable and traps moisture within the brickwork. Therefore, the use of cement was unsuitable for this application and its likely that the eroded bed joints and numerous spalled bricks are resultant of these works, as trapped water can break apart bricks and mortar, via free/thaw action (photograph 1). Within future years this effect will worsen and will lead to further segments of mortar or brick falling from the wall and as this is a risk to public using the area below, it would be prudent to repoint this area with a suitable lime mortar. It also makes sense to utilise the scaffolding whilst it is in place.

Photograph 1 - Brickwork erosion from cement mortar works

- c. The outer parapet brickwork will need repointing with a suitable lime mortar. Spalled brickwork will need replaced with suitable units
  - d. All embedded ferrous elements such as rain water pipes and ladders will need to be replaced or repaired and re-fixed to the walls.

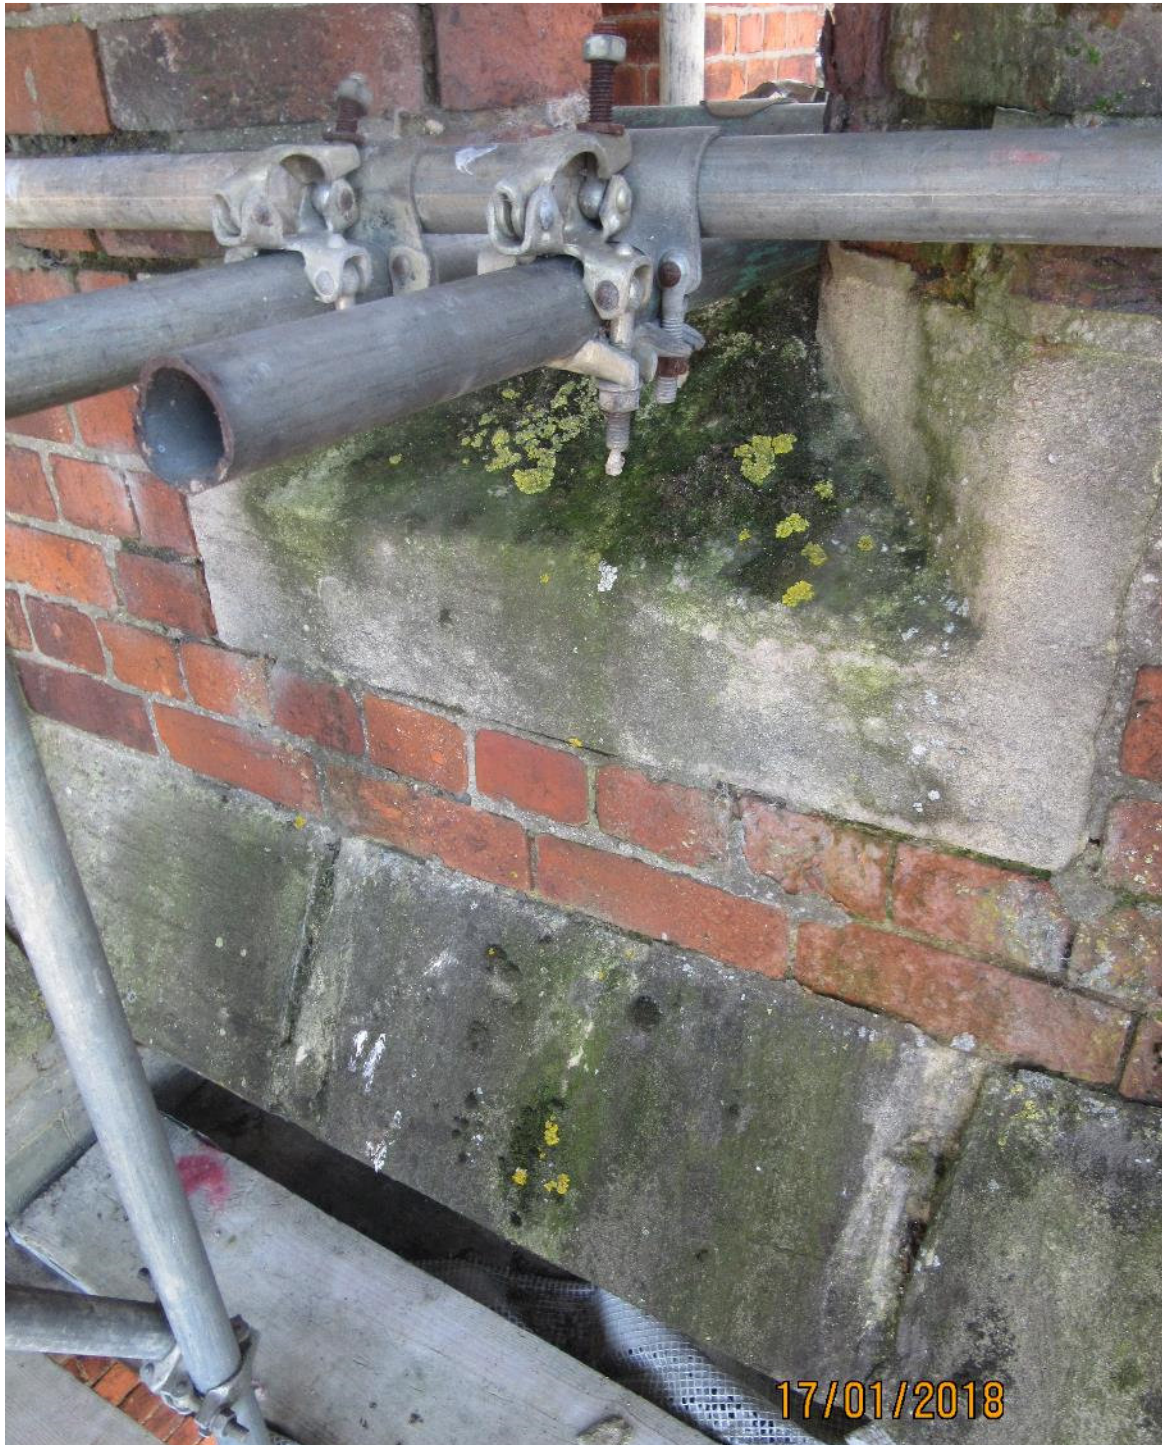
It was also clear that the bath stone features at the parapet drip, where the parapet meets the roof slab and at coping and edging details was beginning to erode. This is likely to be resultant of years of wind and driven rain to a highly exposed area of the building (photograph 2). The worst areas of erosion were directly beneath the castellation's, where storm water is collecting along the wall opening and has worn away a channel on the drip stone. These areas generally coincide with the areas where the bath stone is delaminating on its underside or cracking (photograph 3). Which suggests that water is getting to the underside of the detail via channels or joints in the drip stone and causing the stonework to delaminate and break apart. Eventually this will affect the stability of the wall, although currently the main concern is segments of stone falling on the public below. Therefore, its suggested that damaged stones are repaired by a bath stone repair specialist, with an appropriate repair mortar, to prevent water from collecting on the underside of the drip and to build up the areas delaminated. It would be useful to get a specialist to view these areas, so they can assist in specifying the appropriate repair mortar.

Photograph 2 - Bathstone eroded beneath castellation

- a. Damaged and delaminating bath stone to both the main parapet and turret coping detail will need a suitable repair mortar and reinforcement. As this is a specialist material, it may be worthwhile consulting a specialist contractor to assess these areas pre-tender, to assist with preparing a suitable specification.

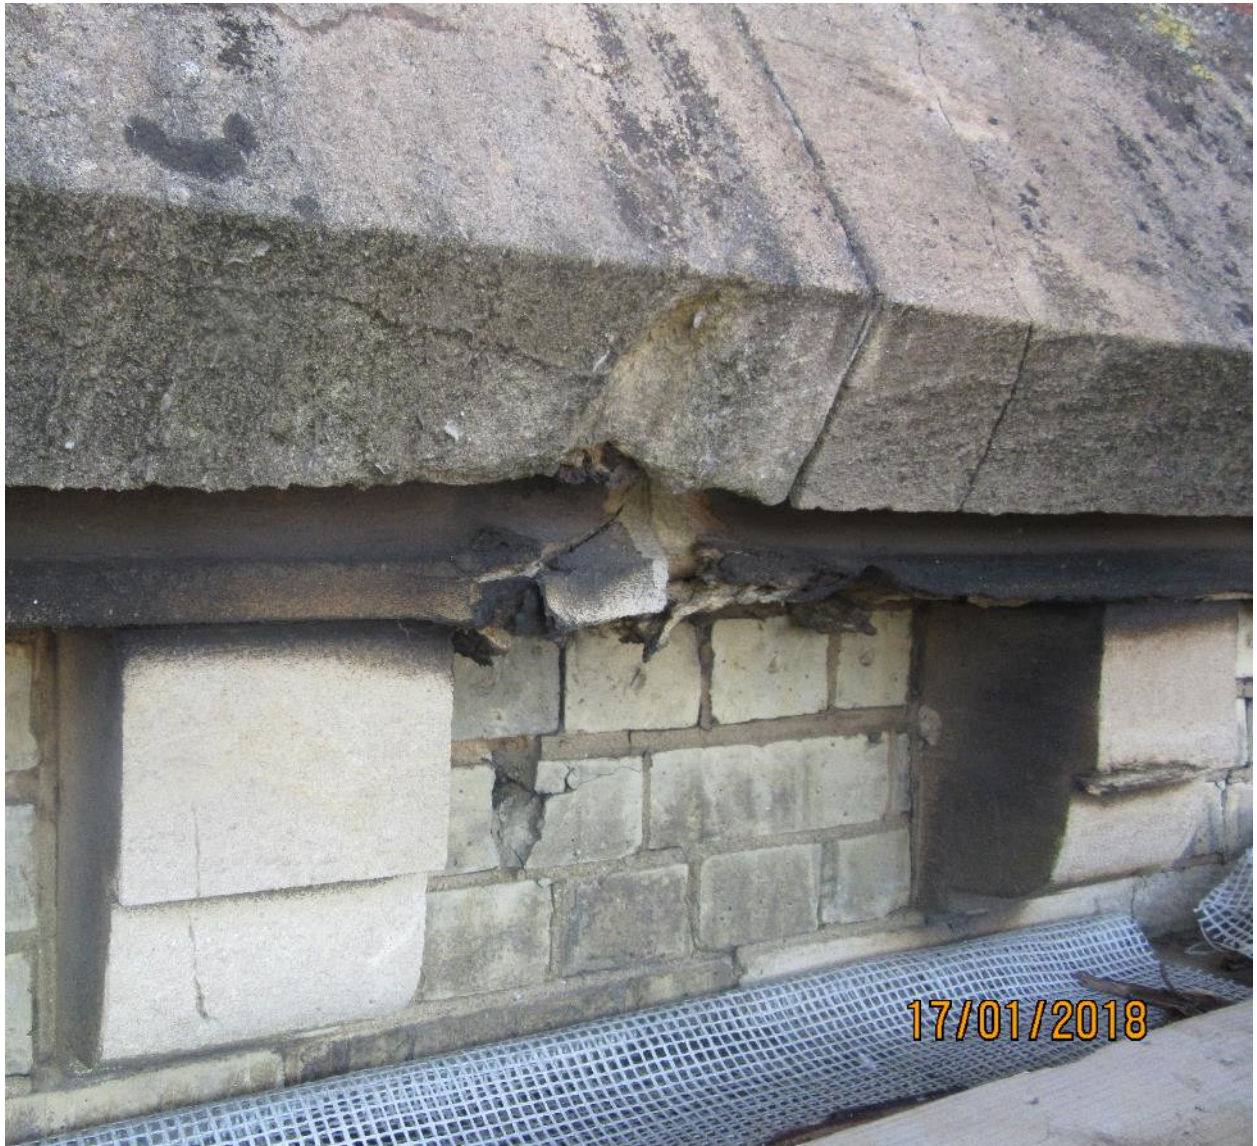
Photograph 3 - Under side of bathstone delaminating beneath eroded cracked area

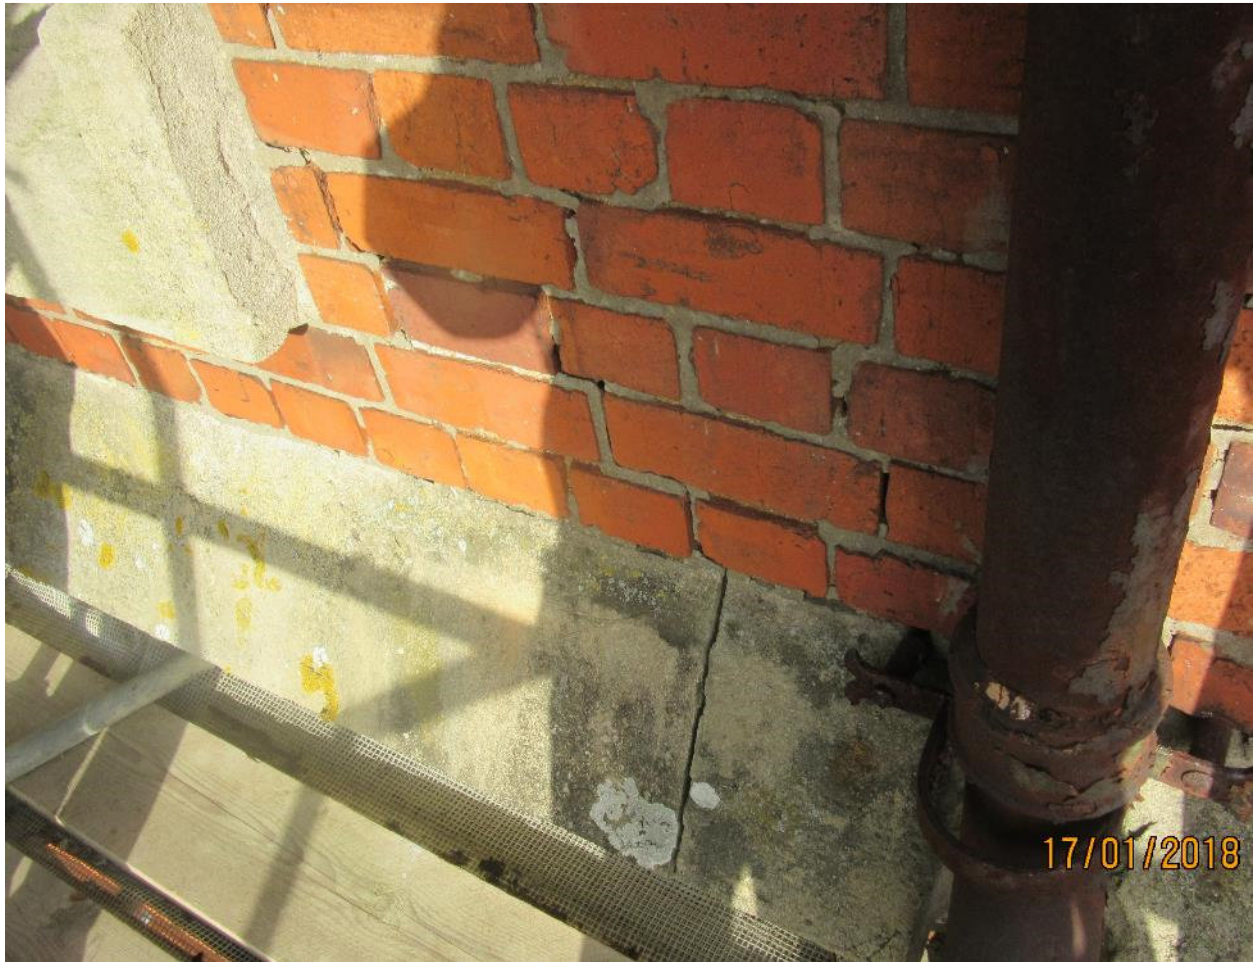
Furthermore, cracking to brick and stone work was noted throughout the parapet and turrets. Typically, these were around castellation's (photograph 4) and to the

turret walls. On the main parapet walls the direct cause of this cracking is unknown, although it's possible causes are thermal movement, where cement mortar is brittle and susceptible to cracking from thermal expansion and shrinkage effects, which normally occurs around openings where the wall is at its weakest. Its also possible that water accumulation or corrosion from nearby embedded ferrous elements are linked to this defect. The turrets brickwork had noticeably bad cracking especially on the west elevation of the North east turret where the ladder is embedded into the brickwork (photograph 5). In this area it is clear that the expansion effects caused by the corrosion of iron ladder, is jacking apart the brickwork and causing the cracking noted. The cracking also extends to the stone corbel detail (photograph 6) and in some instances causing the faces of the stone work to delaminate. This defect was clear on other elevations of both turrets (photograph 7) and there are signs in some area of the bridging stone being repaired (photograph 8), suggesting this has been a continuing problem. These areas coincide with the base of the cast iron water tank and its assumed that the tank is embedded in the wall at some point and the wall is subject to corrosion jacking effects from the expansion of the cast iron tanks.

Photograph 4 - Cracking to parapet walls

- b. All cracked brickwork, will need suitable crack repair and stitching works, with helical bars grouted into mortar beds, especially around the tower areas.

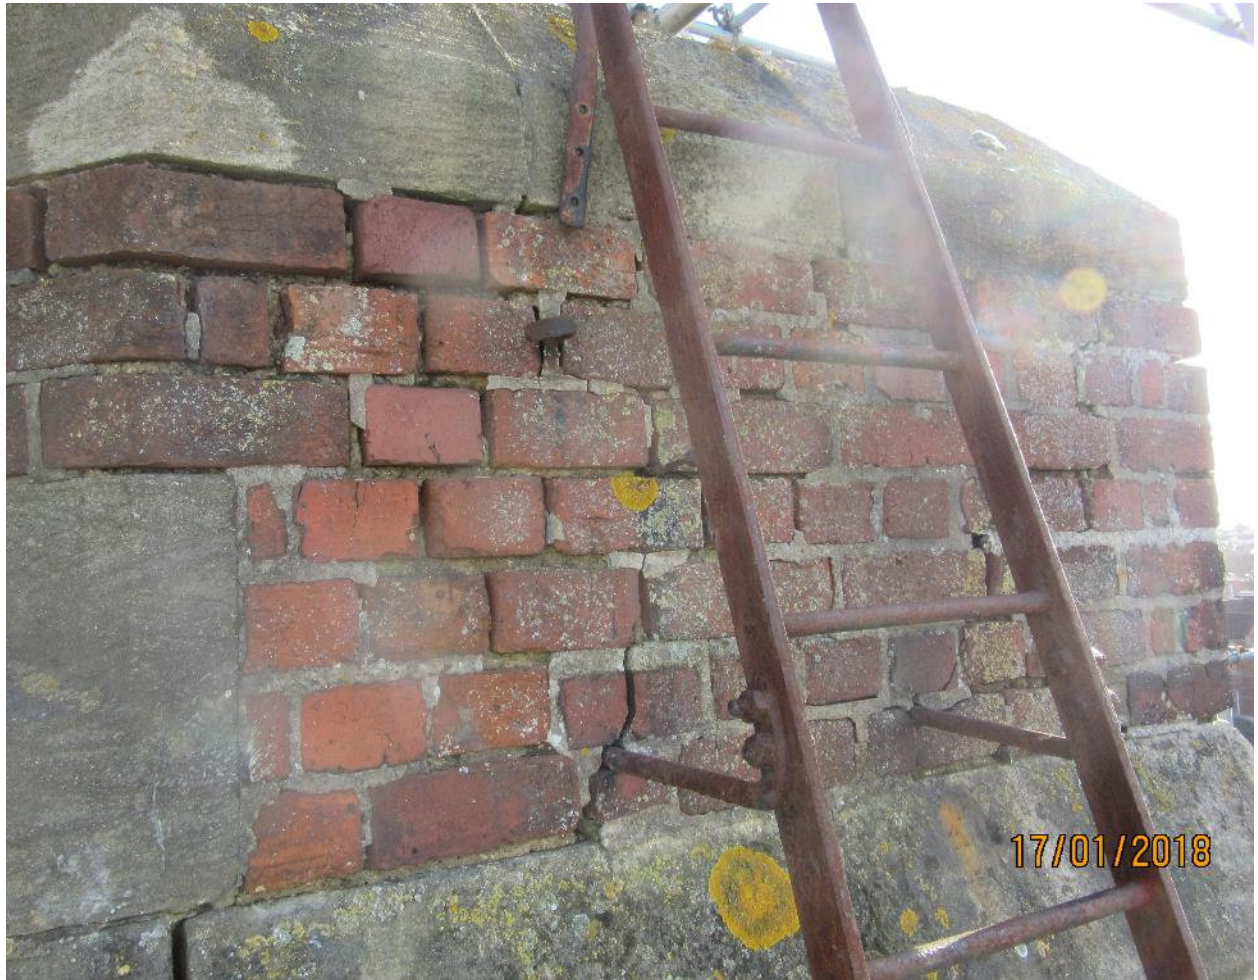
**Photograph 5 - Cracking to brickwork turret at ladder fixings**

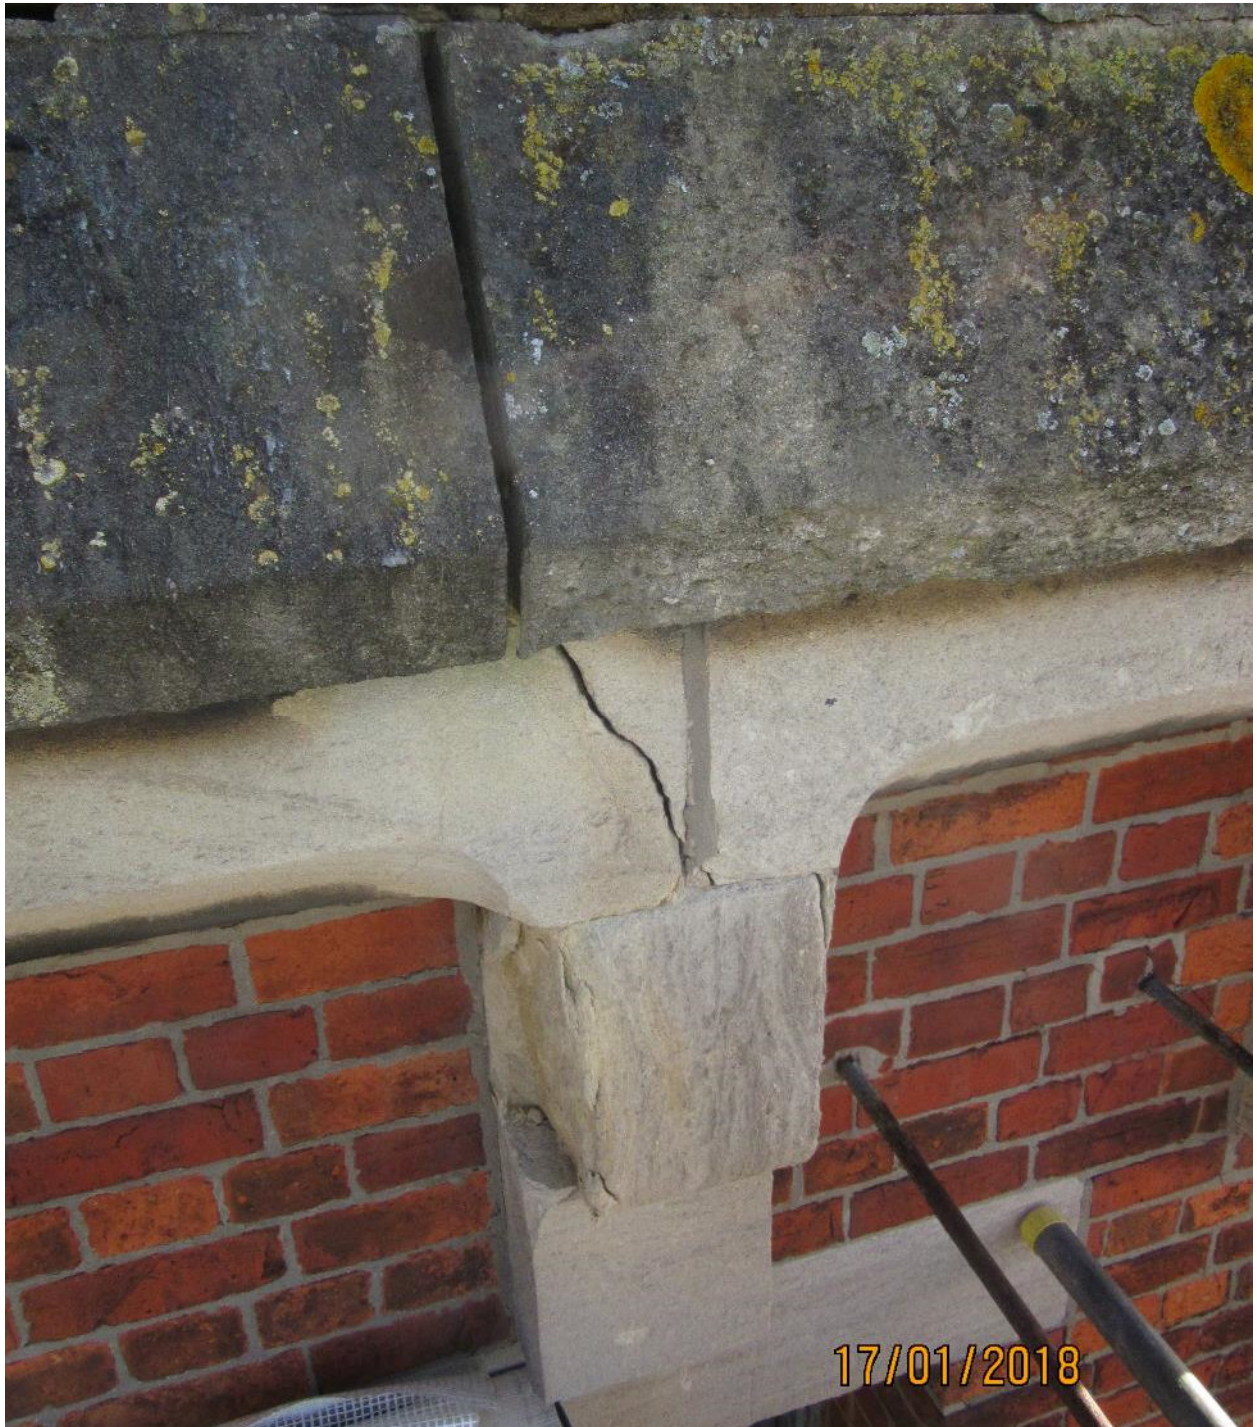
Photograph 6 - Cracking to bathstone corbel beneath turret parapet and delamination of corbel side

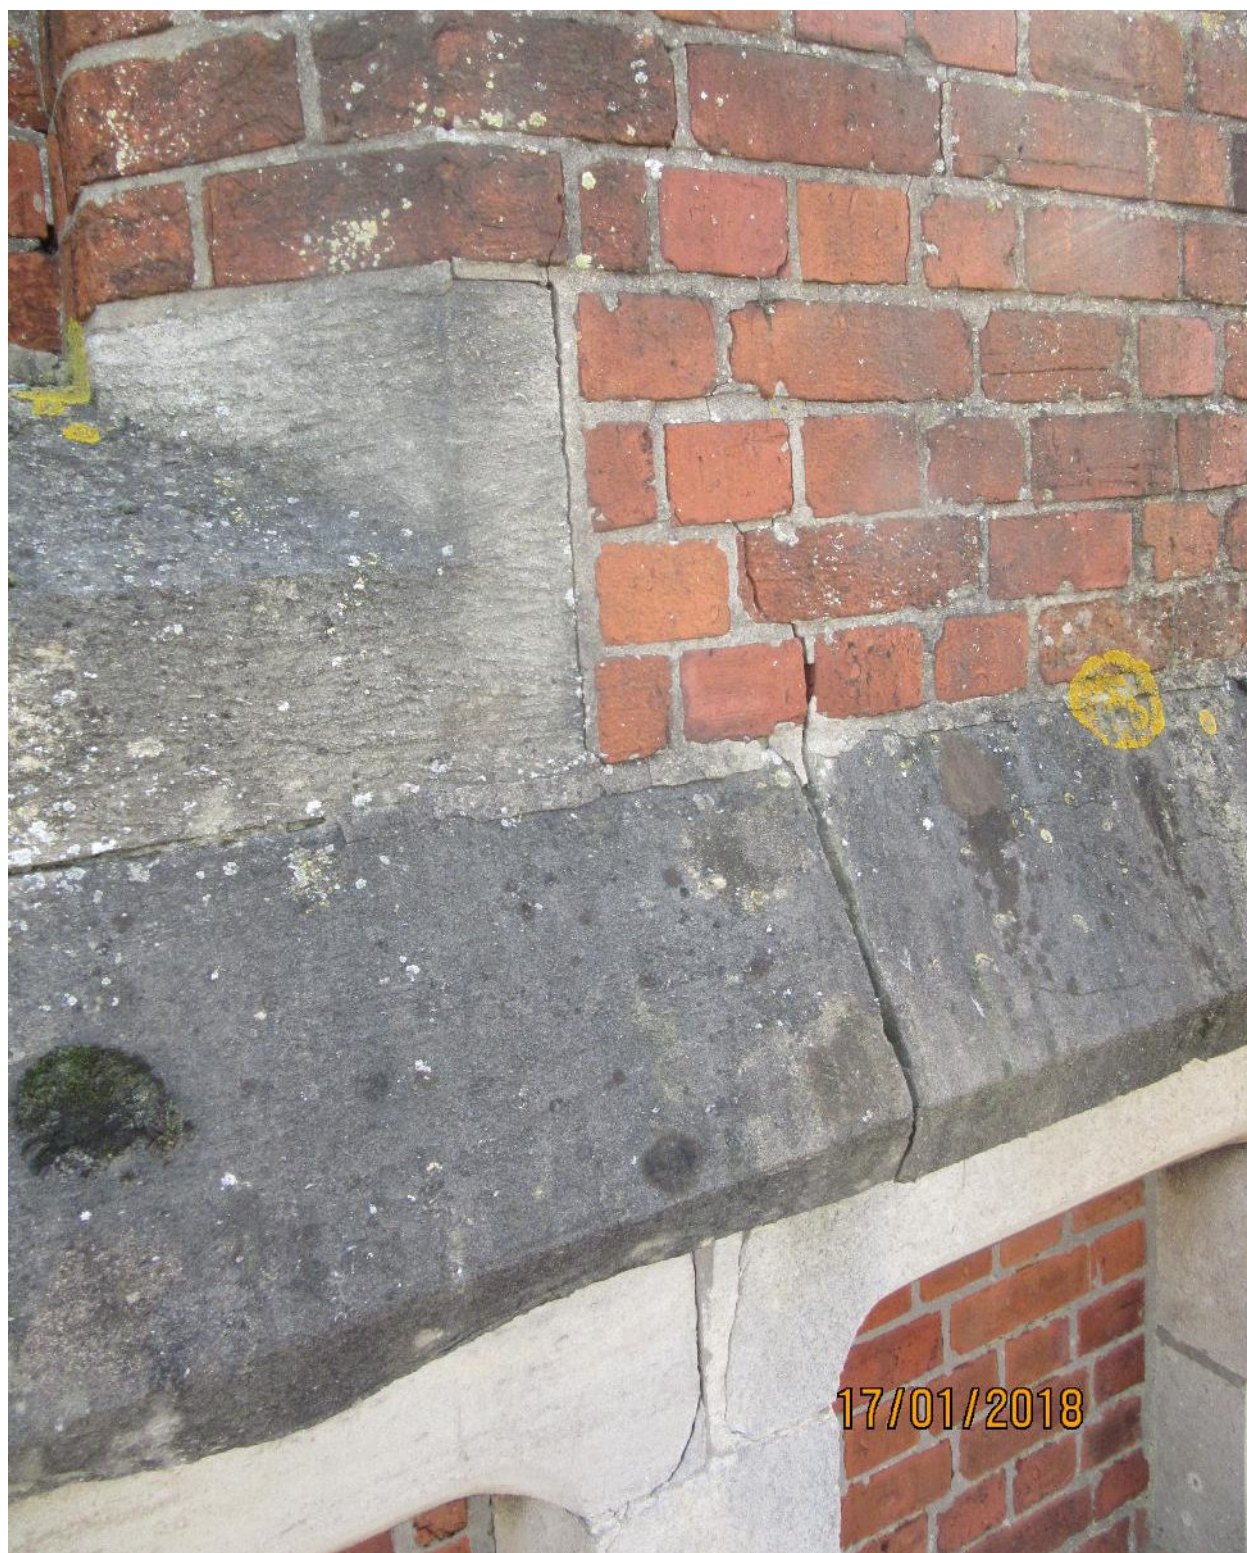
**Photograph 7 - Cracking to bathstone corbel beneath turret parapet**

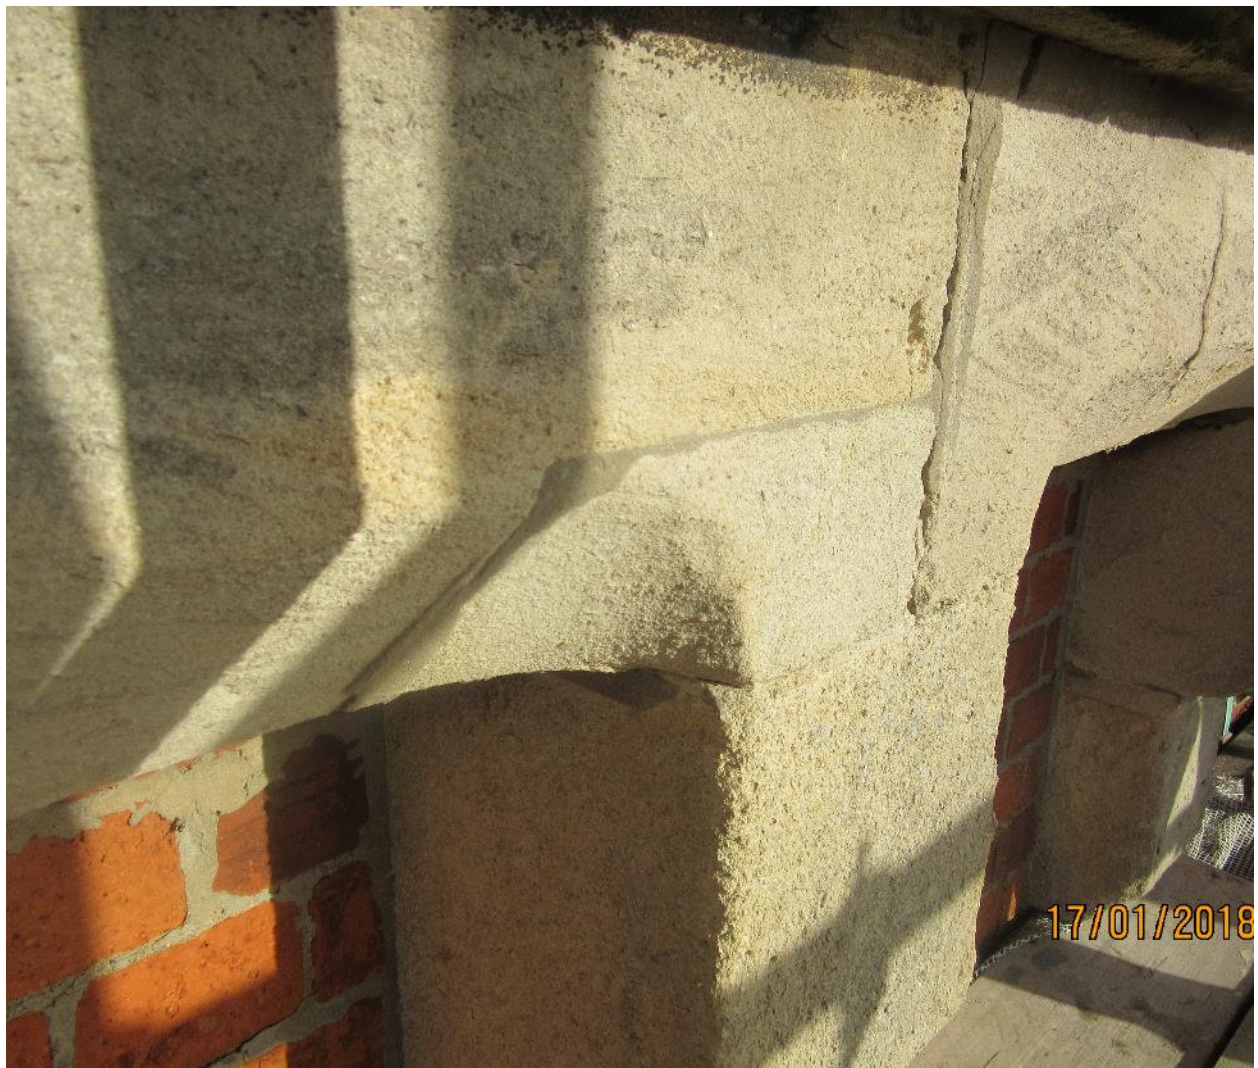
**Photograph 8 - Repair to bathstone**

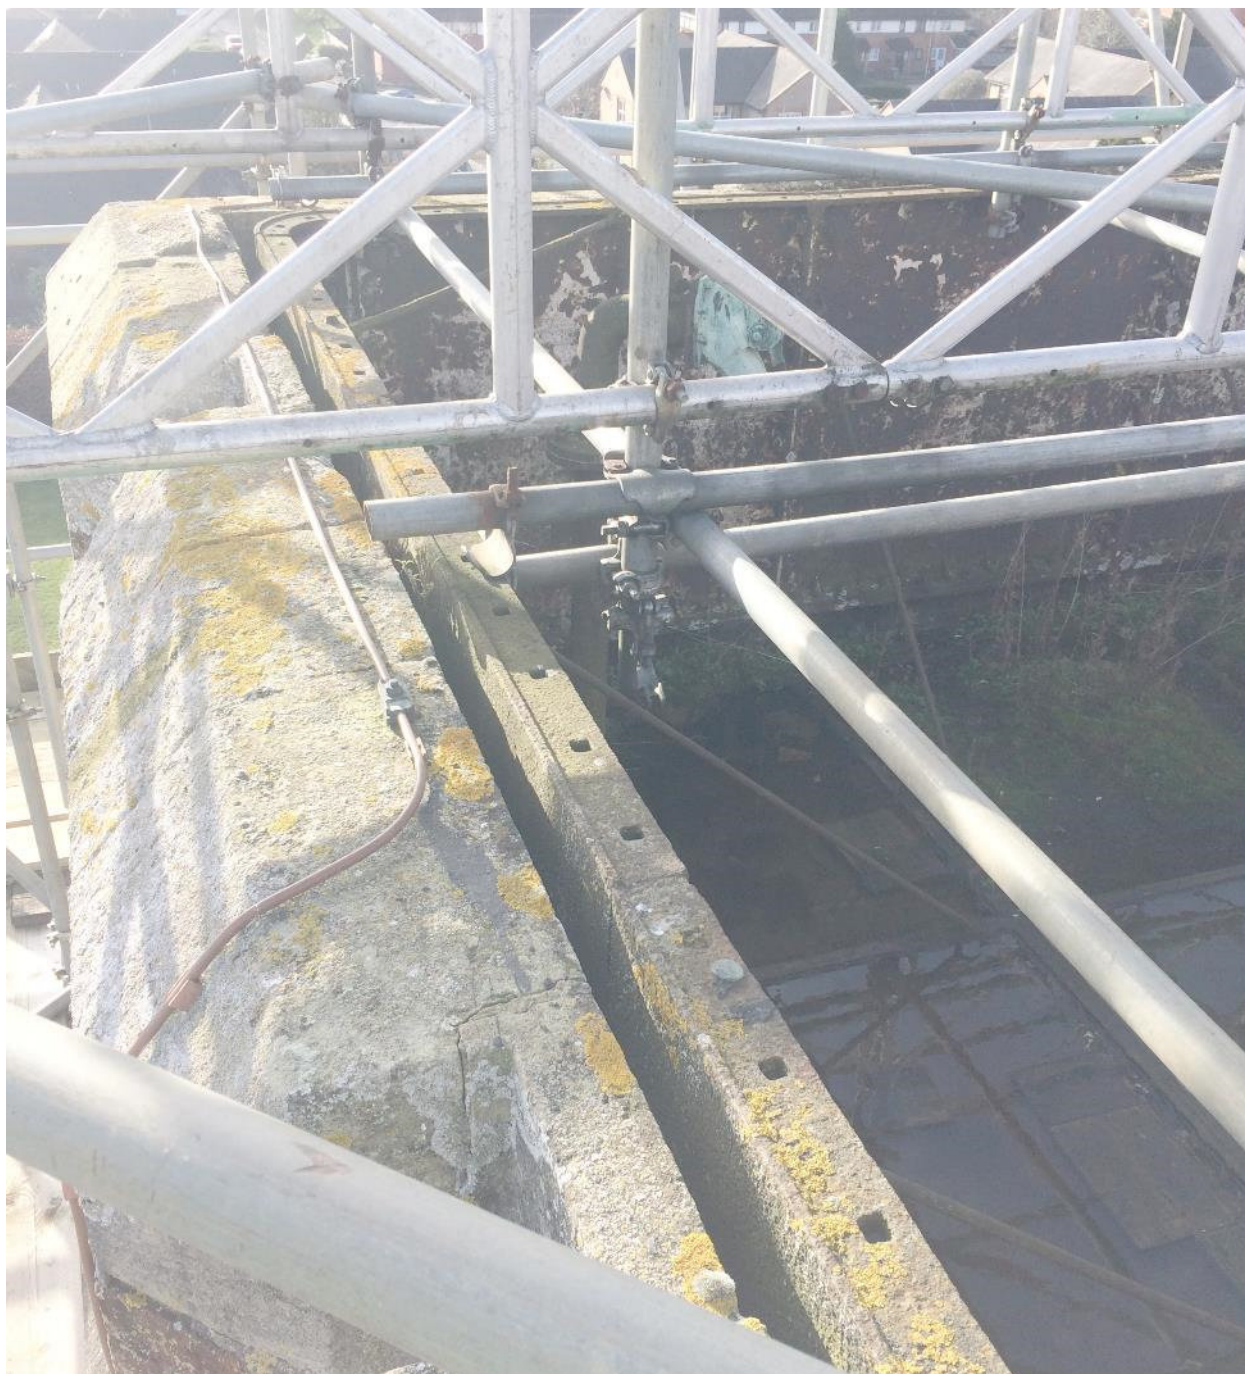
The condition of the tanks appears aged and there are signs of corrosion due to the tanks being exposed to the elements. It's understood that this section was originally covered, therefore the corrosion may only have occurred since the roof was removed. There was also a small gap between the brickwork parapets and the sides of the water tank where debris is likely to be accumulating (photograph 9). Its assumed the water tank is either built into the turret wall at its base, or packed tight to the wall so that any expansion caused by corrosion is pushing the brickwork out and causing the cracking observed. Its critical to ensure the longevity of the turrets that the cracked brickwork and stonework is repaired by appropriate crack stitching and repointing. Although there is no guarantee that further corrosion to the water tank will not cause the next weakest part of the turret to crack further down the line. Therefore, it is recommended that the water tanks are broken apart in-situ and safely removed, prior to repairing these areas. This will allow the space to be used as a viewing platform as a part of the proposed development. Its understood that removing theses tanks is a difficult decision to be make, as the

**Photograph 9 - Gap between water tank and parapet**

2. Due to the maintenance required to keep the water tanks in place and the potential corrosion issues imposed on the surrounded brickwork, it is recommended that the existing tanks are safely cut apart and removed by crane. Once removed the condition of the existing turret slab can be confirmed and the relevant upgrade works can be carried out to suit the proposed plans. Its appreciated that these tanks are a part of the building's heritage and its understood that these are going to be rebuilt, repaired and re-used on the surrounding grounds to the keep. To facilitate removal works, it is anticipated that opening up works will be required to confirm how the tank sits on the supporting turret.

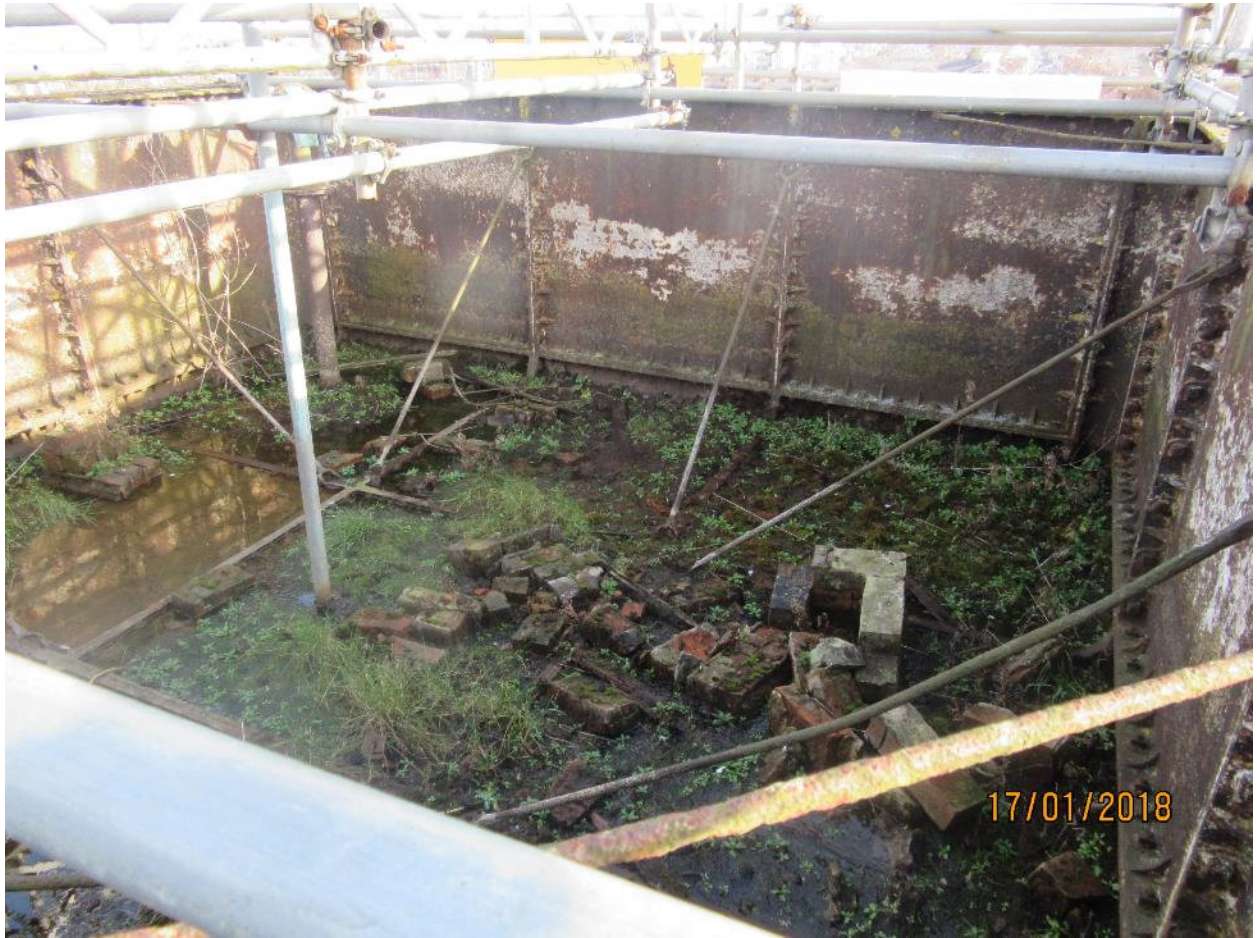
Furthermore, a section of chimney appears to have locally collapsed into the North East water tank (photograph 10). It would be prudent to safely remove these elements from the water tanks and if required rebuild this area to match the South West turret.

**Photograph 10 - Collapsed chimney stack within water tank**

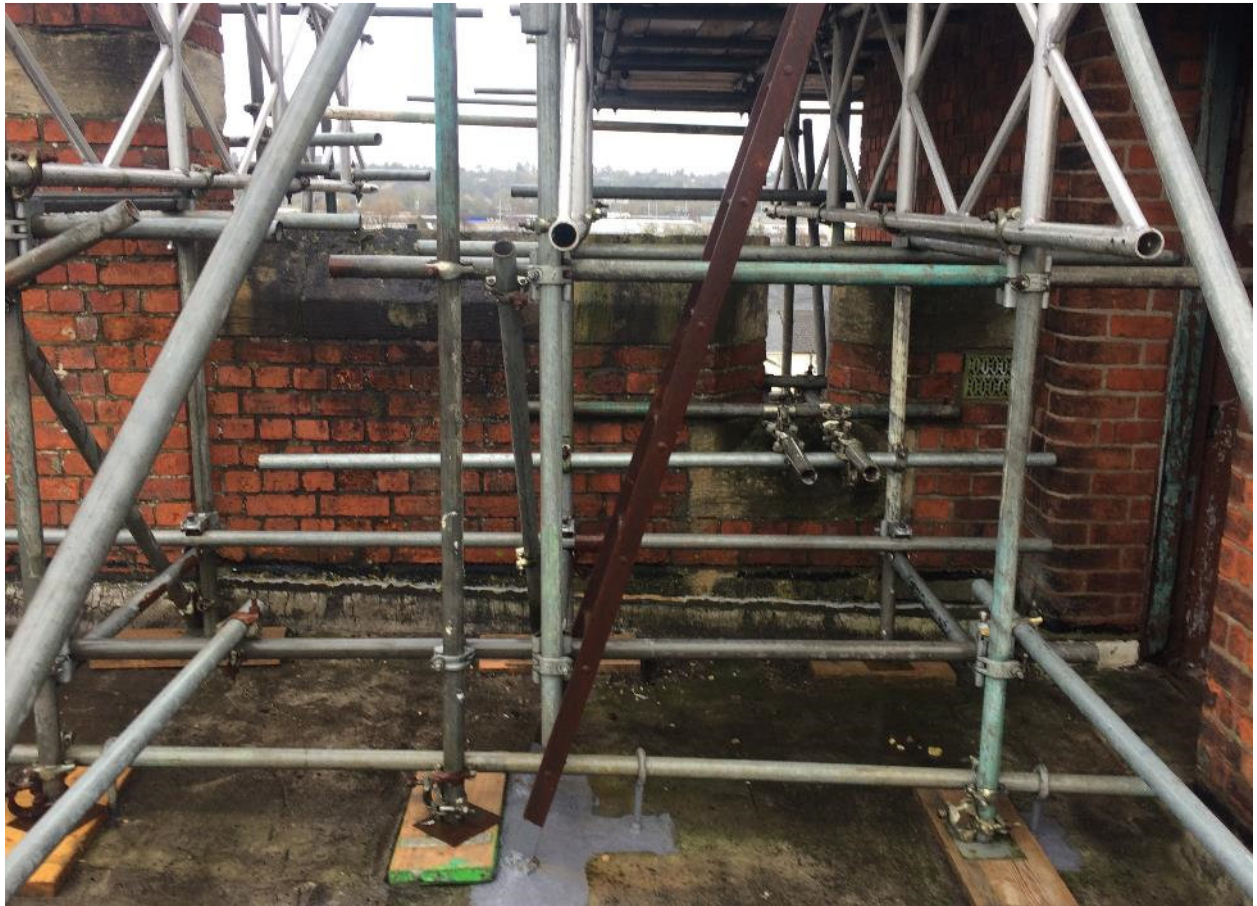
Its agreed that the asphalt has been compromised by scaffold fixings and its likely that water has penetrated the finish and worked its way into the structure, which is indicated by the damp marks to the ceiling below (photograph 11, 12 and 13).

**Photograph 11 - Scaffold eye bolts penetrating the roof finish**

- a. Roof Finish - Due to damage from eyebolts and deteriorating upstand details the current asphalt finish will need to be stripped off and replaced. From advice sought from Bauder flat roof systems, several options have been given (see Appendix C), although the final decision on the proposed finish is yet to be made.
