| SURVEY OF TREES AT HILLSIDE HOUSE & COURT, ALLCROFT ROAD, READING | | | | | | | | | | | | | | | | | | | | | | |

PROJECT:  
**Hillside House & Court,  
Allcroft Road, Reading**

TITLE:  
**Tree Protection Plan**

DRAWING NUMBER:  
**8680/02 Rev C**

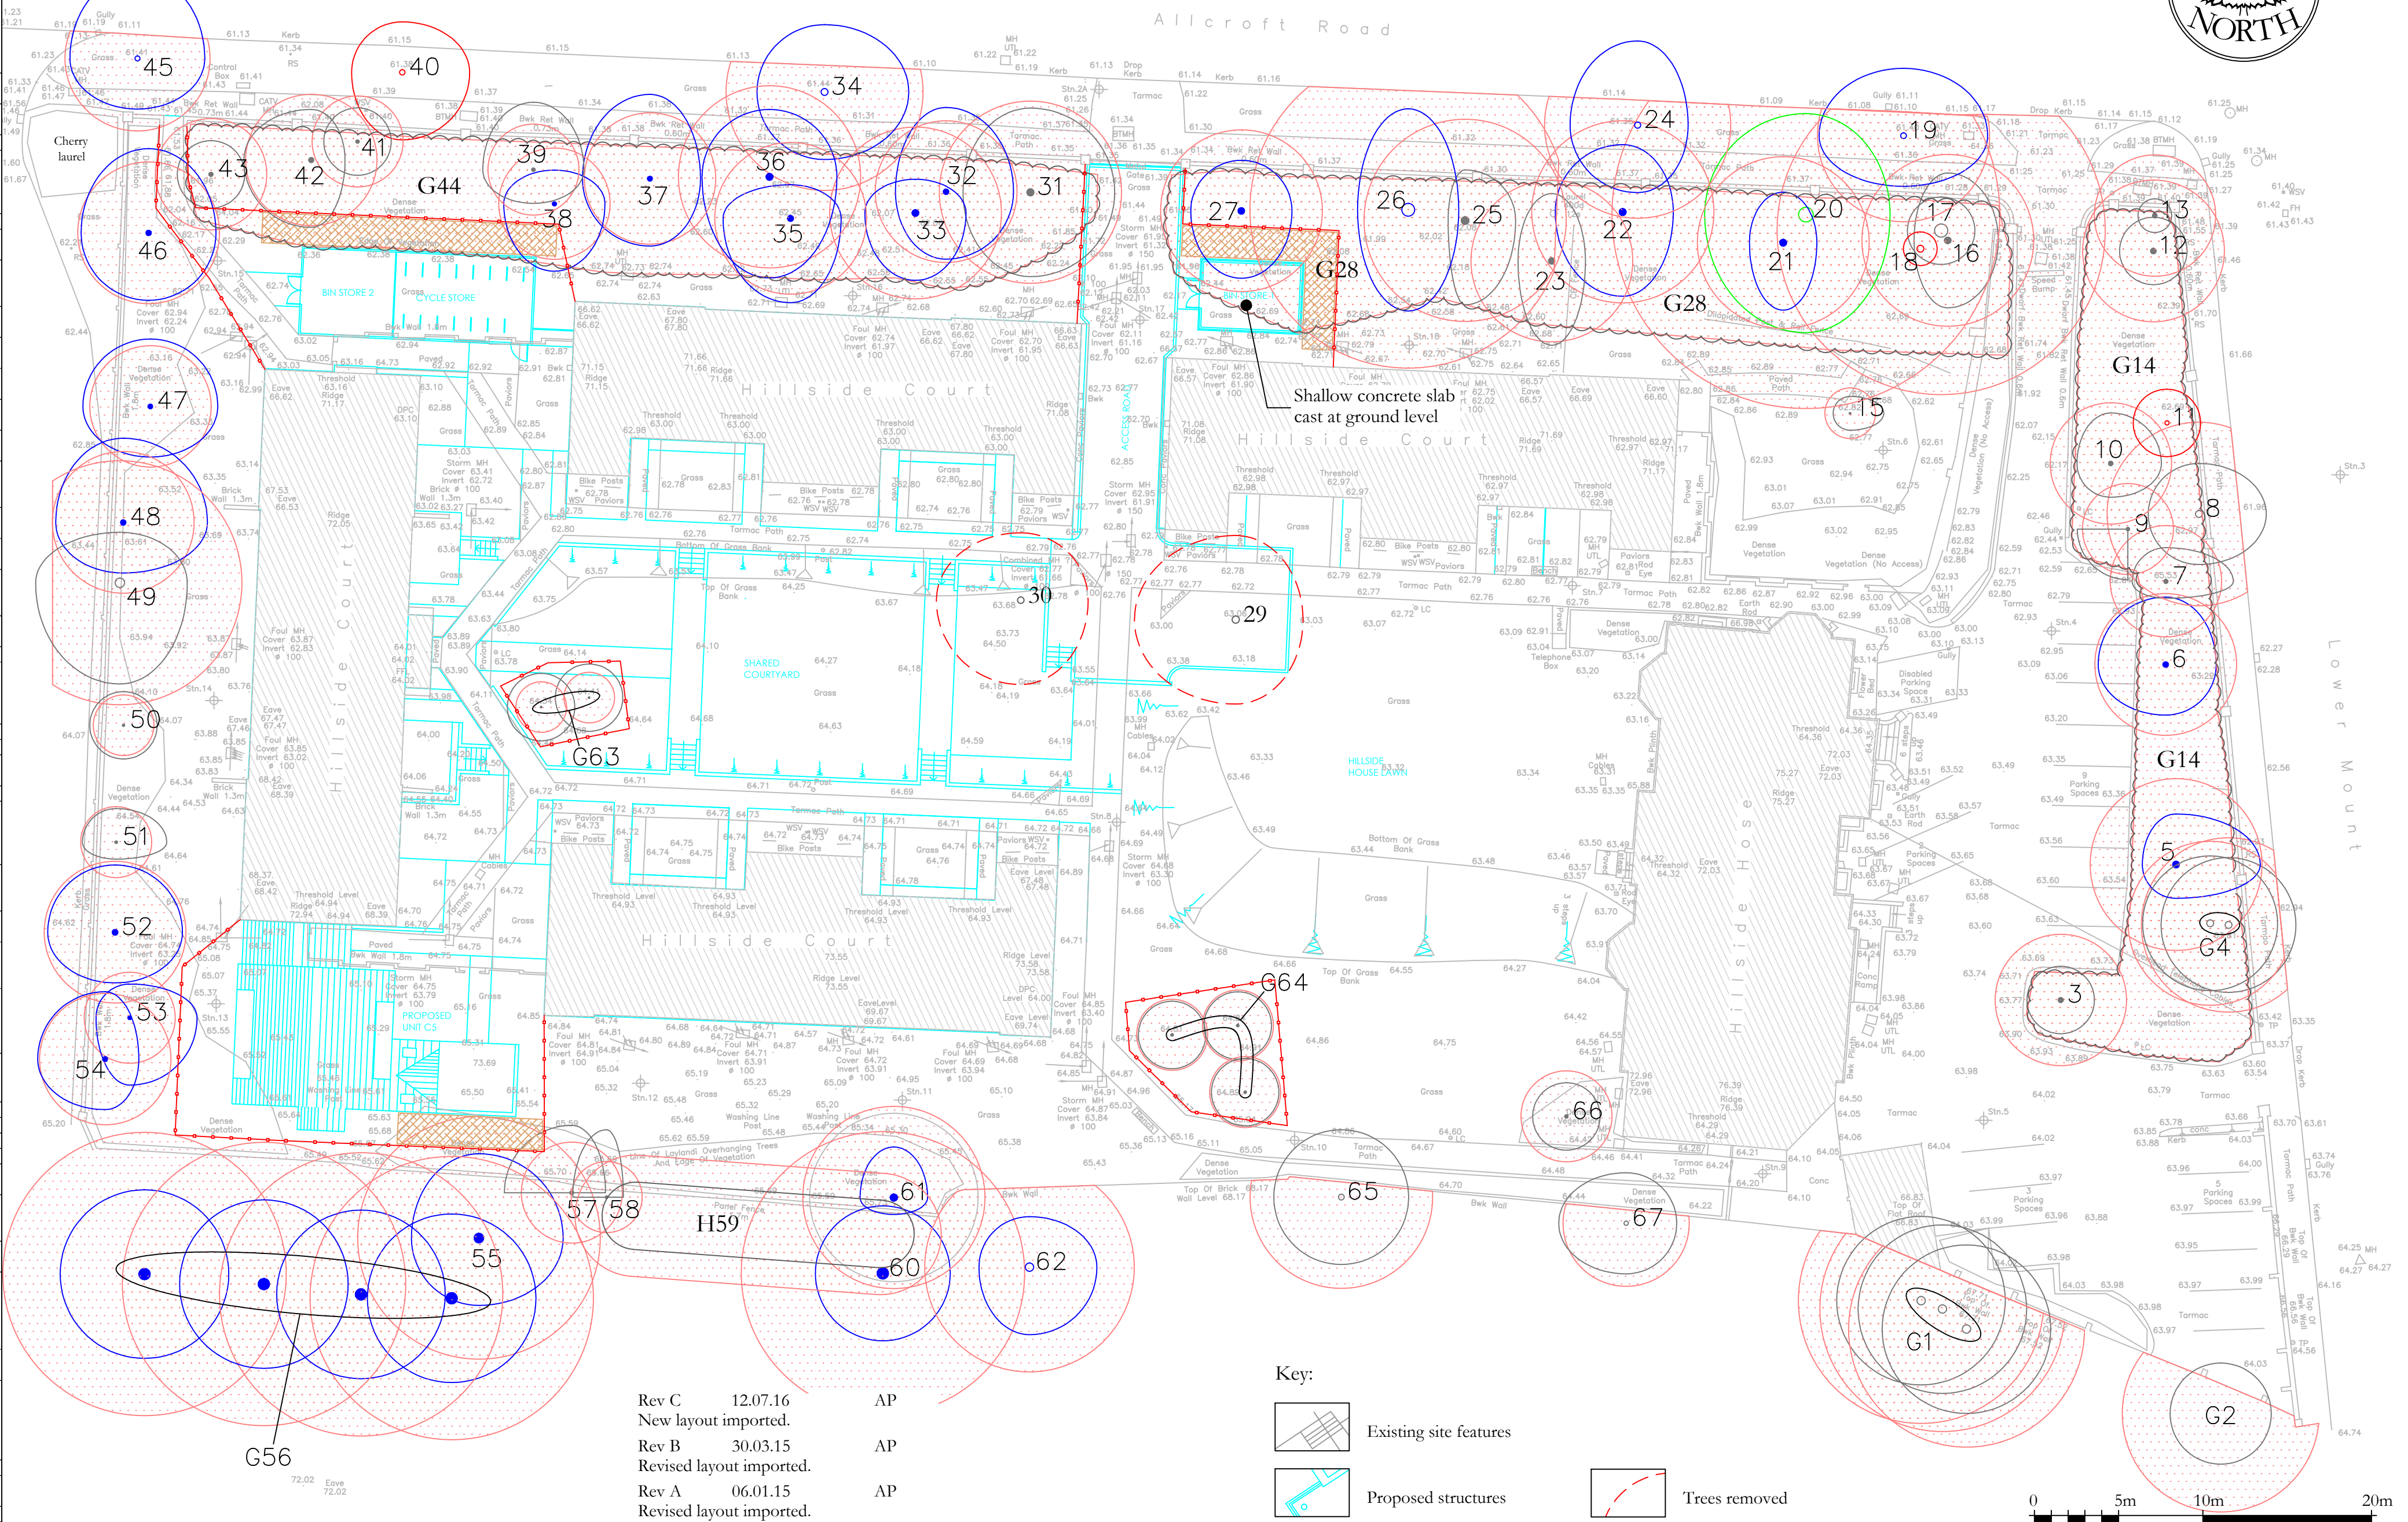
| SURVEY OF TREES AT HILLSIDE HOUSE & COURT, ALLCROFT ROAD, READING | | | | | | | | | | | | | | | | | | | | | | |
|---|---|---|---|---|---|---|---|---|---|---|---|---|---|---|---|---|---|---|---|---|---|---|
| 8 | Sycamore | 12 | 3 | 4 | 3 | 3 | 41 | | | | | | | 5 | 4E | B | C1 | >10 | Prominent tree located on property boundary. Boundary wall and railings appear to be bowing at this point. | | 4.92 | 76 |
| 17 | Larson Cypress | 16 | | 2av | | | 77 | | | | | | | 4 | 2N | M | C1 | >10 | Very open crown on western side, main stem divides at approximately 2.5m right fork with included bark visible. | | 9.24 | 268 |
| 29 | Himalayan Birch | 13 | 5 | 4 | 5 | 6 | 43 | | | | | | | 1 | 1.5W | B | C1 | >10 | Established tree with spreading form although evidence of bleeding canker on the northern side at approximately 1m. Low branches over the footpath and close to adjacent dwellings. | Remove. | 5.16 | 84 |
| 40 | Silver Birch | 12 | 3 | 4 | 4 | 3 | 32 | | | | | | | 2.5 | 4E | B | U | <10 | Monobum. Tree is offsite located within roadside verge and has suffered with the main stem snapping out in the past. Has a tree removal notice on from Reading Borough Council to say it is going to be removed on 20th November. | | 3.84 | 46 |

| SURVEY OF TREES AT HILLSIDE HOUSE & COURT, ALLCROFT ROAD, READING | | | | | | | | | | | | | | | | | | | | | | |
|---|---|---|---|---|---|---|---|---|---|---|---|---|---|---|---|---|---|---|---|---|---|---|
| 20 | Lane | 21 | 6 | 5 | 7 | 6 | 87 | | | | | | | 2 | 4S | M | A1 | >40 | Prominent tree both within site and street scene. Some deadwood within crown but no more than is commensurate with this size and age of species. | Crown lift by 2.5m | 10.44 | 342 |
| 35 | Yew | 10 | 2 | 3 | 5 | 4 | 38 | | | | | | | 0 | 2S | S | B2 | >20 | Good form and condition although branches growing close to building. | Cut back to clear the building by 2m. | 4.56 | 65 |
| 38 | Lane | 9 | 2 | 3 | 4 | 3 | 27 | | | | | | | 1 | 2S | B | B1 | >20 | Established tree on roadside frontage in good form and condition. | Remove the lowest southern branch at approximately 2.5m and cut back other southern branches to clear building by 2m. | 5.24 | 33 |
