20<sup>th</sup> December 2017  
W01719/mgl/as

## Reading, 38 Southampton Street, RG1 2QL – Report on further investigation structural survey

Michael Lakey CEng MStructE of Scott White and Hookins, undertook a structural inspection of the exposed structural elements at the above property on 6<sup>th</sup> December 2017.

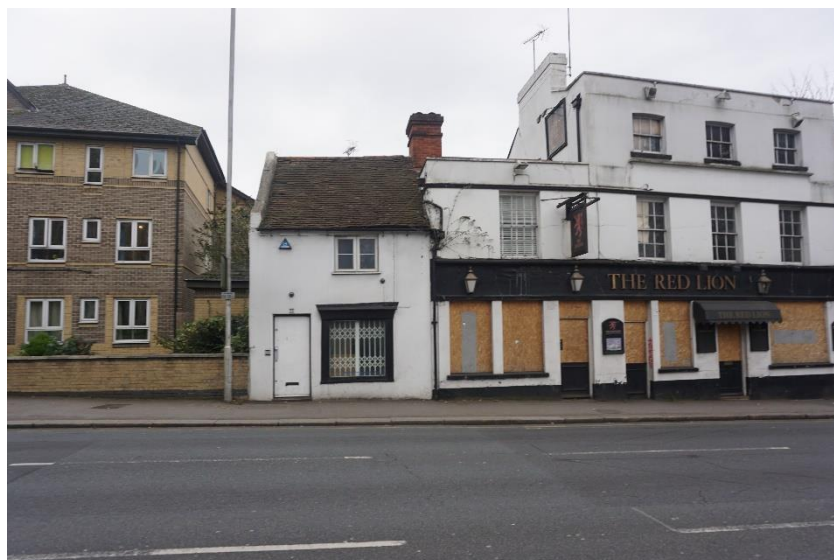
Photograph 1

The property comprises a “two up two down” semi-detached house adjoining the Red Lion public house (photo 1). The property is of loadbearing masonry and timber frame with external elevations of rendered brickwork. The roof is pitched front to back under a plain clay tiled roof (photos 2 and 3). There is a small single storey projection to the rear (photo 4).

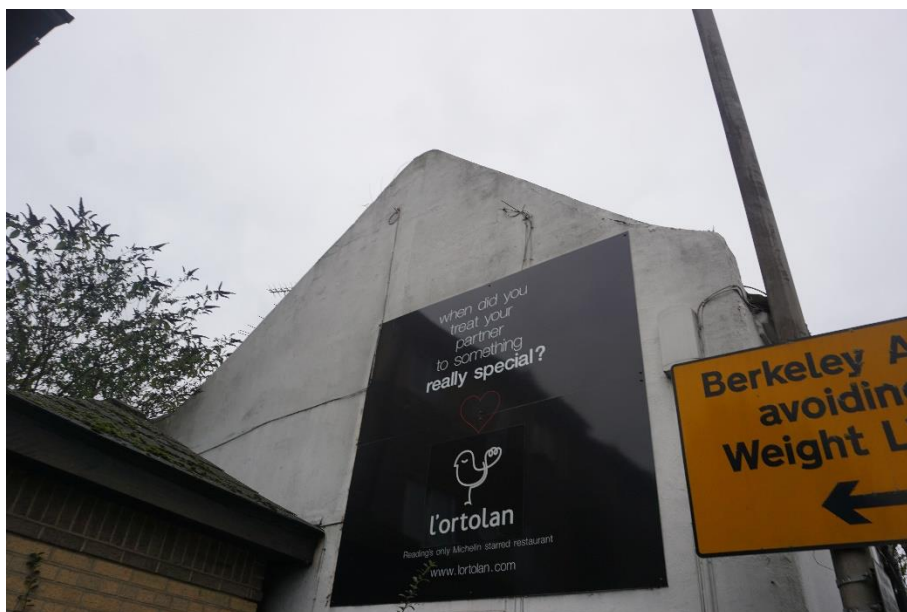
**Photograph 5**

There are several hairline to 1mm wide horizontal / stepped cracks to the external render (photo 5). There is also some cracking and disturbance to the roof verge to the end gable wall.

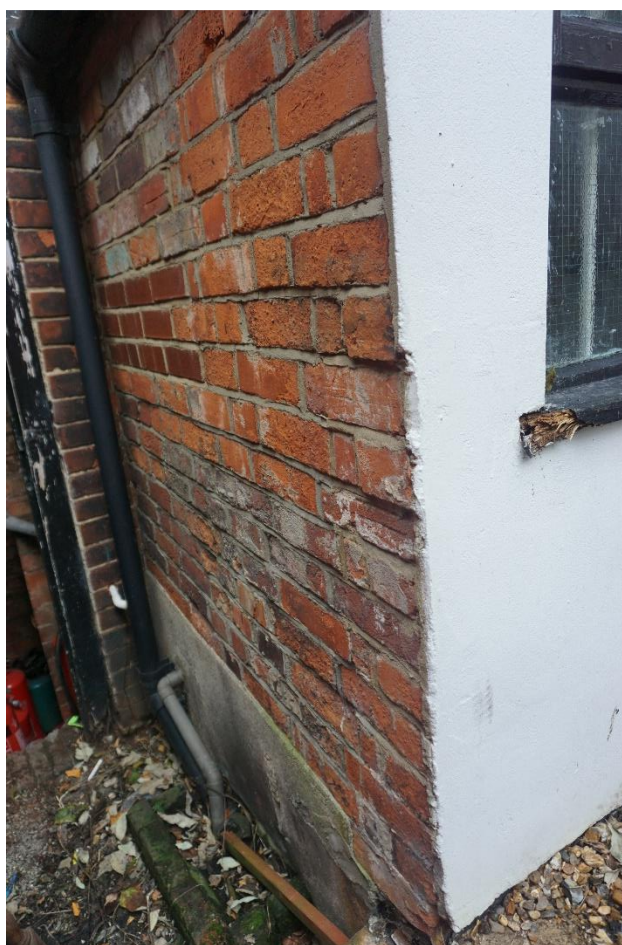
**Photograph 6**

The flank wall of the single storey projection was of face brickwork. Frost damage was noted to the surface of bricks (photo 6). There is an external, semi-basement boiler room to the rear of the property partly extending under the stairs of the

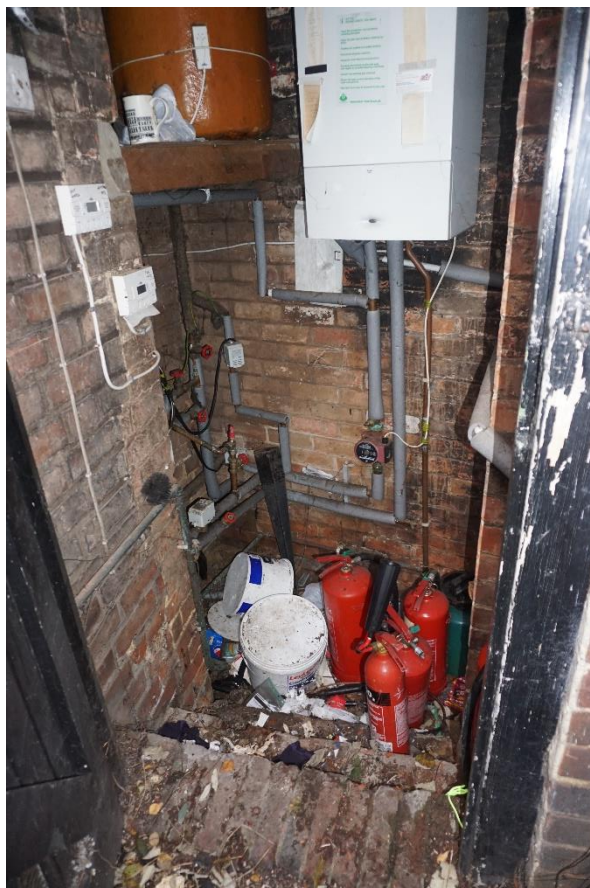
**Photograph 7**

property (photo 7).

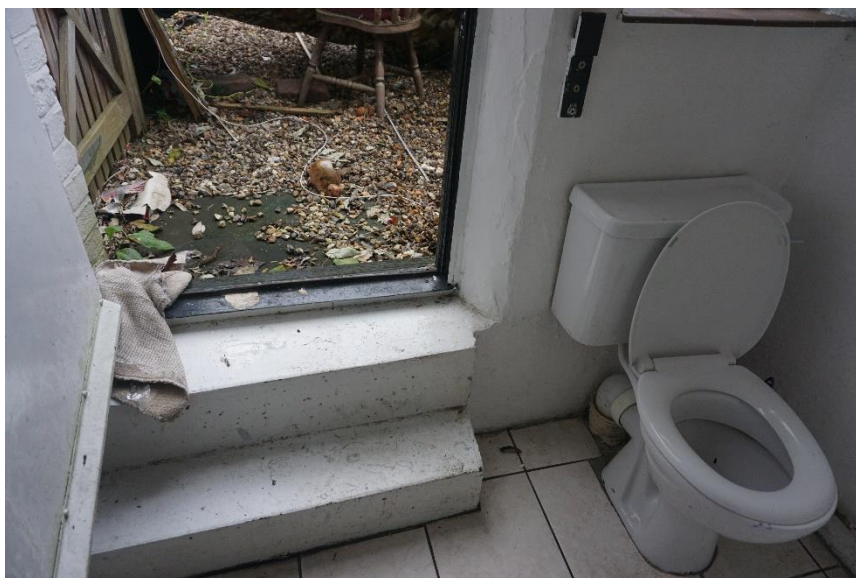
**Photograph 8**

The floor of the rear single storey projection is also partly below external ground level with steps up to the back door (photo 8). Externally a section of foundation was exposed to the rear projection above the line of the side path to the boiler room, which is approximately at internal floor level. The path then steps down further into the boiler room.

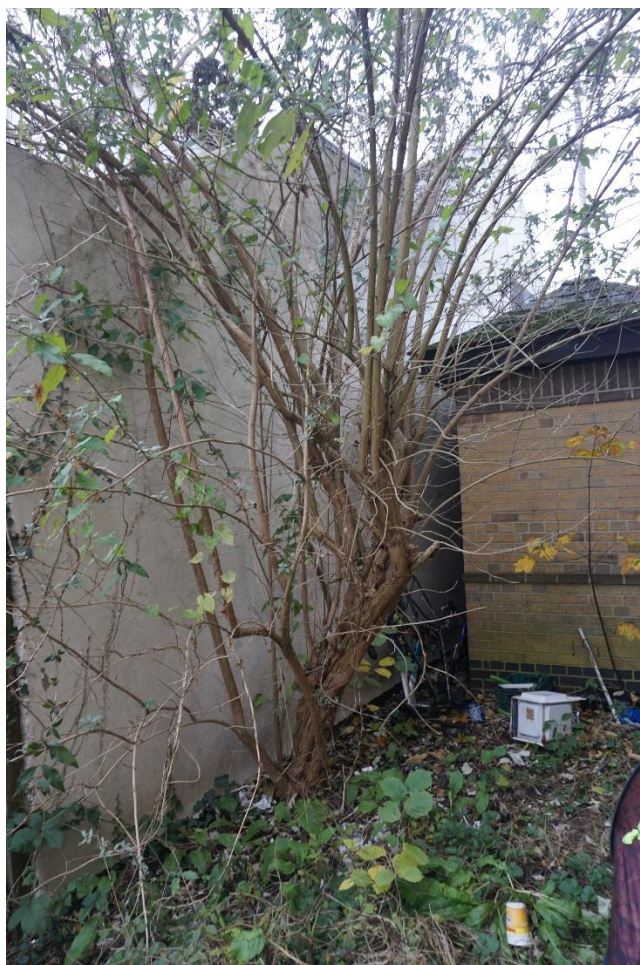
**Photograph 9**

There is a very large Buddleia within 200mm of the end gable wall of number 38, which appears to be on the neighbour's property. There is a small service building on the neighbour's property in close proximity to the end gable wall of number 38 (photo 9). This building was at a slight angle to the end wall with the front edge touching the gable; with a flashing installed to the gable wall the rear edge was approximately 300mm clear of the building.

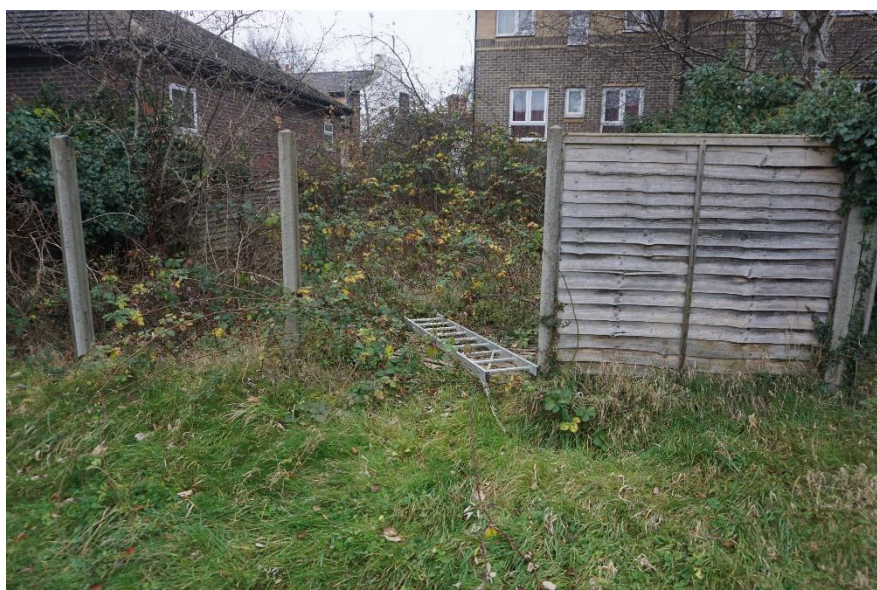
**Photograph 10**

To the rear of number 38 there is a long very narrow garden extending beyond the public house and beyond the building at the rear. The garden then opens out into a larger outside open space. Several of the fence panels were missing allowing access through the rear (photo 10). The central narrow section of garden is inaccessible due to dumped garden cuttings and other rubbish (photo 11).

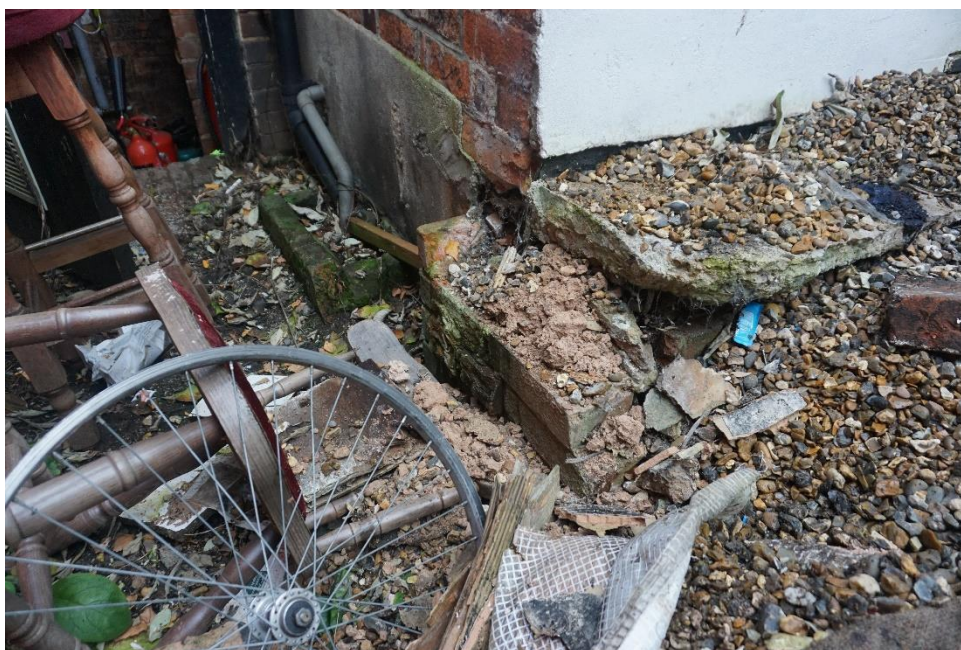
**Photograph 12**

A short section of the rear garden close to the house has been laid with large shingle / stone rejects. A section projecting foundation and external wall is partly exposed through the shingle. The single storey lean-to appears to be partly built off the old external wall. The section of foundation is built on rubble and loose debris and the slab has become partially undermined (photo 12).

The raised foundation to the rear appears to be possibly surplus so can be broken out and the wall infilled where concrete is removed.

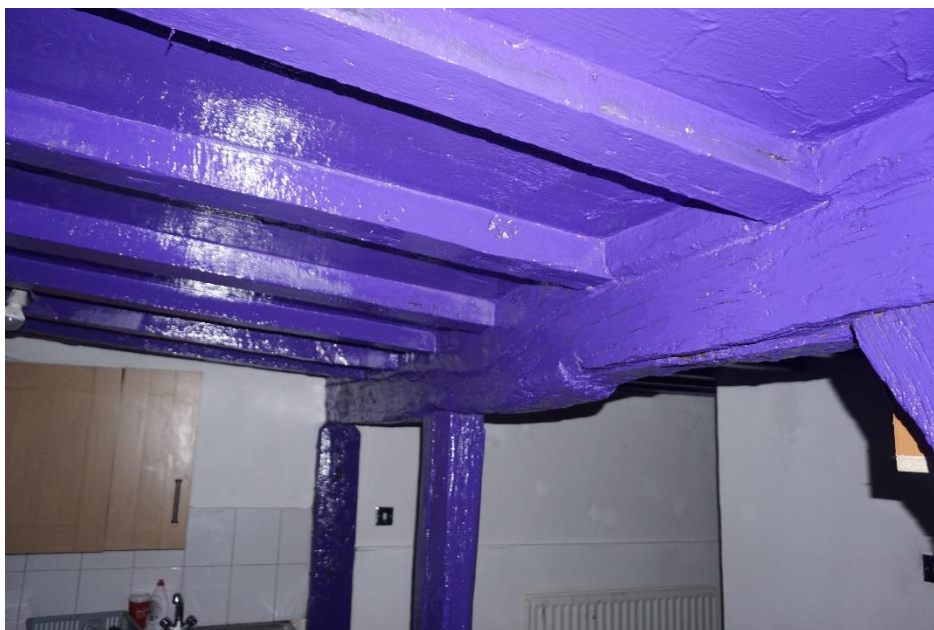
**Photograph 13**

The exposed timber elements have been painted with a thick layer of purple gloss paint. The thickness of the paint partially obscures the condition of the timbers and defects could only be fully determined with very close inspection (Photo 13).

The floor and ceiling joists are of poor quality timber and poor condition. The thick paint obscures their true condition and the random size, some of split logs triangular in section, so it will be very difficult to determine their section properties to assess their strength. Considering the size span and condition observed it is unlikely that the floor joists could be proven adequate by calculation for domestic floor loading. The joists are connected to the main beams with mortice and tenon joints. The horizontal mortice connecting the joists to the main beams is less than half the timber cross section; this remaining cross section is inadequate for support and in some locations the mortice connections have failed. The floor boarding notched into the wall is not satisfactory and clearly decayed where exposed. In view of the above it is considered likely that the original floor joists will need to be replaced.

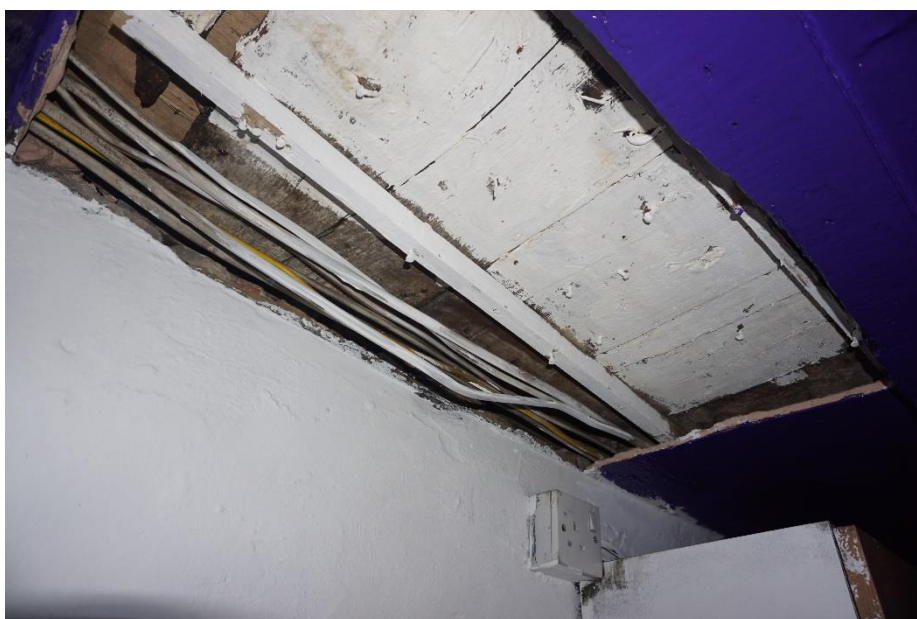
**Photograph 14**

The underside of the floor boarding to the first floor was exposed at one location, where the plaster was locally removed. The floor above has been over boarded and the new boarding could be seen where the original boarding has decayed. There is no edge joist to support the floor boards; boards are notched directly into the wall (photo 14).

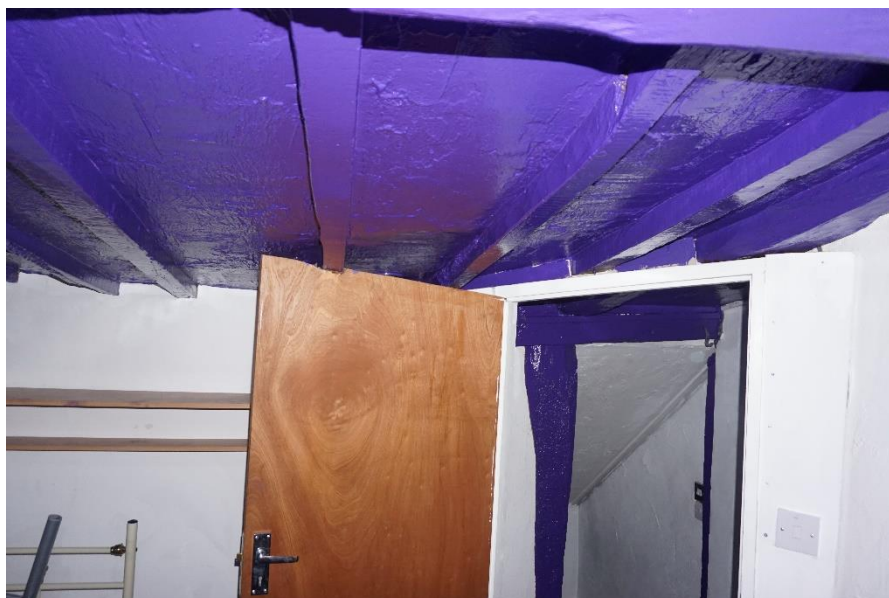
**Photograph 15**

At first floor the ceiling is very low. The doors have been cut down to fit in the space. At one location the top of the door has been cut out in the shape of the timber joists so the door can open (photo 15).

The ceiling heights at first floor are very low. It will not be possible to strengthen the floor without increasing the floor depth therefore lowering the ceiling height further. Therefore, in order to provide sufficient headroom it is likely that the roof will need to be removed to place the structure at a higher level.

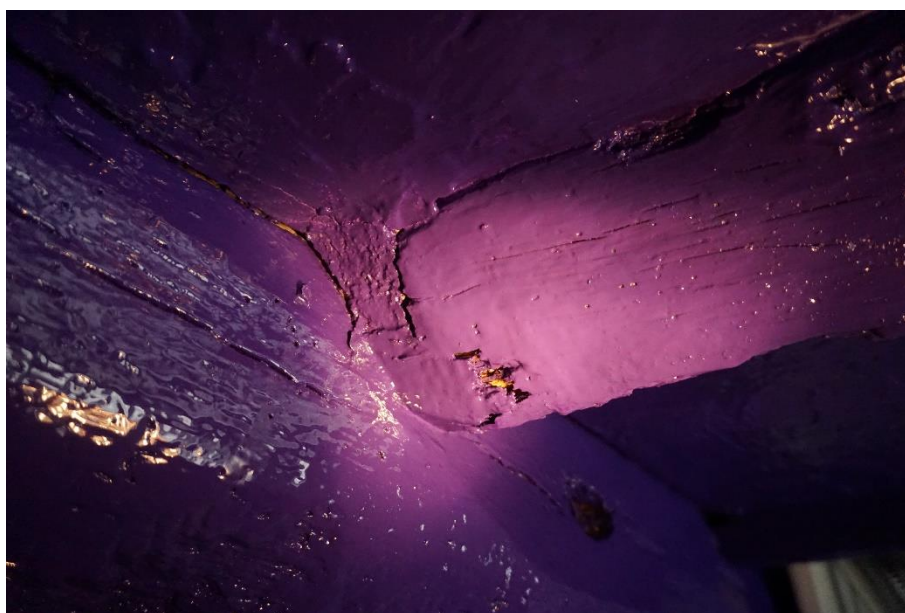
**Photograph 16**

The structure over the first floor follows a similar profile to the structure above ground floor with a timber beam spanning onto the chimney breast and a timber frame towards the rear on the line of the head of stair and internal partition. The joists have been connected with the same horizontal tenon. In some locations the timber tenon has failed and cracked the timber (photo 16).

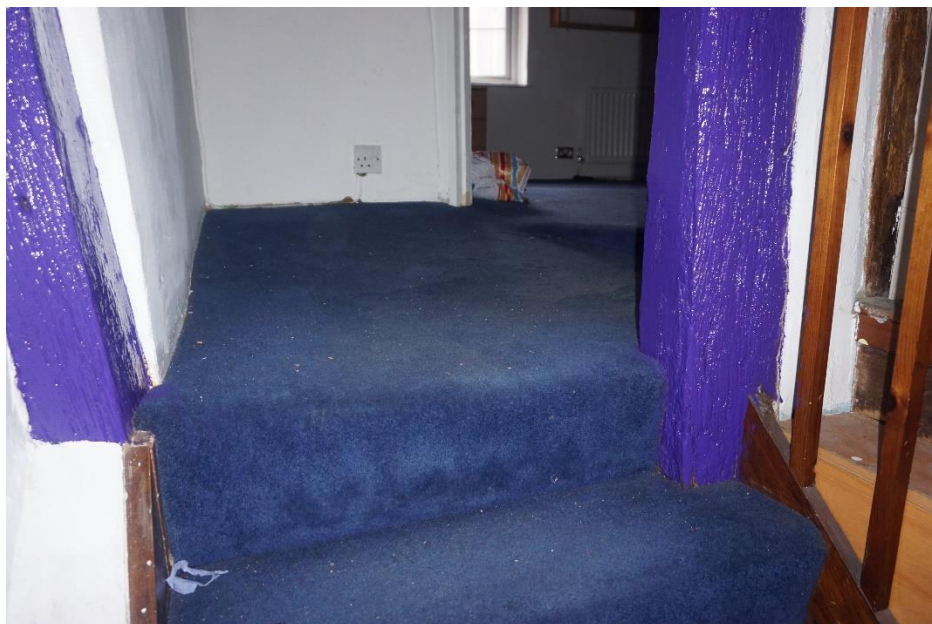
**Photograph 17**

The first floor is very uneven. There is a disconcerting slope to the landing at the top of the stairs, rising more than 100mm over the landing width. To accommodate the slope there is a triangular step at the door threshold of the main bedroom; approximately 75mm high at one end diminishing to no step at the other (photo 17). There is also a step up into the second bedroom.

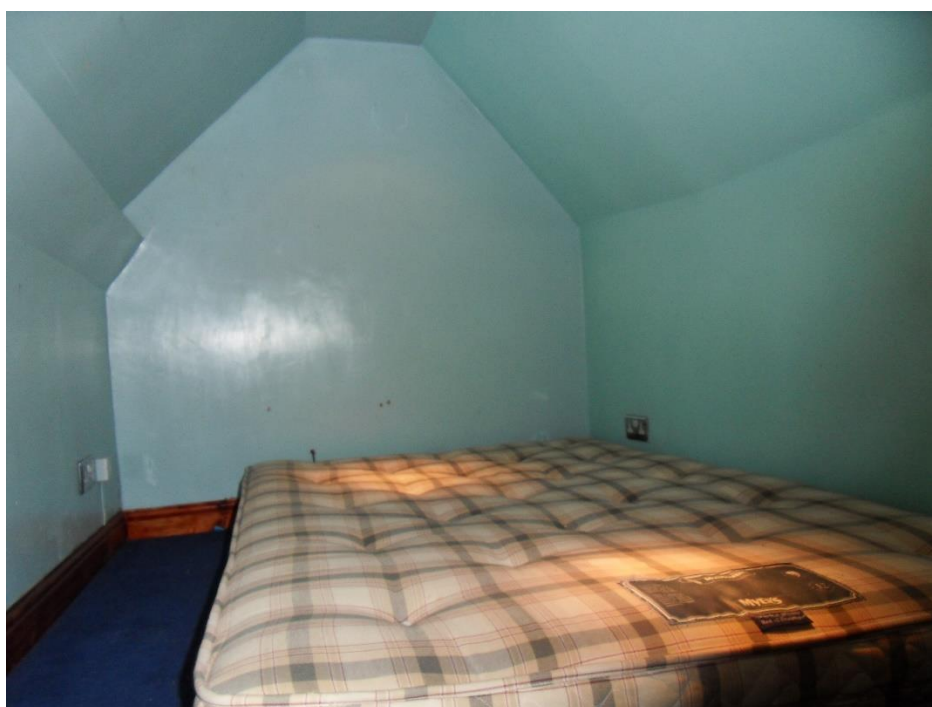
**Photograph 18**

Opening of the loft hatch reveals a loft access ladder. The loft has been converted into a room above the central section of the space (Photo 18). There is no window opening to the space. The floor is also very uneven with a similar disconcerting slope.

Previous adaptations and alterations of the property have been poorly executed without Building Control approval. The loft conversion is a prime example. The conversion has no windows or ventilation and it is likely that roof supports were removed to form the space. Further investigation would be required to determine the means of support provided to the roof structure to form the conversion and the extent of remedial works required to strengthen the roof.
