**82 Chichester Road  
Tilehurst  
Reading  
Berkshire  
RG30 4XD**

## **Daylight Bat Survey**

**Ref: R1830/a**

**January 2018**

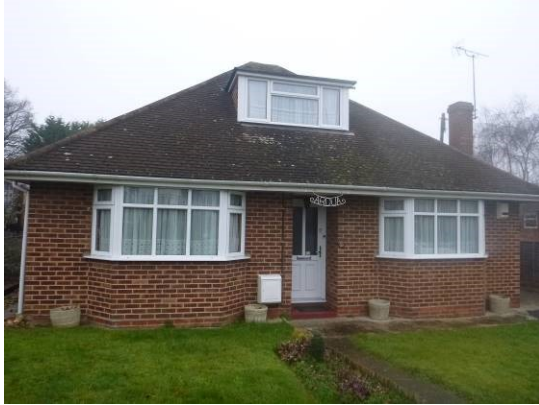
- 3.2.1** The chalet bungalow had a hipped roof covered with flat clay roof tiles; with a detached single storey pitched roofed garage present to the rear (northern) side of the bungalow (**Photographs 1, 2 & 3**).

**1. Front of the chalet bungalow viewed from the south**

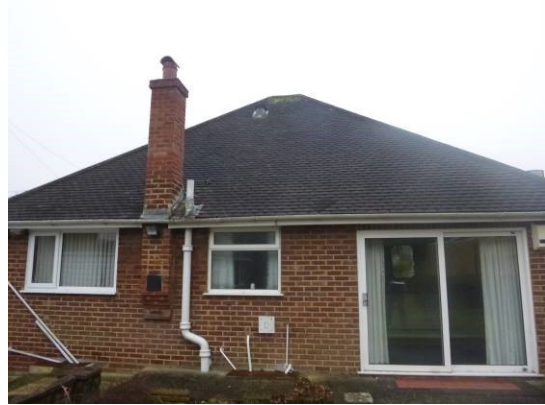
**2. Rear of the chalet bungalow viewed from the north**

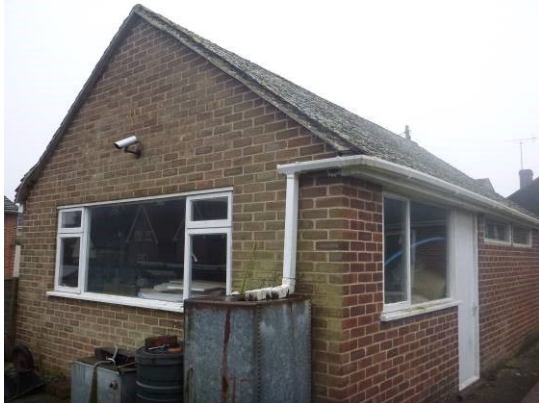
**3. The pitched roof garage situated to the rear of the chalet bungalow**

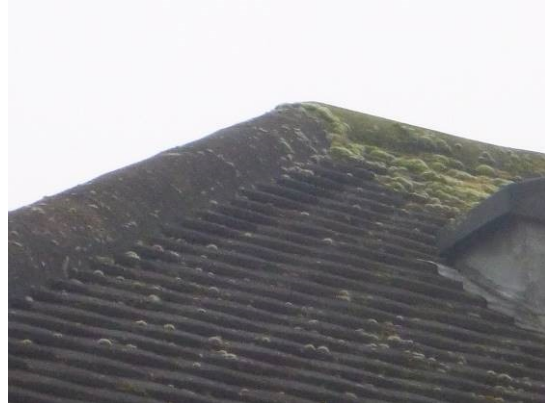
- 3.2.2** The roof tiles were mostly in place, but with the occasional gaps under the roof tiles just below the hip tiles on all elevations of the bungalow, under lifted tiles beneath the ridge on the front (south facing) elevation, under a broken tile on the front (south facing) elevation and under a group of sunken tiles behind the chimney on the rear (north facing) elevation, creating gaps suitable for roosting bats (**Photographs 4, 5, 6 & 7; Target notes 1, 2, 3 & 4**). The hip and ridge tiles were all in place and mortared fully (**Photograph 8; Target note 5**).

**4. Occasional gaps under the roof tiles just below the hip tiles to the rear of the property**

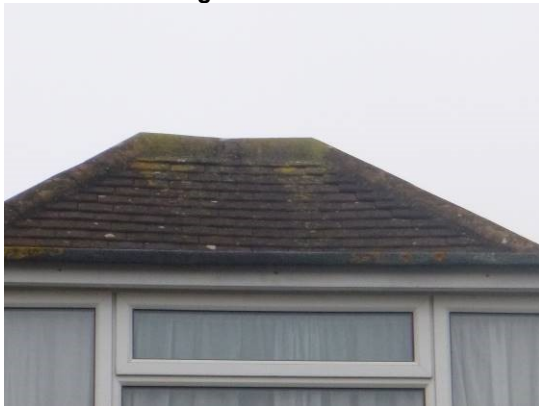
**5. Lifted roof tiles just below the ridge to the front of the property and just below the hips**

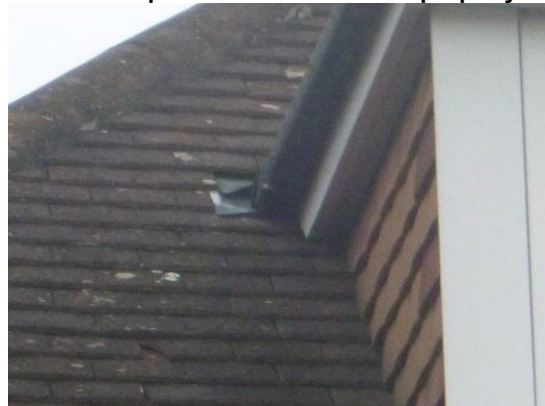
**6. Broken roof tile to the front of the property**

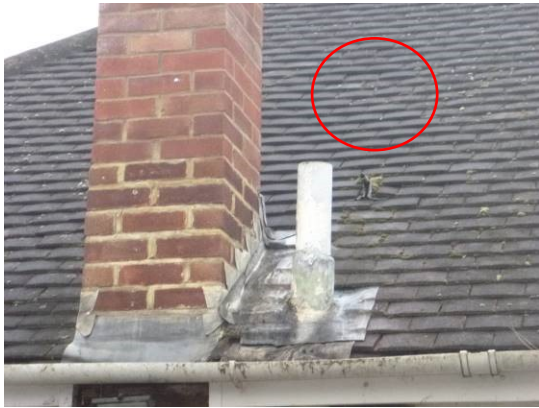
**7. Sunken roof tiles behind the chimney on the rear of the property**

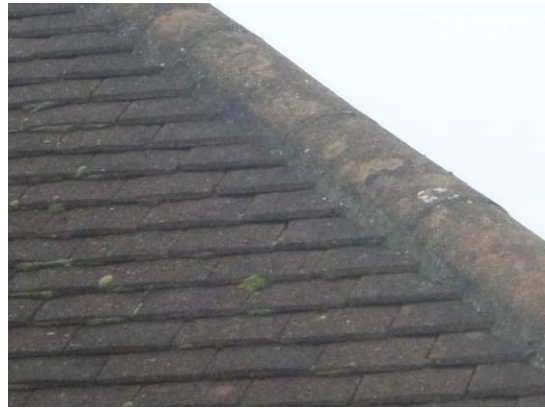
**8. Hip tiles in place and fully mortared**

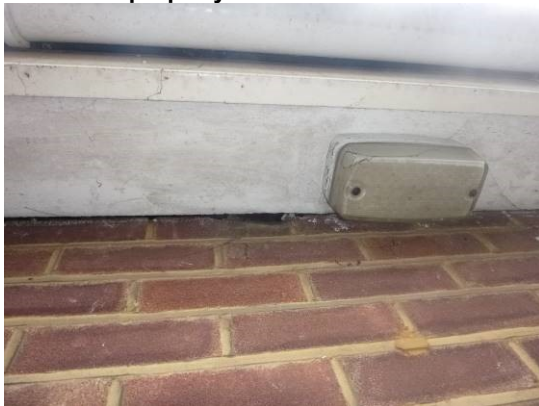
- 3.2.3** The soffits were mostly sealed tightly to the brick walls to the front of the bungalow; however, gaps were visible behind the soffits on the rear and side elevations (**Photographs 9 & 10; Target notes 6 & 7**). Lead flashing was uneven around the base of the chimney on the side (east facing) elevation and gaps were visible beneath the roof tiles directly behind the chimney on the rear (north facing) elevation (**Photograph 11; Target notes 8 & 9**).

**9. Gaps behind the soffits along the eastern side of the property**

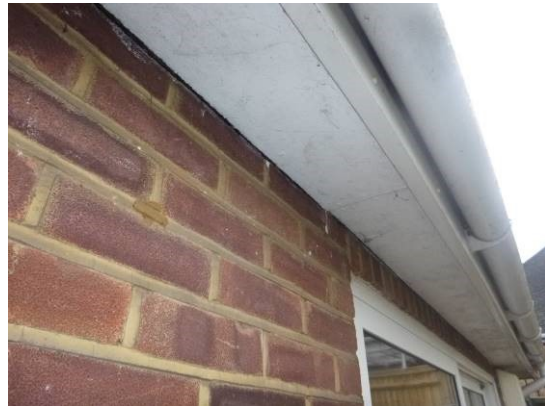
**10. Gaps behind the soffits along the rear of the property**

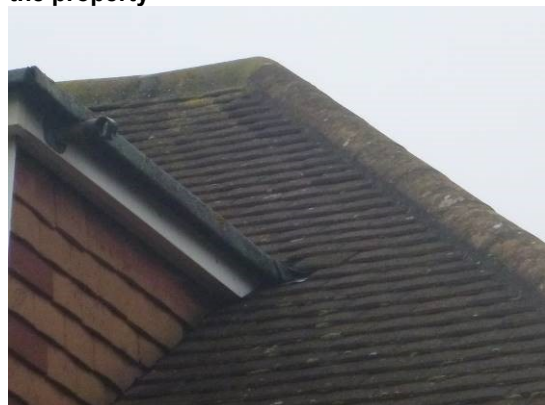
- 3.2.4** The hanging tiles on the dormer window were generally tightly fitted; however, gaps were visible at the junction of the tiles with the main roof, offering potential roosting opportunities for bats (**Photograph 12; Target note 10**).

**12. Potential gaps where the dormer window joined the main roof**

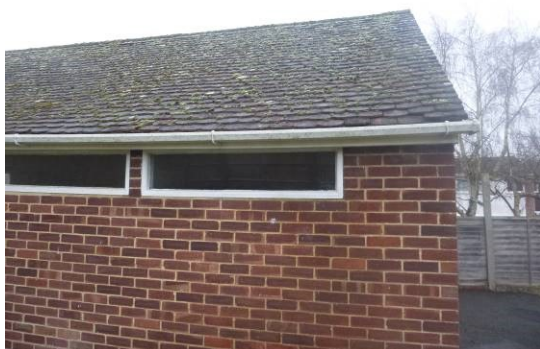
- 3.2.5** The garage was of brick construction with a pitched roof covered in flat roof tiles. The roof and ridge tiles were all in place and tightly fitted (**Photograph 13; Target note 11**). The front (southern facing) gable end was clad with hanging tiles, which were relatively flat; however, a couple of tiles were

**13. Roof tiles in place and tight on the garage**

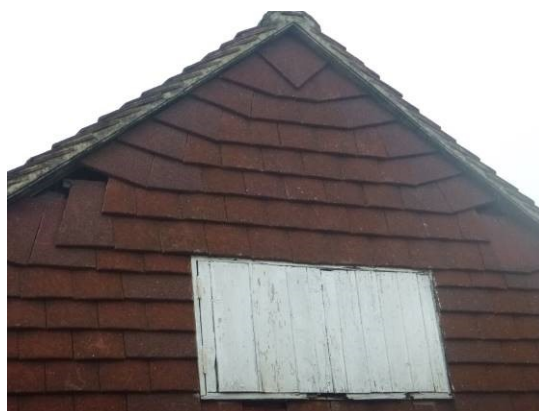
missing, creating access opportunities for bats (**Photograph 14; Target note 12**). The verge tiles at the front of the garage were mostly mortared apart from a large gap which was present where the tiles joined the soffit box (**Photograph 15; Target note 13**). Gaps were visible between the under-cloaking and bricks along the verge at the rear of the garage (**Photograph 16; Target note 14**). There were also a couple of cracks in the mortar and a large gap where the under-cloaking was damaged at the rear gable end (**Photograph 17; Target notes 15 & 16**).

**14. Hanging tiles missing on the gable end to the front of the garage**

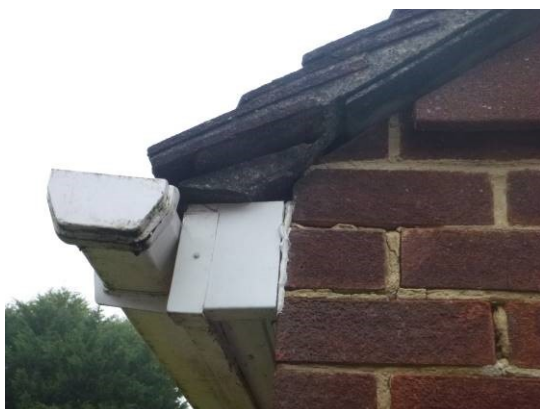
**15. Large gap present where the verge tiles joined the soffit box at the front of the garage**

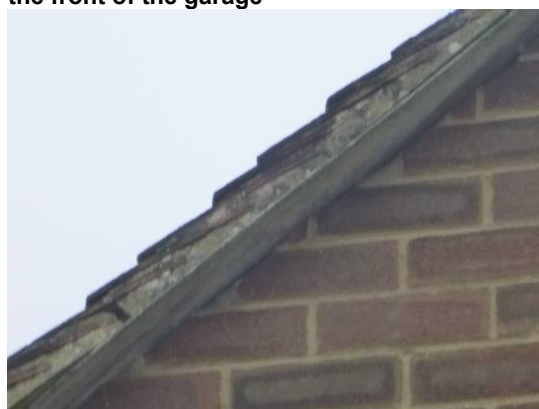
**16. Gaps between the under-cloaking and bricks along the rear gable end of the garage**

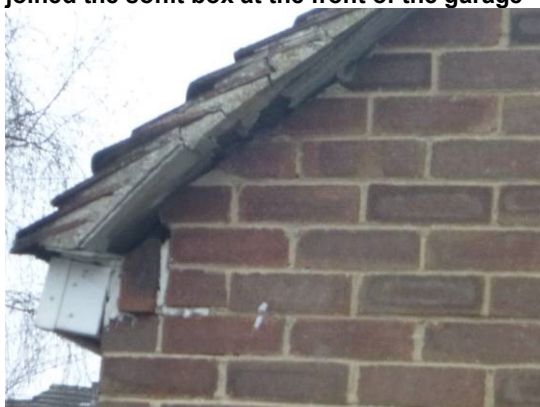
**17. Crack in the mortar and a large gap where the under-cloaking was damaged on the rear gable end of the garage**

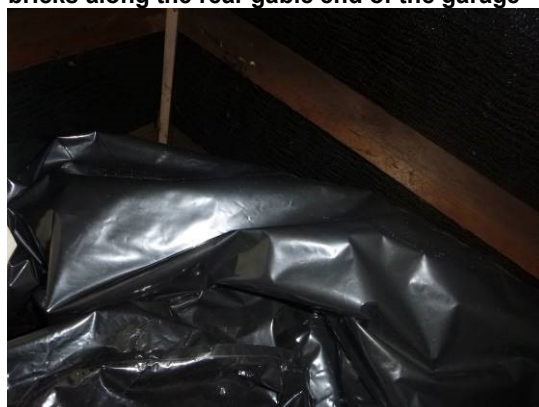
**3.3.1** The bungalow's roof space was accessed via a loft hatch and had an estimated roof to ridge height of one metre. The roof was of 'cut and pitch' construction with hipped ends, and was lined with bitumen roofing felt. A large water tank below the ridge blocked access into the roof space (**Photograph 18**). The bitumen felt, where visible from the loft hatch, was fitted tightly (**Photograph 19; Target note 17**). The ridge was cobwebbed, which can indicate that there has been little or no recent bat activity at the ridge (**Photograph 20; Target note 18**). The floor was insulated with fibreglass (**Target note 19**).

**18. Internal view of the roof space with access blocked by a water tank**

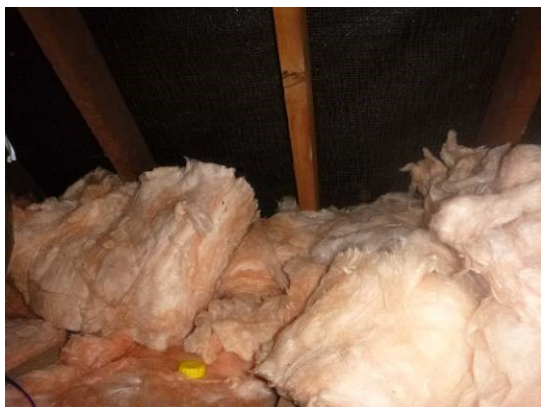
**19. The roof space lined with bitumen felt.**

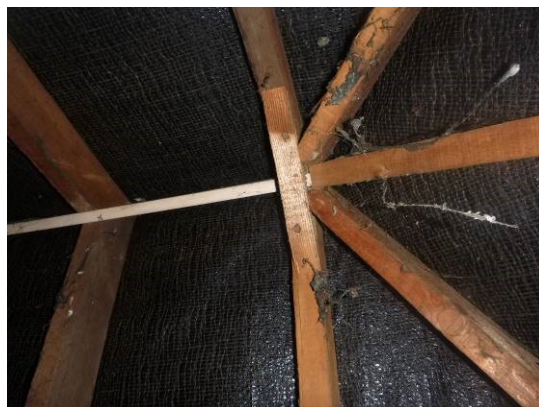
**20. The ridge of the roof space which was cobwebbed.**

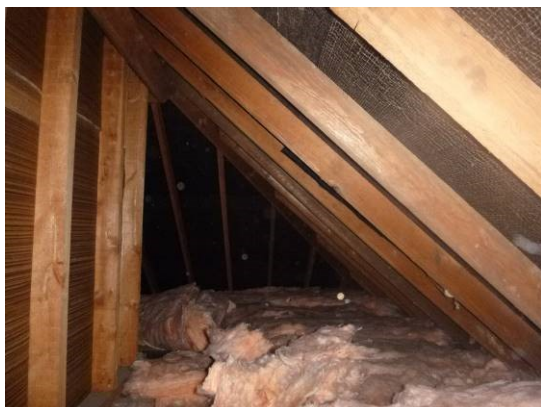
**3.3.2** The eaves space was accessed via a doorway along the northern side of the bungalow and had an estimated roof height of 1.5 metres. The roof was lined with bitumen roofing felt, which was intact and fitted tightly (**Photograph 21; Target note 20**). Paper backed fibreglass was present on the internal walls (**Photograph 22**). The rafters were cobwebbed, which can indicate that there has been little or no recent bat activity within the eaves space (**Photograph 23; Target note 21**).

**21. Internal view of the eaves space which was lined with bitumen felt.**

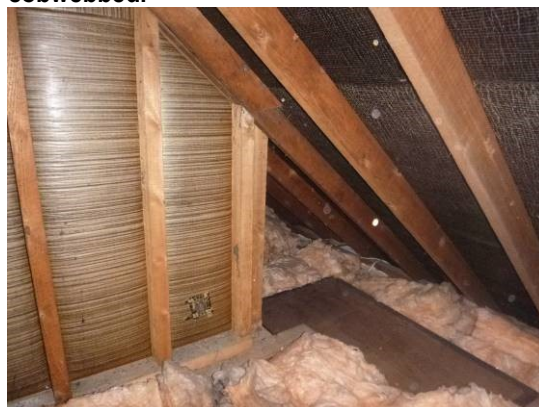
**22. The internal walls of the eaves space insulated with fibreglass and paper.**

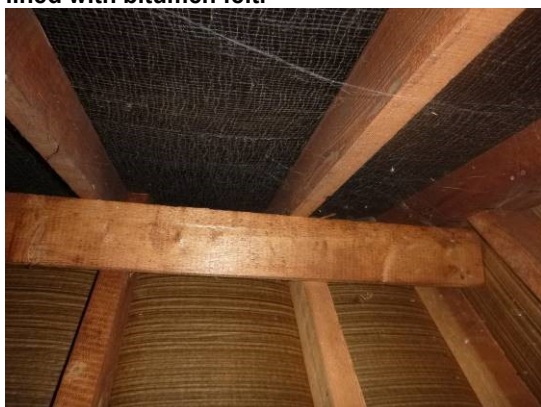
**23. The cobwebbed rafters of the eaves space.**

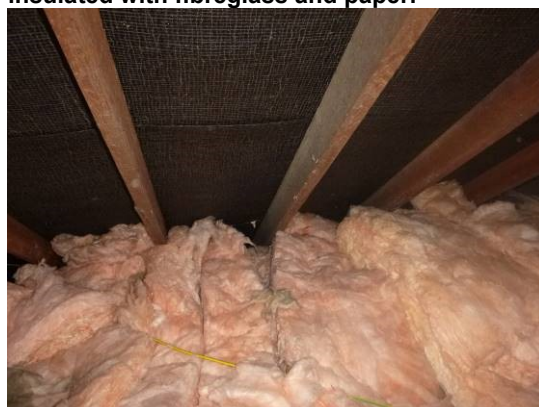
**3.3.3** The floor was boarded partially and insulated with fibreglass, which did not extend as far as all of the eaves, which were open in places (**Photograph 24; Target note 22**). Two old wasps' nests were present in the eaves space, along the eastern and rear roof elevations (**Photograph 25; Target notes 23 & 24**).

**24. The eaves which were filled with fibreglass in places.**

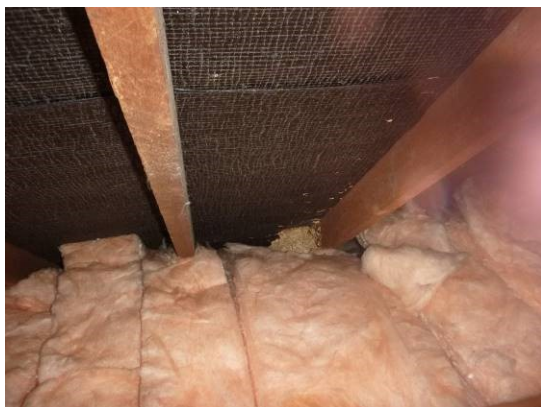
**25. Wasps' nest present along the rear (north facing) side of the eaves space**
