**24 Park Crescent  
Reading  
Berkshire  
RG30 2NL**

# **Preliminary Bat Roost Assessment**

**Ref: 1942/b**

**June 2018**

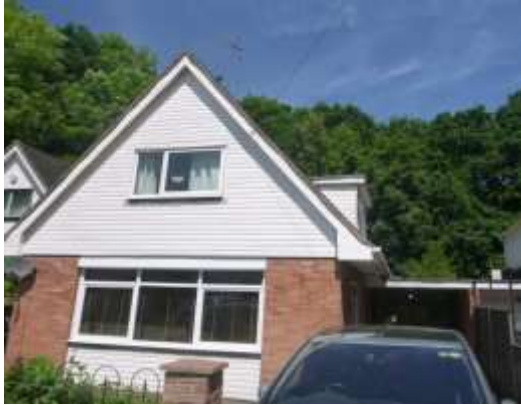
- 3.2.1** The house was of modern brick, cavity wall construction with a two storey pitched roof (**Photographs 1 & 2**); a single-storey flat-roof garage was situated to the western side (**Photograph 3**).

**1. Front elevation viewed from south.**

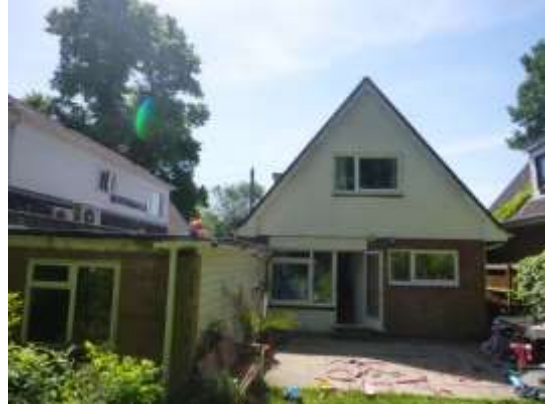
**2. Rear elevation viewed from the north.**

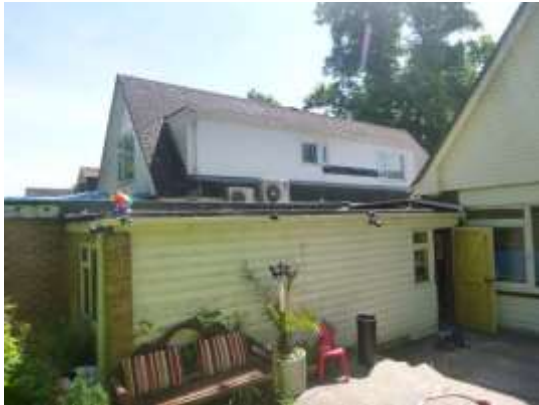
- 3.2.3** The flat-roofed sections of the dormer windows were covered with bitumen felt, with the lead flashing at the base fitted tightly (**Photograph 7; Target Note 4**). The roof of the garage was covered with bitumen felt also with the sides clad with tightly fitted barge boards (**Photograph 3; Target Note 5**); no gaps were visible.

**3. Rear garage extension.**

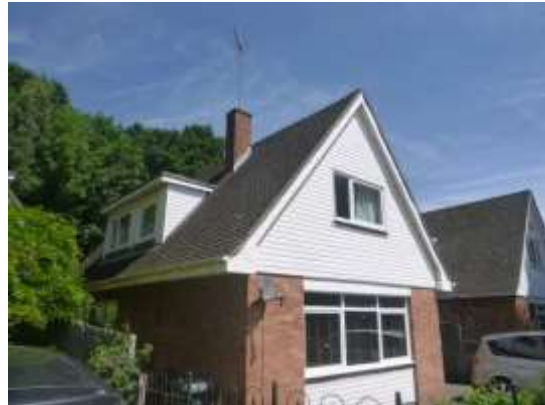
- 3.2.2** The roof was lined with flat clay tiles that were intact and fitted tightly, with no visible gaps (**Photograph 4; Target Note 1**). The ridges were all mortared fully, with UPVC boards cladding the second elevation throughout and at the dormers on either side. The eaves was fitted with wooden soffit boxes that were fitted tightly in most places; however, a small cobwebbed gap was present at the north-western corner at the rear (**Photograph 5; Target Note 2**). Another narrow gap was present behind the soffits at the rear gable but this was cobwebbed and unsuitable for bats (**Photograph 6; Target Note 3**).

**4. Roof tiles tightly fitted; second elevation clad with UPVC.**

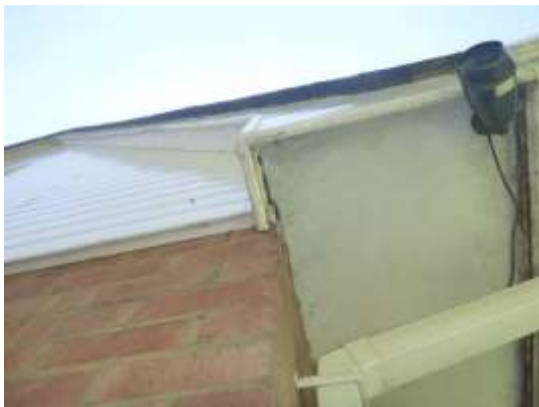
**5. Cobwebbed gap under soffit at rear.**

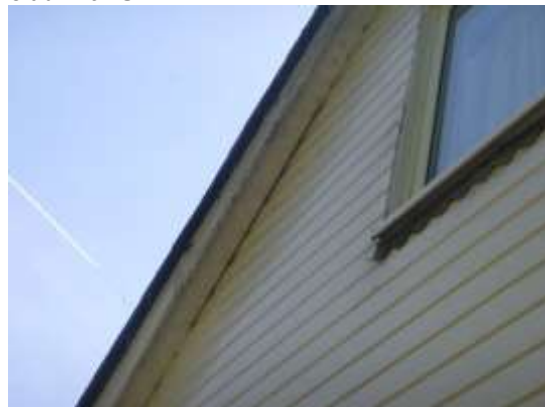
**6. Cobwebbed barrow gap behind soffit at rear elevation unsuitable for bats.**

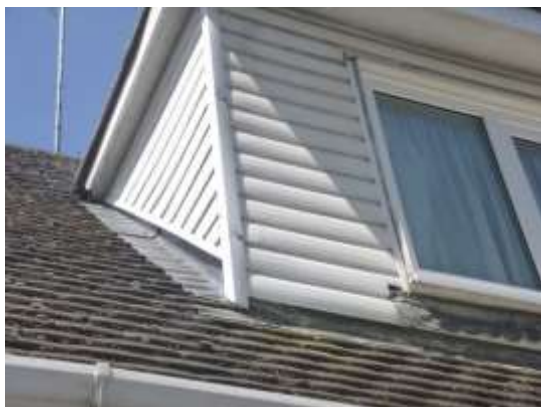
**7. Lead flashing at base of dormer fit tight.**

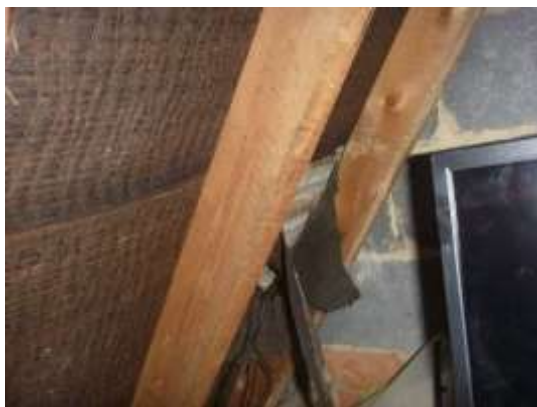
- 3.3.1** The house had one internal space which was accessed via a loft-hatch located centrally. The roof was of cut-and-pitch construction and was approximately two metres in height at the ridge, which was cobwebbed. The roof was insulated with bitumen felt, which was mostly intact; however, a tear in the felt was present at both ends, behind which, the roof tiles were

visible (**Photograph 8; Target Note 6**). The floor of the roof space was boarded centrally; this appeared to be relatively new and had fibreglass installed in 2009 underneath. A combination of fibreglass and Styrofoam filled the eaves (**Photograph 9; Target Note 7**). Block work was present at both gable ends. Several gaps were visible through the blockwork but they were filled with fibreglass (**Photograph 10; Target Note 8**), offering no visible opportunities for roosting bats to access the void. A light draught was felt flowing through the roof space, entering via a circular roof vent (**Photograph 11**).

**8. Tear in bitumen felt; tiles visible.**

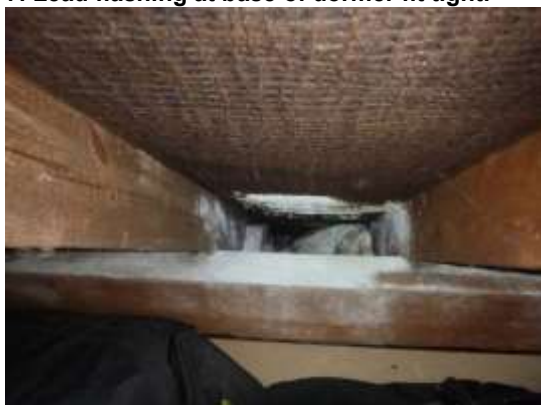
**9. Styrofoam and fibreglass lining eaves**

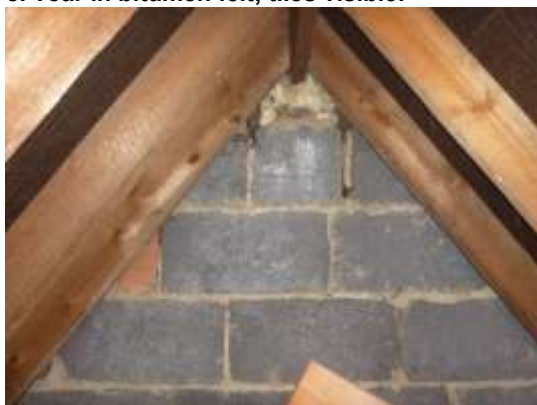
**10. Fibreglass filling gaps between blockwork at gable ends.**

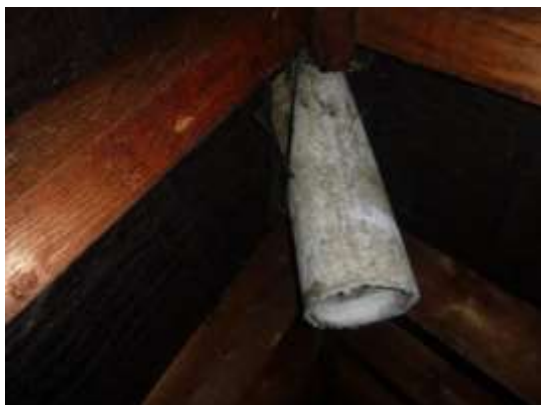
**10. Roof vent allowing draught into roof space.**

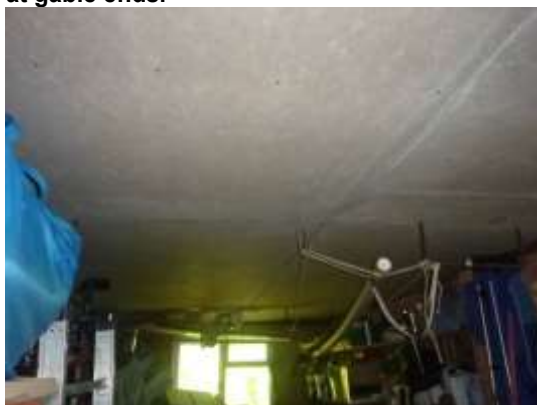
- 3.3.2** An inspection of the interior of the garage was carried out and no evidence of bats was visible. The garage is currently used for storage, with the roof space being partly-boarded (**Photograph 12; Target Note 9**)
- 3.3.3** No bats or evidence of bats were visible within the loft space of the house or inside the garage during the survey. A few rat and mouse droppings were discovered in the roof space of the house in the fibreglass lining between the wooden boards.

**11. Roof space of garage partly-boarded centrally.**

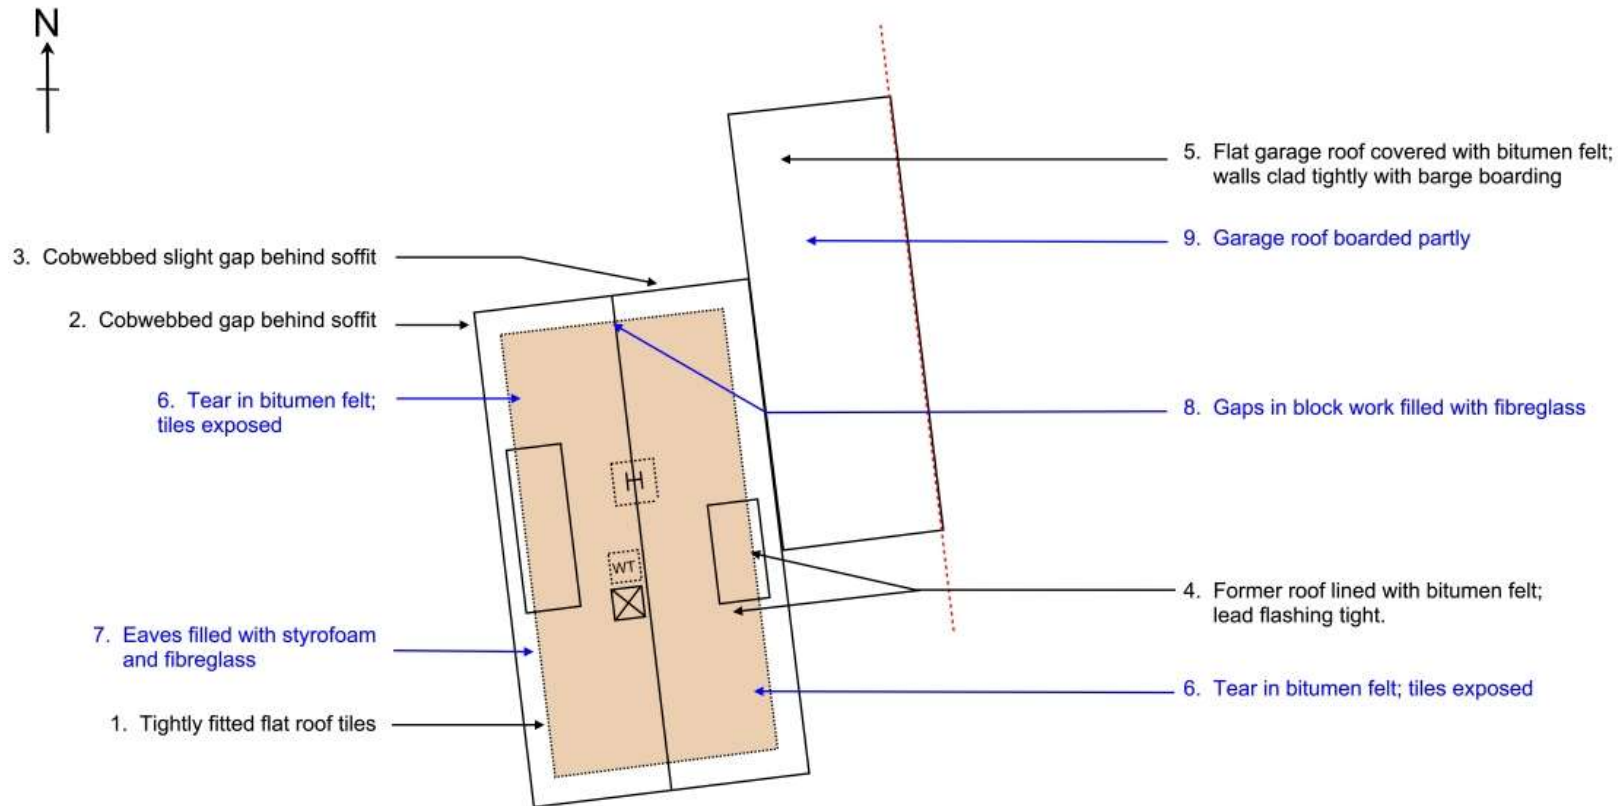
- 3.1.1** Photographs of the site are presented in **Appendix 1** and a plan of the external and internal survey findings with associated target notes is shown in **Appendix 2**. The survey findings from the exterior and interior of the house and garage are described as follows:
