**37 Coley Avenue  
Reading  
Berkshire  
RG1 6LL**

## **Daylight Bat Survey**

**Ref: R1864/b**

**April 2018**

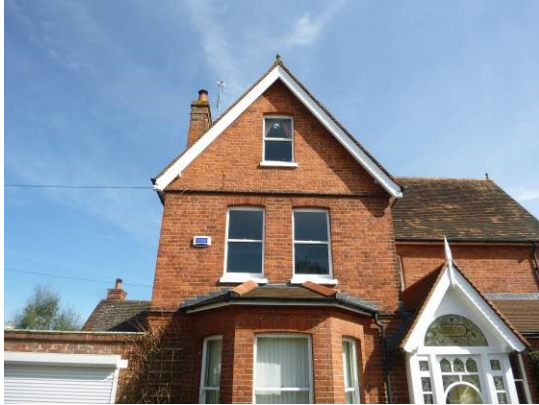
- 3.2.1** The house is of brick solid wall construction. It is a three storey building with multi-pitched roof covered with clay tiles, and has a flat roofed garage to the northern side. A single storey pitched roof extension is situated to the rear (eastern side) (**Photographs 1 & 2**).

1. Front of the house viewed from the west.

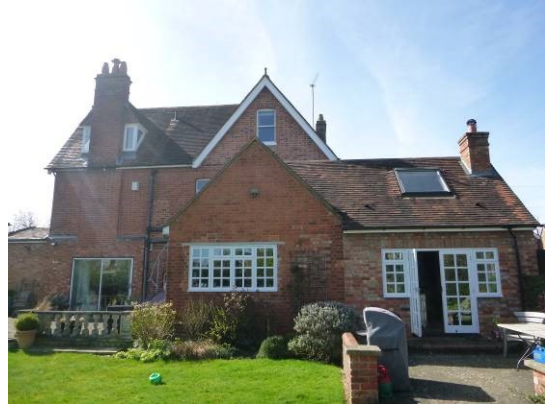
2. Rear of the house viewed from the east.

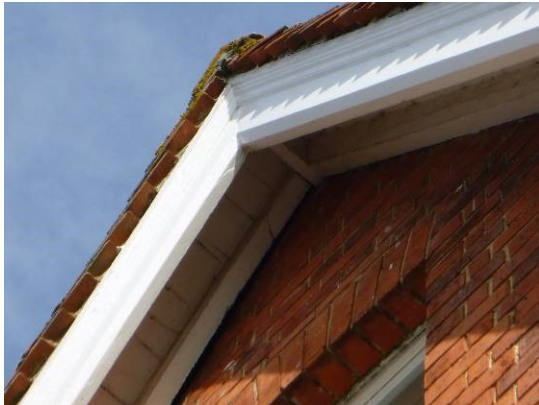
- 3.2.3** There was a large gap under the soffits of the front (west-facing) gable (**Photograph 3; Target Note 1**) and at the corners between the timber soffits and the brickwork (**Photograph 4; Target Note 2**). A gap was also present between the timber soffits at the corner of this section (**Photograph 8; Target Note 5**) although the verges were well mortared (**Photograph 9; Target Note 6**). On the south facing side of the rear extension, an open vent was present that would offer access to bats to the space behind (**Photograph 10; Target Note 7**). On the side (north-facing) section there was a gap beneath the soffits at the corner of the eaves towards the front (**Photograph 11; Target Note 8**). The lead flashing at the base of the chimney was fitted tightly to the tiles (**Photograph 12; Target Note 9**) but gaps were present at the side of the chimney base where the soffits of the chimney met the main roof (**Photograph 13; Target Note 10**). The tiles in this section were mostly flat and even. No gaps were seen on top of the garage at the flat roof section.

3. Gap under soffit of front gable.

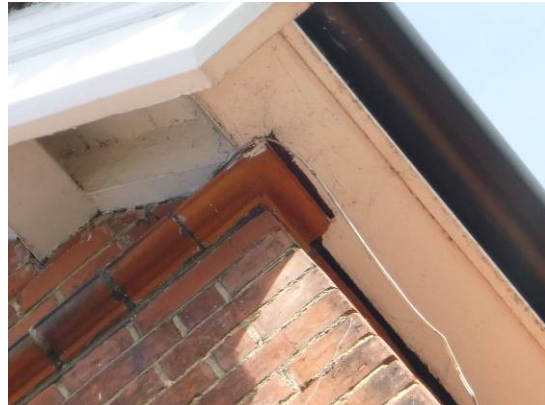
4. Gap at corner of front.

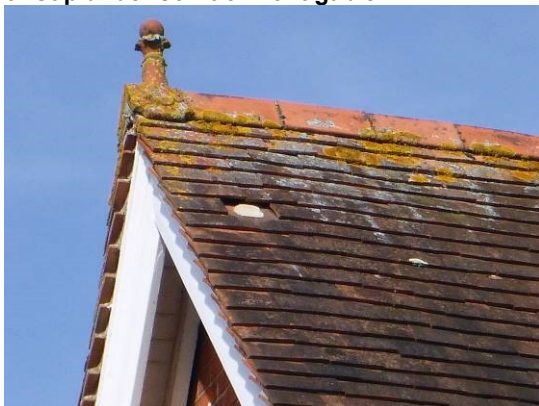
- 3.2.2** The flat clay tiles covering the roof were uneven in several places, with tiles missing occasionally. The gaps were more prevalent at the rear (**Target note 15**) than at the front, offering potential roosting opportunities for bats although no evidence of use was seen at the time of the survey. A missing tile was present at the top of the west facing gable on the south-facing side (**Photograph 5; Target Note 3**). At the rear of the building, occasional gaps beneath the roof tiles were visible (**Photograph 6**). A tile was lifted at the gable junction at the single storey pitched roofed section (**Photograph 7; Target Note 4**).

5. Missing tile at front gable

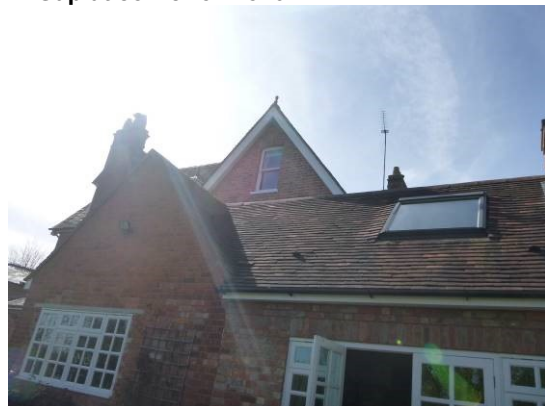
6. Occasional gaps beneath tiles in rear section.

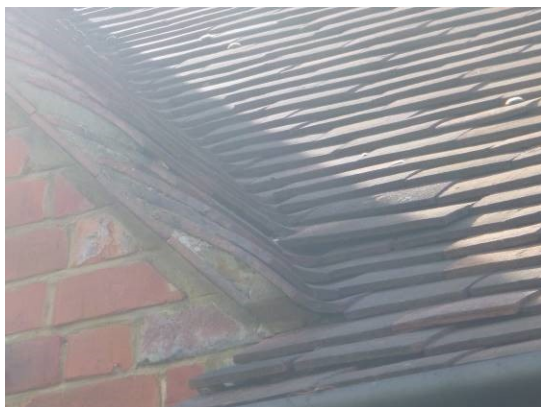
**7. Gap at junction of rear pitched section**

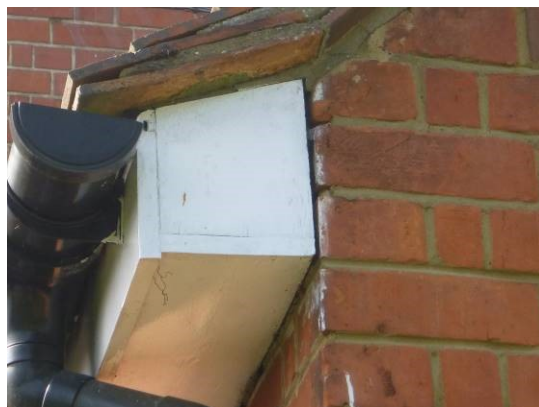
**8. Gap beneath timber soffits.**

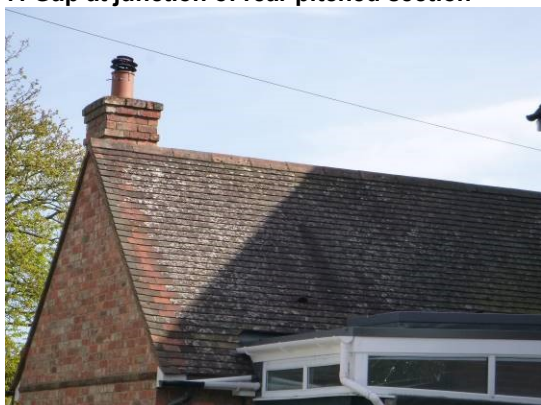
**9. Verges well mortared.**

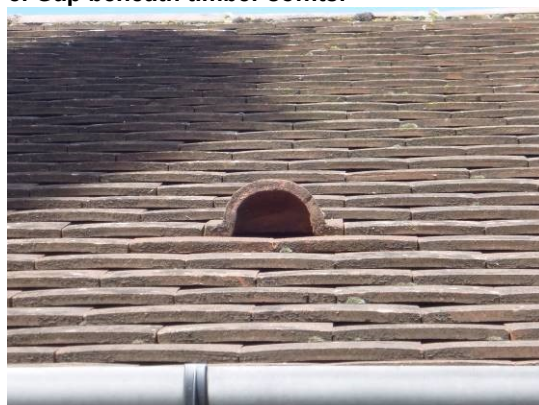
**10. Vent on rear extension.**

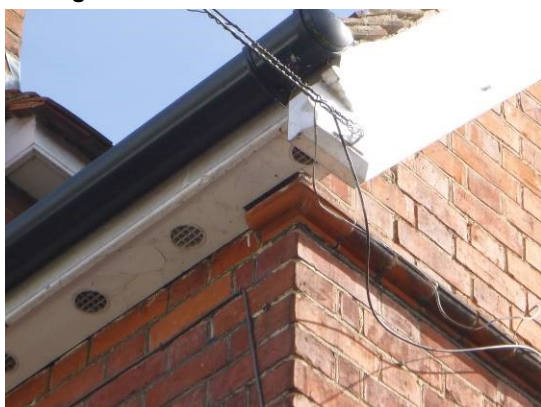
**11. Gap under soffit at north-western corner.**

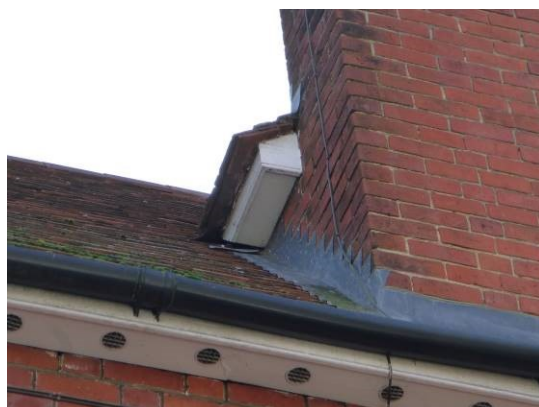
**12. Lead flashing tight around chimney.**

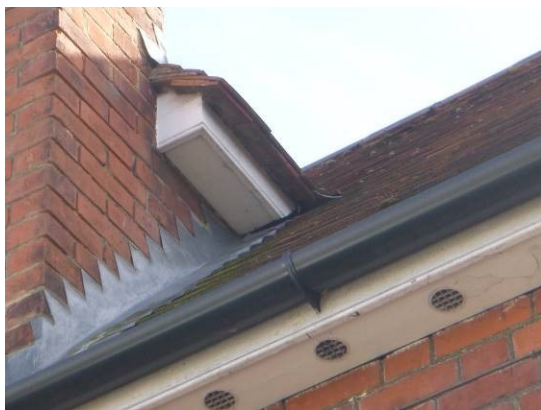
**13. Gap under soffit at junction of chimney and roof.**

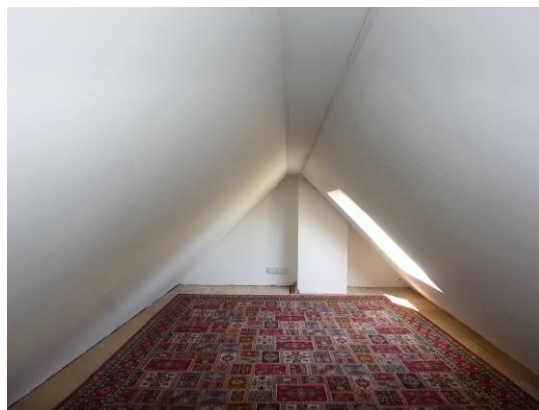
- 3.3.1** The house had two main enclosed roof spaces. The first was located in the main roof between the west-facing (front) and south-facing (side) gables; an eaves space was situated towards the rear of the roof void. The rear extension contained a second loft space above the kitchen that had been converted into a room (**Photograph 14**). The walls of this section had been plastered over.

**14. Internal view converted loft space.**

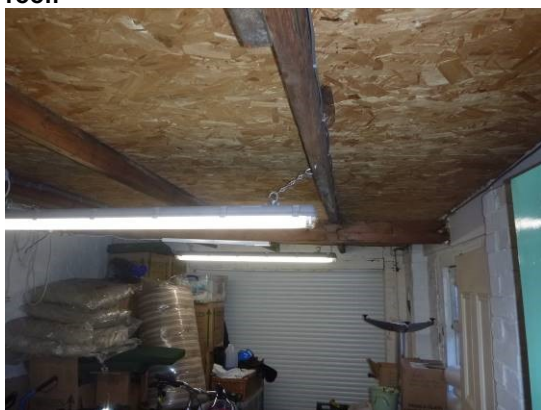
- 3.3.4** The garage had a chipboard ceiling (**Photograph 15**) that sloped to join the pantry section containing a skylight (**Photograph 16**). The garage had tightly fitted polystyrene at the eaves (**Photograph 17; Target Note 11**).

**15. Chipboard ceiling in garage.**

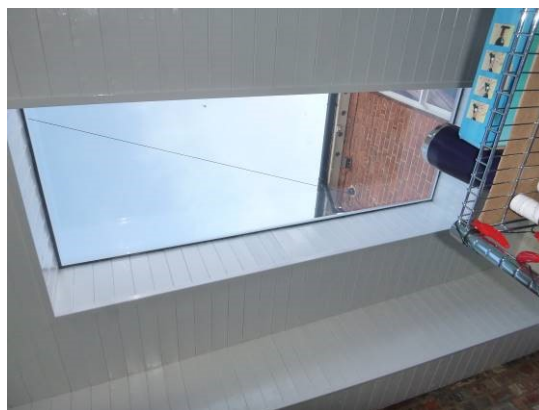
**16. Skylight above pantry space.**

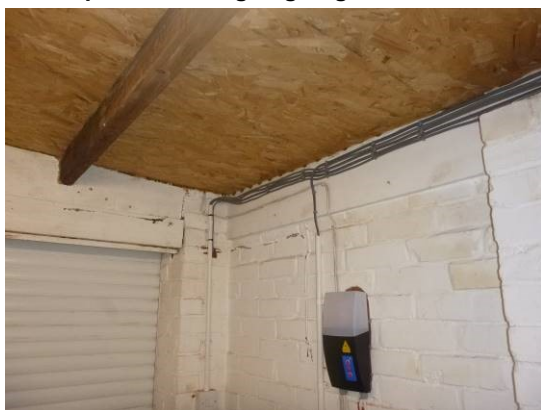
**17. Polystyrene fittings at eaves.**

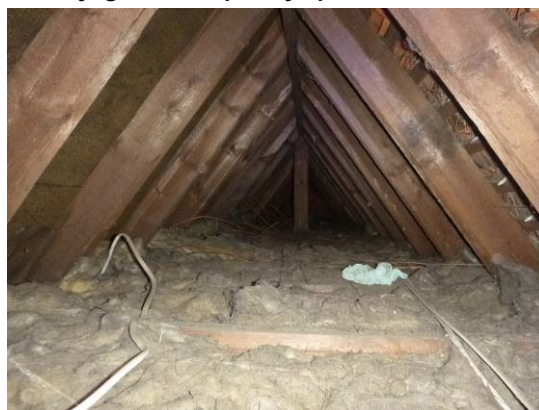
**18. Main roof space half lined with bitumen felt.**

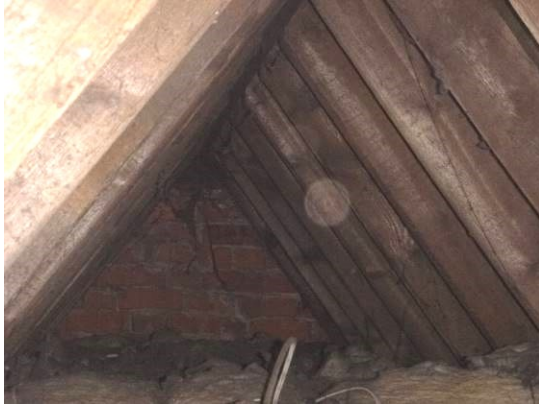
**19. Brickwork intact at front facing gable.**

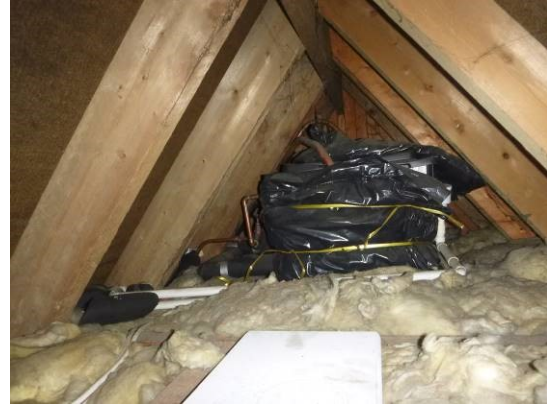
**20. Boarded gable toward rear behind water tank.**

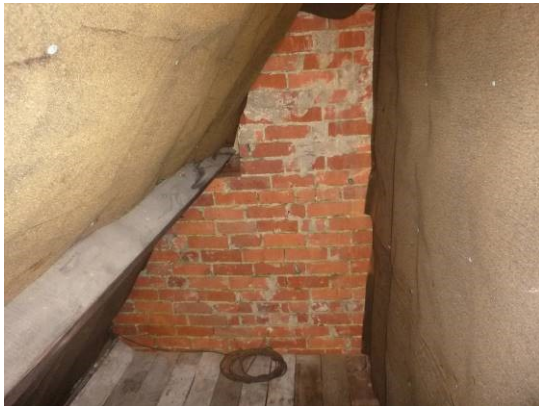
- 3.3.3** An eaves space was located towards the rear, below the main roof space and was accessed via a door. The roof and side wall contained fibreglass and was covered in bitumen felt (**Photograph 21; Target Note 15**). Wooden panelling lined the floor and the brickwork at the end had a gap beyond, where wooden boards were visible (**Photograph 22; Target Note 15**).

**21. Brickwork at end of rear eaves space.**

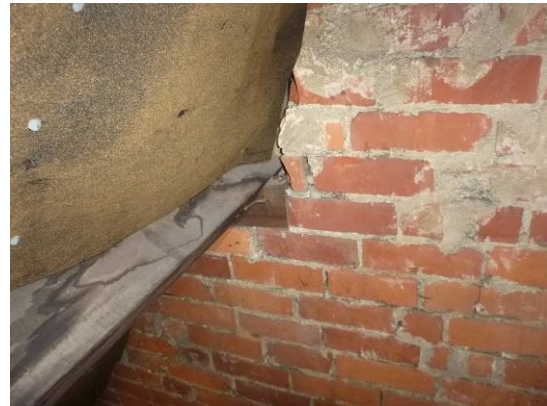
**22. Gap at rear eaves space with wooden board exposed.**
