**Arboricultural survey to British  
Standard B.S. 5837: 2012 'Trees in  
relation to design, demolition and  
construction - Recommendations'  
at  
Former Cox and Wyman premises  
Cardiff Road  
Reading**

**Prepared by**  
Simon Hawkins N.D Arbor M. Arbor. A.

19/12/2016

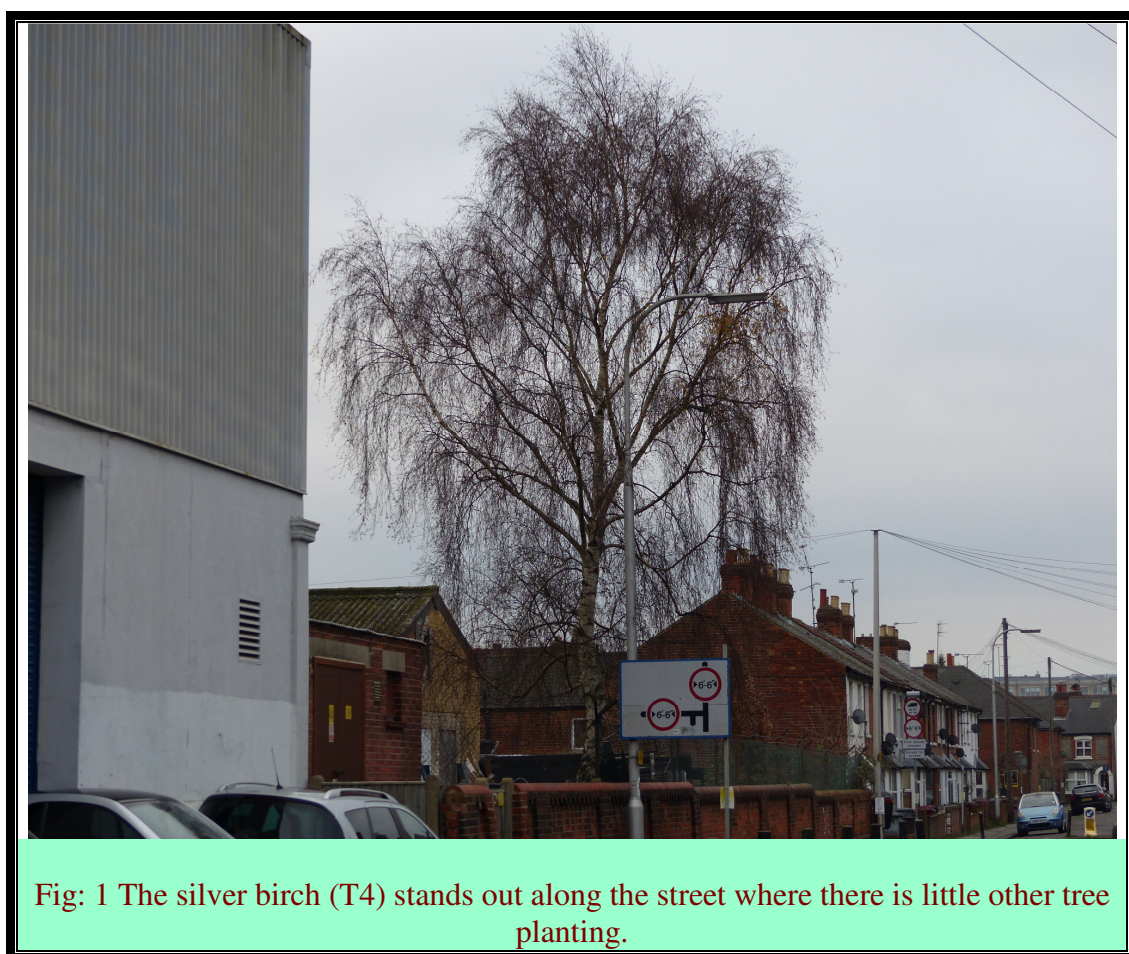
- 4.1 The site is an industrial warehouse with few tree planting opportunities. Nevertheless trees have been established around the periphery of the site, including some recently planted fastigate hornbeams along the inside eastern boundary.
- 4.2 Within the site itself, on the east side around the parking areas, two limes (T1 and T2) have been long established. These have been pollarded in the past, but have been left to grow back in more recent times.
- 4.3 Also along the east side is a mature silver birch (T3) which has not been pruned.
- 4.4 The silver birch (T4) is growing along the southern boundary and is a good example of where an established tree in a street devoid of other planting can really stand out, making a positive impact on the local landscape (fig.1).
