## **OUTLINE SCHEDULE OF WORKS**

**82 Star Road, Caversham, Reading**

**Brewin JV Ltd.**

Date: November 2017

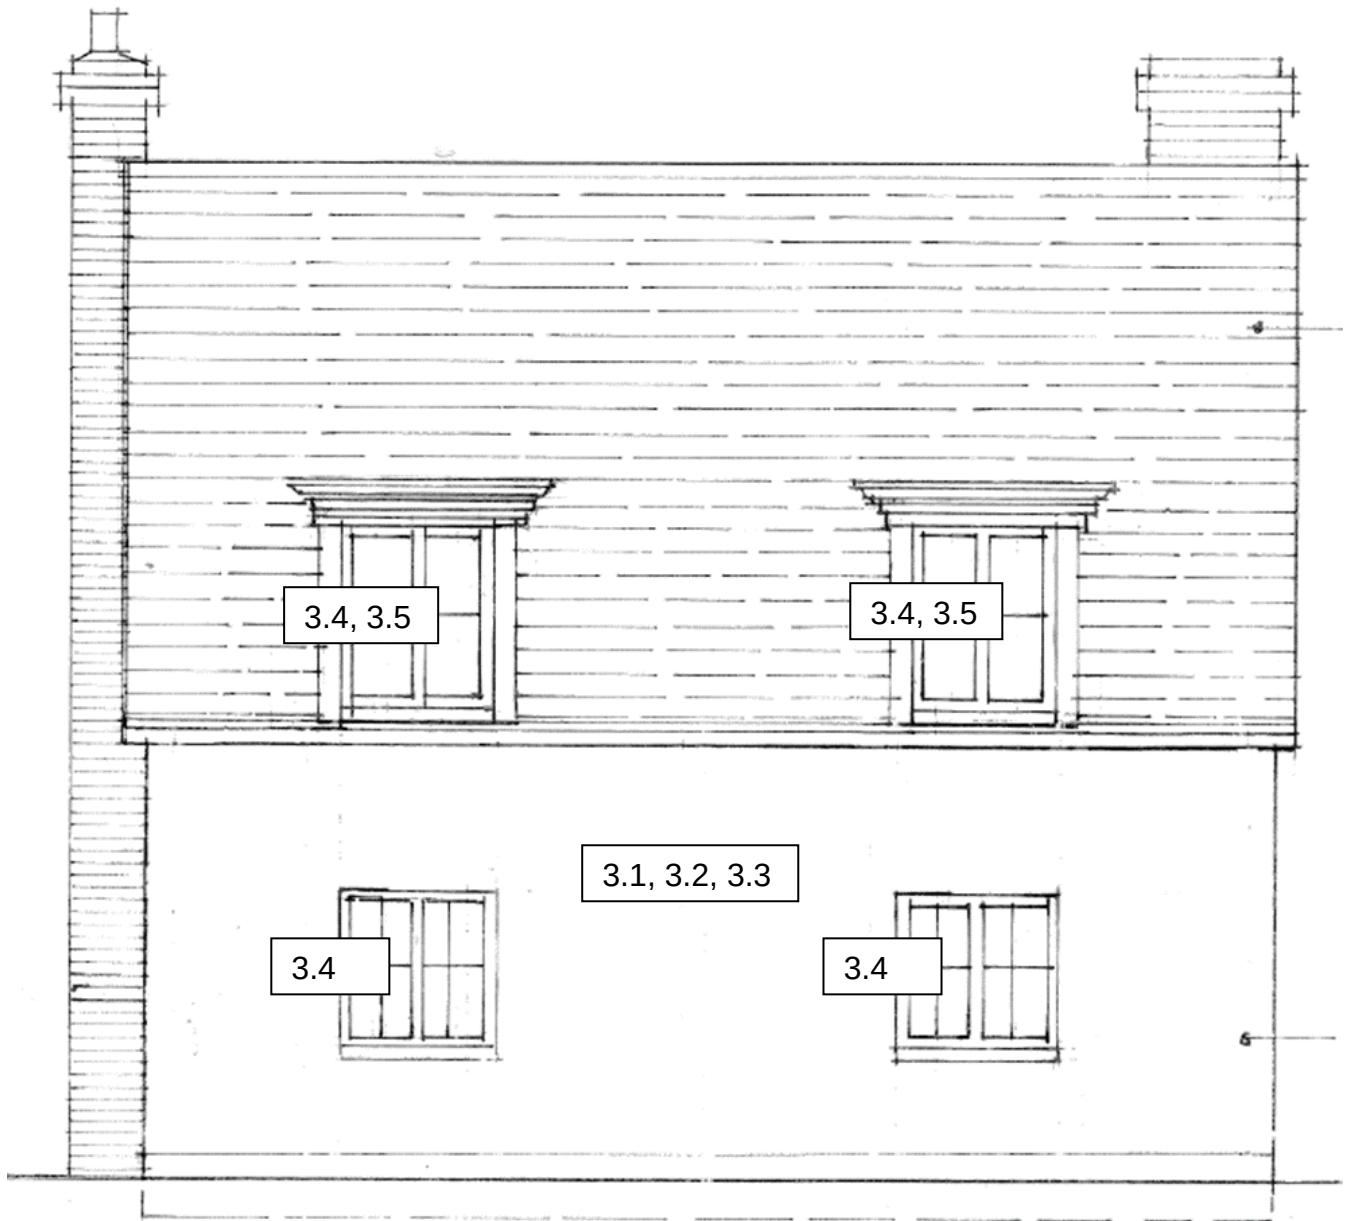
West (front) elevation

- 3.4 All four (modern) windows are to be replaced with side-hung timber casement windows finished in paint (all joinery details subject to approval).
- 3.5 The two (modern) dormer windows are totally rotten and are to be reconstructed with new lead cheek walls, soakers and a lead roof covering (all in accordance with the Lead Sheet Association Guide).

- 3.1 The existing cement render is to be carefully removed to expose the brickwork. The cement render is thick (approx. 40mm) and care should be taken to ensure that the brickwork is not damaged during its removal. If damage to the brickwork is unavoidable it may be necessary to reconsider whether it is preferable to leave the cement render in place. Test samples should be undertaken to establish that the render can be satisfactorily removed.

- 3.2 If evidence of construction joints, former openings or remnants of timber framing are revealed during the removal of the render they should be photographically recorded.

- 3.3 The elevation is to be insulated and lime rendered externally using breathable insulation (woodfibre board such as Steico or similar) all in accordance with the manufacturer's written instructions. The render is to be finished with breathable mineral paint.

- 3.6 The modern concrete block garden wall attached to the north corner of the building is to be removed.

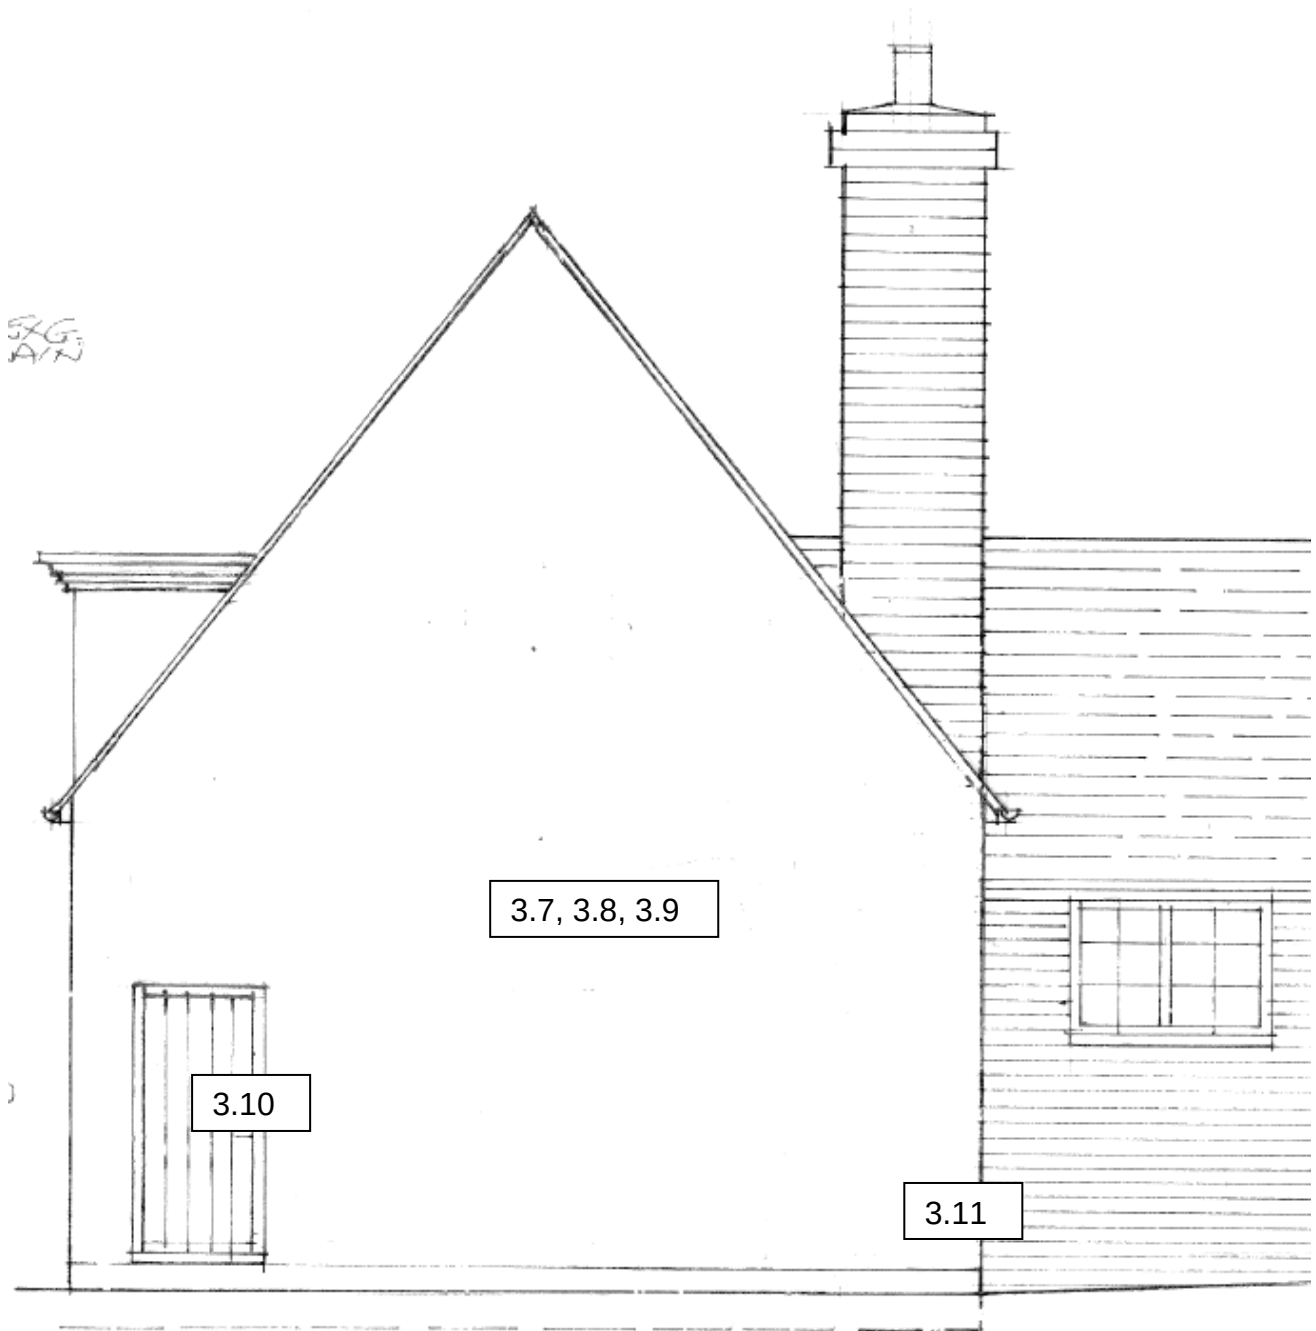
South (right) elevation

- 3.7 Isolated timber frame members which survive in the south elevation include parts of vertical posts, including corner posts and the tie beam. However, most of the historic timber frame members have decayed beneath the cement render and are either totally lost isolated remnants. There is no integrity to the frame as a whole and the wall currently functions as a loadbearing brick wall. In these circumstances there is little to be gained by repairing isolated timbers or by replacing those that are missing. The approach to be taken is to conserve all those historic timbers that do survive in situ but to enhance the structural integrity of the brickwork by repairing any gaps (left by decayed timbers) using soft red bricks and lime mortar with strengthening and stitching across any vertical joints or fractures.

- 3.8 The south wall is considered too fragile to remove the cement render so it should be left in situ.
- 3.9 The elevation is to be insulated and lime rendered externally using breathable insulation (woodfibre board such as 'Steico' or similar) all in accordance with the manufacturer's written instructions. The render is to be finished with breathable mineral paint.

- 3.10 The door and frame are to be replaced with a new vertically boarded, ledged and framed door. Joinery detail to be approved.
- 3.11 The bottom of the post at the south-east corner is presently unrestrained. It should be strapped to the surrounding brickwork using stainless steel straps prior to the application of insulation/render.

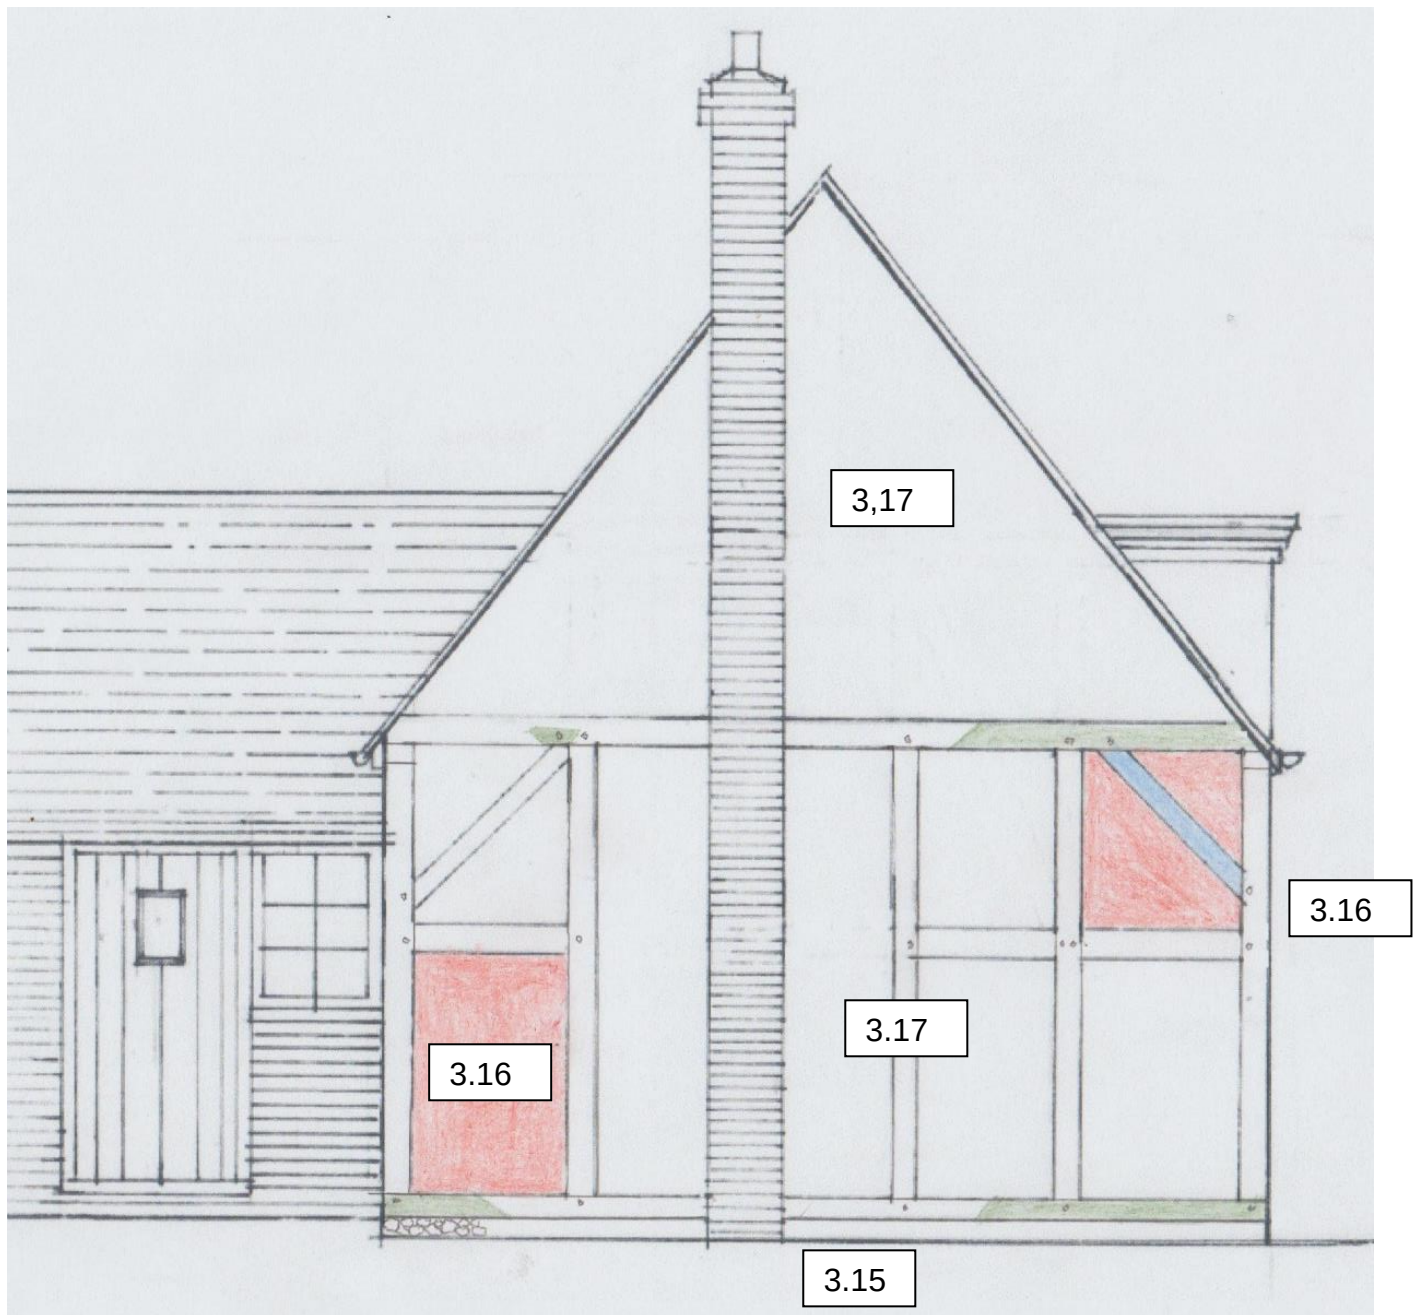
North (left) elevation

Green shading indicates extent of repairs to oak frame

Blue shading indicates the reinstatement of a missing brace

Red shading indicates brick infill panels that are to be removed and rebuilt

- 3.12 The oak timber frame of the north elevation is substantially intact and is quite capable of conservative repair and reinstatement. The approach to this frame, unlike the other elevations, is to repair the frame where necessary to restore its structural integrity. Repair is to include the following: replace one missing brace, repair the brick infill panels where necessary, remove cement render and re-render in lime. The frame is to be exposed externally with insulation provided internally (see interior below).

- 3.13 Frame repairs are to be carried out using semi-seasoned oak with growth, grain and physical characteristics to match those of the timber which is to be repaired. All joints, pegs and frame elements are to be checked for soundness.

- 3.14 Areas shaded green on the elevation are to be splice or face repaired. Each repair shall be designed to cause the minimum loss of historic oak. One diagonal brace (180 by 80mm) shaded blue on the elevation, is to be reinstated.

- 3.15 The external ground level is to be reduced by approximately 150mm and the flint plinth repaired and repointed in lime mortar as required.
- 3.16 Brick infill panels are to be retained in situ where they are sound and stable. The two panels indicated (shaded red) on the elevation are not stable or will need to be removed to accommodate the reinstatement of the diagonal brace. In these isolated cases the brick panels should be carefully removed and the red bricks put aside for reuse.

- 3.17 Cement render is to be carefully removed from all the brick infill panels and from the gable and re-rendered using lime render. Junctions between the new render and the oak frame are to be feathered to a natural line and particular attention should be paid to top edged of infill panels to avoid ledges that might encourage water ingress. Render to be finished with breathable mineral paint. It is likely/possible that close inspection after the removal of render may reveal that other brick infill panels need to be removed and rebuilt.

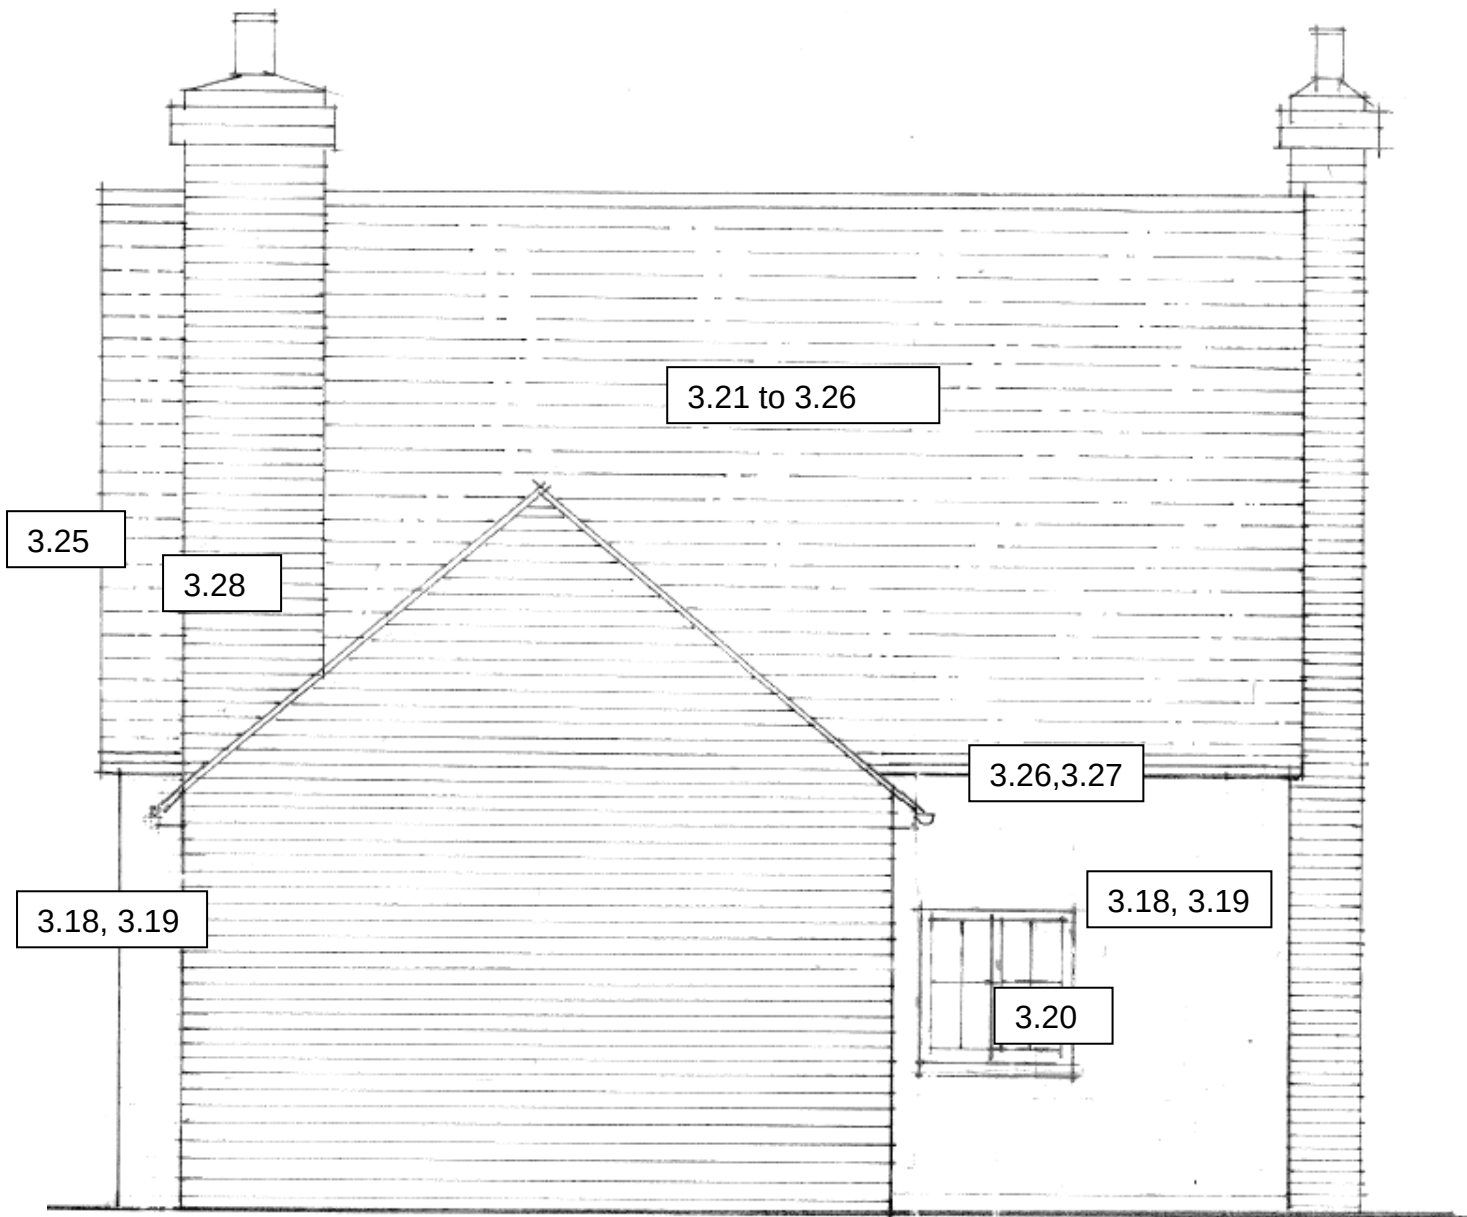
East (rear) elevation

- 3.18 Several oak uprights and the original (lower) wall plate of the rear elevation survive intact. The sole plate and some of the secondary horizontal frame members have been lost through decay or have been removed. The uprights typically do not carry any load, the load paths having transferred over time to the brick infill panels. In this circumstance it is not the intention to restore the structural integrity of the frame which would involve considerable intervention and conjectural reconstruction. Those timbers that survive are to be preserved in situ.

- 3.19 Parts of the historic rear elevation which will be internalised by the proposed extension are to be left in painted brick with the timber frame exposed. Those parts of the historic rear elevation which are to become or remain external are to be protected by external insulation and lime render using breathable insulation (wood fibre board such as Steico or similar) all in accordance with the manufacturer's written instructions. Render to be finished with breathable mineral paint.

- 3.20 New side-hung casement window to replace existing (modern) window. Joinery details subject to approval.

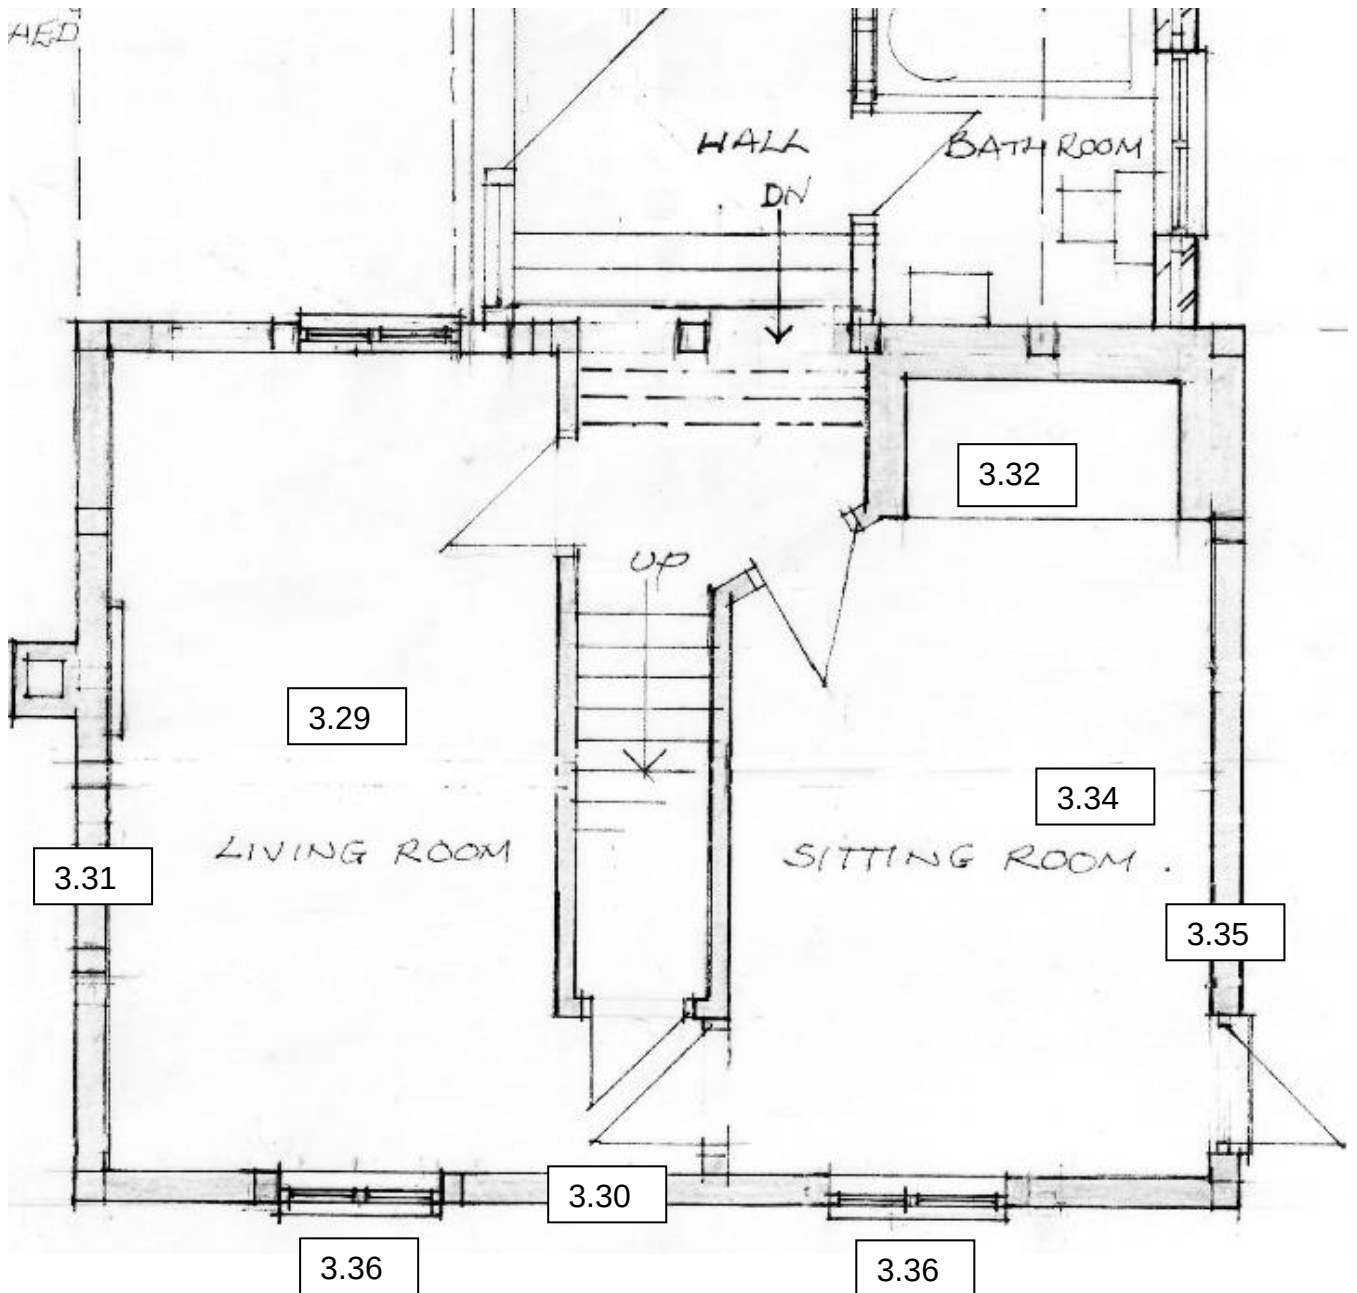
Ground floor plan

- 3.34 A 125 by 125mm oak post is to be inserted to support the south end of living room spine beam which currently has no bearing. Foundation to be specified by structural engineer.

- 3.35 All voids in south wall, where timbers once existed but have decayed as a result of cement render, are to be filled with soft red bricks and lime mortar to match the surrounding brickwork. Infill brickwork is to be stitched into surrounding brickwork to avoid structural lines of weakness.

- 3.36 The soundness of the lintel over the front windows is to be investigated and repaired or replaced if necessary. Also check the soundness of the bearing of the floor joists onto the lintel in the sitting room.

- 3.29 Floor: Existing concrete floor slab to be carefully removed and replaced with limecrete floor (subject to investigation of foundation depths).
- 3.30 Walls: existing cement render and gypsum plaster is to be carefully removed from wall surfaces and replaced with three coat lime plaster (except for north living room wall, see below).

- 3.31 The north living room wall is to be insulated and lime plastered internally using continuous breathable insulation (wood fibre board such as Steico or similar) all in accordance with the manufacturer's written instructions.

- 3.32 Fireplace: The brickwork of the sitting room fireplace is to lightly cleaned and repointed where necessary.
- 3.33 Ceiling beams: The beams and the underside of the first floor boards, some of which are painted black, are to be stripped using a sensitive non-abrasive cleaning system such as DOFF or TORC. Then to be finished with natural beeswax in turpentine (Libron Black Bison Wax or similar). Alternatively, floor joists, beams and the underside of floorboards could be limewashed as evidence indicates this has been applied in the past.

- 3.37 First floor joists in the living room are to be checked for structural soundness and isolated joists to be replaced on a like-for-like basis, only if required.

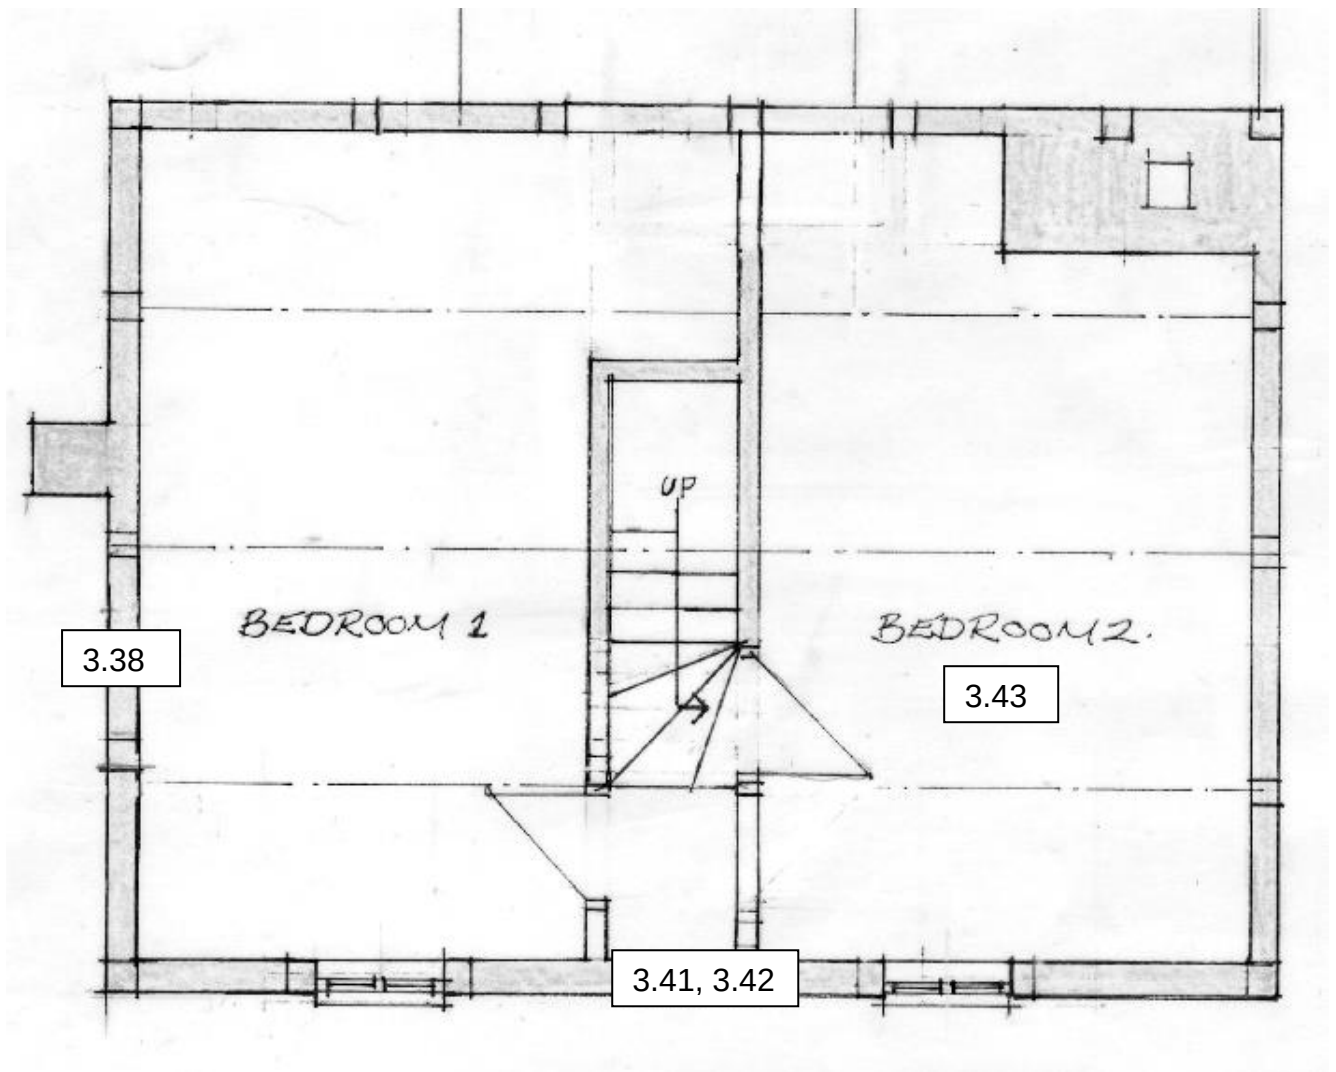
First floor plan

- 3.41 The front elevation lower wall plate is heavily decayed, particularly but not exclusively below the two dormer windows. All decayed areas are to be replaced with oak to match, scarfed to sound sections of existing plate.

- 3.42 The front elevation upper wall plate is of sawn softwood (probably contemporary with the roof structure. It is heavily decayed through most of its length and should be totally replaced on a like-for-like basis.

- 3.43 All floorboards are intact, but weak in places due to beetle infestation and decay. The entire floor is to be overlaid with new softwood floorboards.

- 3.38 North wall of bedroom 1 to be internally insulated and lime plastered using continuous breathable insulation (wood fibre board such as Steico or similar) all in accordance with the manufacturer's written instructions. The tie-beam currently projects from the face of the wall so can be left exposed.

- 3.39 Other internal wall finishes are to be repaired or made good using materials to match.
- 3.40 Lath and plaster ceilings are to be checked for soundness and repaired where necessary on a like-for-like basis.
