**Red Lion**  
**Southampton Street, Reading**

**Structural Survey & Report undertaken  
on behalf of Vogue Assets Ltd**

**ML/ASm/W01719**  
**September 2017**

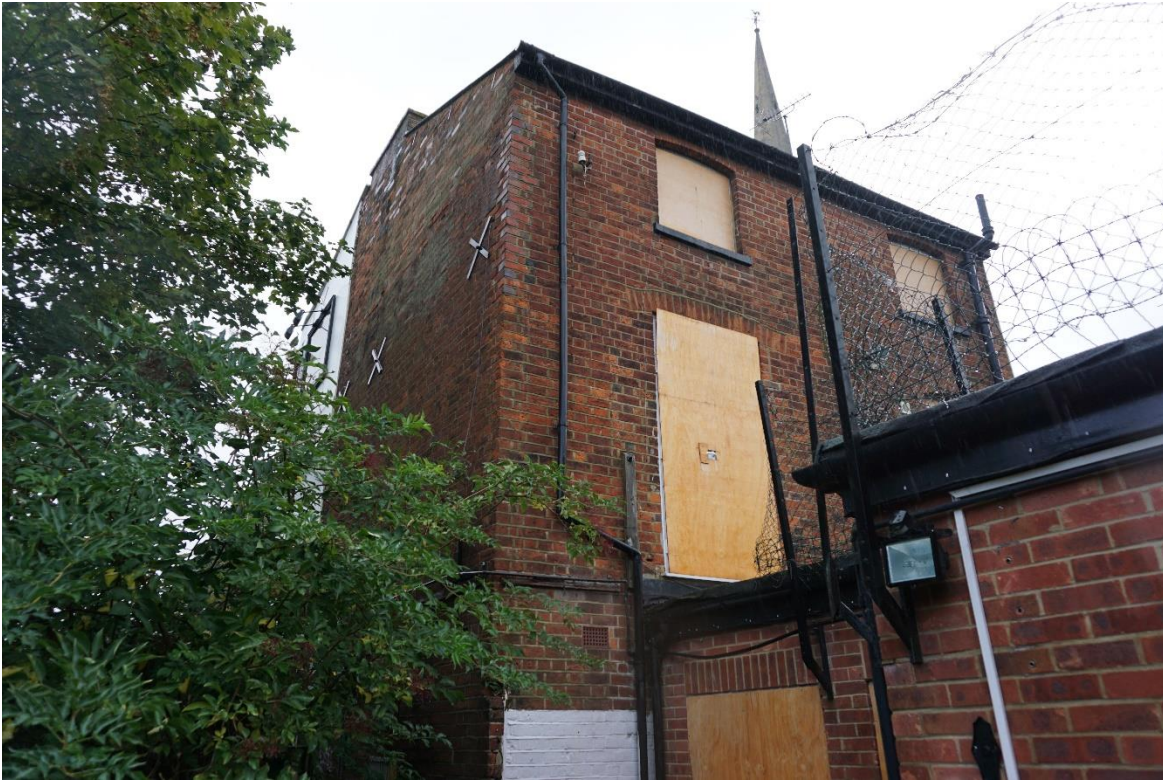
- 3.1.1 The RIGHT hand end gable wall was of face brickwork towards the rear and rendered masonry towards the front. There were seven cruciform pattress plates to the gable end; three at first floor level and four at second floor level (photo 2).

**Photograph 2** - Rear & Right hang Gable

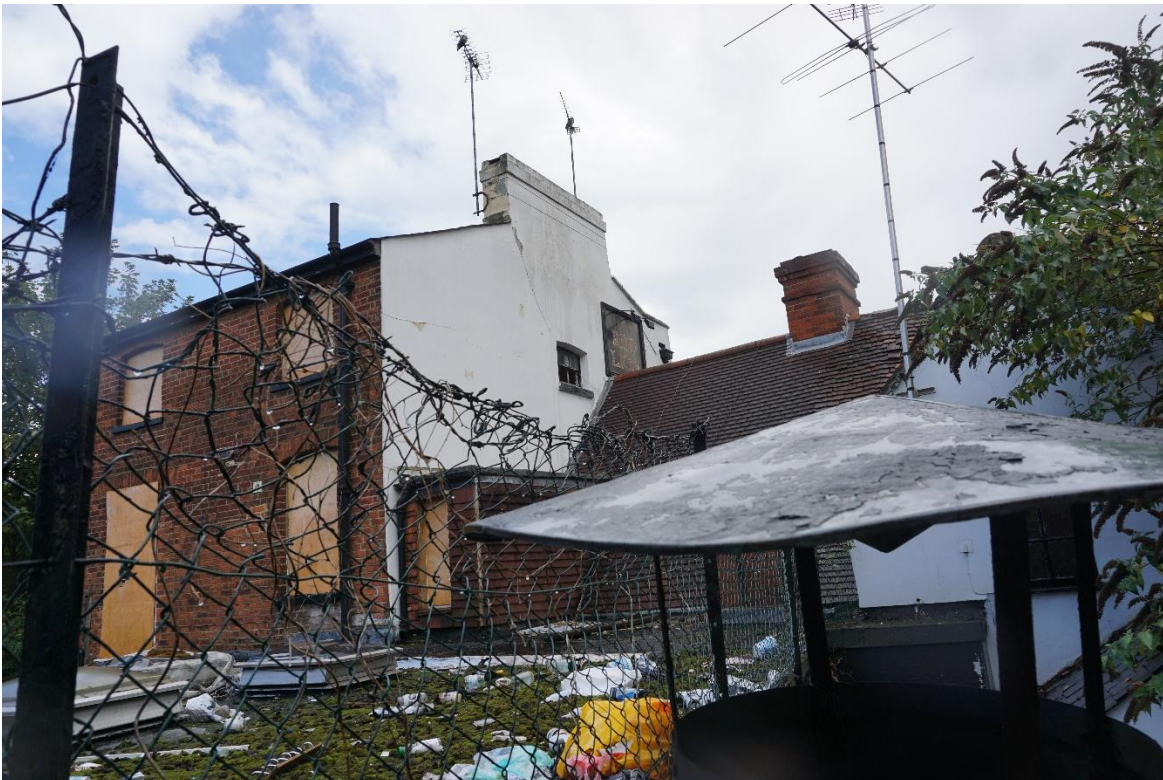
- 3.1.4 In considering the main gable wall to the LEFT hand side of the main three storey section of the property, where the rendering externally was exposed above the two storey section (Photo 3); There were several notable stepped cracks to the render on the gable wall; particularly a diagonal crack across the chimney breast from the top of the landing window to the parapet level (photo 9).

**Photograph 3** – Rear and Left hang Gable

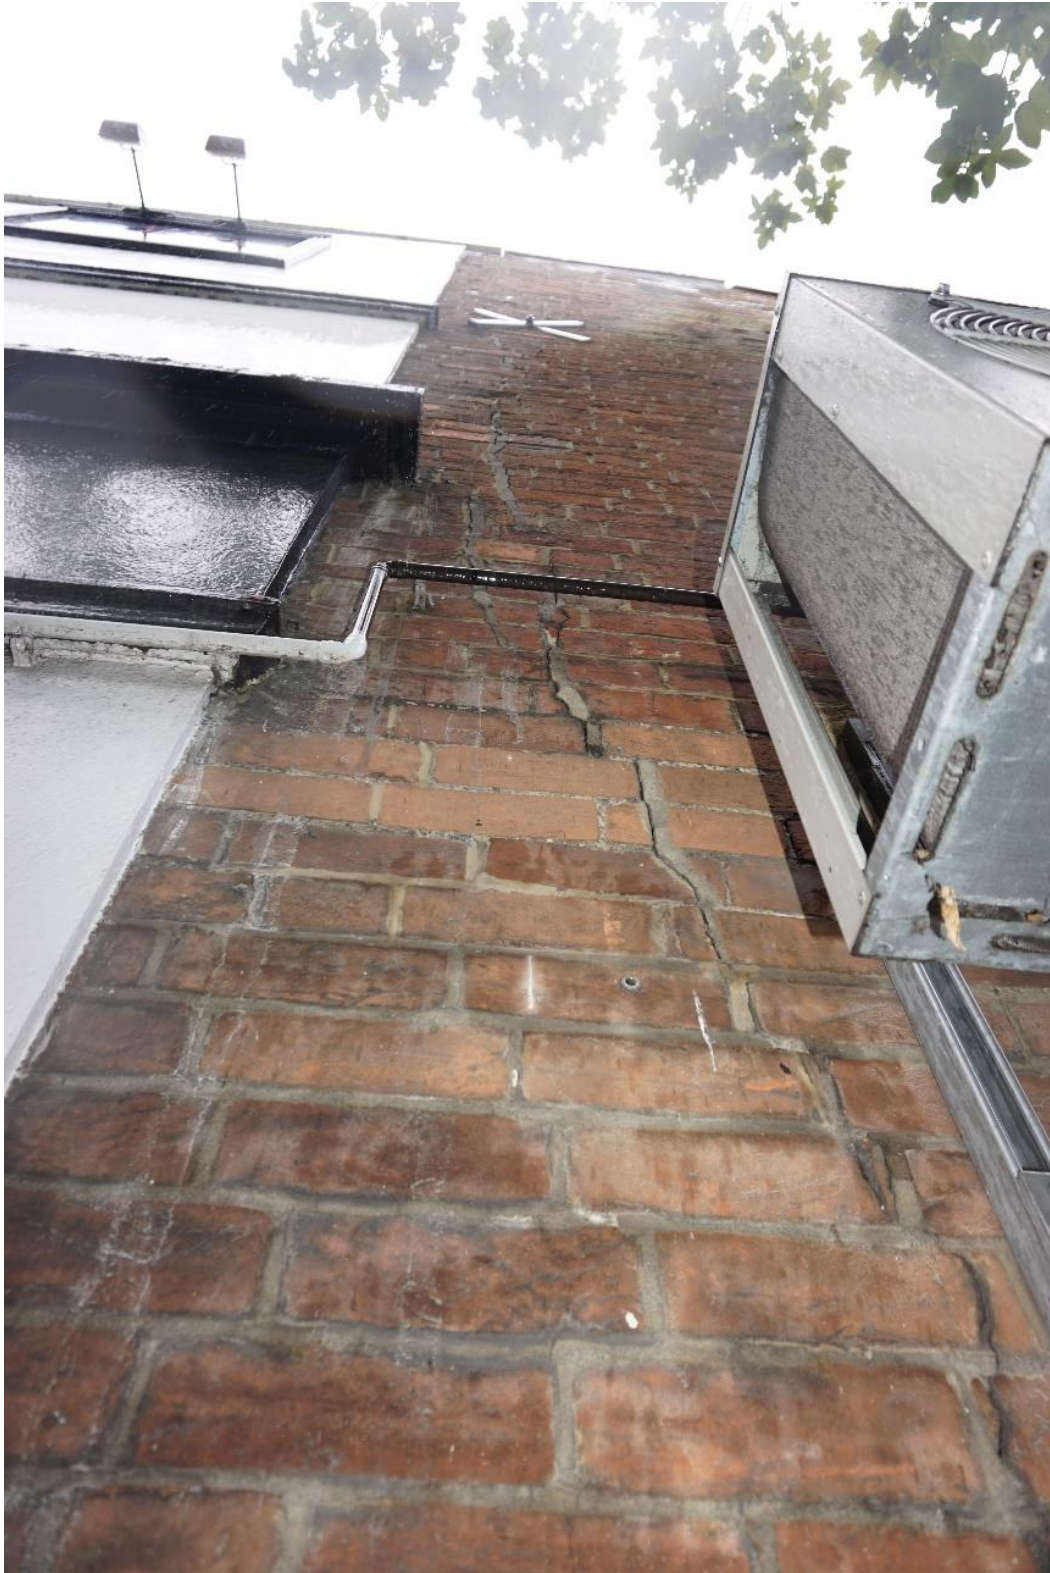
- 3.1.2 There was a full height vertical crack to the brickwork just forward of the centre of the gable wall (photo 6). There was displacement of the brickwork and missing / spalling pointing associated with this crack, with indications of recent movement / ongoing cracking (photo 7). There was a second vertical just rearward of the centre of the gable wall. This crack extended for approximately two thirds the wall height from first floor upwards. This crack has been previously filled possibly on several occasions (Photo 8). There was third vertical crack further towards the rear extending again about two thirds the wall height. A fourth vertical crack was noted between the two rear cracks only at ground floor level.

**Photograph 6** – Full height crack to gable wall

- 4.1** The RIGHT hand full gable wall is bulging and has a series of vertical cracks. These have been historically been repaired but cracking has recurred to the full length of the remediated crack, suggesting this movement is still active and that the cruciform pattress plates have not provided lateral restraint to resolve the issue. Considering the extent of cracking and bulging it will be necessary to fully rebuild the flank wall and associated chimney breasts.

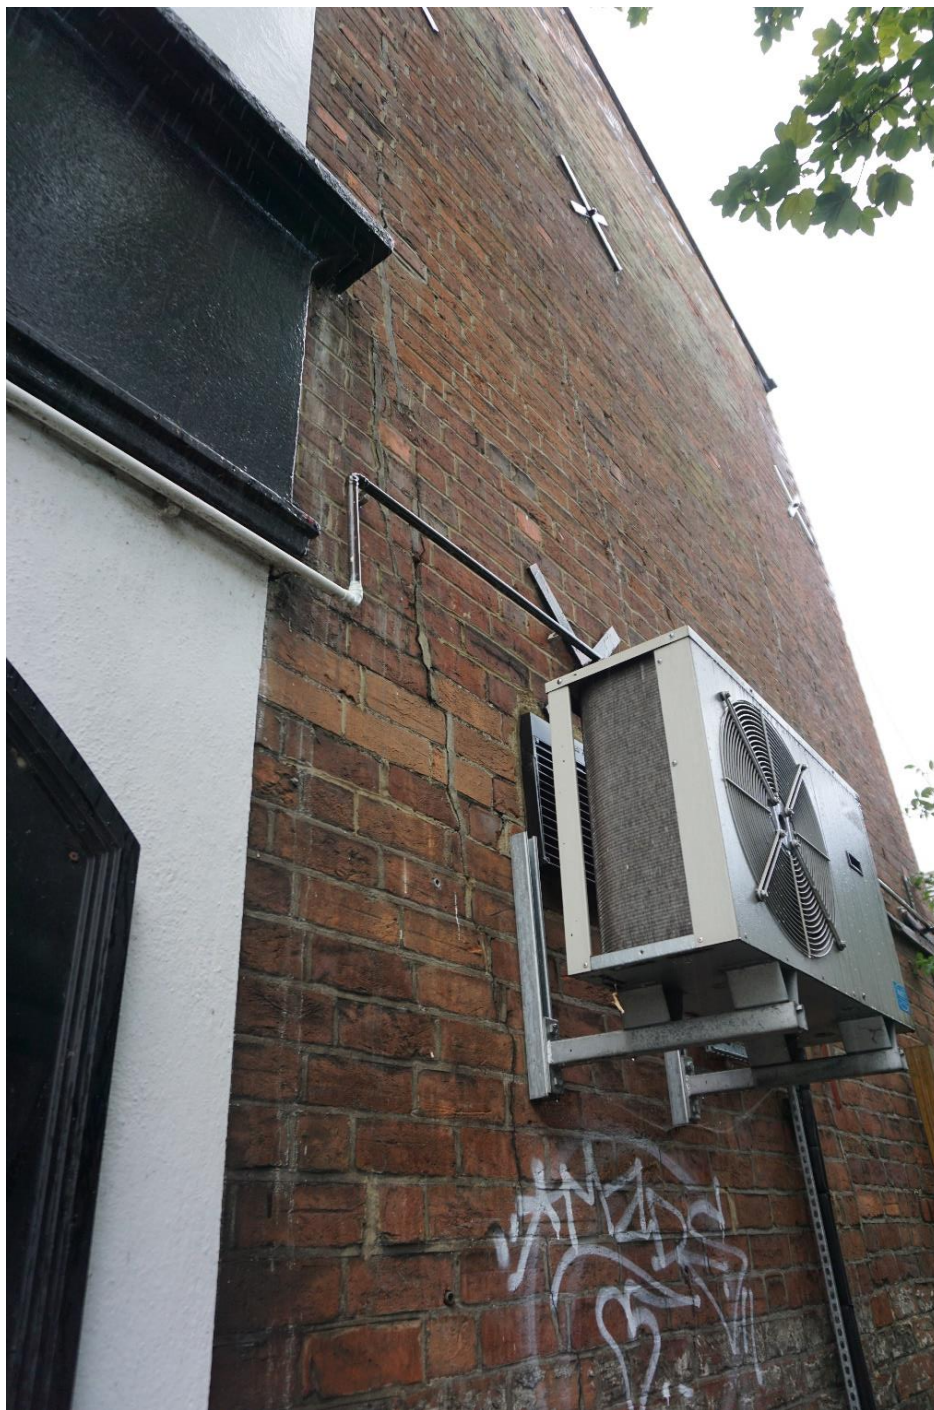
**Photograph 7** – Displacement of wall at crack position

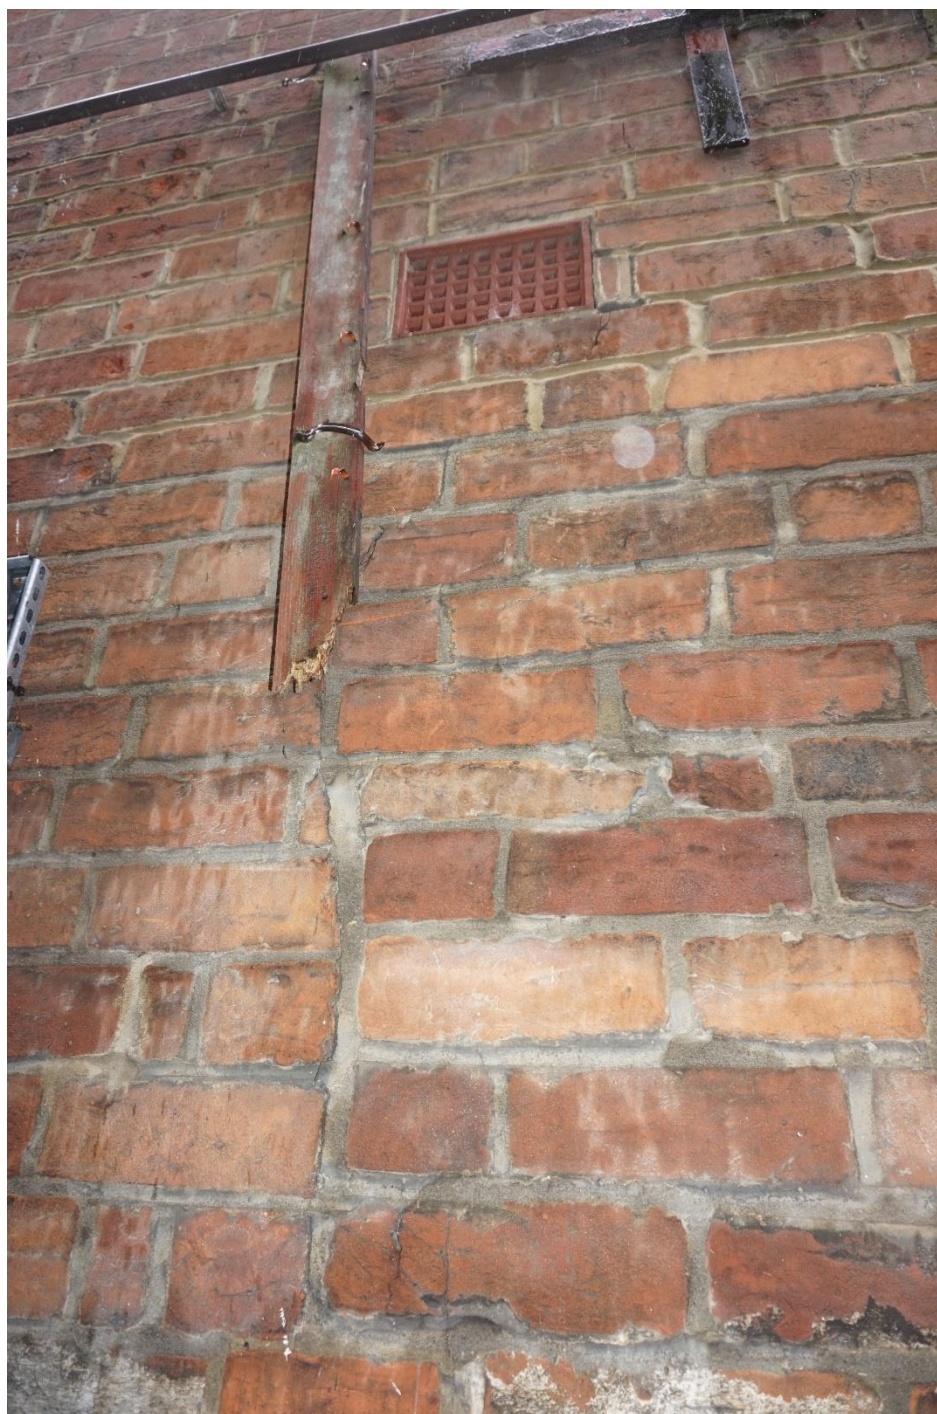
**Photograph 8** – Cracking to Gable wall

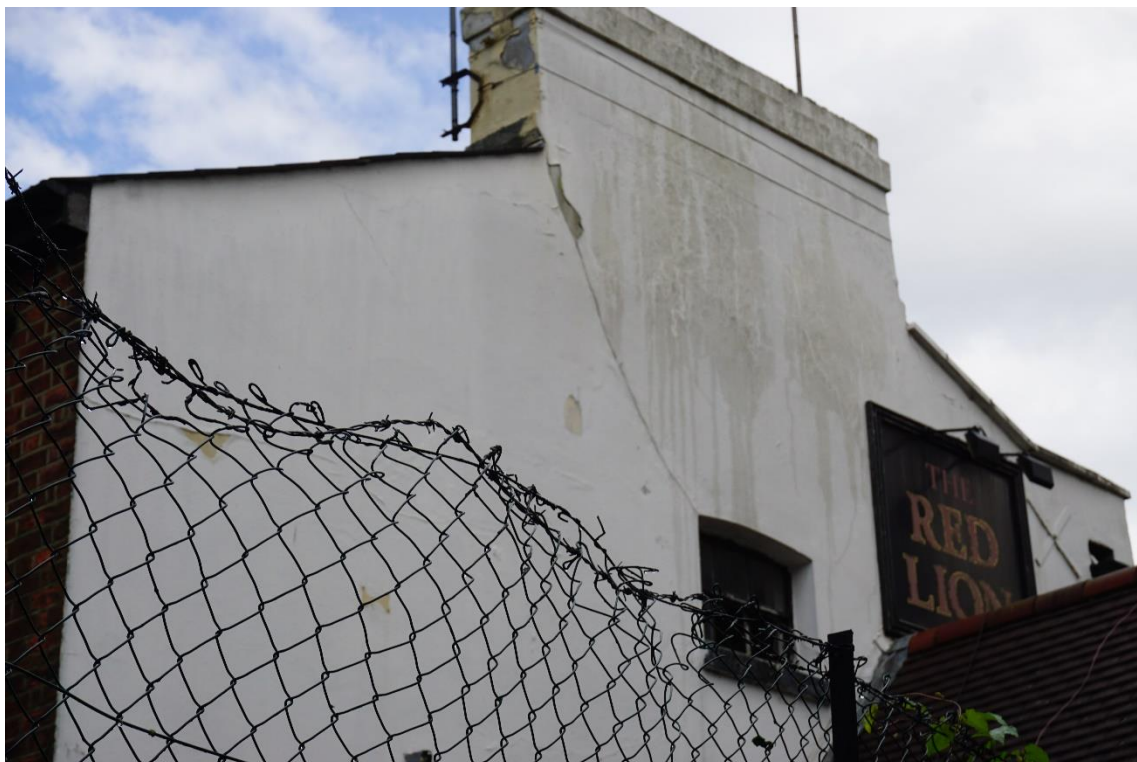
**Photograph 9** – Cracking to left hand Gable

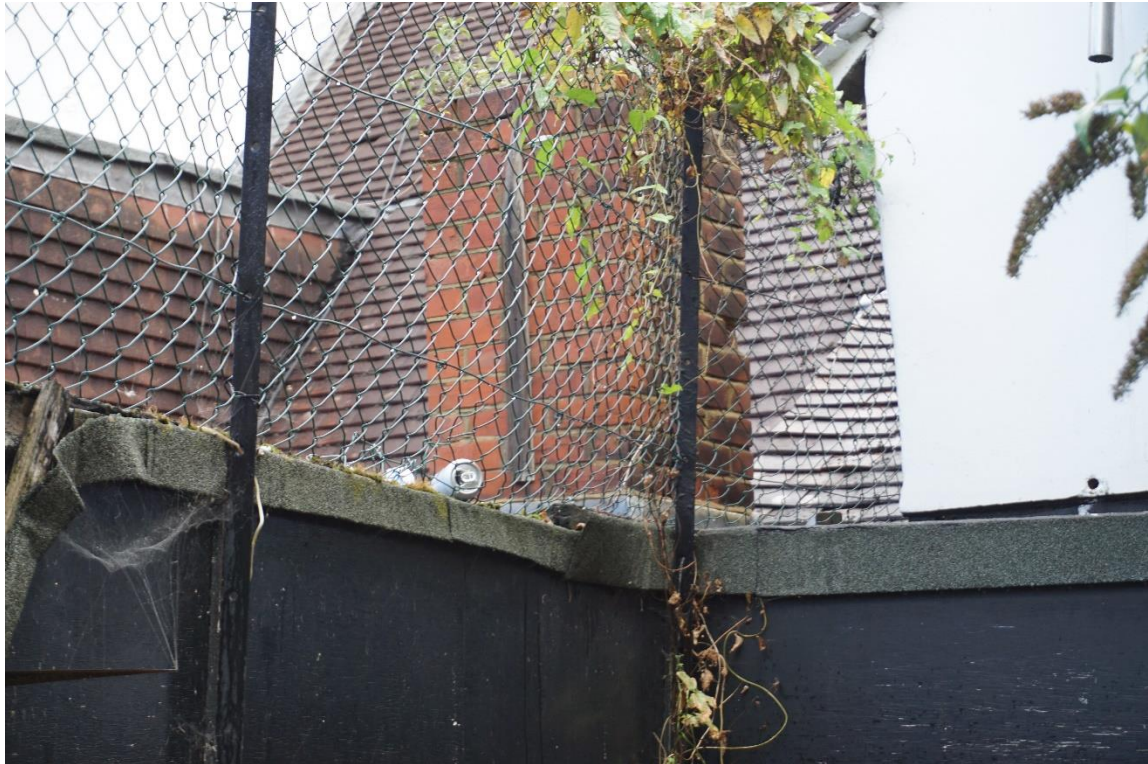
- 3.1.10 There is a chimney at the corner of the flat roof area at the junction with the neighbouring property. The chimney brickwork appeared to be in poor condition (photo 11).

**Photograph 11** – Chimney in poor condition

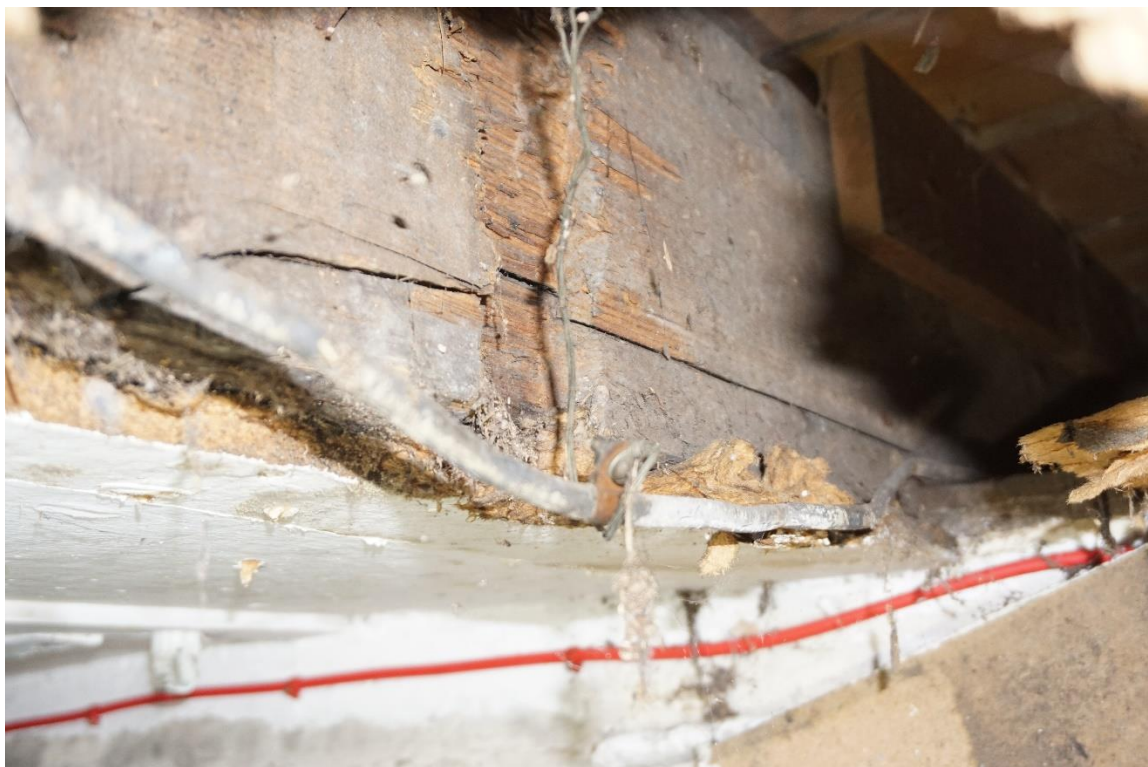
- 3.2.1.1 The basement was separated into two adjoining rooms. Two areas of the ceiling have previously been locally broken out; one in the centre of the right hand basement room, this has exposed floor joists locally. One of the joists exposed was split through possibly due to previous overloading or impact damage (photo 12). The second area of opening up to ceiling was at the front LEFT hand corner of the LEFT hand room. Where exposed there was notable decay to the joists at the wall junction (photo 13).

**Photograph 12** – Split to floor joist at midspan

- 4.3** The ground floor joists over the basement show indications of decay and structural damage in the small number of locations exposed. The extent of defects was not fully determined, but it is likely that a large proportion of the ground floor over the basement will require replacement to rectify defects and to replace basement beams.

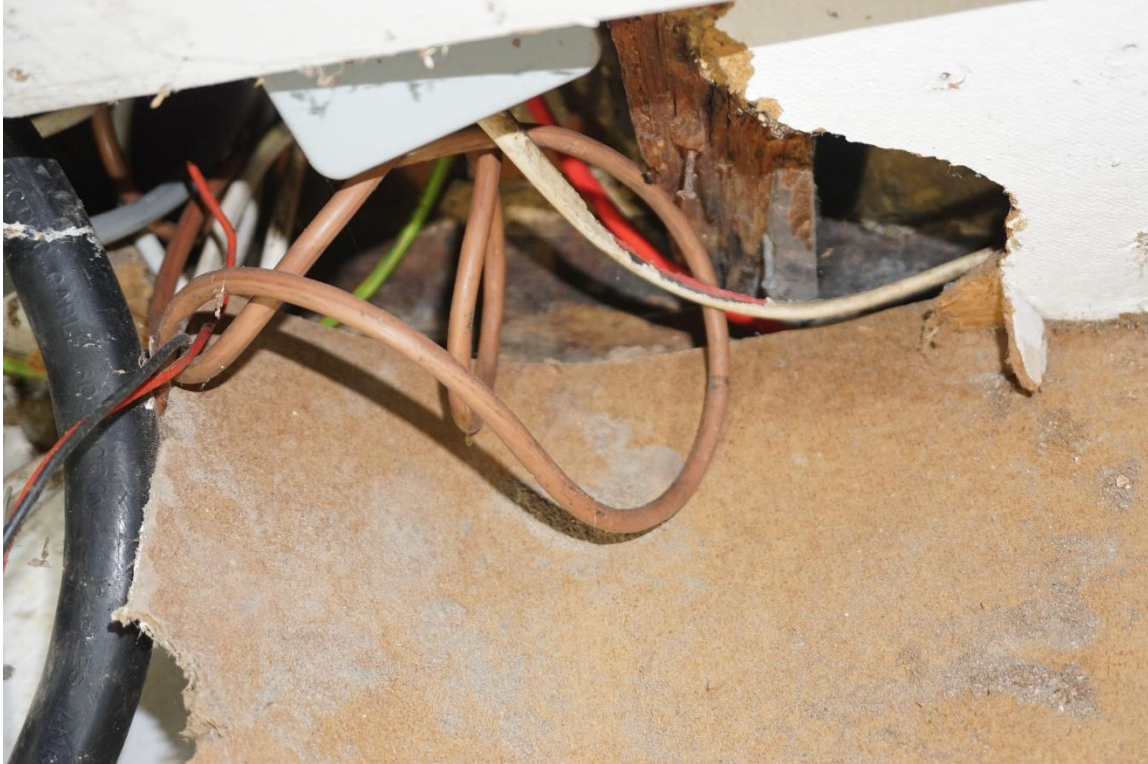
**Photograph 13** – Decay to ground floor joists over basement

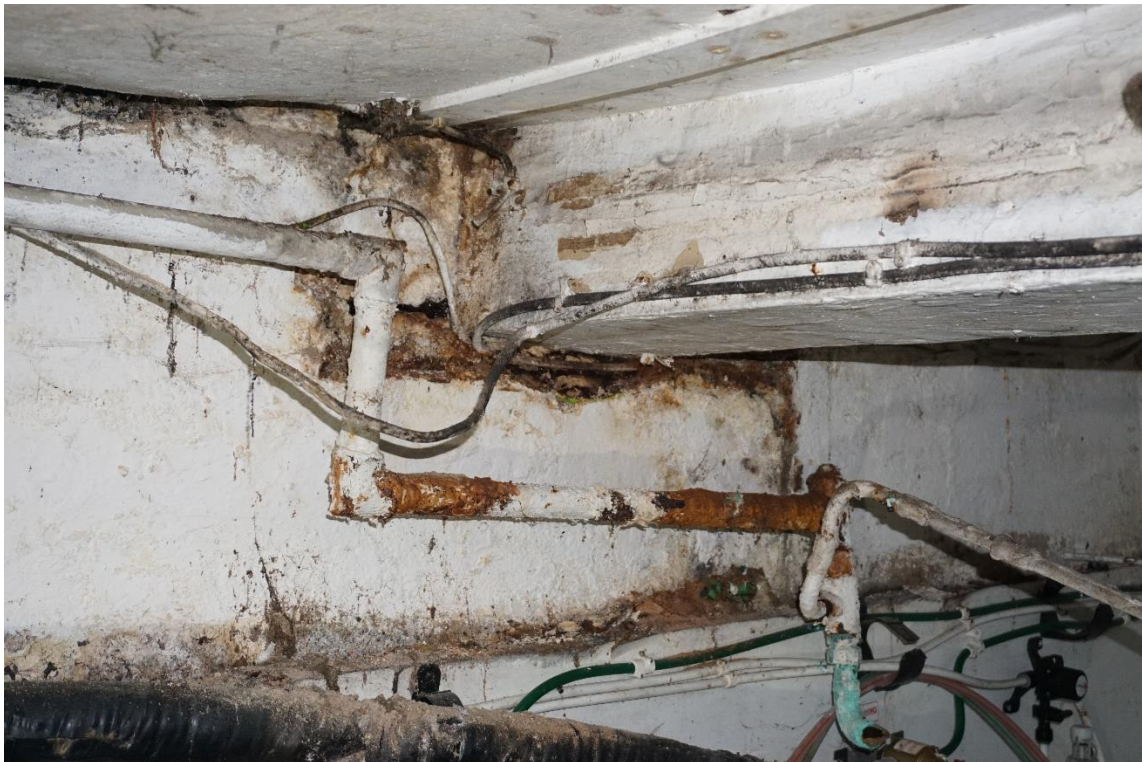
- 3.2.1.2 Two timber floor beams were noted supporting the floor over the basement. One at the centre of the RIGHT hand room halving the span of the floor joists. There was evidence of decay to this beam particularly at the front external wall junction (photo 14). Part of the beam bearing was also eroded away. The second timber floor beam was on the rear basement wall closing the sub-floor void along the line of the masonry wall and possibly providing a bearer for a steel column at the corner of the bar over. This beam has signs of decay and worm; the holes were larger than common woodworm so could be indications of death watch beetle.

**Photograph 14** – Decay to ground floor main beam at bearing

- 4.2** The main timber beams over the basement show indications of decay. It is likely that the two main beams supporting the ground floor will require replacement.

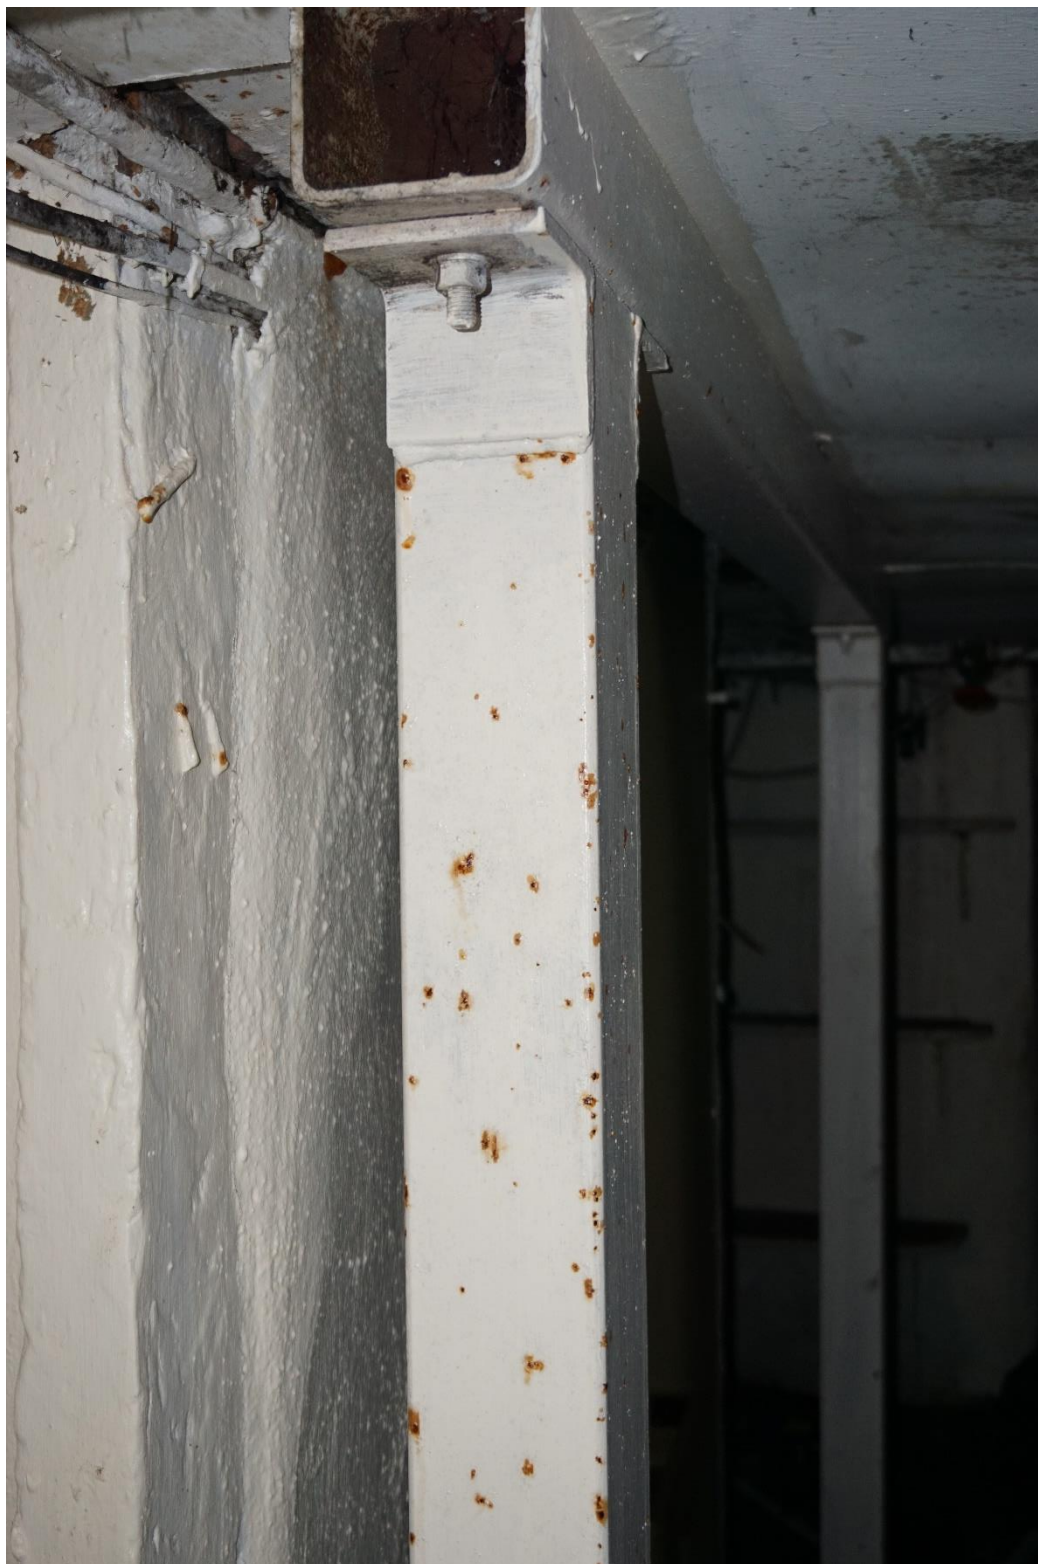
- 3.2.1.3 There was a steel goal post frame in the basement adjacent to the RIGHT hand gable wall; possibly supporting the chimney breast (photo 15). There was significant corrosion of this frame particularly to the baseplate (photo 16).

**Photograph 15 – Steel goalposts**

- 4.5** The steel goalpost in the basement is considered to be temporary remedial work and with the observed corrosion would not be acceptable as a permanent strengthening in a fully refurbished building. Therefore an alternative form of strengthening or remedial work to the structure would be required to eliminate the frame.

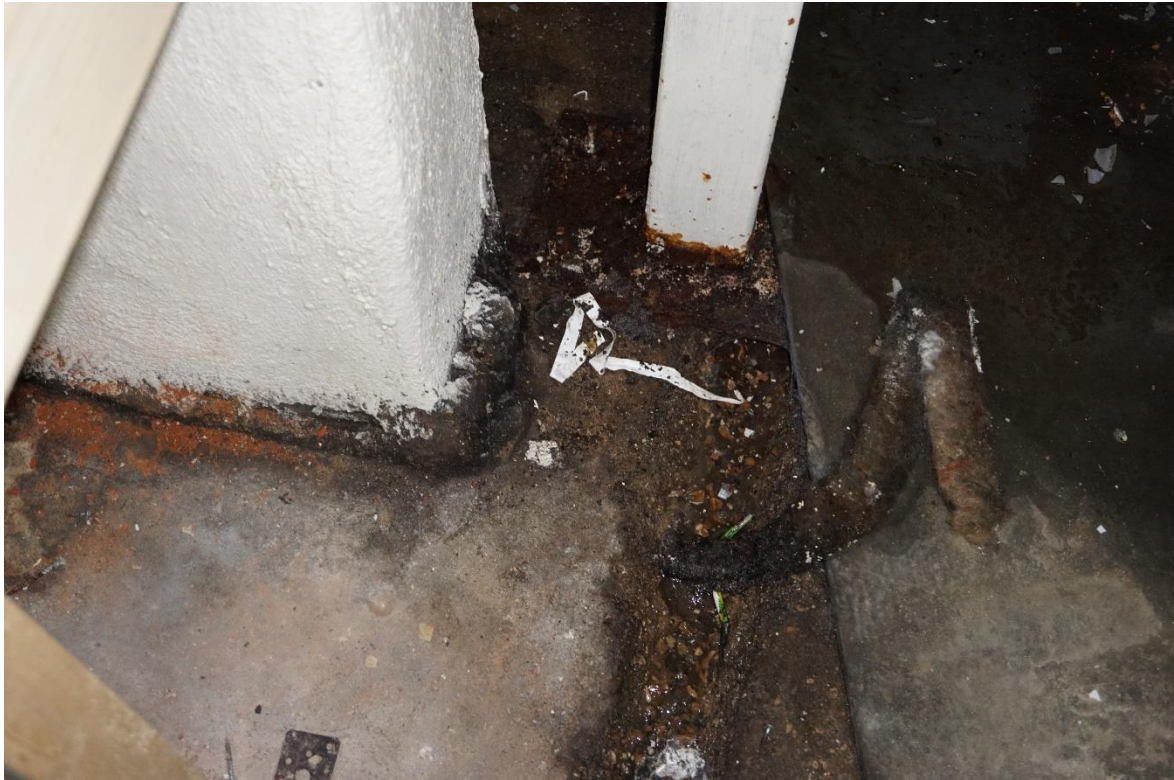
**Photograph 16** – Corroded baseplate to goal posts

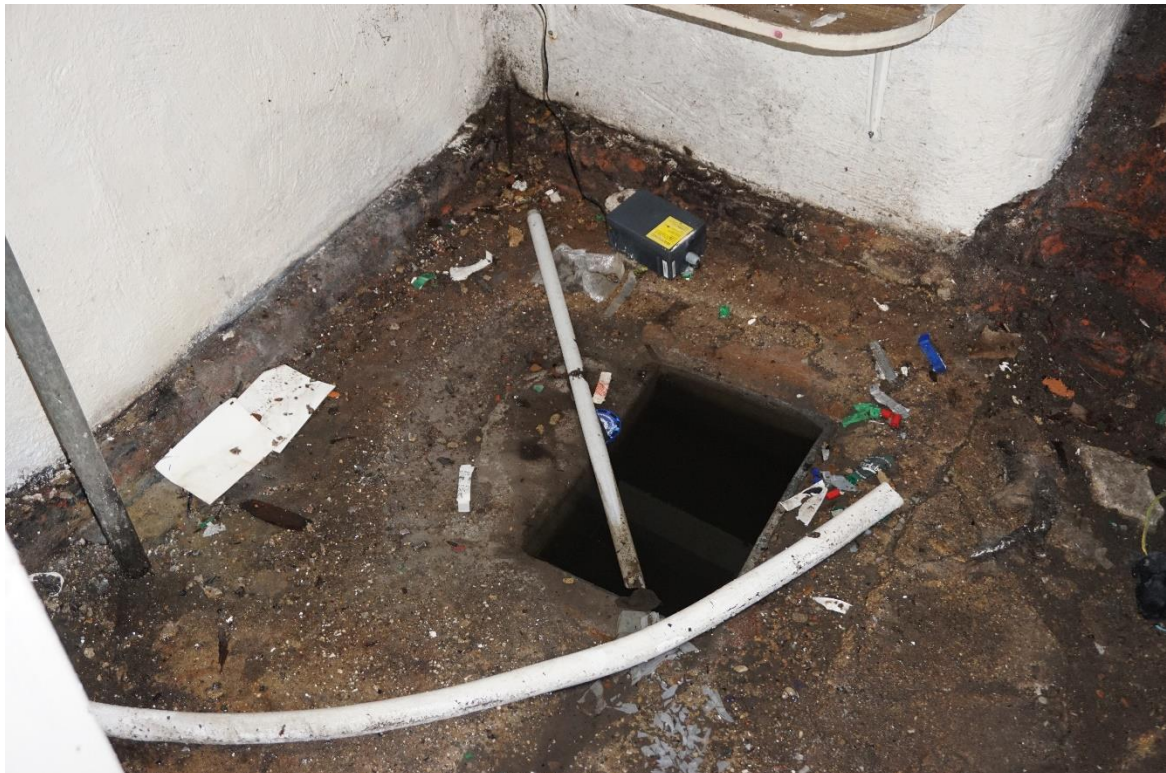
- 3.2.1.4 There was a leaking water pipe in the basement dripping constantly. Whilst it was raining water was running down the barrel ramp. There is an open gulley in the basement floor. Water was overflowing from this gulley (photo 17).

**Photograph 17** – Water build up in basement

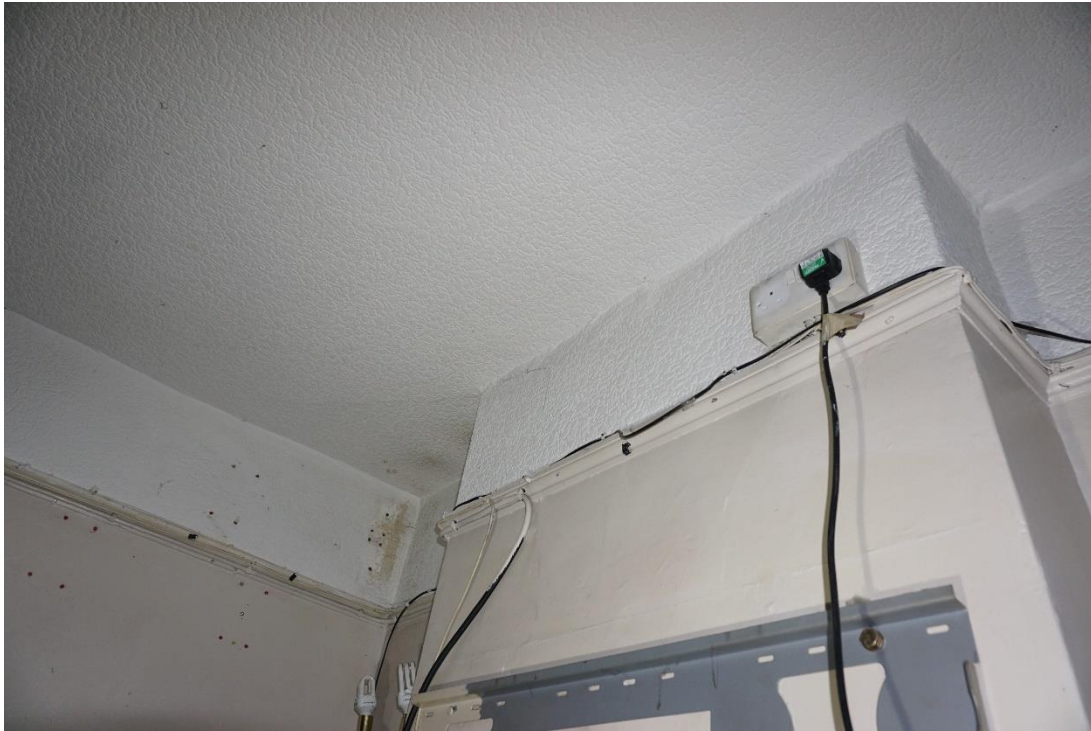
- 3.2.2.1 There was indications of displacement between the ceiling and RIGHT hand gable wall. Any cracking is obscured by the heavy embossed wallpaper, which has buckled and distorted but has remained intact (photo 18). There are various hairline cracks to the flank wall.
- 3.2.2.2 There is a full height 1mm to 2mm vertical crack to end of the main internal cross wall at the end of the bar; extending down from the lintel bearing adjacent to the stair. There is extensive damp to the internal walls at ground floor of the single storey extension particularly into the kitchen corridor (photo 19). There was heavy

**Photograph 18** – Displacement to wall at ceiling junction

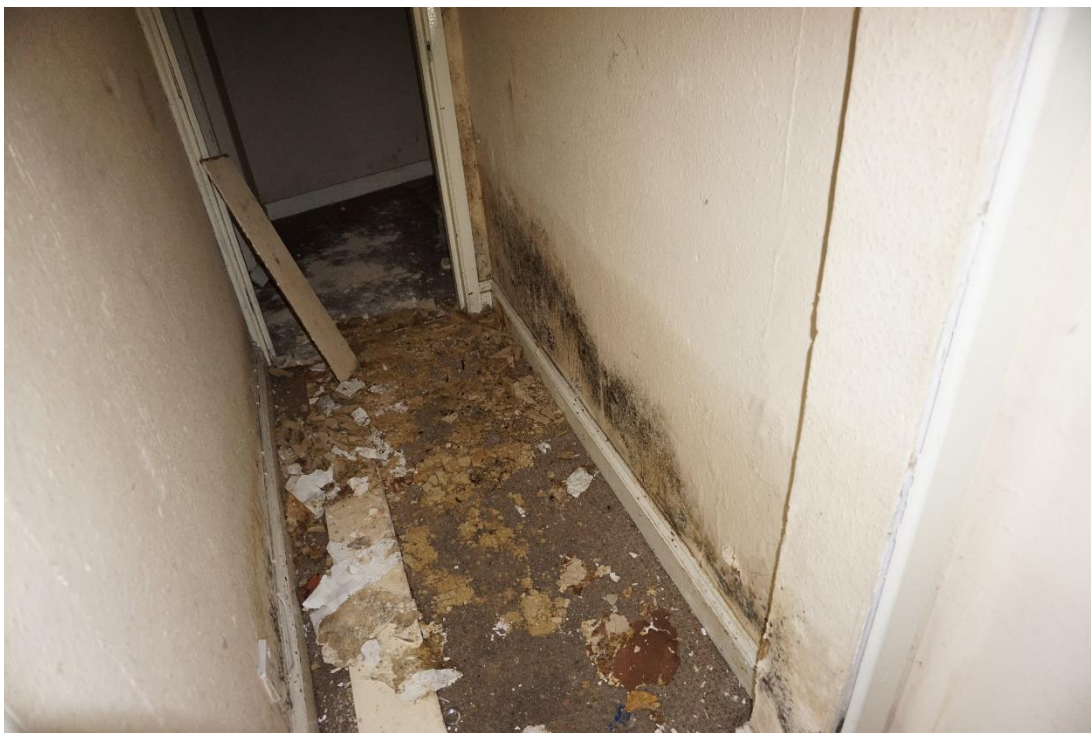
rain during the survey and water was pouring into the corridor through the defective roof coverings and into the kitchen area through a broken roof light.

**Photograph 19** – Damp to walls

- 4.6** The water ingress in the ground floor corridor is likely to have caused decay to the floor structure and damage to the walls and plaster associated with rising damp. We would recommend specialist timber expert be appointed to determine the extent of decay and confirm the presence of any active woodworm or death watch beetle.

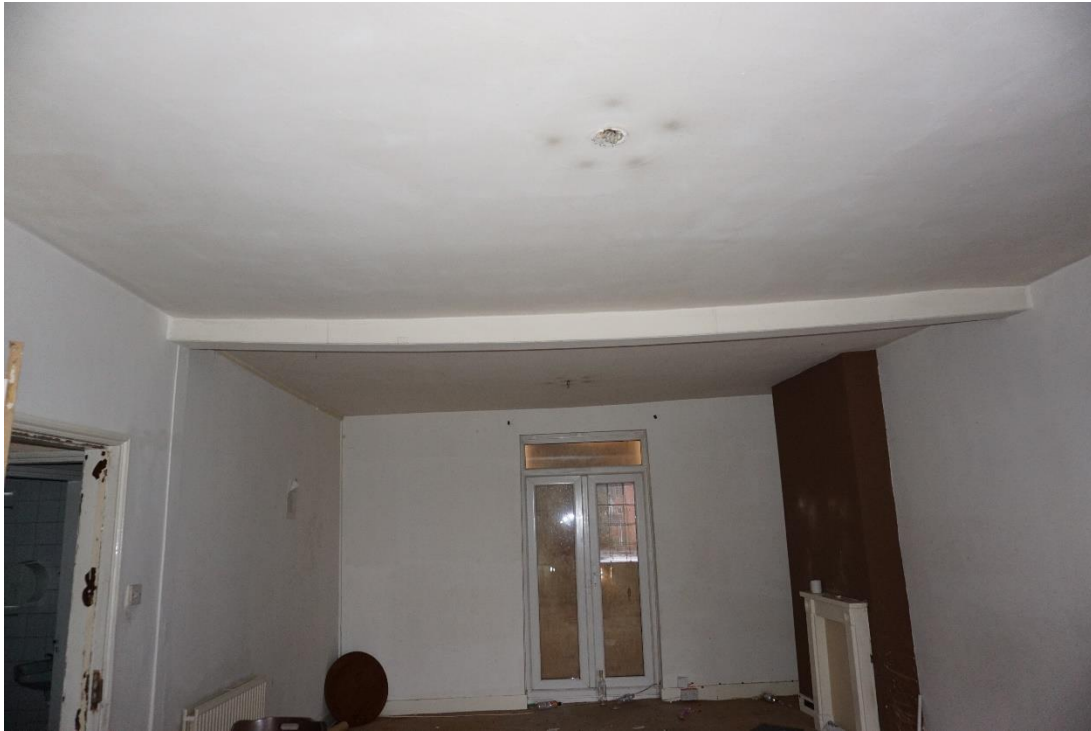
- 3.2.3.1 The downstand beam spanning across the lounge area has deflection in excess is 50mm (photo 20). There is a full height hairline to 1mm vertical crack and a hairline vertical crack to the RIGHT hand flank wall extending down from the cross beam bearing. Similar cracking was noted to the internal beam bearing with a diagonal crack extending down to the top corner of the door opening.
- 3.2.3.2 There is significant bowing and cracking to the masonry wall to the rear of the stair (photo 21).
- 3.2.3.3 The LEFT hand room at first floor was not inspected as the door was screwed shut.

**Photograph 20** – Deflection to beam supporting second floor

- 4.7** The beam over the lounge supporting the second floor has excessive deflection and is clearly beyond adequate design limits, therefore will require replacement. The beam is partially within the floor depth so replacement without removing the floor will be very difficult.

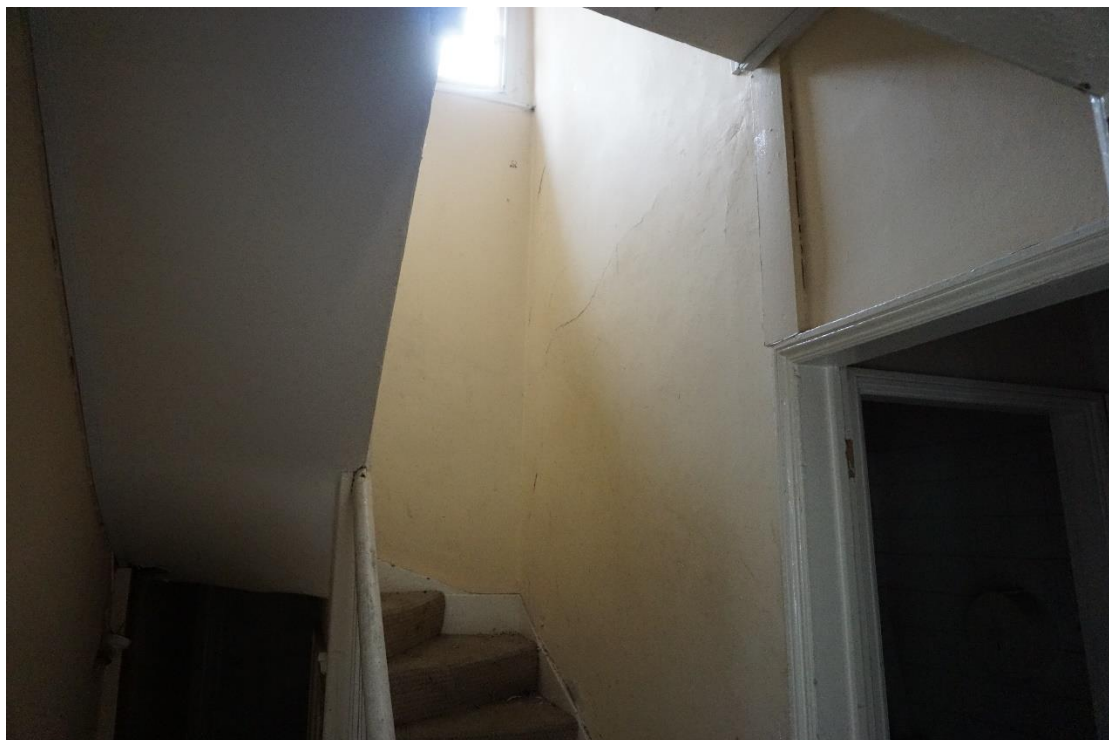
**Photograph 21** – Bulging/cracking to stair wall

- 4.9** The cracking to the stair wall has possibly been caused by lack of restraint or possibly due to disturbance cause by movement described in 4.7 above. The wall is bulging and fractured horizontally so will require rebuilding.

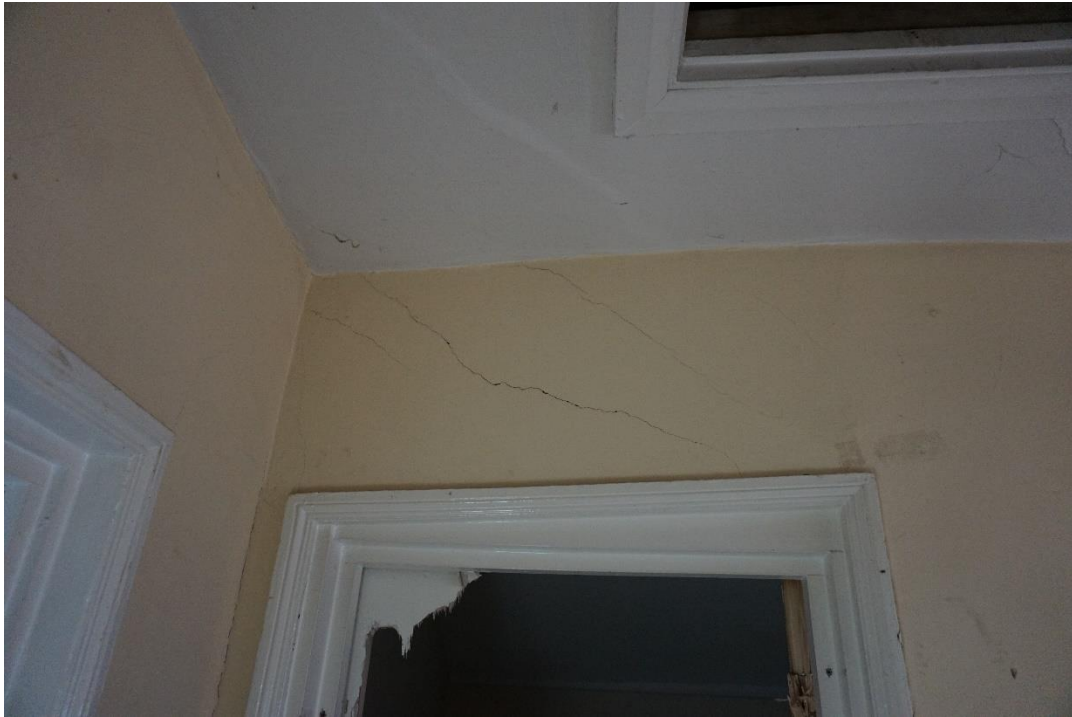
**Photograph 22** – Diagonal cracking to wall, note displacement to door frame

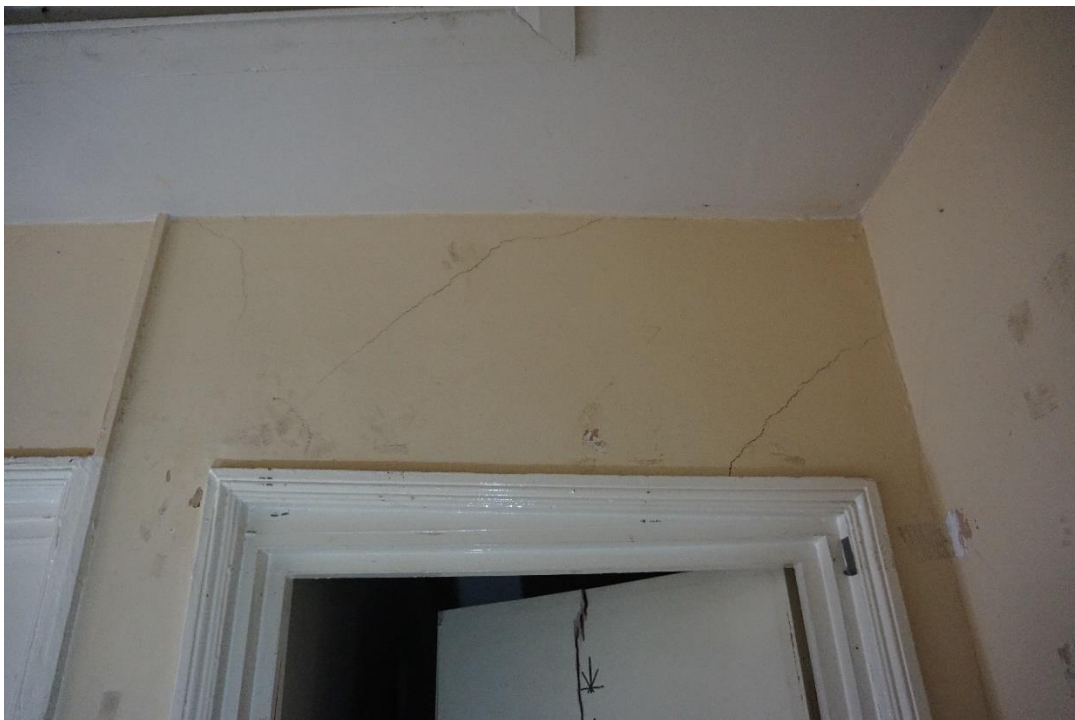
**Photograph 23** – Diagonal cracking to wall, note displacement to door frame
