## Arboricultural Post Completion Report

Geoffrey Field Infant School  
Exbourne Road  
Reading  
RG2 8RH

Reading Borough Council  
Level 11  
Civic Centre  
Castle Street  
Reading RG1 7AE

Survey Date: 30<sup>th</sup> January 2018  
Report Date: 13<sup>th</sup> February 2018  
Project no: 564

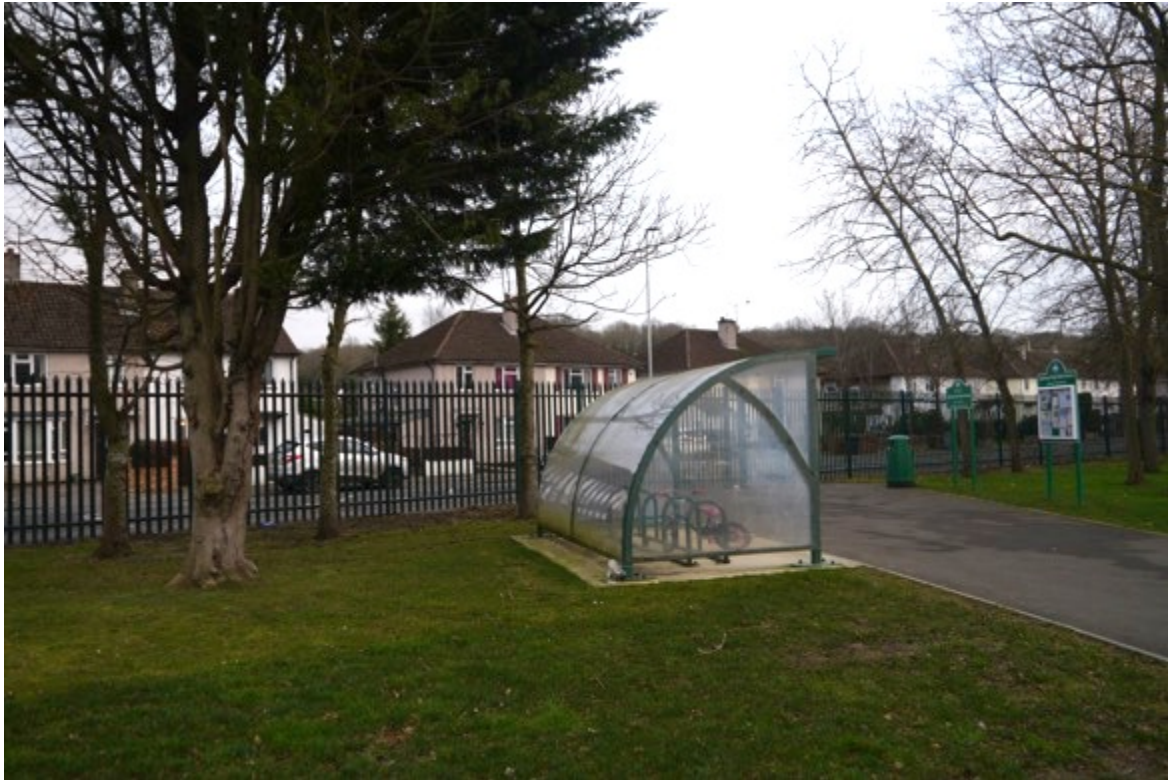
- 3.1.3** The new cycle store has been constructed to the north side of the access road, and is within the root protection area of the Lawson cypress, T117. The cycle store has a concrete base, which is set into a grassed area, adjacent to the road. The tree is not showing any adverse impact from this work. A photo is included in Appendix A.

New cycle shelter constructed within the Root Protection Area of the Lawson cypress, T117.

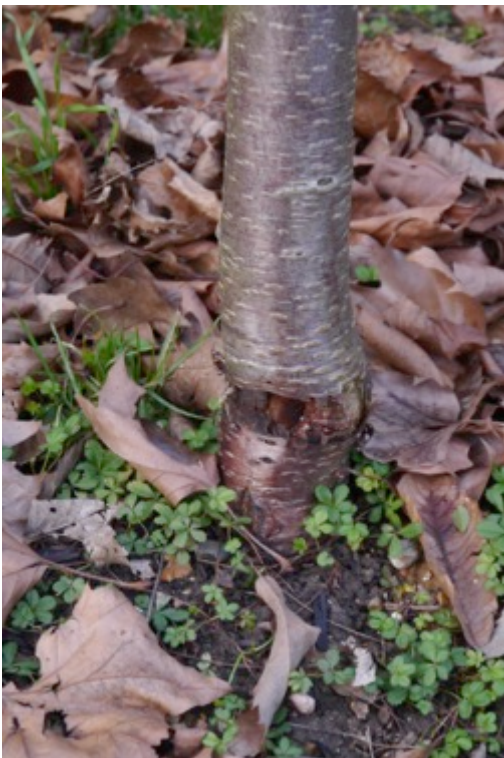
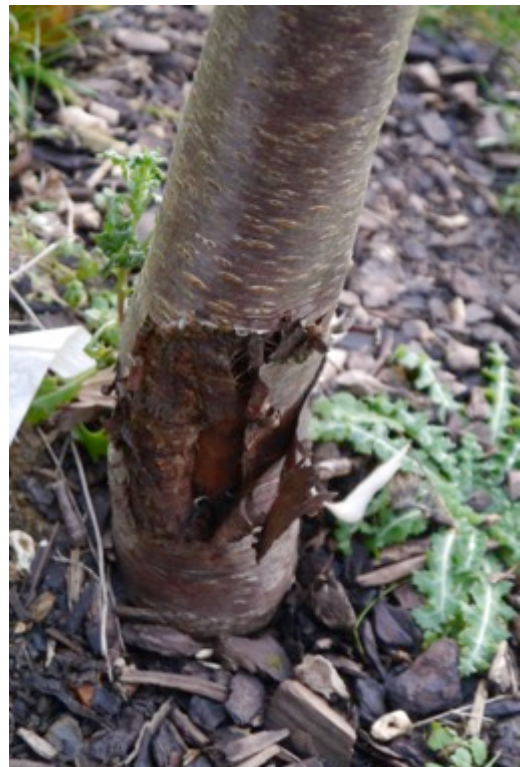
- 3.2.1 New trees have been planted in the positions shown on the approved detailed planting plan. The trees are the correct species and size, and are of good form and structure.
- 3.2.2 It is not possible to ascertain whether the tree pits were excavated in accordance with the specification, or whether fertilizer has been incorporated. However the trees are showing good vitality and appear to be firmly planted.
- 3.2.3 Trees have been double staked and tied with rubber ties and spacing blocks. An irrigation tube was present at the base of each tree. An area of bark mulch is spread around the base of each tree.
- 3.2.4 Two cherry trees (*Prunus avium* Plena), located in the northeast corner of the school site, have significant basal stem wounds, shown in the photos attached as Appendix A. It is not known how these wounds have occurred.

Basal stems of two newly planted cherry trees (*Prunus avium Plena*). Both have significant wounds and may require replacement.

- 4.1 It is recommended that the two damaged cherry trees in the northeast corner of the site are re-inspected within 18 months to ascertain whether the basal stem wounds are occluding, or whether heartwood decay is developing. If the trees are found to be of poor vitality, or if there are other signs that decay is progressing, then the trees must be replaced in accordance with Condition 20 of the approved planning permission.
- 4.2 Trees must be maintained in accordance with the approved maintenance plan. It is of particular importance that the trees ties and spacers are adjusted as necessary to allow for growth, in order to prevent stem damage, until such time as the trees are established and the ties can be removed.
