# 1-3 CASTLE CRESCENT

Reading RG1 6AQ

## Asbestos Refurbishment / Demolition Survey Report

29 September 2017

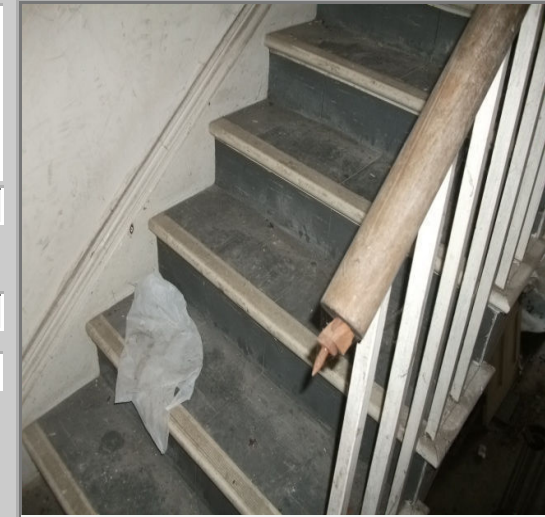
5.0 m2

Good condition

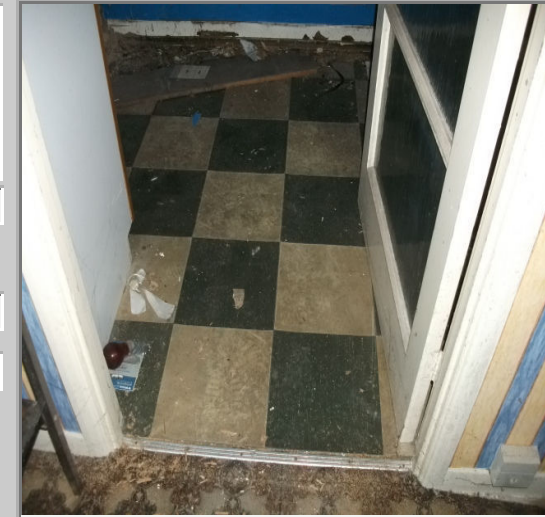
4.0 m2

Good condition

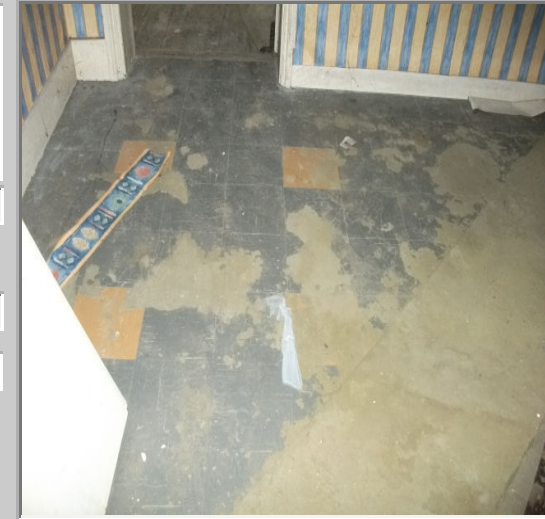
20.0 m2

Good condition

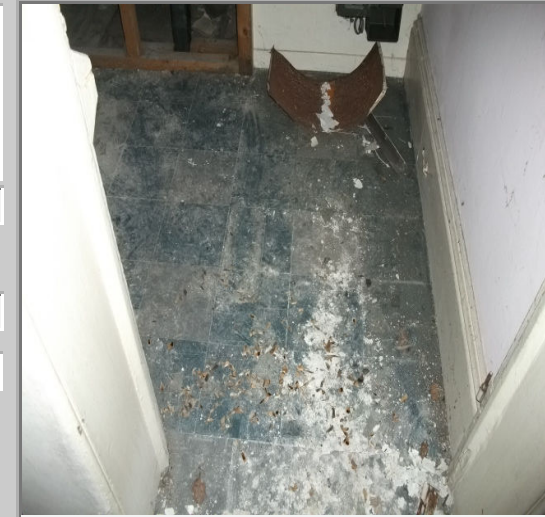
3.0 m2

Good condition

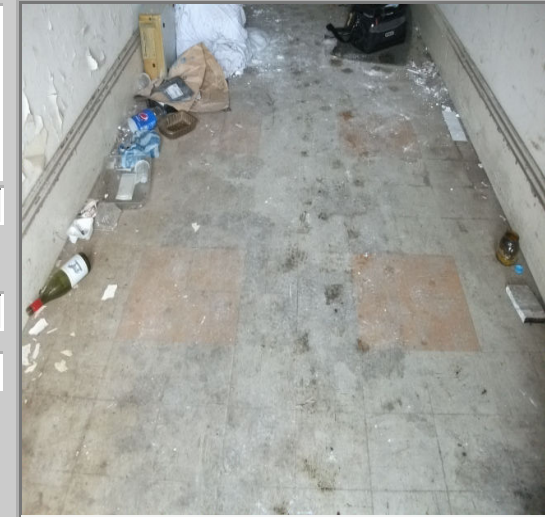
40.0 m2

Good condition

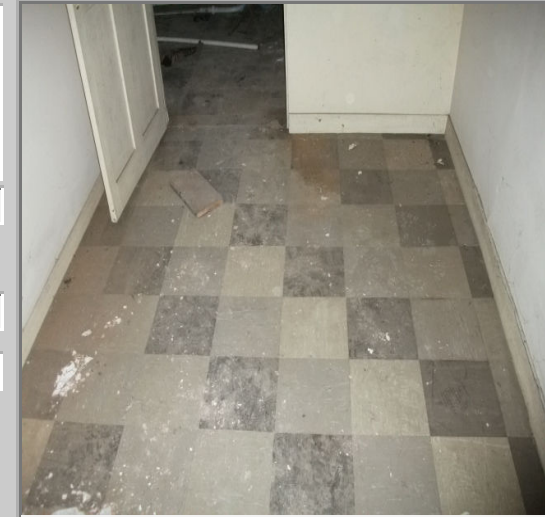
8.0 m2

Good condition

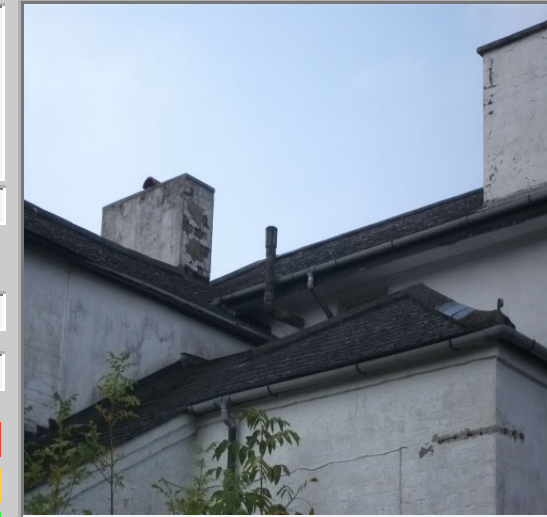
Good condition

3

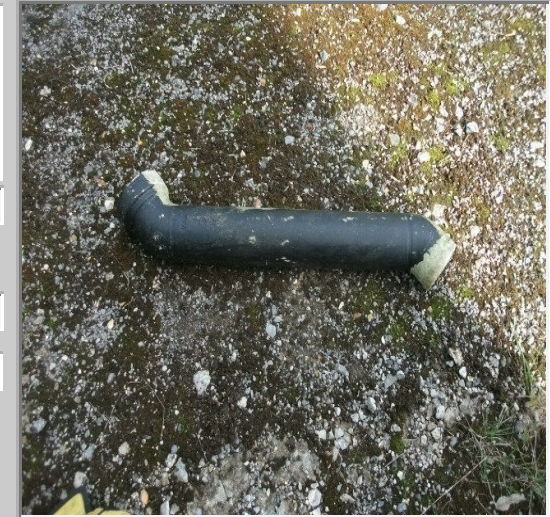
Loose, asbestos cement, rainwater goods.

1.0 Lin m

Good condition

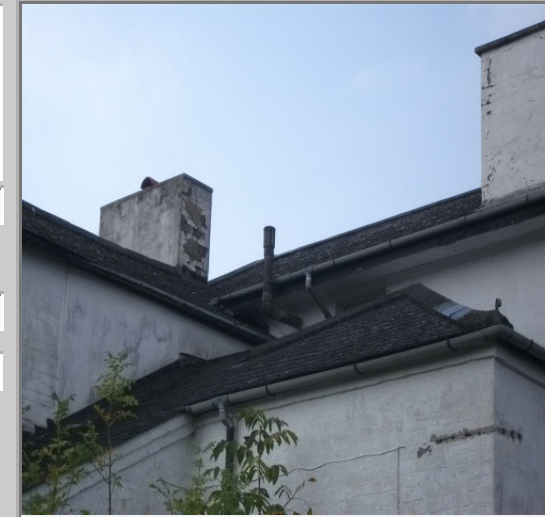
1.0 Lin m

Good condition
