## DETERIORATED SOFFIT TO THE ENTRANCE PORTICO OF THE ROYAL BERKSHIRE HOSPITAL NORTH BLOCK

### HERITAGE STATEMENT / DESIGN & ACCESS STATEMENT

June 2017

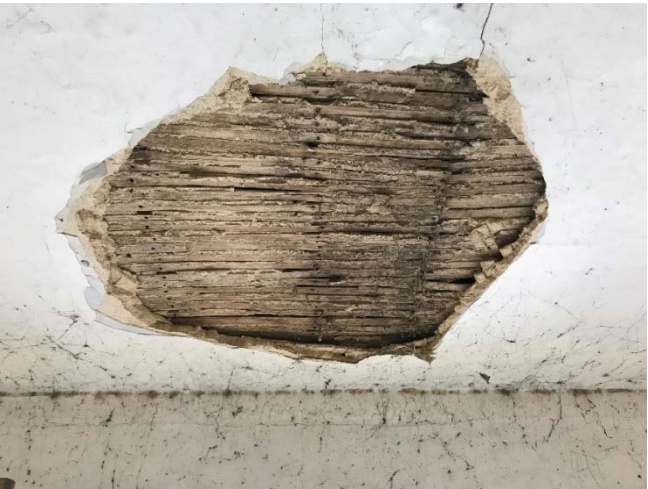
Figure 1: Area of missing / fallen plaster viewed with live plaster surrounding.

An area of plaster measuring approximately 1m² has become detached from the substrate and was found to have fallen to the portico floor below. This area is directly in front of the main entrance door.

Following a full inspection of the entire portico soffit from a suitable access scaffold platform, and consultation and approval from the Conservation Officer, we recommend that any deteriorated and live plaster be stripped to sound material surrounding. The condition of the wooden laths should be assessed, although there does not appear to be any deterioration to these from the initial visual inspection.

We recommend that the plasterwork is then patch repaired using a traditional lime plaster to match the existing, with an appropriate material used as reinforcement to ensure the strength and longevity of the repair.

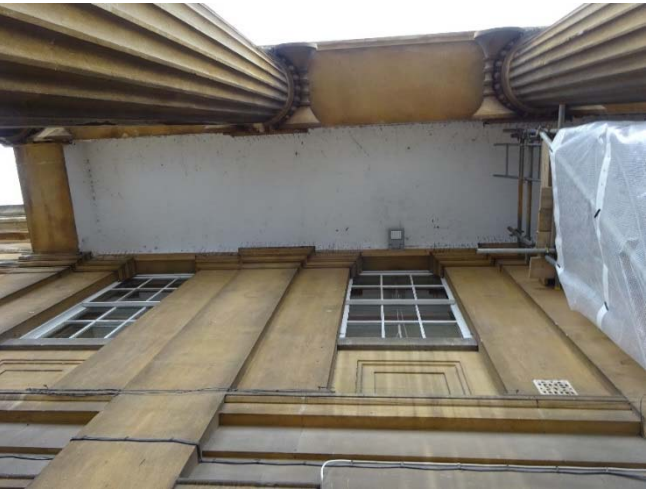
Figure 2: Eastern end of portico soffit which may also contain areas of loose / live plaster.

In addition the area where plaster has fallen, there exists a surrounding area where the plaster is live, friable, brittle plaster which appears liable to fall at any moment subject to normal building vibrations, or strong winds or other atmospheric changes. The area of surrounding live plaster appears to measure a minimum of approximately 3/4m², although there may be further areas to either side of the portico soffit which could not be closely inspected from the current scaffold platform.

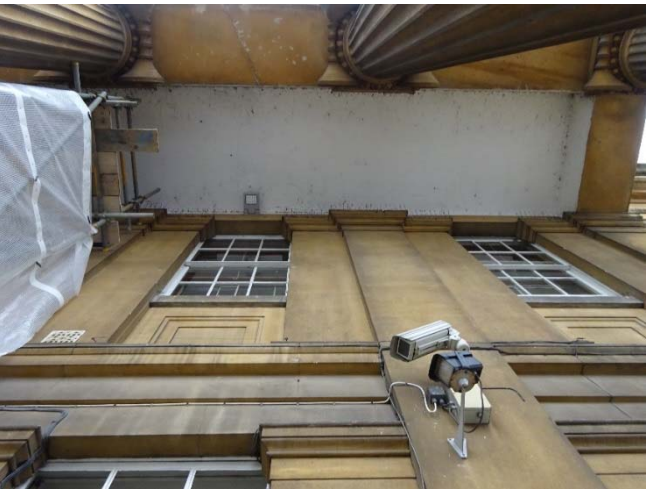
Figure 3: Western end of portico soffit which may also contain areas of loose / live plaster.

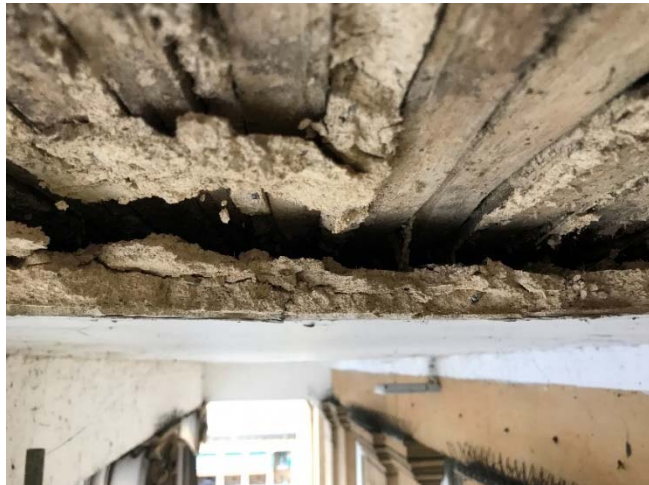
*Figure 4: Close-up of edge of missing plaster; showing further loose material at risk of falling away from lath substrate.*

Horsehair reinforced lime plaster is a stable and long lasting material which will withstand normal continued vibration and minor building movement, however, holes are common in plasterwork which has been water damaged. It is likely that at some point in the past a leak has developed from the roof covering above.

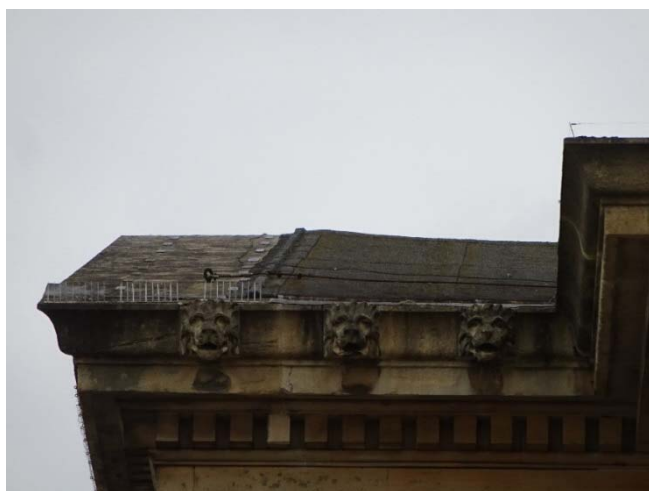
*Figure 5: Portico roof viewed from the west showing overlaid possibly deteriorated bitumen asphalt sheeting.*

This diagnosis is supported by the presence of the current overlaid bitumen asphalt sheeting to the portico roof. There may have been a number of slipped or deteriorated slates or ridge tiles leading to water ingress in the area above the fallen plasterwork.

We recommend that the existing roof covering be visually inspected as soon as it practically possible. Should (as suspected) the bitumen asphalt layer be found to be defective we recommend that, following consultation and approval by the Conservation Officer, this external temporary protective layer be carefully stripped to allow inspection of the roof slates below.

Depending on the condition of the underlying roof covering, individual replacement slates or ridge tiles may be recommended to be applied; alternatively the full replacement of the portico roof may be more appropriate to ensure the long term protection of the building fabric below and a manageable future maintenance liability. Any such decision would need careful consideration and approval from the Conservation Officer.

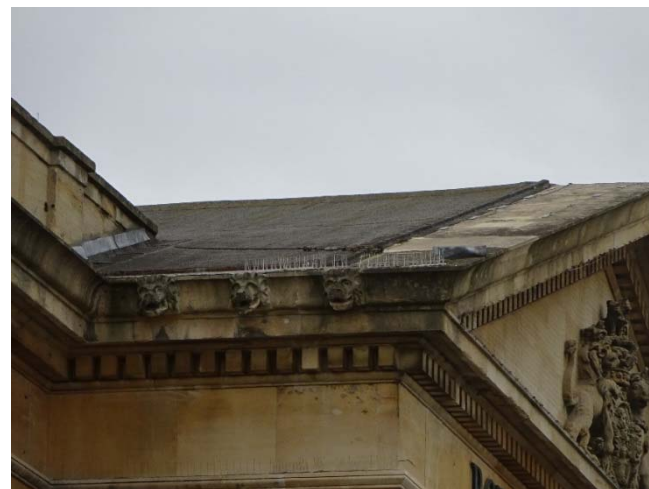
It is unclear how long the overlaid temporary roof sheeting has been in place for. It is possible that this waterproof covering has itself deteriorated and may be allowing water to penetrate and saturate the plaster soffit.

*Figure 6: Overlaid bitumen asphalt sheeting to East slope of portico roof.*

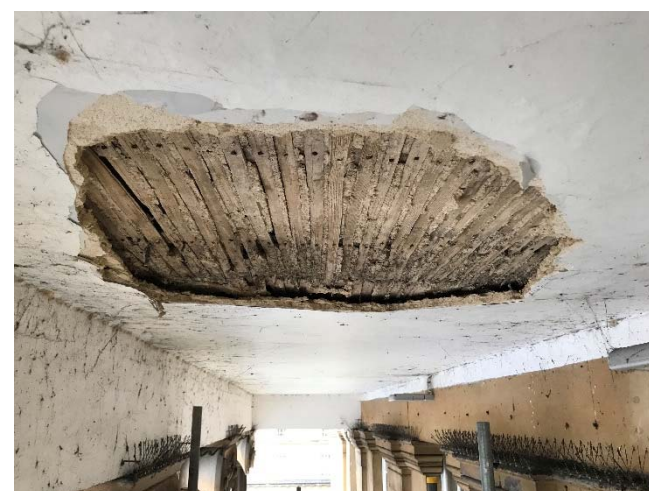
Figure 8: Area of damaged plaster

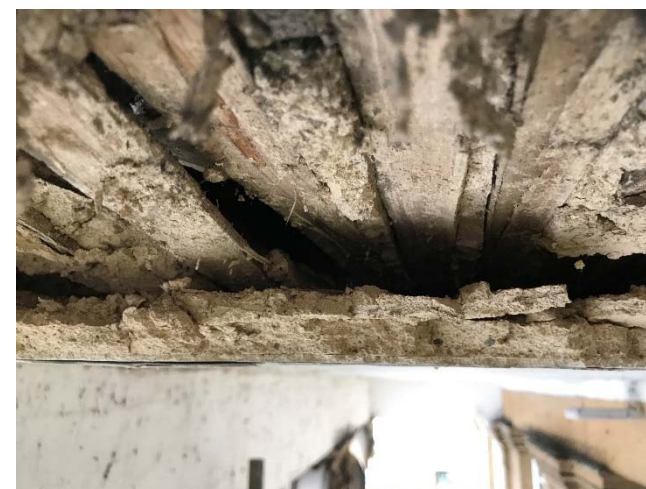
Figure 9: close up of timber laths

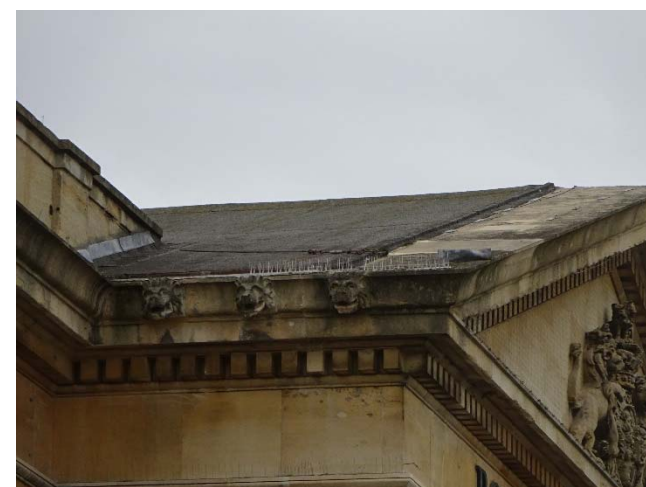
Figure 10: close up of roof covering
