RIVERSIDE DENTAL CENTRE, BRIDGE STREET, CAVERSHAM,  
READING, BERKSHIRE RG4 8AA

TREE CONDITION SURVEY, ARBORICULTURAL IMPLICATIONS  
ASSESSMENT REPORT WITH RECOMMENDATIONS

MAY 2017

Prepared by:  
Goodger Design Associates  
75a St Leonards Road Windsor  
Berkshire SL4 3BZ  
Email: [info@gda-design.com](mailto:info@gda-design.com)

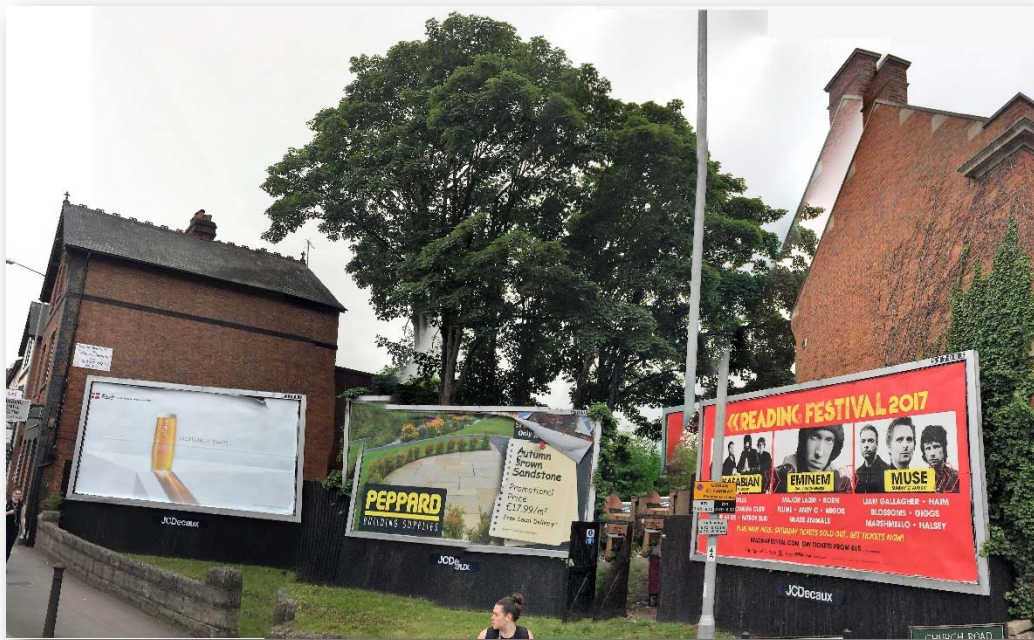
**Image 1: Looking south west to Trees T5 to T1 behind Hoardings (All Sycamore-*Acer psuedoplatanus*)**

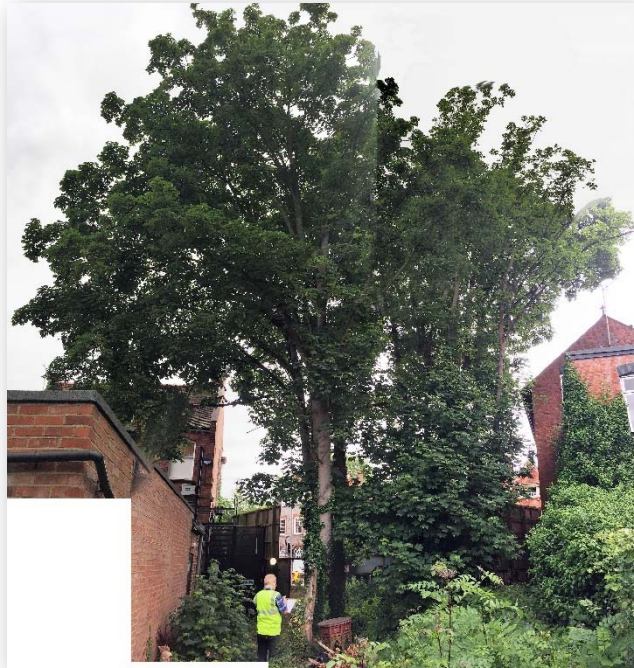
**Image 2: Looking east towards Tree 1 to left and Trees T2-T5 to right (all Sycamore)**

This group of trees was surveyed in full leaf and on good weather. Tree T1 has a decay column extending 1.8m from ground level possibly caused by a canker with no sign of reaction wood growing around the decayed area. It is likely to decrease in vitality and we estimate that it will not have a useful life beyond 20 years. It may be a maintenance issue for the adjoining property in terms of leaf/branch fall and sap drip from the leaves as it is located in a confined space for a 'forest' tree.

Tree T2 is in better condition than T1 and is a multistem. The crown is suppressed on the south side by T1 and there is a small amount of butt rot evident at the base. It is likely to be causing similar issues as T1 to the adjacent buildings.

Tree T3 is an uneven collection of seven multistems that would have arisen when the tree was cut down as a coppice in the past. There is some decay evident in the smaller stems. It is infested with ivy growth although the ivy is being controlled in the other trees in this group. It is suppressed on the north side by tree T5.

Tree T4 has an unbalanced crown growing towards the south over the roof of the dental centre and is suppressed on its north side by tree T1. The principal of the dental surgery has indicated that the overhanging trees are causing similar maintenance issues with leaf /branch fall/sap drip as to the buildings to the north side of the site.

3.1 It is not possible to retain any of the surveyed trees within the current Dental Centre Extension Proposal as indicated on drawing nr. 274/01. Sycamore is a very widespread tree which is currently not under any significant threat from tree diseases such as those that are currently affecting Ash and Alder trees. In our opinion, it would not present a significant loss to the urban streetscape if they are removed as they are 'forest' trees not well suited to the confined space that they are currently growing in. A planted courtyard is proposed to the new building's rear for patients and staff to enjoy and we recommend the planting of two attractive fastigate tree species such as the Sweet Gum Liquidamber styraciflua 'Slender Silhouette' with a girth of 18-20cm and height of 4.5 metres. These are slender trees that will be not much more than 1m in crown width.

- 3.2 The arborist employed to fell the trees must provide a comprehensive method statement to ensure the health and safety of pedestrians and their workforce while felling the trees. They must be felled in sections, the ground checked for live underground services, the stumps grinded to a depth of not less than 300mm. To prevent regrowth a proprietary stump killer must be applied to the stumps after stump grinding. The hoardings should also be removed prior to the tree felling works.

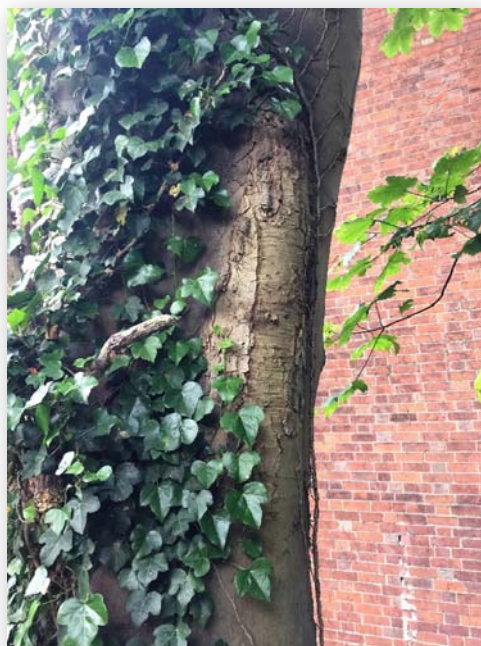
Tree T5 is the most substantial tree on the site and is likely to have a useful remaining life of up to 40 years. It is suppressed on its north side by trees T2 and T3 and its crown is growing above the roof of the dental centre thus causing the maintenance issues already alluded to. T5 has a compression fork at 2.5m height and there is a bulge or rib present on the trunk's west face. This indicates that 'reaction' wood has grown over an area of weakness and a crack may be present between the two stems under the 'reaction' wood. This may indicate a point of instability and possibly failure in the future. The bulge is indicated in image 3 on the next page.

**Image 3: Close up view of the west face of Tree T5's trunk showing Pronounced bulge or Rib between two stems in a compression fork**

| TREE CONDITION SURVEY SCHEDULE (For further details and explanations of notations see associated arboricultural report) | | | | | | | | | | | | | | | | |
|---|---|---|---|---|---|---|---|---|---|---|---|---|---|---|---|---|
| T5 | Acer pseudoplatanus | B2 | 27.6 | 560 | 3.4 | 7.97<br>5.6 | 6.1 | 6.2 | M | G | F | NV | 20-40 Years | 137m² | 6.6m | Double stemmed at 2.5m, full crown unbalanced to north, tall canopy, ivy controlled, fully leafed out, rib evident on west face between compression fork where double stem joins. |
