# **Record of Site Inspection**

**Island Road, Reading**

**August 2017**

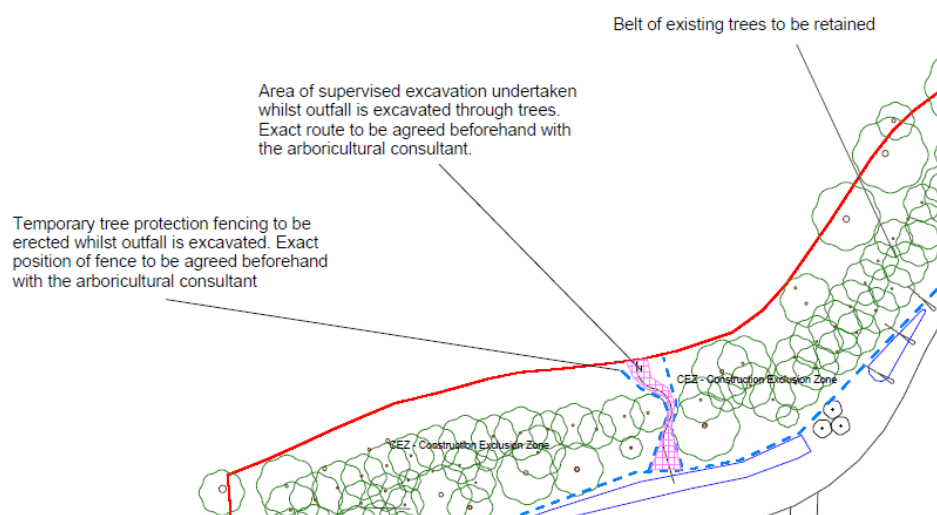
2.1 **CLIENT BRIEF** : To undertake an arboricultural inspection of the route excavated between existing retained trees, as indicated below (hatched pink);
