**SCHEDULE OF REPAIRS**  
1-3 Castle Crescent, Reading, RG1 6AQ

Prepared for: Lucas Design  
Issue 1: 26 September 2017  
Ref: TR8170910/AM/LR/002

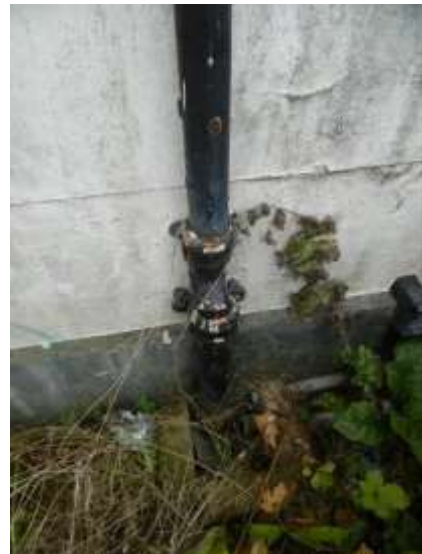
| Item | Location / Element | Defects | Repairs | Photo Ref |
|---|---|---|---|---|
| 2.2 | Rainwater Goods | <p>Half round plastic guttering of some age and deteriorated and likely to be brittle and leaking.</p> <p>Black colour painted cast iron downpipes corroded and blocked with vegetation.</p> <p>Missing downpipe section to West flank elevation. Possible contributory factor to collapsed bay window roof structure and damp penetration.</p> | <p>Remove and cart away all existing rainwater goods including guttering, downpipes, hoppers and brackets. Replace with cast iron in black colour with heritage / traditional style hoppers and half round guttering to ensure sympathetic with the period.</p> <p>The hopper and downpipe picking up waste connection on the north elevation at first floor level should be omitted and the waste connections redirected internally to a new soil and vent pipe.</p> <p>Allow to carry out flow analysis of run-off to confirm proposed design and falls are satisfactory. Specialist advice to be sought from MEP designers/engineers.</p> | 8-11 |

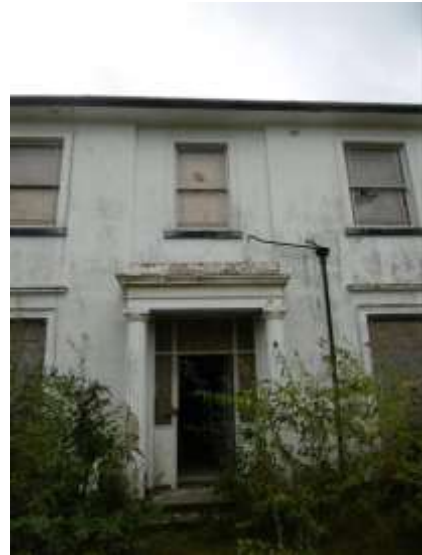
20.

| Item | Location / Element | Defects | Repairs | Photo Ref |
|---|---|---|---|---|
| 3.0 | Entrance Door and Glazing | Timber entrance door in very poor state of repair from previous break-ins and works to secure premises. Glazing broken and boarded over and joinery damaged. | Considered beyond repair, replace with new to match existing. Finish to Local Authority approval. | 19-20 |

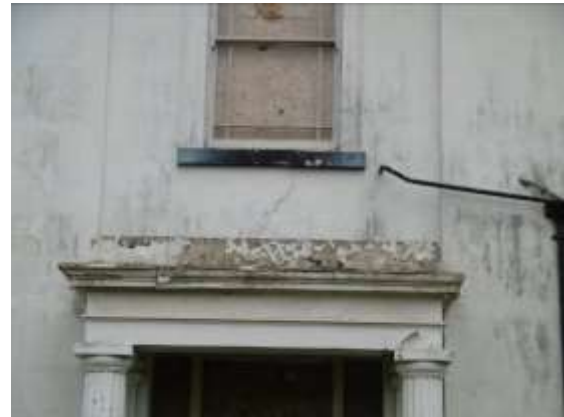
22.

| Item | Location / Element | Defects | Repairs | Photo Ref |
|---|---|---|---|---|
| 3.1 | Window and Door Openings | Vertical cracking above all window openings.<br><br>Large vertical crack above portico structure / entrance opening; circa 5mm wide. Window sill above dropped on right side. | Provide support; open up and inspect structure above openings; allow to remove all existing lintels and beams and replace with new to Structural Engineer's design and specifications. Make good all affected wall materials and surfaces.<br><br>Cut out and replace damaged and deteriorated brickwork above openings, carry out brick crack stitching where necessary using Helifix type rods. Make good all affected and disturbed materials and brickwork. | 6, 21-23 |

| Item | Location / Element | Defects | Repairs | Photo Ref |
|---|---|---|---|---|
| 3.3 | Window Sills | All concrete sills are cracked and deteriorated; painted surfaces have deteriorated. | Remove existing sills and replace with new to match style and dimensions. Carry out decorations to match existing black colour to Local Authority approval. | 7,22,25 |

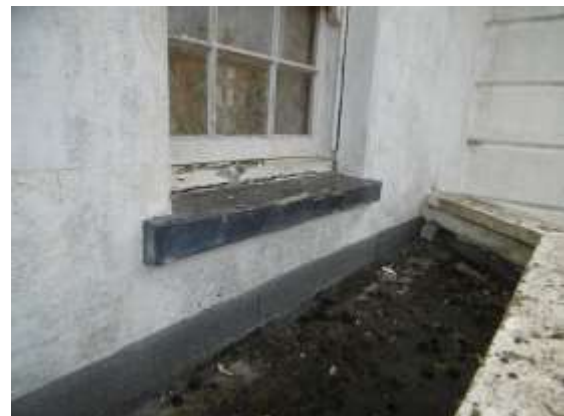
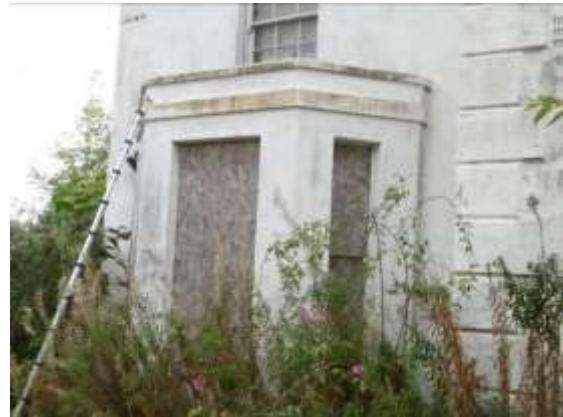
| Item | Location / Element | Defects | Repairs | Photo Ref |
|---|---|---|---|---|
| 3.2 | Bay Window<br><br>Bay Window cont'd... | Vertical cracks below and above window openings. Cracks join-up horizontally and extend up through string course and copings to parapet.<br><br>Flat roof covering deteriorated and lead flashings missing. Roof has failed causing substantial water ingress into room below.<br><br>Building wall above bay (below 1 <sup>st</sup> floor window) showing vertical cracking and sill has dropped. Open joints around window | Further investigations of sub-structure and ground conditions required. Dig trial holes to expose and allow inspection by structural engineer. Underpinning of the bay may be required.<br><br>Provide support to structural opening in wall and allow to open up structure above bay to inspect and replace existing bressumer beam / lintel and replacement with new steel beam / pre-stressed concrete plank lintel to engineer's design and specifications. Carry out repairs to brickwork including raking out mortar joints, removing | 24-28 |

| Item | Location / Element | Defects | Repairs | Photo Ref |
|---|---|---|---|---|
| | | opening approximately 10-30mm wide indicating structural movement. | defective brickwork, preparing surfaces and carrying out re-instatement works including brick crack stitching as necessary.<br><br>Allow to remove existing timber roof structure and replace with new structure including insulation material to Architect's detail and engineer design. Lead flashings and lead roof covering to be installed to Lead Association recommendations. | |

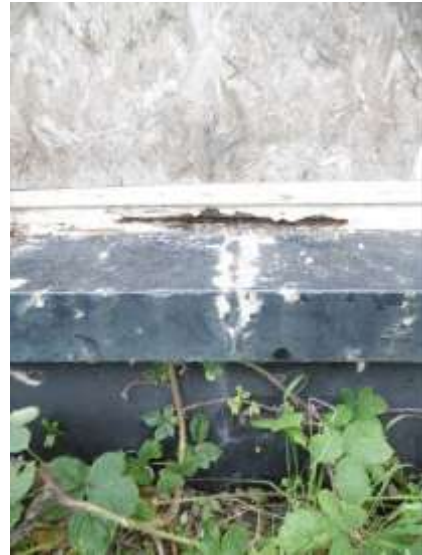
| Item | Location / Element | Defects | Repairs | Photo Ref |
|---|---|---|---|---|
| 4.2 | Bay Window | Cracking above and below all structural openings. No access to inspect high level; roof structure collapsed inside room below. | <p>Allow to remove failed roof structure and replace with new timber structure; include insulation material and recovering and flashings with lead to Architect's detail and Lead Association recommendations. Roof structural design to be by engineer.</p> <p>Provide support to structural openings and carry out opening up works to replace existing lintels to engineer's design. As a precautionary measure allow to open up, inspect and replace the bressumer beam over the opening into the bay to engineer's design.</p> <p>Further investigations required of sub-structure conditions by digging trial holes to be inspected by engineer. Underpinning works may be needed.</p> | 41-44 |

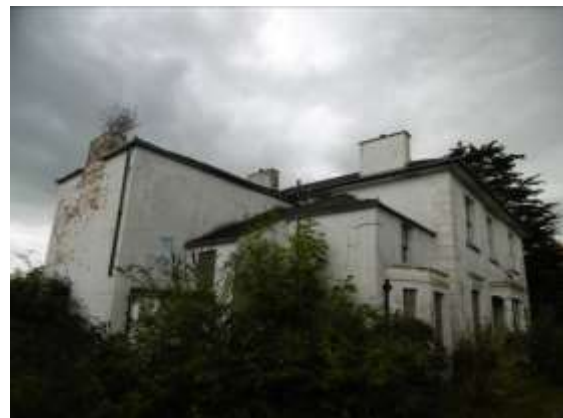
46.

| Item | Location / Element | Defects | Repairs | Photo Ref |
|---|---|---|---|---|
| 5.0 | Walls | <p>Later additions to this elevation are to be demolished as part of the redevelopment of the site. The existing construction to be demolished concealed the majority of the structure being retained. The first floor window and box gutter were not possible to inspect or visible from ground level.</p> <p>Stepped cracking at eaves level seen by downpipe.</p> <p>Drill holes in brickwork to corner at first floor level and evident of deteriorated and spalled brickwork present.</p> | <p>Providing support to window openings, remove lintels, windows, sills and joinery and replace to match existing to Architect and engineer design.</p> <p>Brickwork to be inspected following demolitions and repairs completed as necessary.</p> <p>Temporary weatherproofing of newly exposed walls to be provided including securing existing openings to prevent unauthorised access until area watertight and secure.</p> <p>Renew high level box gutter including under boards and lead soakers to Architect's detail and installed to Lead Association recommendations.</p> | 45,46 |

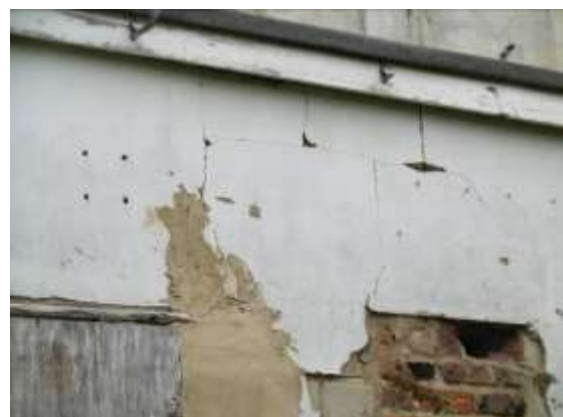
48.

| Item | Location / Element | Defects | Repairs | Photo Ref |
|---|---|---|---|---|
| 6.0 | Single Storey Flat Roof Structure | Substantial cracking to rear wall, poor brick infill of existing window. Basic construction (possible ½ brick thick walls). | <p>The construction is basic and considered at the end of its useful life. Demolition and reconstruction including excavations to replace sub-structure is required, all to Architect's and engineer's design.</p> <p>Temporary weatherproofing and securing of the newly exposed wall and openings at ground floor level may be necessary following demolitions until watertight and secure from construction.</p> | 47,48 |

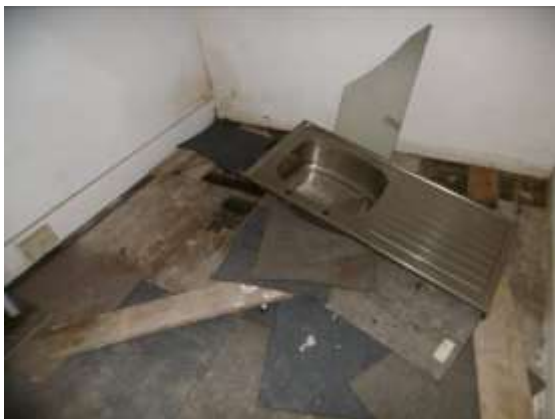
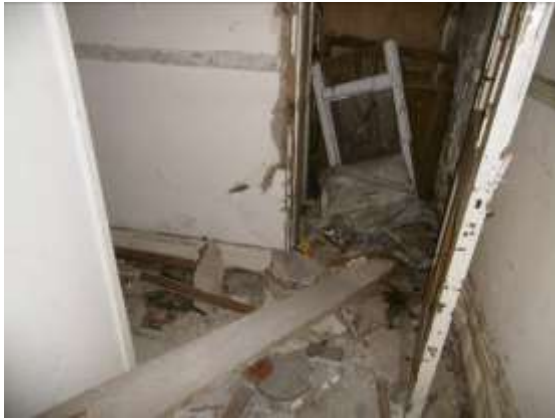
| Item | Location / Element | Defects | Repairs | Photo Ref |
|---|---|---|---|---|
| 7.2 | Internal Joinery | The timber stairs in the entrance lobby and to the north east of the building appeared to be in a sound condition, but are in need of an overhaul. The balustrade to the main flight is loose. | Remove all internal doors and ironmongery and cart away. Allow to replace with fire and smoke resistant doors and ironmongery in a heritage style sympathetic with the period and to Architect's specifications. | 60-69 |

| Item | Location / Element | Defects | Repairs | Photo Ref |
|---|---|---|---|---|
| | Internal Joinery cont'd... | <p>The balustrade to the stairs from the half landing up to first floor level is loose and should be overhauled as part of the refurbishment to the building.</p> <p>The internal doors whilst some are original most are not hung, missing ironmongery and are not modern fire doors and a health and safety risk in a block of residential units.</p> <p>Rotten door frame head between room G2 into bathroom, joinery likely to be decayed behind where in contact with damp masonry.</p> <p>Evidence of different stages of decay to skirtings, door frames, linings, boarding and mouldings. Substantial rot to joinery and mouldings around ground floor bay windows as a result of collapsed roof and prolonged damp penetration. Decay likely behind timbers where in contact with damp masonry. High risk of dry rot and wood-boring insect attack to concealed timbers.</p> | <p>All architraves, door frames and linings to be removed and replaced with new softwood joinery to match existing profiles and wall thicknesses. Decorate to finish to Architect's specifications.</p> <p>Mouldings, linings, sills, skirtings to be removed and disposed off-site. Allow to replace with new bespoke softwood joinery by joinery company. Joinery to match existing heights, profiles and design to maintain character and heritage features of the building.</p> | |

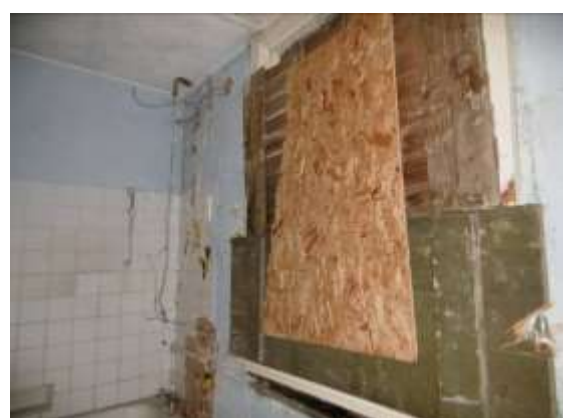
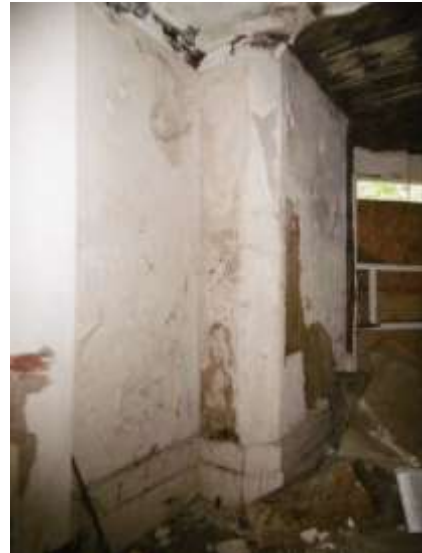
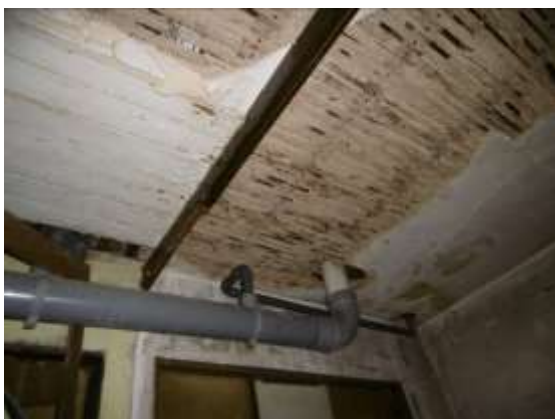
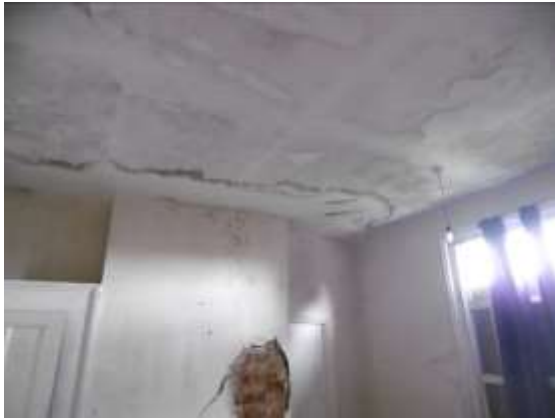
| Item | Location / Element | Defects | Repairs | Photo Ref |
|---|---|---|---|---|
| 7.4 | Internal Finishes (including Studwork, Partitions and Ceilings) | There is substantial dampness and mould growth affecting all rooms in the building which has been ongoing for some time. Ceilings have collapsed in areas and the internal condition is very poor. | <p>Allow to hack off and dispose off-site all plaster, finishes, ceilings and stud partitions in the property as are considered beyond repair. New materials to be used should meet BS EN Standards and internal plaster finishes to be in a style sympathetic to a historic building and heritage asset. A contractor experienced at this type of work should be appointed.</p> <p>The original mouldings around the arched opening in the entrance lobby are in a good condition and should be retained.</p> <p>The decorative plaster finish to the hallway ceiling is generally in good condition and should be retained is possible, there is a missing section of cornicing that required repair. A closer in section is required.</p> <p>A ceiling rosette in G3 is in a reasonable condition and should be retained if possible.</p> <p>It may be difficult to remove the rosette and retain the existing ceiling to carry out the refurbishments. We recommend detailed records are made so reinstatement to match the existing can be carried out in the event of damage.</p> | 57,60, 72-82 |

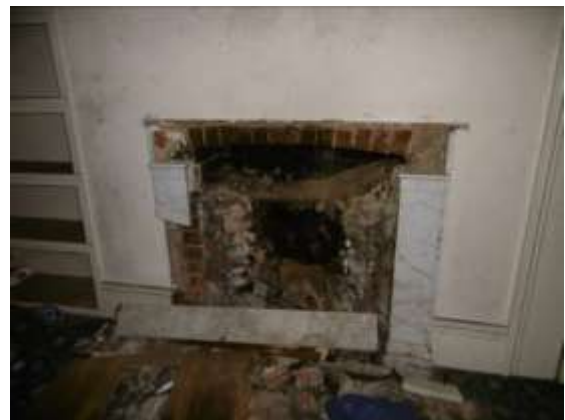
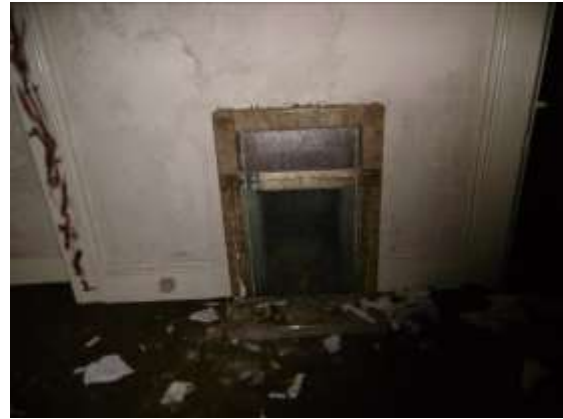
| Item | Location / Element | Defects | Repairs | Photo Ref |
|---|---|---|---|---|
| 7.6 | Fireplaces / Chimney Breasts | <p>Chimney breasts were concealed behind wall finishes, but substantial damp penetration was noted to the breast in room F4 and the brickwork in this area is completely disintegrated to dust and was loose when touched. Flues are likely blocked.</p> <p>Nearly all of the fireplaces and surrounds are missing, damaged and in a deteriorated state including rooms F1, F2, G2, G3, G5.</p> | <p>Re-building of large sections of the chimneys breasts are likely to be required and include providing support, cutting out and removing damaged bricks and replacing with new.</p> <p>Sweep flues; replace missing fire places in a style sympathetic to the period; carefully remove and refurbish off-site remaining surrounds and fire places.</p> | 88-97 |
