07 November 2017

### **43 Brooklyn Drive, Reading - Bat Preliminary Roost Assessment**

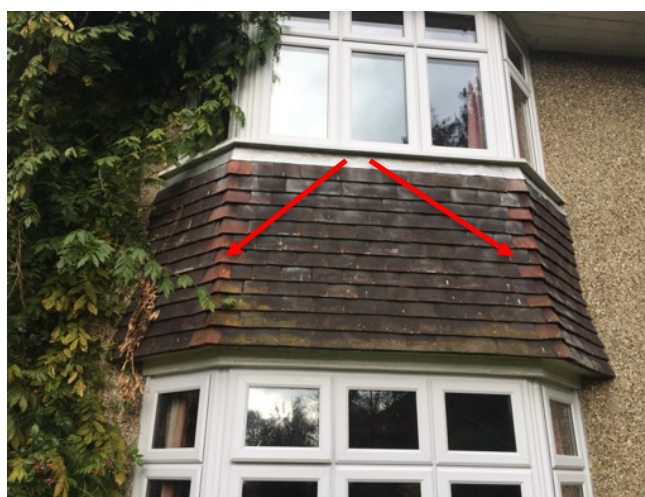
The preliminary roost assessment did not identify evidence of bats internally or externally, furthermore the property was in a good, well maintained condition. There were a few very small gaps under the hanging tiles which could have formed potential roosting features however for a space so small, evidence in the form of scratching, staining or droppings would be expected and there was none, it is also possible that old vegetation was blocking many of the gaps from the inside. There was also one small hole on the underside of the soffit box, however due to its position it would be a very awkward angle for bats to get into and due to this and the lack of evidence in the form of scratching, staining or droppings it is highly unlikely bats would use this as a feature. Therefore, in the sites current state, bats pose no constraint to the proposed works. However, due to the close proximity of woodland to the house it is recommended that a single bat box is installed on the house or garage after the works are completed to provide a new roosting feature as an ecological enhancement.

Photo 5 – Lifted hanging tiles – southern elevation

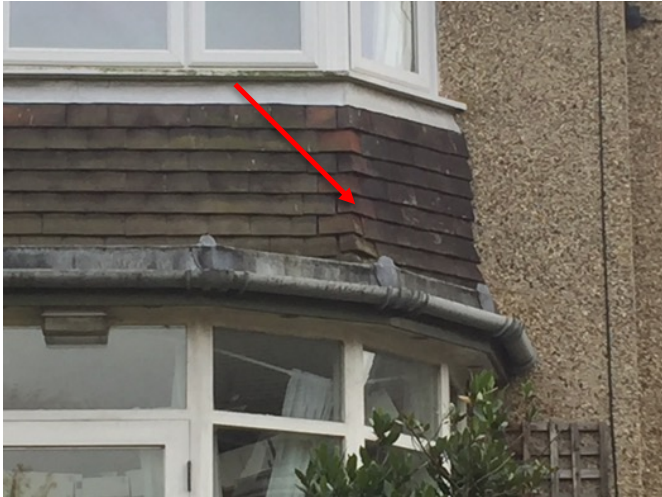
Photo 6 – Lifted hanging tiles – northern elevation

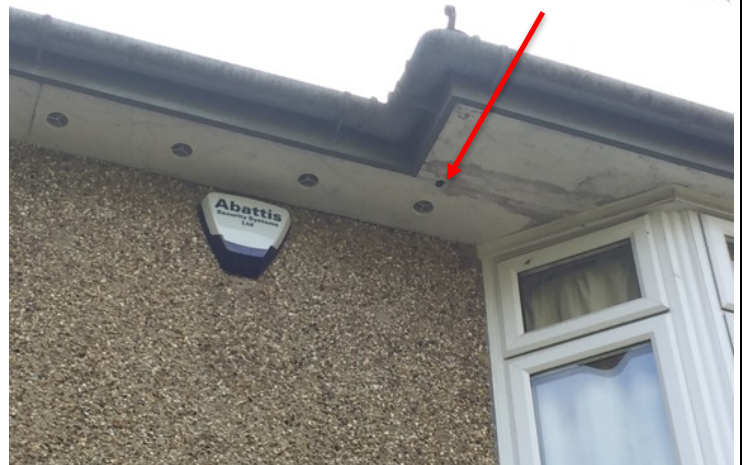
Photo 7 – Hole in soffit box – northern elevation

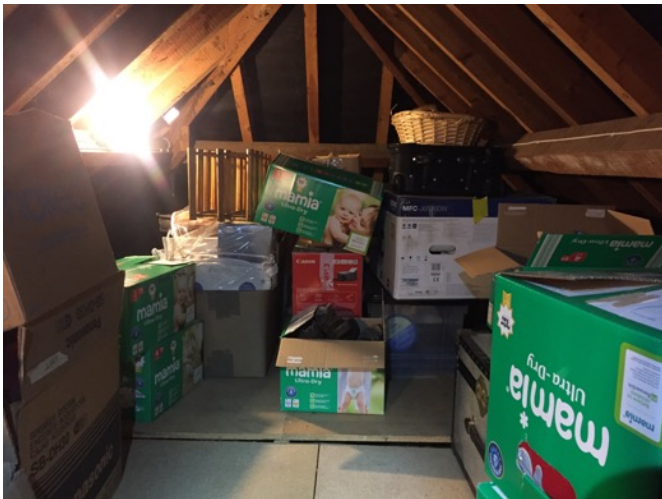
Photo 8 – Main loft space

Internally, the main loft space was felt lined, insulated and boarded throughout. The ridge was cobwebbed and there was no light ingress. The whole loft space was used as storage. The felt was in good condition with no pockets and there was no evidence of bats. The newer extension loft space was not boarded and therefore not accessible but could be seen sufficiently from the main loft space. It was lined with both felt and a modern plastic membrane underneath and was fully insulated. There was no evidence of droppings on the insulation, the felt was in good condition and there was no light ingress.
