# Initial Bat Assessment

**154 St Peters Avenue**  
Caversham Heights  
Reading  
RG4 7DR

Dr Stacey Dawn Waring  
17-001-IBA  
January 2017

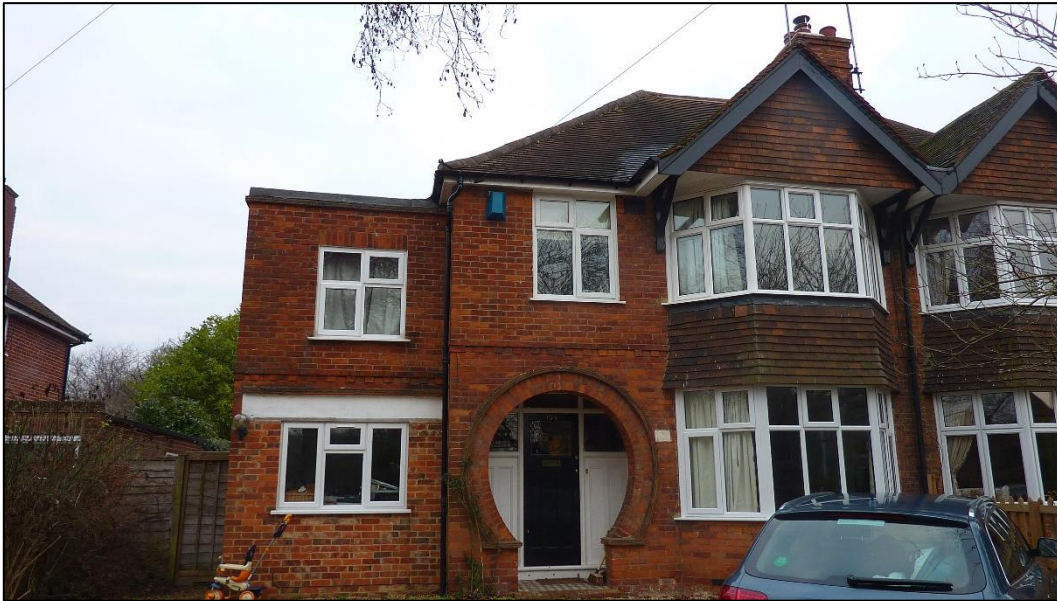
The site consists of a 20<sup>th</sup> Century, 1920's semi-detached, two storey building of cavity wall, brick construction (Figure 2) with a pitched roof, consisting of timber rafters resting on the walls and a clay/concrete tile covering. The property has a more recent first and second floor extensions to the side of the property and a further extension to the rear of the building. All of which are brick construction with flat roofs(Figures 2 & 3). The property is in good condition and currently occupied.

**Figure 2 - Front elevation of 154 St Peters Avenue**

The hanging tiles on the front elevation of the property (Figures 2 & 8) are machine-made and so tightly fitting. Combined with the good condition of the tiles they provided negligible opportunity for roosting bats at this time.

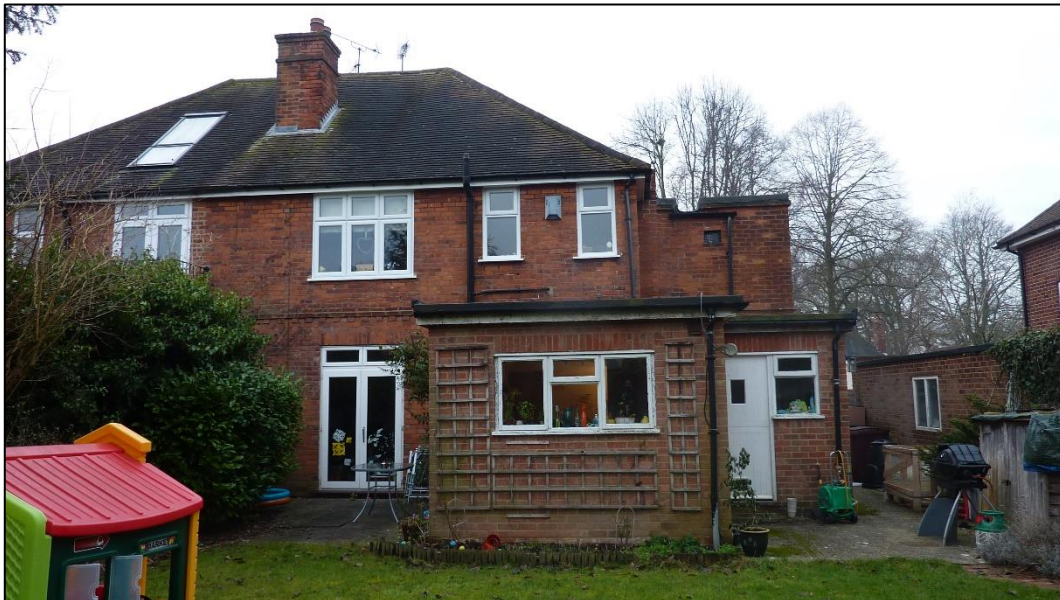
**Figure 3 – Rear elevation of 154 St Peters Road**

The flat roof on the modern single storey extension to the rear of the property was well sealed and good condition (Figure 3) providing no roosting potential for bats.

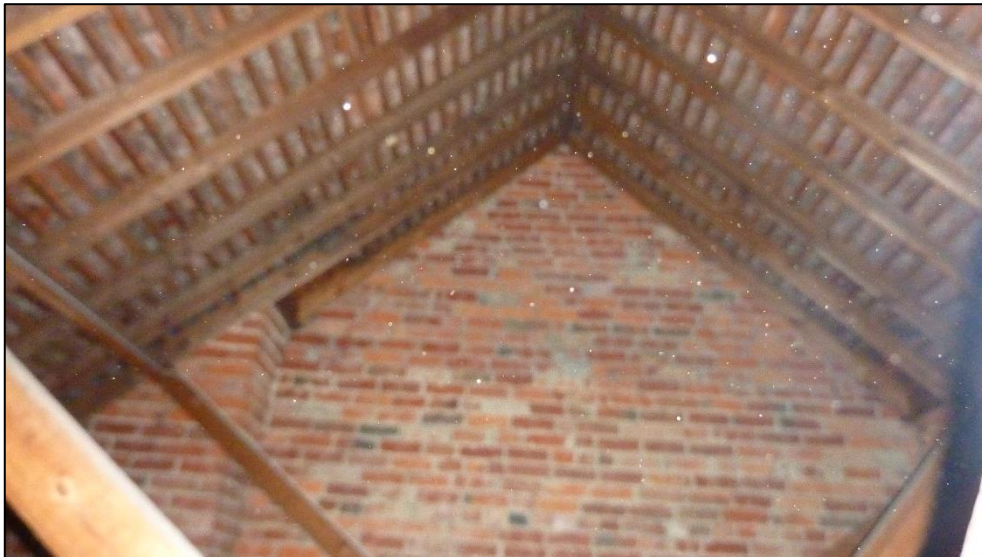
The property had a single roof void accessible through a hatch in the ceiling. The roof void was simple in shape and approx. 2.8m high (at the ridge) throughout the length of the roof (Figure 4). There was a smaller section of roof behind the pediment on the front of the property. This was open to the main roof void. There was no underlay fitted throughout the roof and this resulted in the void being very draughty (Figure 5). The lack of underlay also resulted in numerous visible gaps in the roof tiles throughout the roof void. The roof void had a single chimney stack located along the dividing wall between 154 St Peters Avenue and the neighbouring property, which was in good condition. There was a very high level of cob-webbing throughout the roof (Figure 6), suggesting bats had not been flying around or recently using the area.

**Figure 4** – showing interior of roof void at 154 St Peters Road

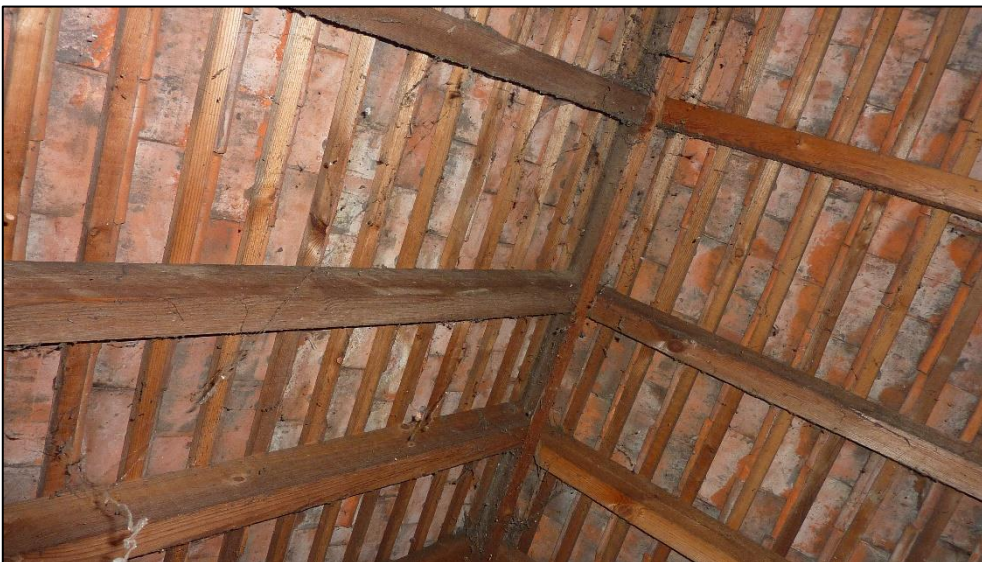
**Figure 5** – showing lack of underlay interior of roof void at 154 St Peters Road

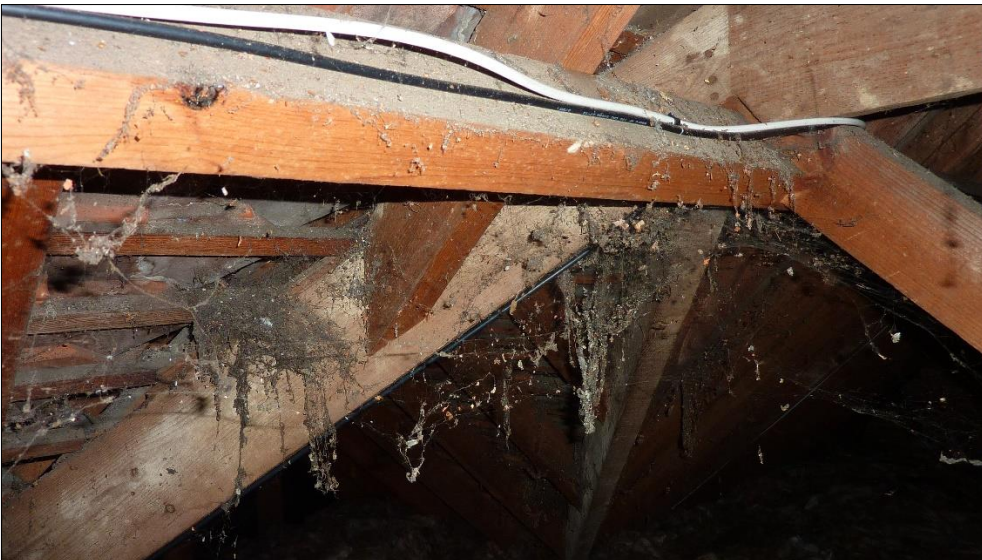
**Figure 6** – showing high level of cobwebbing at 154 St Peters Road

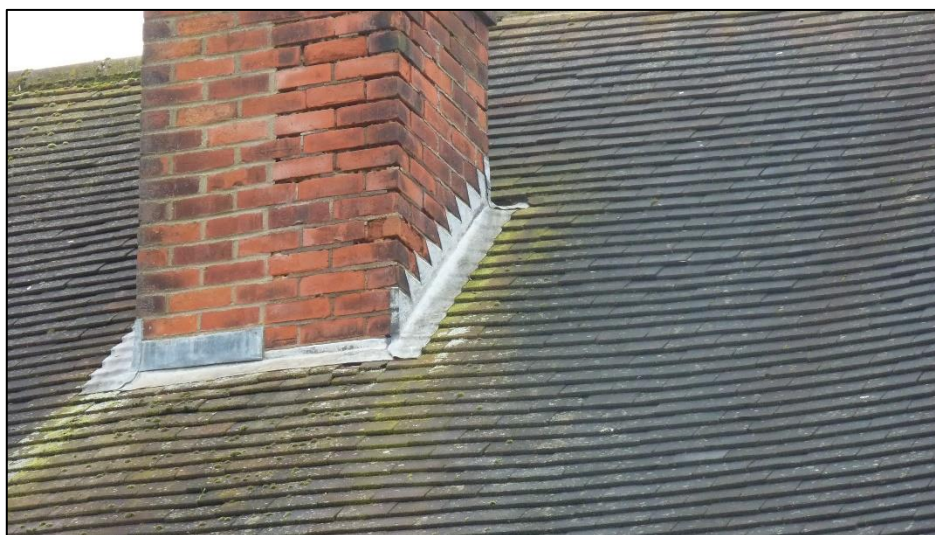
The primary roof covering consisted of machine-made clay/concrete tiles over the whole of the property (Figure 7). The primary roof covering was in good condition and had been maintained over the years. The tiles were tightly fitting and there were very few missing or broken tiles (Figures 6&7), which could provide access to roosting bats. The ridge consisted of half round tiles (Figure 2 &7) which were all present and the mortar along the ridge and verges was in good condition (Figure 8) with no missing sections that could be utilised by bats. Around the chimney the lead flashing was in good condition with no areas missing or lifted (Figure 7). The eaves were sealed the barge-boards well-fitting and good condition (Figure 8).

**Figure 7** – roof showing clay tiles and ridge section on the rear elevation

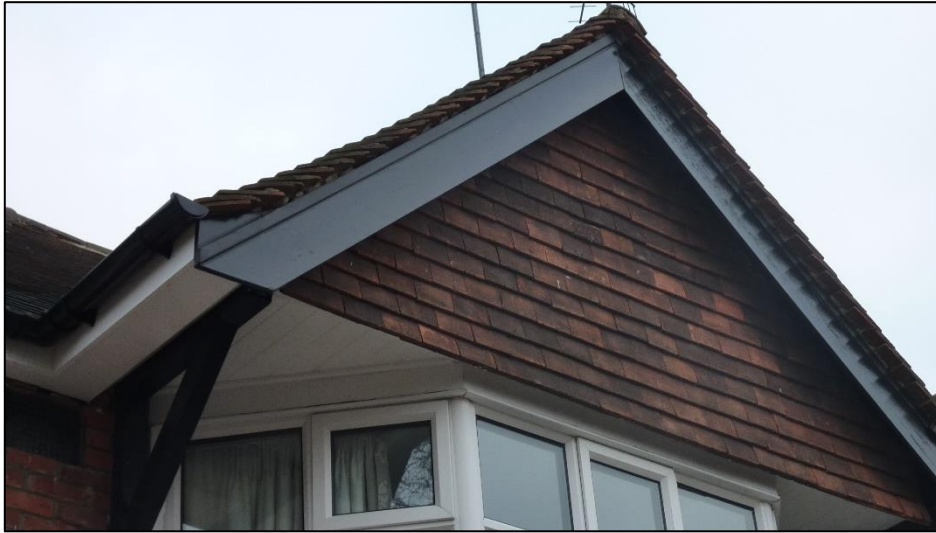
**Figure 8** – roof showing verges, soffits and hanging tiles on front elevation
