## **Little Lea Farmhouse, Reading**

Little Lea Farmhouse  
Reading International Business Park  
Basingstoke Road  
Reading  
Berkshire  
RG2 6DA

### **Current Building Condition**

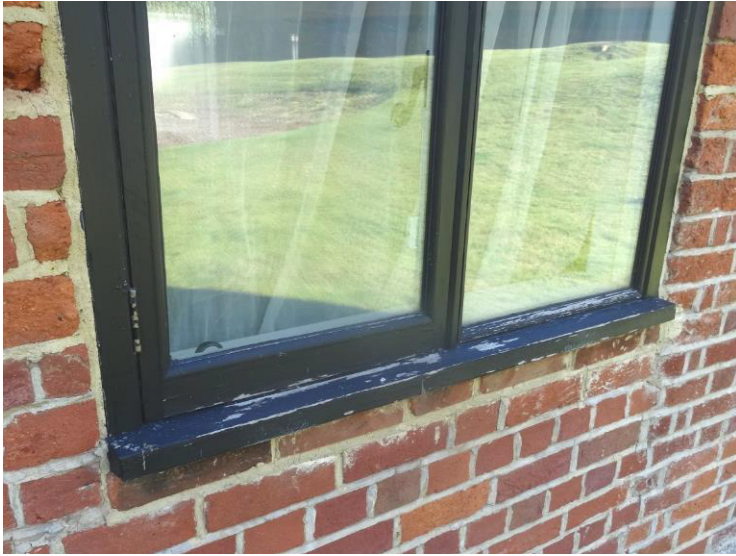
Paint on woodwork is in poor condition and external redecorations are required.

5. External paintwork in poor condition with bare wood exposed.

| Paint exterior of external windows | | no |

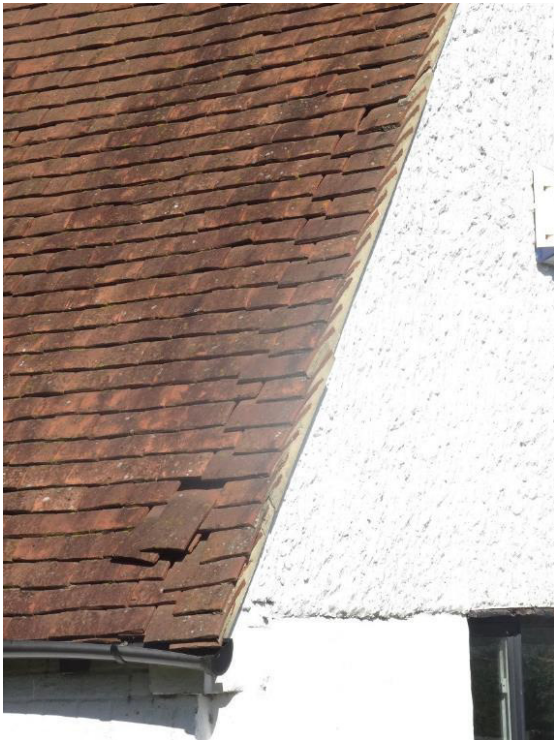
There are isolated slipped and missing tiles on the roof and the front verge has slipped downwards dislodging the eaves gutter. Repairs are required but the roof otherwise remains in good condition.

6. South elevation: slipped verge tiles

| Isolated patch repairs | | item |

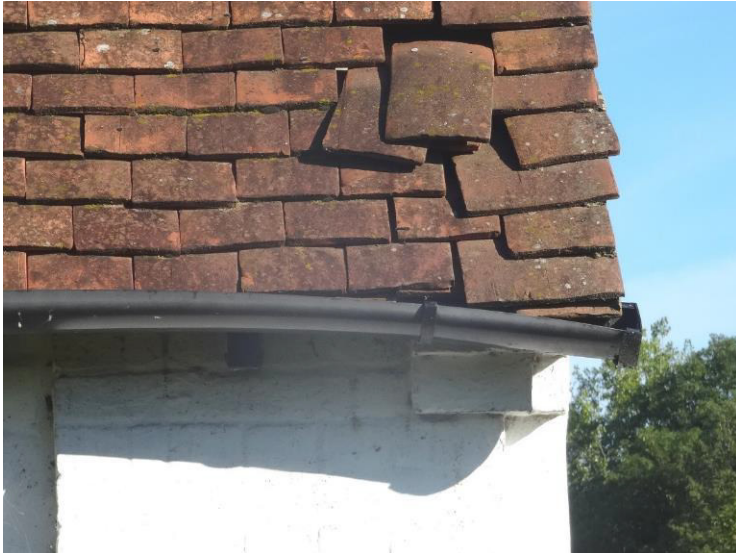
7. Slipped verge tiles and dropped gutter.

| Rain water goods - clear out and re fix all areas | | item |

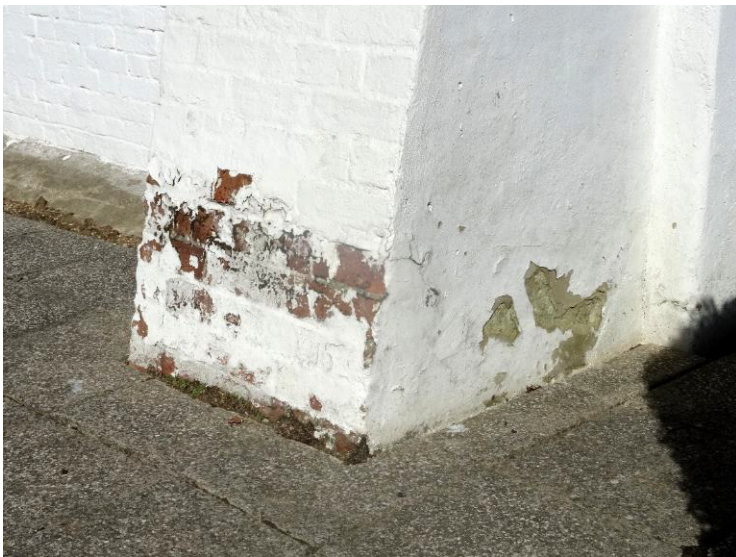
The building suffers from dampness, both from below and above. The front wall around the entrance door shows peeling paint on the outside and detached plaster and blistered paint on door reveals internally. Damp meter readings confirm high levels of moisture in the wall. The dampness is not confined to the entrance door, but shows elsewhere at low level externally along the front wall and at the south elevation buttress.

8. South elevation: Damp affected paint and detached rendering on buttress.

The low lying location and the known presence of a below ground drain across the site contribute to high moisture levels in the ground. The insertion of a chemical damp proof course in the refurbishment works has not proved adequate to prevent ground water rising into walls. A new damp proof course is required but it would also be advantageous to lower ground levels externally as a first measure. The perimeter paving is at ground floor level which allows no leeway to prevent splashback from falling rain.

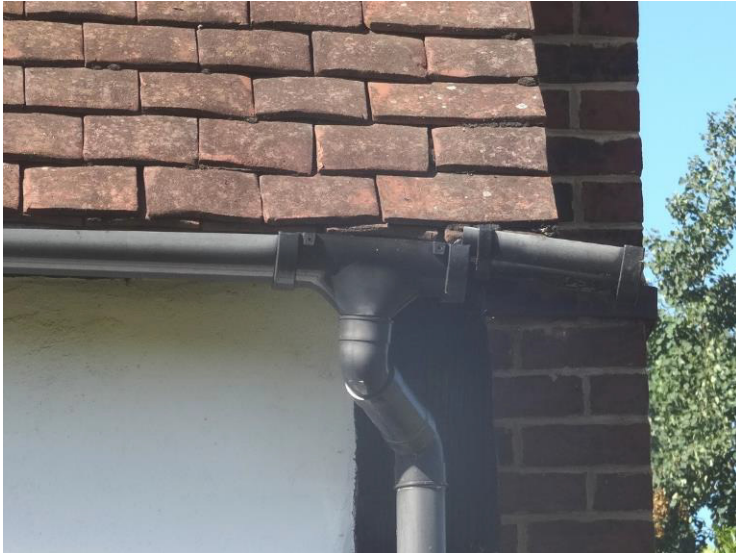
9. Front elevation: Detached gutter at north end.

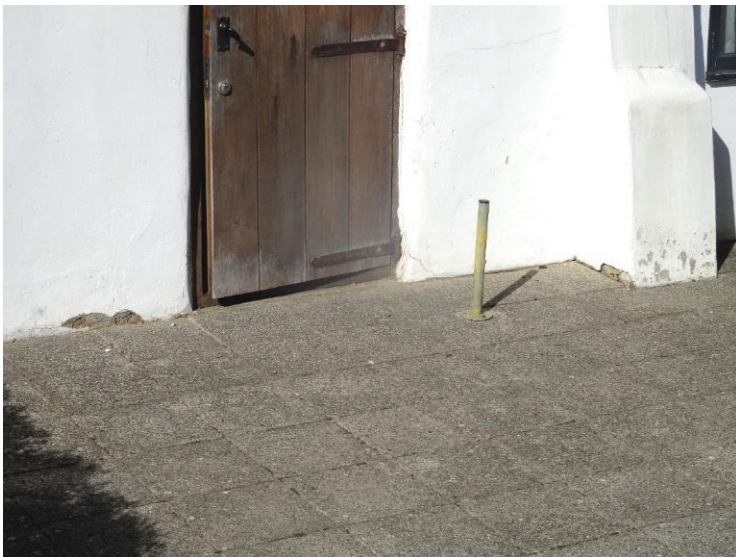
10. Front elevation: Dampness in wall at ground level.

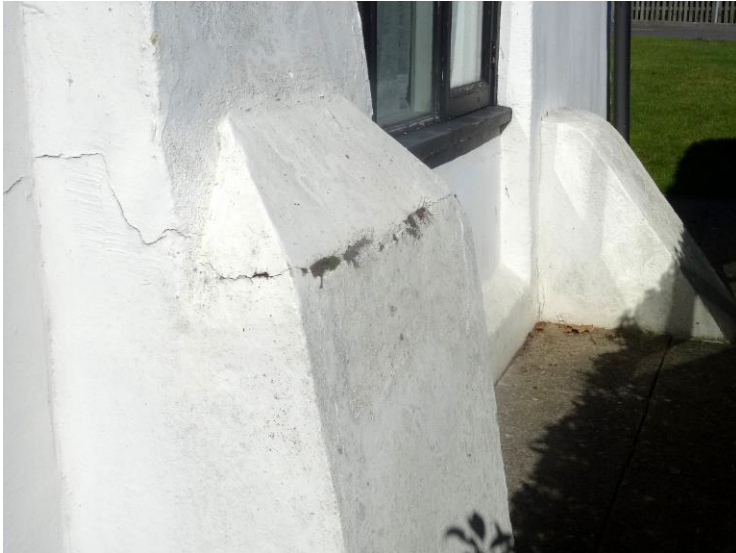
11. Front elevation: Horizontal crack with moss growth on buttress.

| <b>Grind</b> out and repair cracking | | m2 |

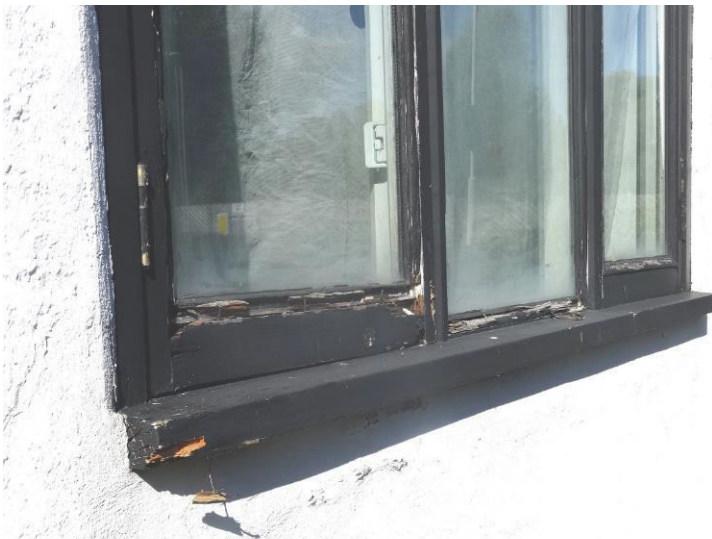
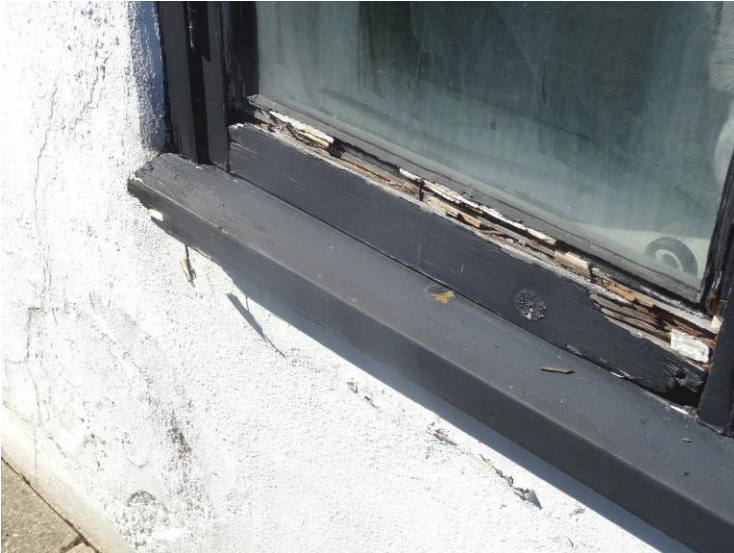
The front window to the reception area is rotten beyond repair and requires replacement.

12. Front elevation: Reception room window rotten

13. Front elevation: Reception room window rotten

| Supply and fit new softwood windows to ground floor | | m2 |

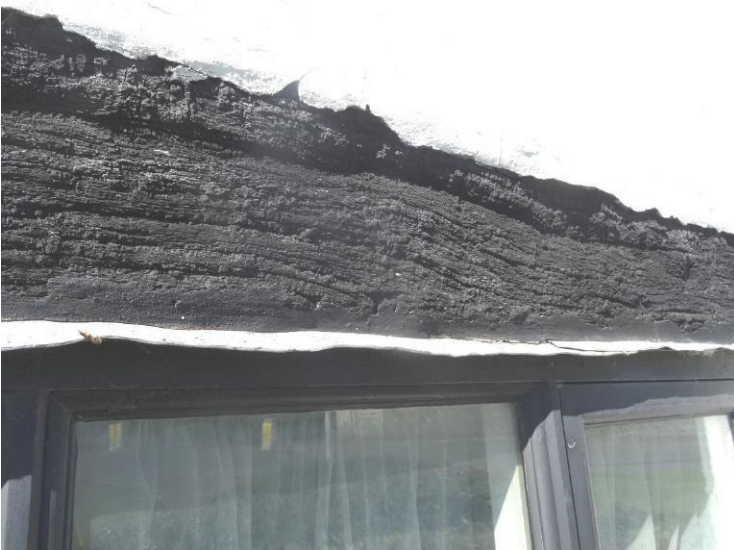
14. Front elevation: Timber frame degraded and crumbling.

| Splice structural frame | | LnM |
| <b>Specialist</b> treatment to rotten frame | | lm |

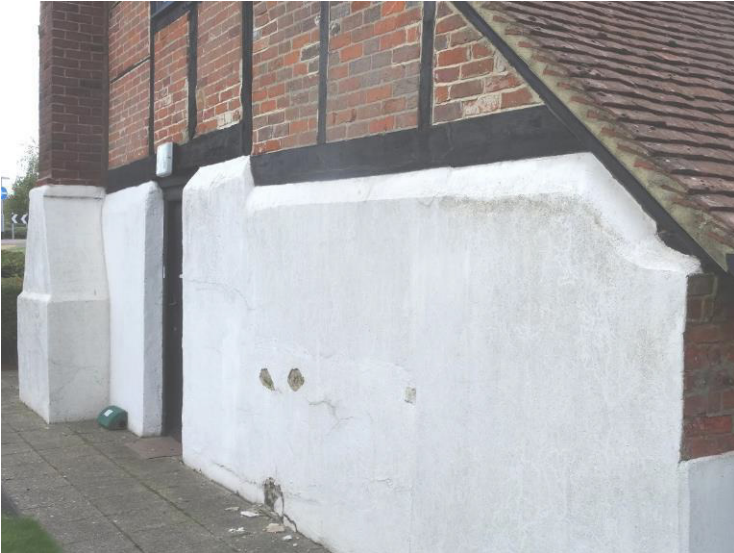
The most likely cause is the offsets in the rendered wall externally, beneath the first floor timber frame and at the chimney breast. They are not weather protected and allow rainwater to soak into the rendering. Flashings should be provided to shed water.

15. North elevation: Rendering cracked, hollow and detached in patches.

| Insert lead flashing beneath first floor level timber beam to weather protect rendering | | item |
| Hack off and repair failed render | | m2 |

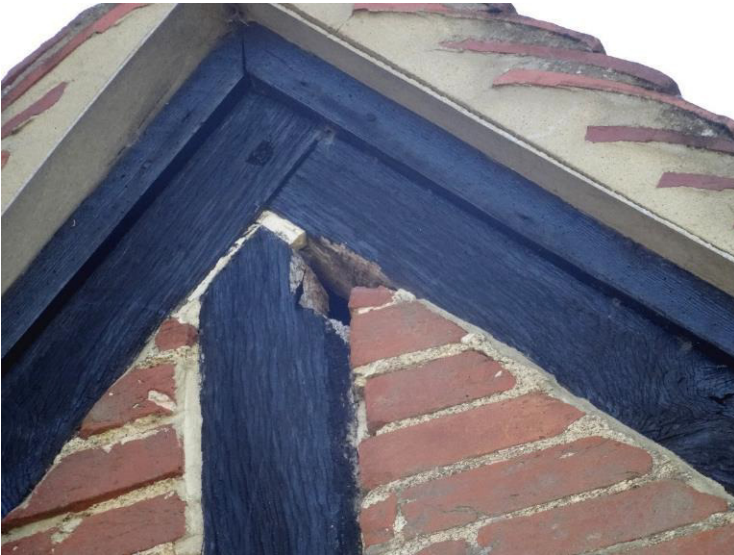
16. North elevation: Hole at ridge.

| Fill hole at ridge to prevent birds, bats and insects entering roof void | | item |

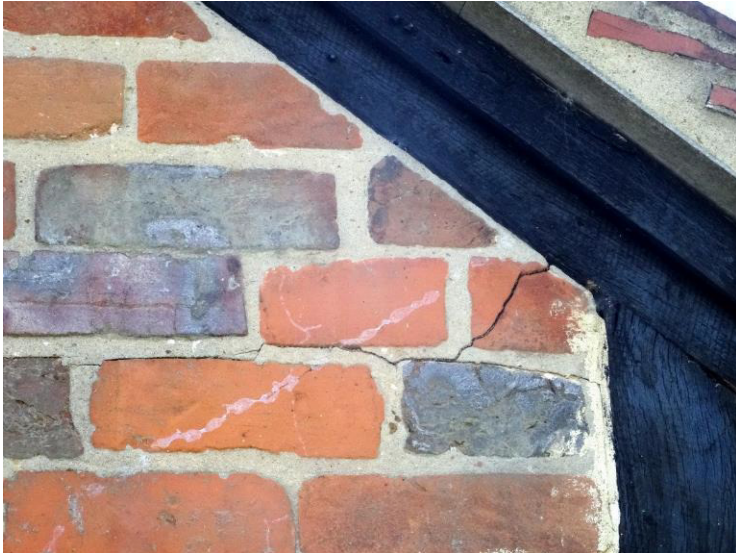
17. North elevation: Cracks in brickwork joints and through brick

| Rake out and repoint all external brick areas (excluding chimneys) | | item |

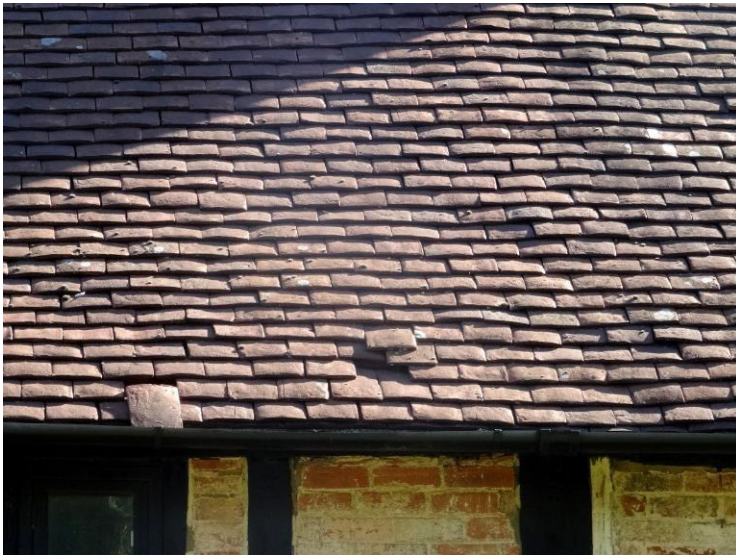
18. Rear elevation: Slipped and missing roof tiles.

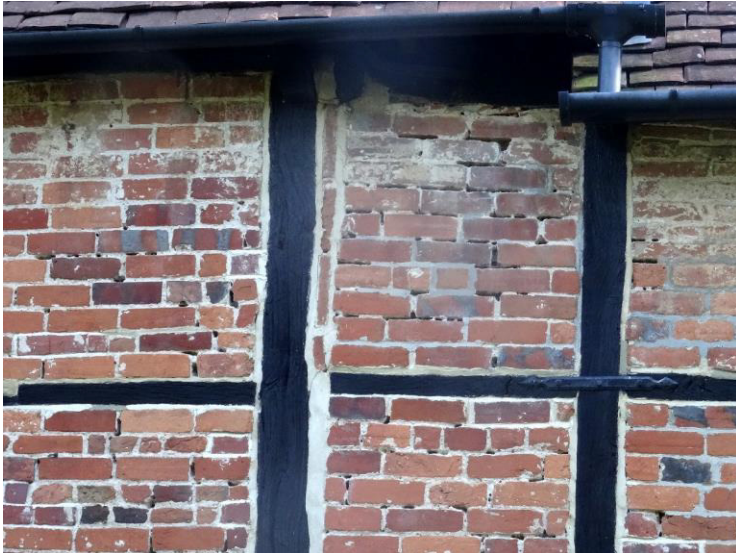
19. Rear elevation: Open joints in brickwork in timber framed panels.

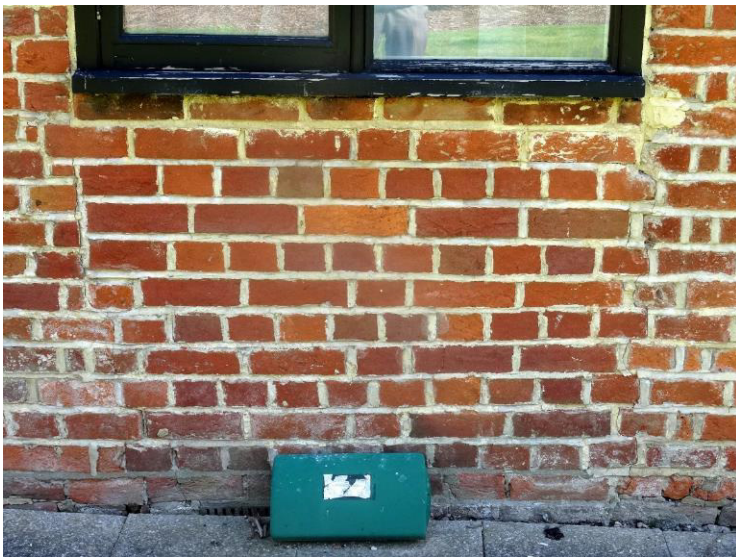
20. Rear elevation: Vertical cracks at window apron.

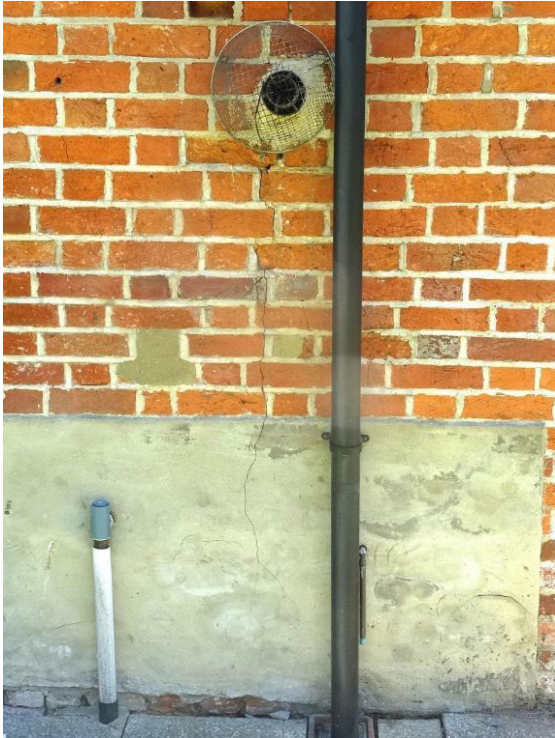
21. Rear elevation: Vertical crack beneath boiler flue.

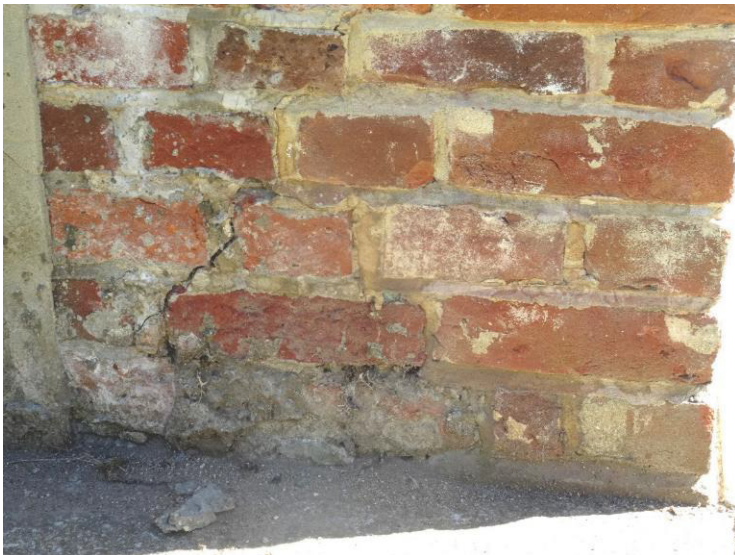
22. Rear elevation: Diagonal crack at south west corner.

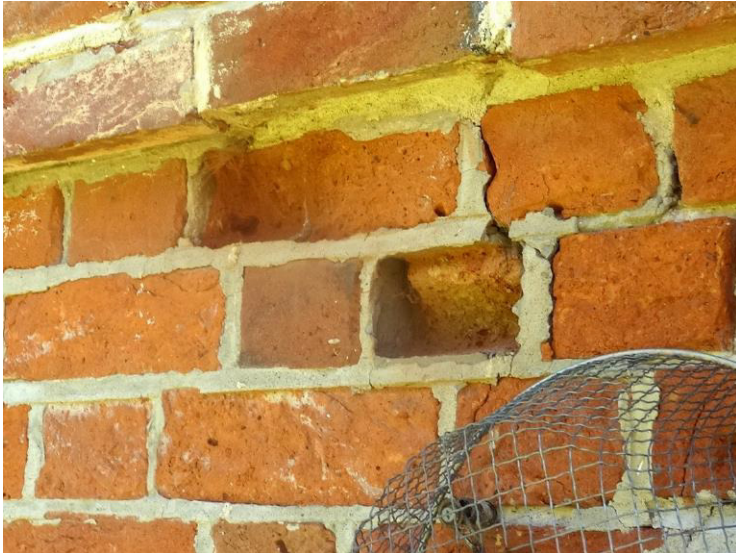
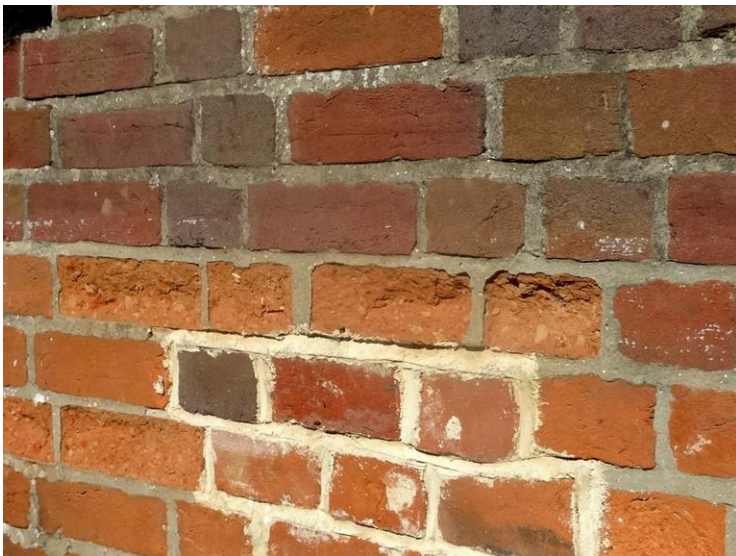
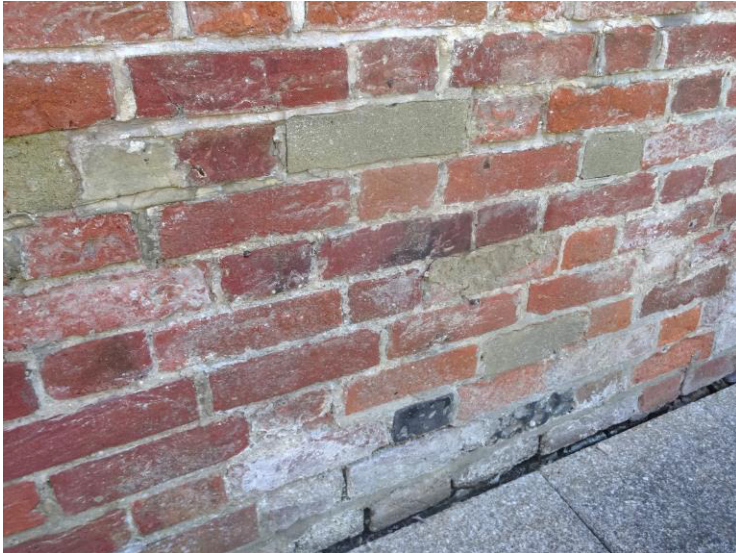
What remains of very old brickwork continues to deteriorate. Patches have been replaced and some bricks have been re-faced with rendering, but spalling, whereby the outer face is removed leaving a crumbly interior continues. They are probably poor quality original bricks, but the defect is exacerbated by the use of hard impermeable cement based mortar which traps water and forces it to escape through the bricks which are evidently not frost resistant. Replacement bricks should be bedded in permeable lime mortar.

23. Rear elevation: Spalled bricks. Spalling exacerbated by the use of impermeable hard cement mortar, also cracked and detached.

24. Rear elevation: Spalled bricks and patch of recently replaced bricks.

25. Rear elevation: Facing of rendering on spalled bricks.

| Replace spalled bricks | | no |

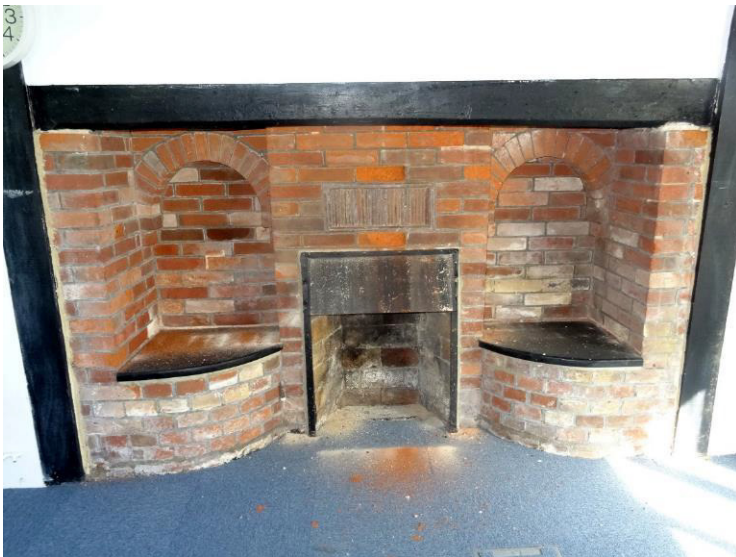
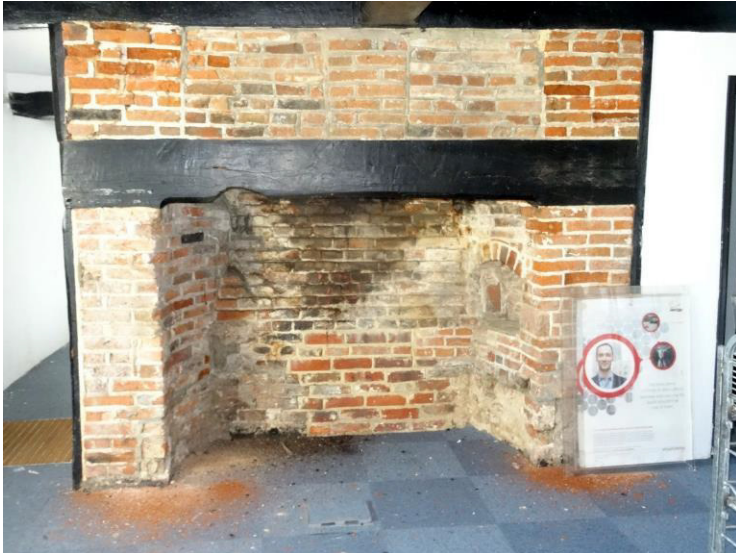
26. Reception room: Spalled bricks in fireplace.

27. Open Plan Area: Spalled bricks in fireplace.

| Cut out spalled bricks from fireplace | 15.00 | no |

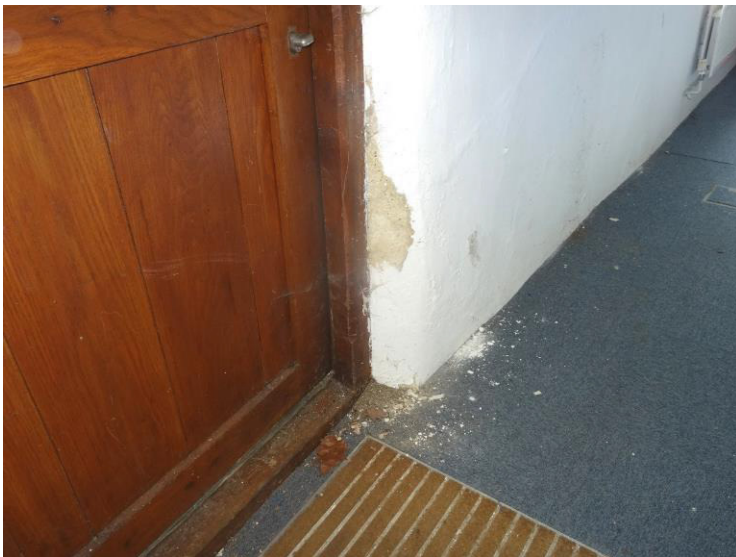
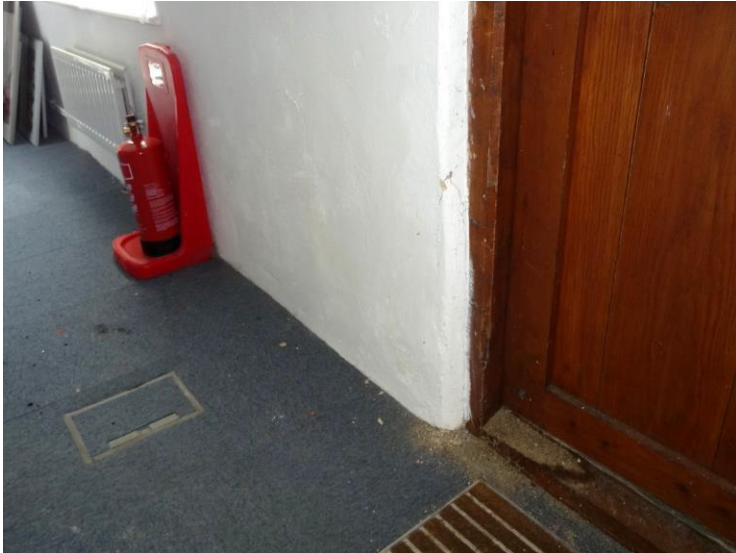
28. Open Plan Area: Detached plaster and dampness at front entrance door.

29. Open Plan Area: Detached plaster and dampness at front entrance door.

| Sand and cement plastering - patch rip out | | m2 |

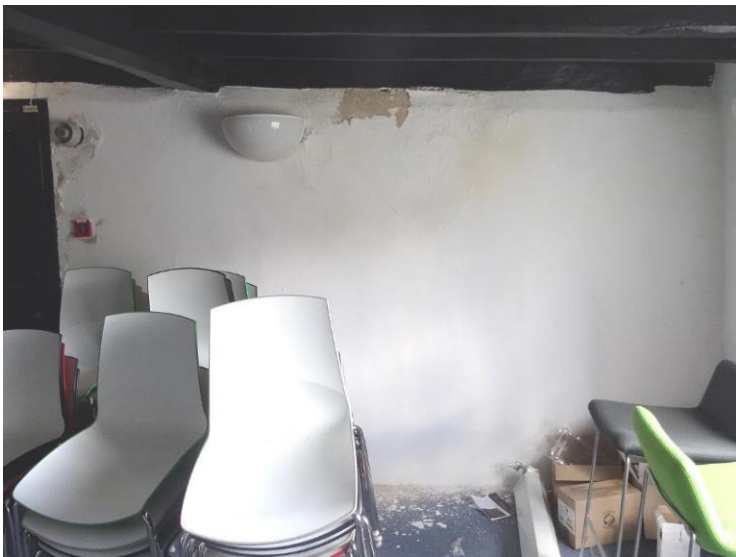
The north wall also suffers from penetrating dampness, evidenced by blistered paint and detached plaster in the open plan area and ladies toilet and confirmed by damp meter.

30. Open Plan Area: Detached surface plaster, cracked paint film and dampness on north wall.

However ensuring that no water enters the wall will not be easy to achieve and if the internal walls are to be free of dampness internal dry lining should be provided. The schedule makes an allowance for this.

| <b>Bond</b> out and skim North wall | 12.00 | m2 |

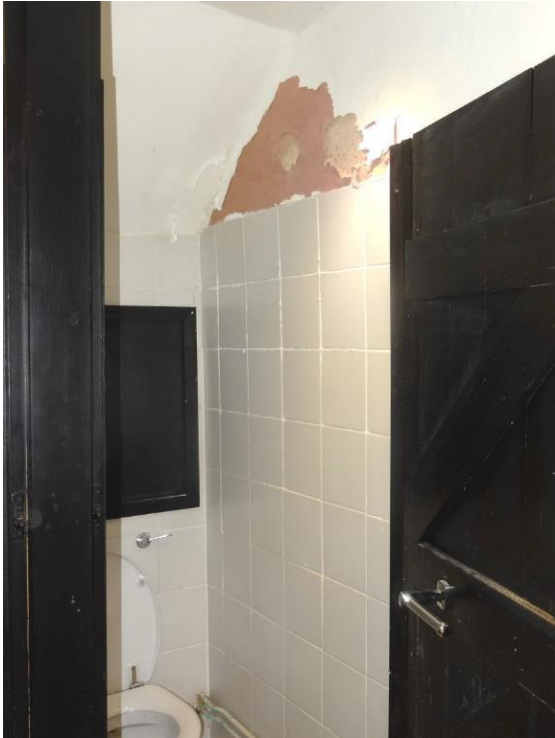
31. Ladies Toilet: Dampness and detached plaster and paint. Hollow wall tiles.

| Tiles - North facing wall to GF toilets | | m2 |

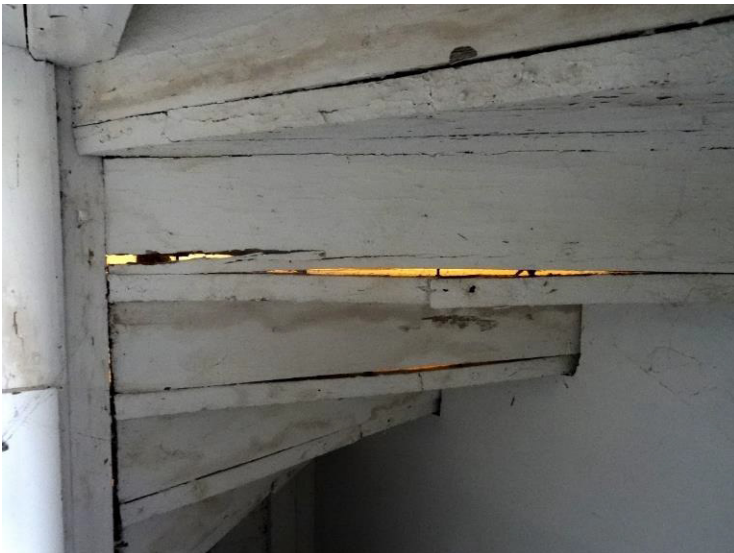
The external works are largely concerned with the prevention of water entering the building and should be carried out as soon as possible. Internal works are more cosmetic and could be left to the end of the lease with the exception of strengthening the stairs which has a safety implication.

32. Staircase: Splits in timber and treads deflected.

| Strengthen staircase with additional timber in below-stairs cupboard. | 1.00 | item |
