Battle Primary Academy  
FAO: ROBERT PYCRAFT  
Cranbury Road  
Reading  
RG30 2TD

Our Ref: S18881/GM/GS

Date: 31<sup>st</sup> July 2016

**Battle Primary School  
Chimney Inspection Report**

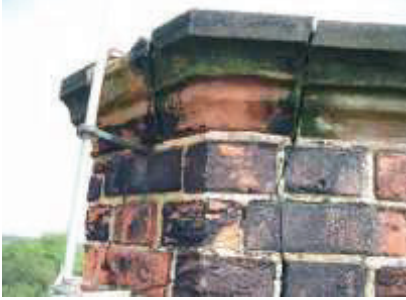
| <u>Image/Item Number</u> | <u>Image</u> | <u>Description</u> |
|---|---|---|
| 1 | | Apex brickwork has fracture running through brickwork which requires immediate attention. |

The chimney stack is structurally in a sound condition however will require repointing works to the top 3metres as bed joints are severely eroded. Apex brickwork requires stainless steel stitching and repointing works as the brickwork in time will become unstable and possible risk of falling brickwork to ground level. Minor repairs to lead flashings on the North elevation are required, my suggestion is that these works will be carried out at the soonest opportunity available.

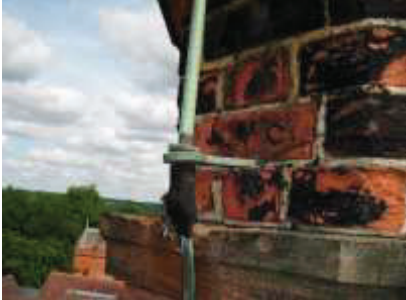
| <u>Image/Item Number</u> | <u>Image</u> | <u>Description</u> |
|---|---|---|
| 2 | | Apex brickwork has fracture running through brickwork which requires immediate attention. |

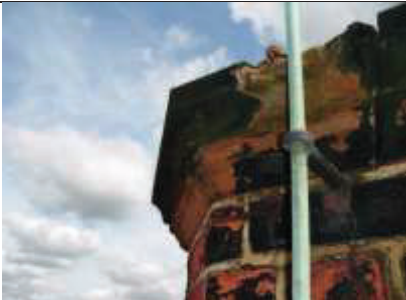
| <u>Image/Item Number</u> | <u>Image</u> | <u>Description</u> |
|---|---|---|
| 3 | | Apex sandstone capping requires compound repairs. |

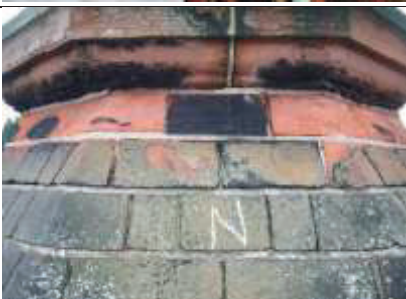
| <u>Image/Item Number</u> | <u>Image</u> | <u>Description</u> |
|---|---|---|
| 4 | | Sloped brick section, minor pointing is required to open joints. |

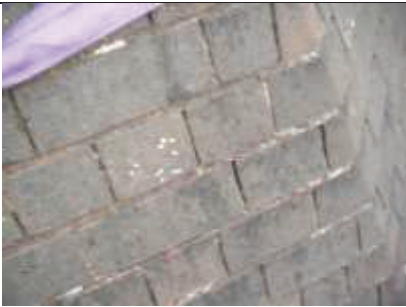
| <u>Image/Item Number</u> | <u>Image</u> | <u>Description</u> |
|---|---|---|
| 5 | | Sloped brick section, minor pointing is required to open joints. |

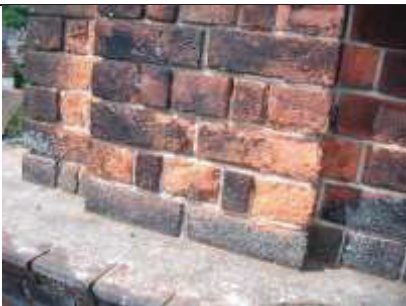
| <u>Image/Item Number</u> | <u>Image</u> | <u>Description</u> |
|---|---|---|
| 6 | | Top 2metres of brickwork to all elevations is severely eroded and requires joint cut back and repointed with new sand and cement mortar. |

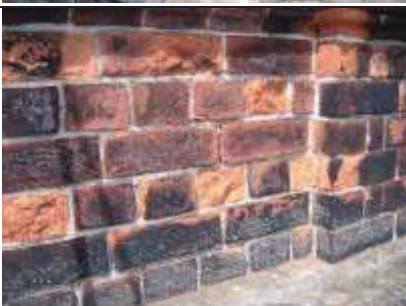
| <u>Image/Item Number</u> | <u>Image</u> | <u>Description</u> |
|---|---|---|
| 7 | | Top 2metres of brickwork to all elevations is severely eroded and requires joint cut back and repointed with new sand and cement mortar. |

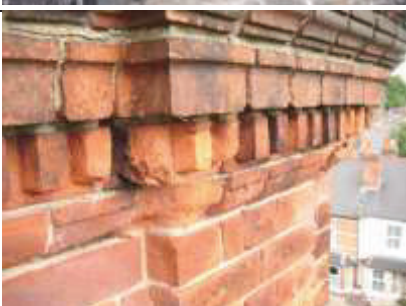
| <u>Image/Item Number</u> | <u>Image</u> | <u>Description</u> |
|---|---|---|
| 8 | | Dog tooth stringer course, minor lamination to decorative course which requires descaling to stop any debris falling on school personnel. |

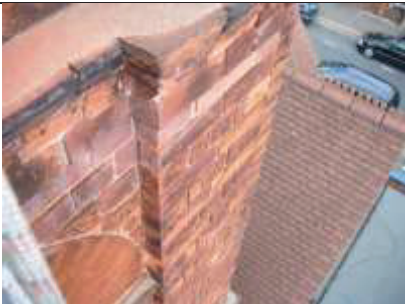
| <u>Image/Item Number</u> | <u>Image</u> | <u>Description</u> |
|---|---|---|
| 9 | | Open joints to brickwork requires repointing. |

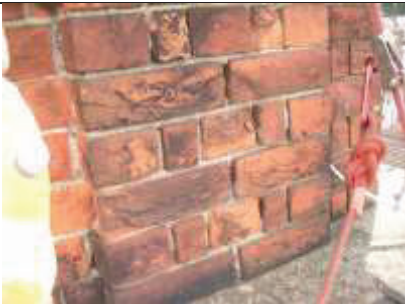
| <u>Image/Item Number</u> | <u>Image</u> | <u>Description</u> |
|---|---|---|
| 10 | | Open joints to brickwork requires repointing. |

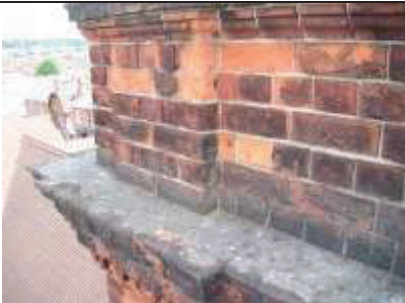
| <u>Image/Item Number</u> | <u>Image</u> | <u>Description</u> |
|---|---|---|
| 11 | | Open joints to brickwork requires repointing. |

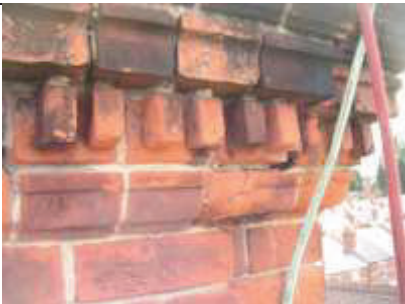
| <u>Image/Item Number</u> | <u>Image</u> | <u>Description</u> |
|---|---|---|
| 12 | | Dog tooth stringer course, minor lamination to decorative course which requires descaling to stop any debris falling on school personnel. |

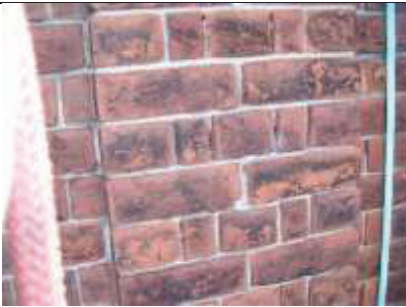
| <u>Image/Item Number</u> | <u>Image</u> | <u>Description</u> |
|---|---|---|
| 13 | | Open joints require repointing works. |

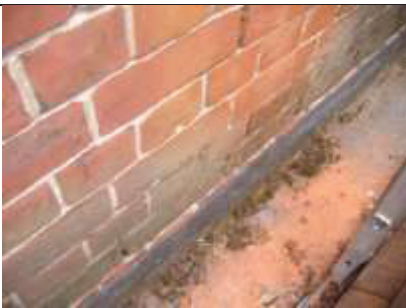
| <u>Image/Item Number</u> | <u>Image</u> | <u>Description</u> |
|---|---|---|
| 14 | | North elevation lead cover flashing missing which will be allowing water ingress, requires new code 4 lead flashing inserting to course of brickwork to prevent any further water ingress. |
