## 1. MATERIALS

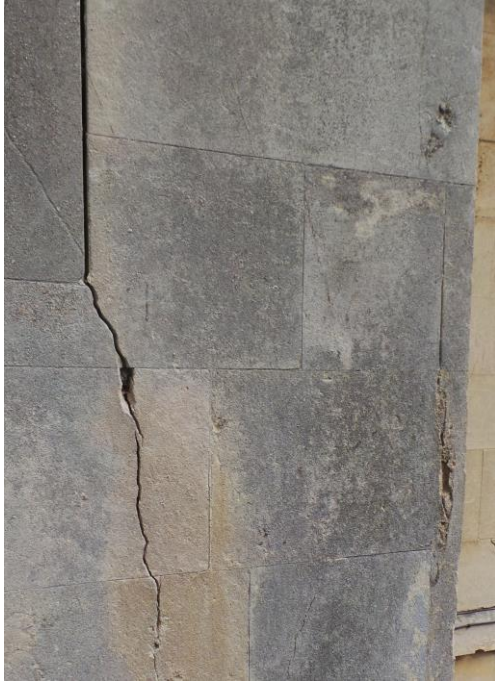
**Photo 1** – Vertical crack to the South Elevation

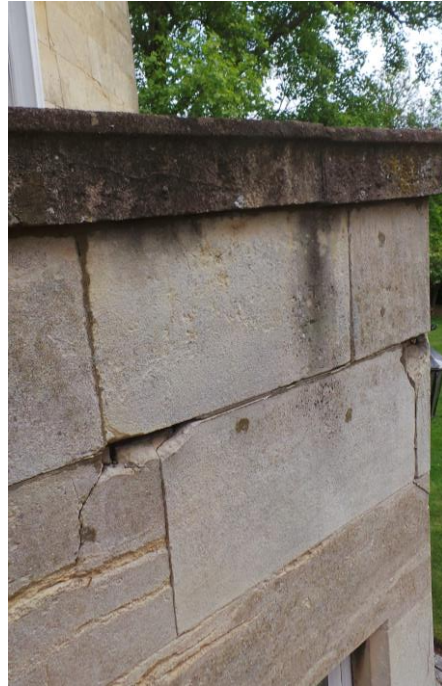
**Photo 2** – Deteriorated cramps and loose stonework to single storey bay window on the South elevation.

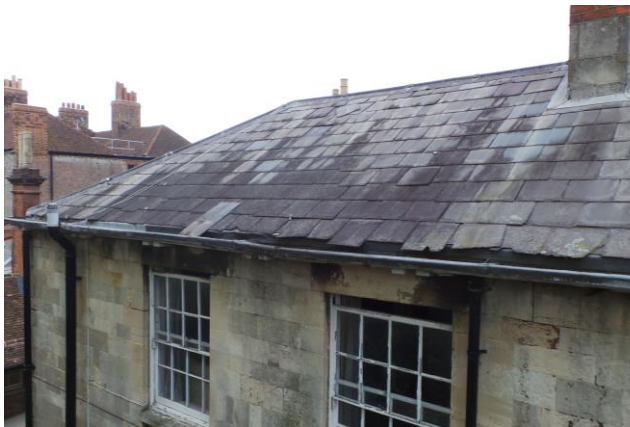
**Photo 3** – Slipped, cracked and broken roof tiles to the South elevation of the West wing.

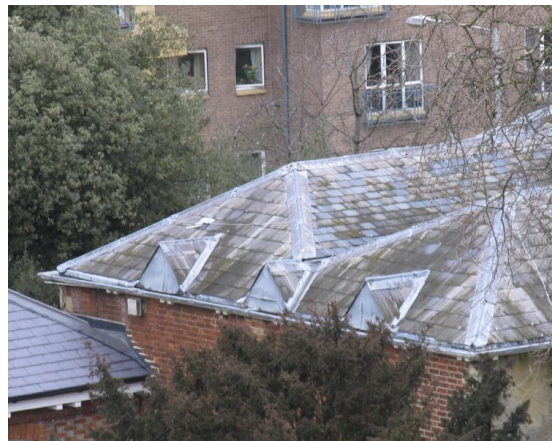
**Photo 4** – Stained, slipped and slipped tiles to the West elevation.

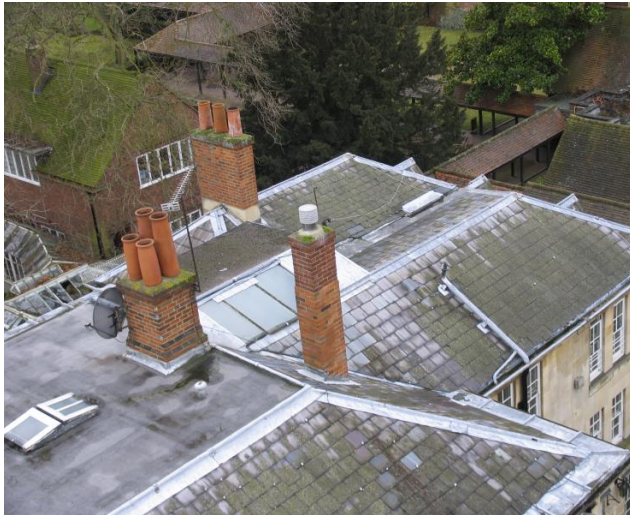
| <b><u>Flat Roof Coverings</u></b> | <p>A crown flat roof is located at the apex of pitched roof coverings to the East wing. The roof is covered with bituminous felt.</p> <p>Bituminous felt covers two dormer windows and the timber framed structure between the wings.</p> <p><b>Photo Reference – Photo 5</b></p> | <p>We propose to strip the existing roof covering and lay a new thermally insulated warm roof. We anticipate an increased roof height of up to 100mm. We propose a GPR capping coat to the new roof, to mimic the appearance of leadwork.</p> <p>As an alternative to the above, we propose to overlay the existing roof with a layer of 30mm thermal insulation overlay board ahead of recovering with a GRP covering.</p> |

**Photo 5** – deteriorated flat roof covering to crown roof of the East wing and bituminous roof to the timber framed walkway.

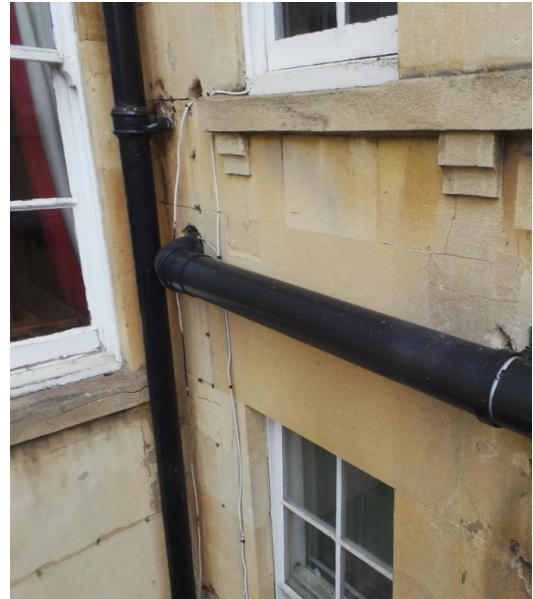
**Photo 6** – Corrosion of downpipe bracket and staining to stonework cladding

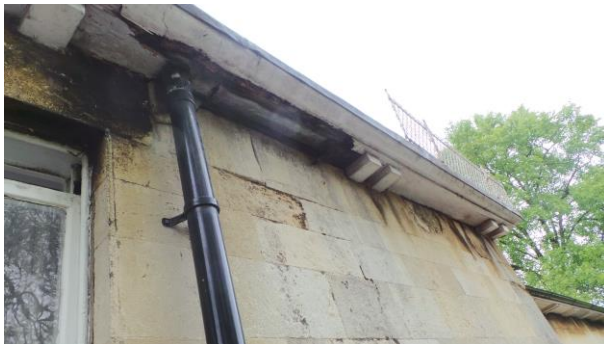
| <b><u>Timber Eaves</u></b> | <p>Sections of timber soffits are in poor condition, with significant areas of rot affected exposed timber.</p> <p>The upper edge of the soffit is lined with rolled leadwork. This is generally aged, lifted and in poor condition throughout.</p> <p><b>Photo Reference – Photo 7</b></p> | <p>Deteriorated sections of timber will be replaced to match the existing. Where there is evidence of rot, timber will be removed to a distance of 500mm beyond the defective area.</p> <p>Rolled leadwork will also be replaced in accordance with proposed leadwork detail drawings.</p> |

**Photo 7** – Deteriorated timber soffit detail. Lead linings are located to the upper edge.

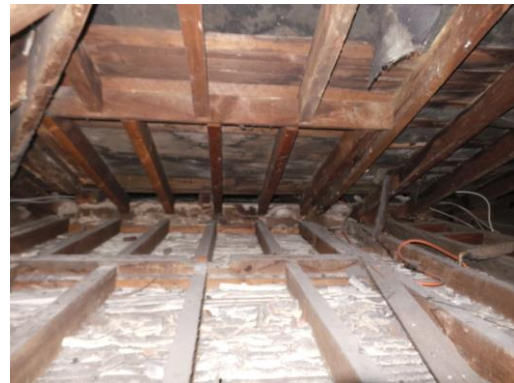
| <b><u>Thermal Insulation</u></b> | <p>There is no thermal insulation within located within roof voids.</p> <p><b>Photo Reference – Photo 8</b></p> | <p>We propose to lay approximately 300mm of thermal insulation above joists, to a depth of 300mm. Insulation will only be installed between joists where there is sufficient depth to avoid disturbing finishes below. Insulation will be provided to water pipework to minimise the risk of freezing pipework within the space.</p> |

**Photo 8** – Lack of thermal insulation to roof void. Lathe and plaster ceiling visible to West wing roof void.
