10 January 2017

Jessica Gavin  
44 Westbourne Terrace  
Tilehurst  
Reading  
RG30 2RP

#### **44 Westbourne Terrace Bat Preliminary Roost Assessment**

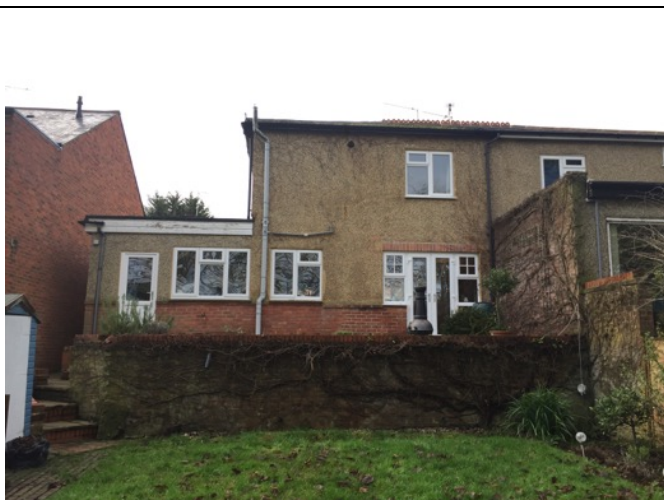
Photo 3 – Northern elevation

Externally the fascia and soffit boards were all in good condition with no gaps or holes. On the northern elevation there were a few lifted slates where the property joined the neighbouring property, however the gap underneath the tiles could be fully viewed and did not lead into the loft space or a cavity. The ridge tiles were all intact. The design of the eastern elevation soffit board included a gap along the length of the central part of the soffit board, however the gap was covered in both cobwebs and ivy growth. There was no evidence of bats on any of the elevations such as scratches, staining or droppings on the tiles or soffit/fascia boards and overall the roof was in good condition. Internally, the roof was also in a good condition and the bitumen felt was intact. It was quite dark in the loft space although there was a small amount of light from the southern elevation. There was evidence of multiple wasp nests along the southern elevation. There was no evidence of bats such as droppings within the loft space.

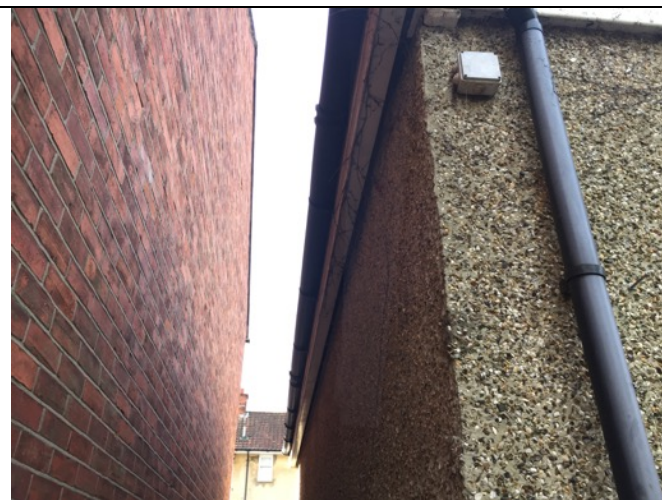
Photo 4 – Eastern elevation

The preliminary roost assessment did not identify any bat droppings or evidence of bats within the property, furthermore the property was in a good condition internally and externally. There was a narrow gap along the central length of the eastern elevation soffit board which could be potentially suitable for bats, however no scratches, staining, rub marks or droppings were identified on the soffit board or on the ground under the soffit board. Furthermore, cobwebs and ivy growth limited access to the soffit gap. The property was located in an urban area with parkland to the north and residential properties to the south, west and east. The close nature of the adjacent

eastern property limited the flight lines from the soffit board and therefore, along with the lack of bat evidence it is very unlikely bats are using this small feature. Bats pose no constraint to the extension of the property.
