***Pipers Island***  
***Preliminary Bat Roost***  
***Assessment***  
***January 2017***

***Report Ref: DFA17003***

**Derek Finnie Associates Ltd**  
82b Toutley Road  
Wokingham  
Berkshire  
RG41 1QL

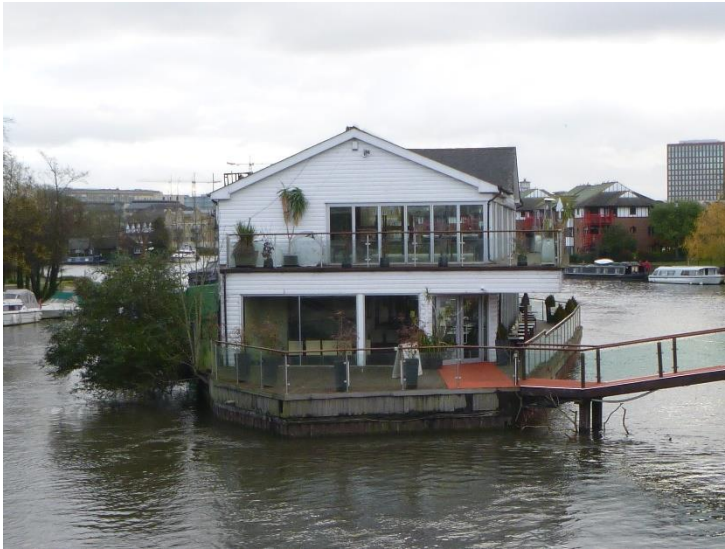
- 3.2.2 The property supports a gable roof, with the ridge line running north west to south east; a cross gable extends to the front (south west) in the centre of the structure (Plates 1 - 3). There are no chimneys or vents exiting the roof. A terrace is present along the front and sides of the upper storey, which extends out over the lower ground floor. The majority of the walls of front and side aspects of the building comprise glass.

Plate 1. General view of the north west aspect of the property

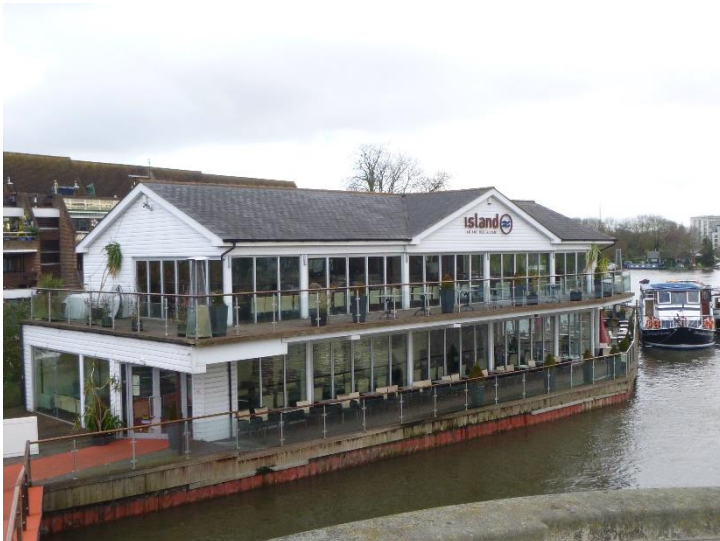
Plate 2. View of the garage to the south west aspect the property.

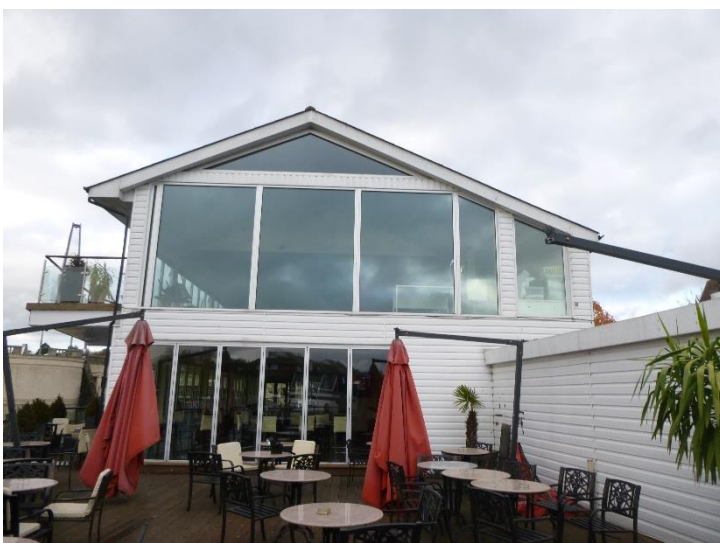
Plate 3. View of the south east aspect of the property.

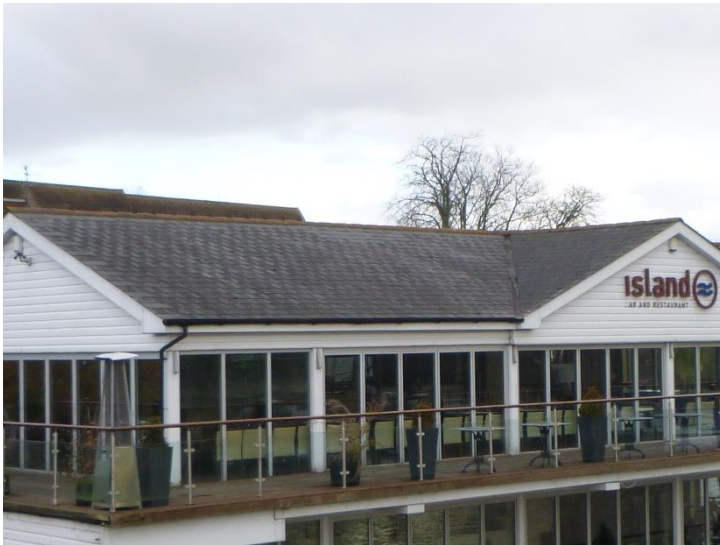
- 3.2.3 The roof of the house is finished with flat, interlocking tiles, which are in good condition throughout and tight with one another (Plate 4). No potential ingress points were noted. The ridge lines are also intact.

Plate 4. The roof is finished with flat, interlocking tiles.

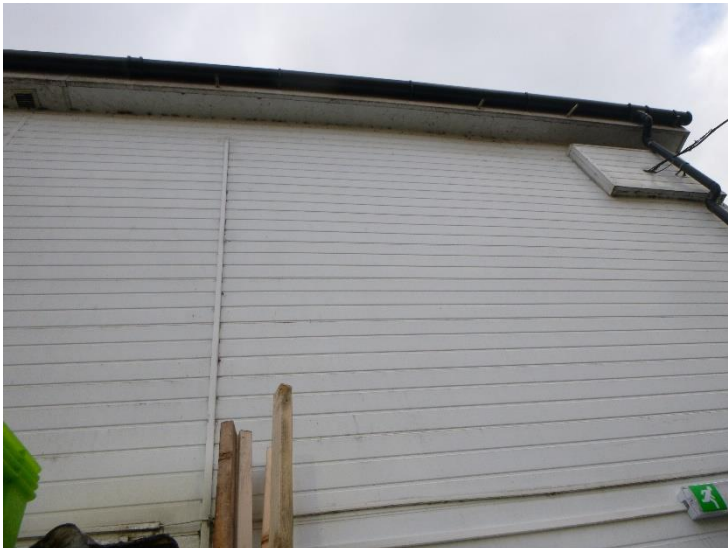
- 3.2.4 The walls of the property support plastic boarding attached onto what is assumed to be a prefabricated frame. The boards are in good condition throughout and tight with one another, with no gaps or splits noted (Plate 5).

Plate 5. The plastic boarding that forms the walls is in sound condition.

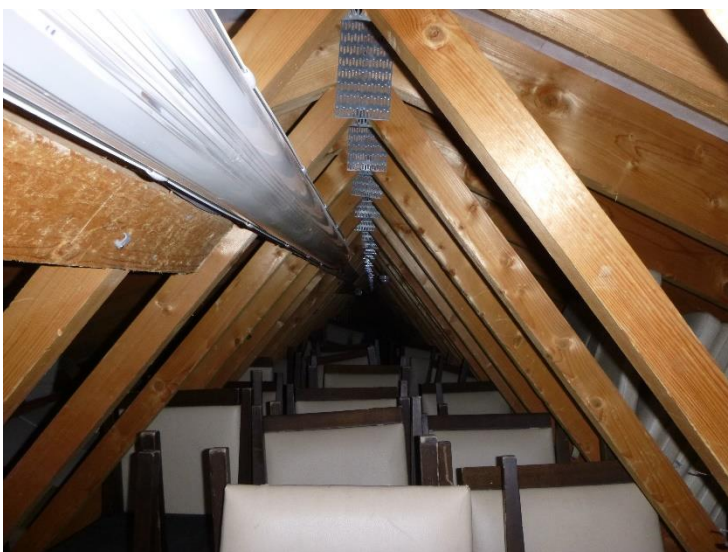
- 3.2.7 Internally, joists and rafters within the roof void are of a simple design. Nail plates are present at the junctions, eliminating any potential gap (Plates 6). A moderate build-up of cobwebs was present around the majority of the junctions, suggesting a lack of bat activity. No staining or scratch marks were noted along any of the beams, and there was no evidence of feeding remains. No droppings were noted despite a thorough inspection; the distinct smell often associated with bat roosts was absent.
- 3.2.8 The roof lining is complete and intact throughout with no egress points noted (Plate 7).
- 3.2.9 The void space is used for storage of restaurant furniture and is exposed to relatively frequent disturbance.

Plate 6. General view of the internal void space.

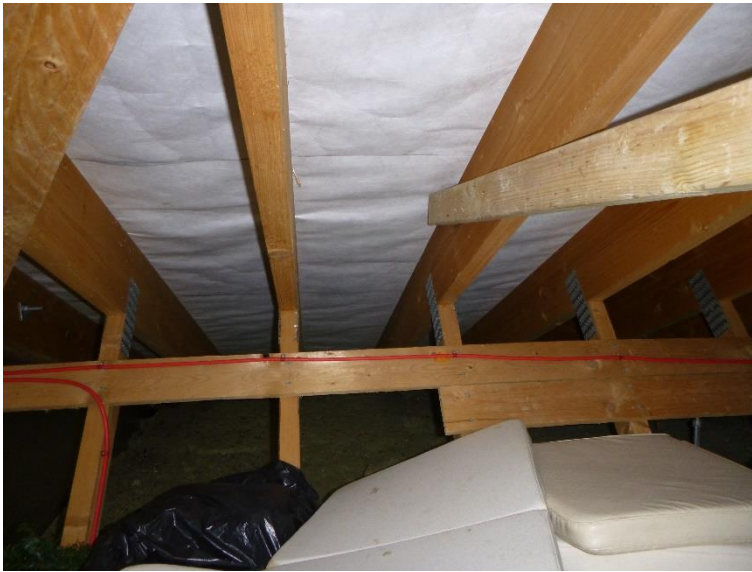
Plate 7. The roof lining is in sound condition.
