# **BATTLE PRIMARY SCHOOL**

## **BRICKWORK REPAIRS**

**PREPARED BY:  
MARTIN HIER MRICS  
(CHARTERED BUILDING SURVEYOR)**

**DATE: 10/09/2016**

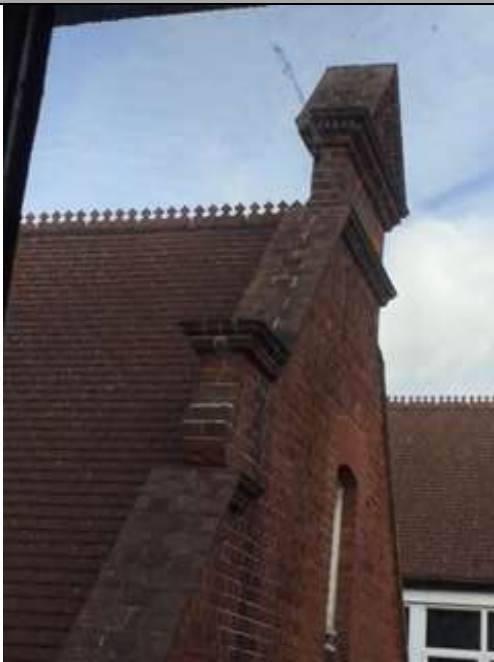
The slender decorative brick gables that protrude beyond the existing roof line are a concern as they are now starting to lean. Access is very difficult to ascertain their true condition without expensive scaffolding however, it is imperative this is checked by a structural engineer. **It is envisaged this brickwork will require repointing and tied back into the existing structure using stainless steel straps**

| <p>1 – High level brick gable parapets that are now leaning and unsafe</p> | <p>2 – High level brick gable parapets that are now leaning and unsafe</p> |

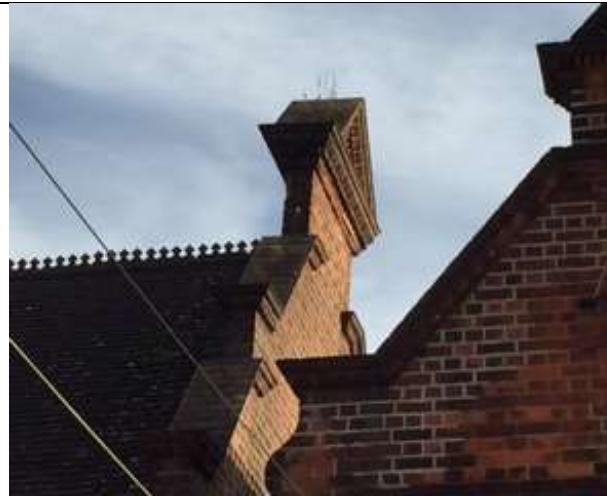
3 – Further high level brick parapets

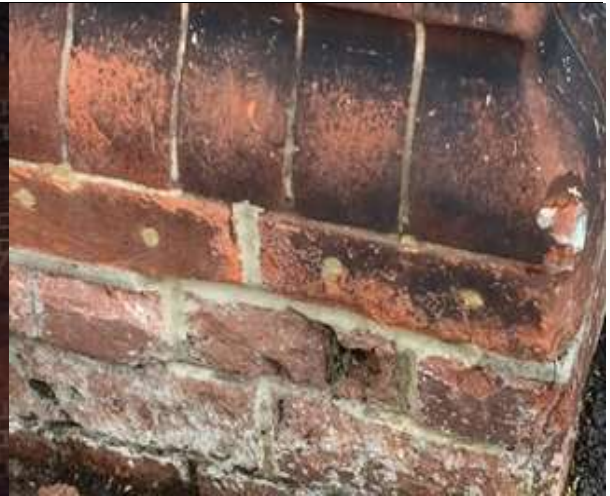
4 – Spalled brickwork

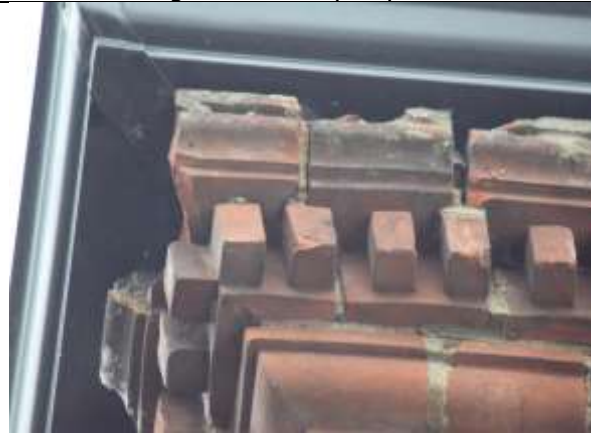
**Brickwork is now starting to work loose and fall from height.** This has been identified in photograph 5 & 6.

5 – Brickwork at high level about to fall

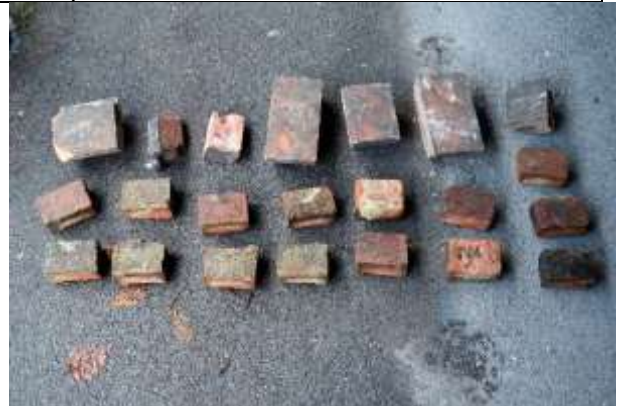
6 – Bricks that have fallen from height since June 2016

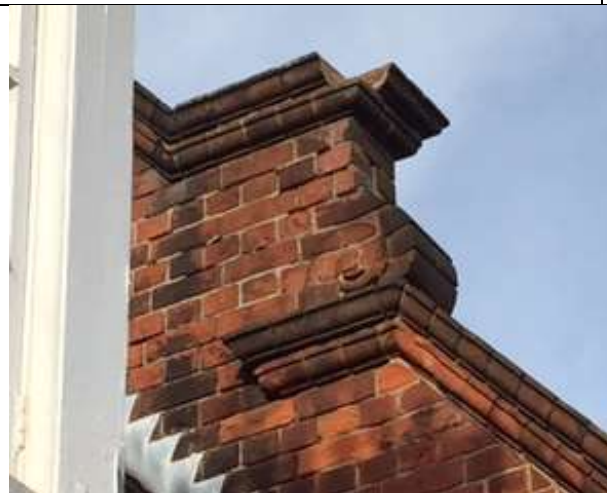
7 – Brickwork already fallen from high level

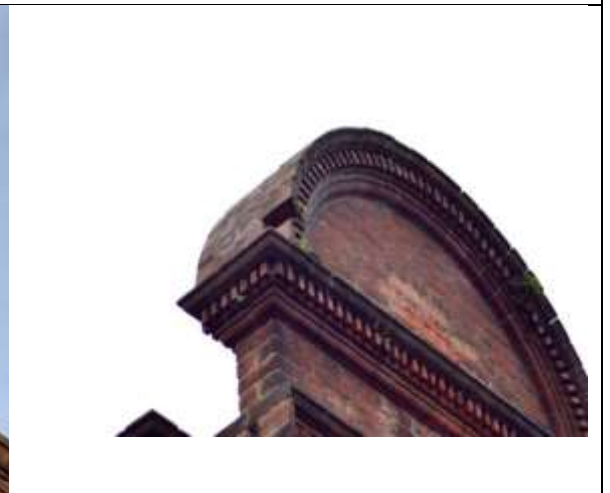
8 – Missing brickwork to high level gable parapet

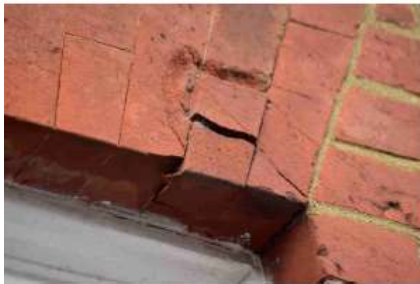
Loose and damaged bricks still in position

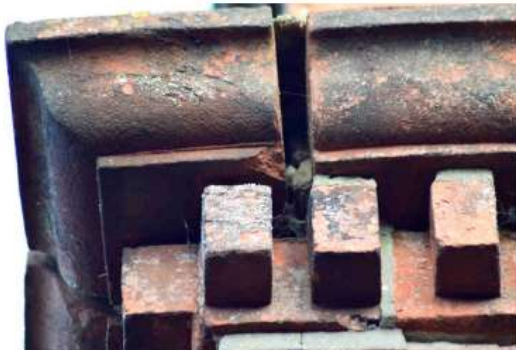
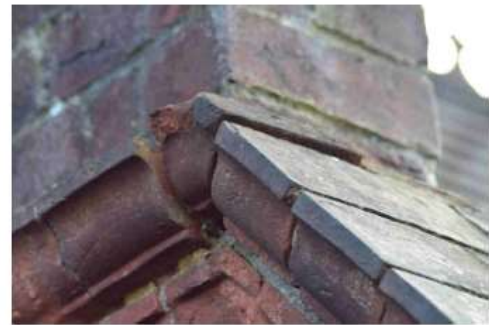
Hole left when brick fell

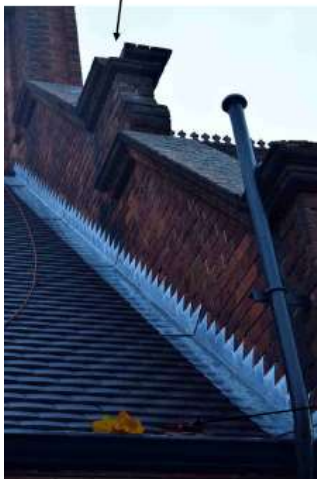
Hole in roof where brick hit and bounced off

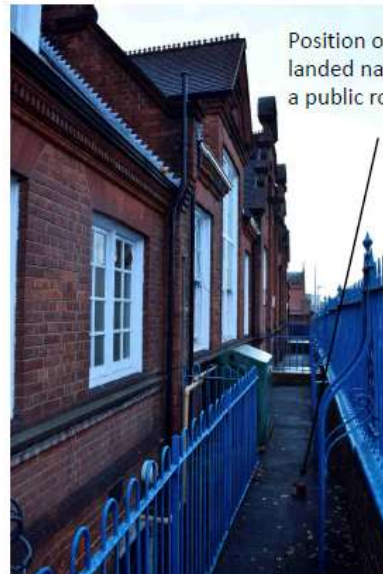
Position of brick where it landed narrowly missing a public road and footpath

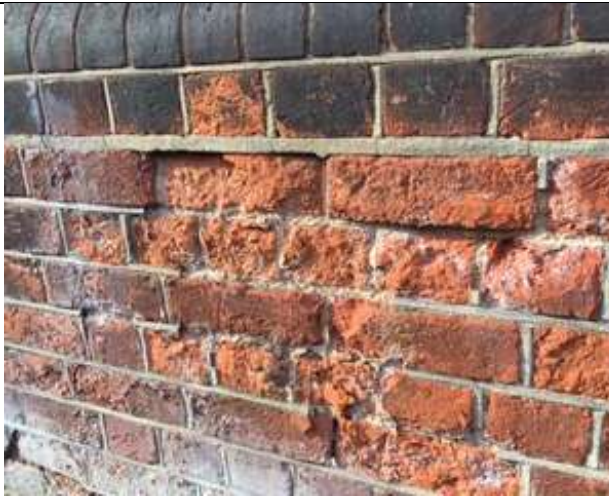
13 – Spalled brickwork

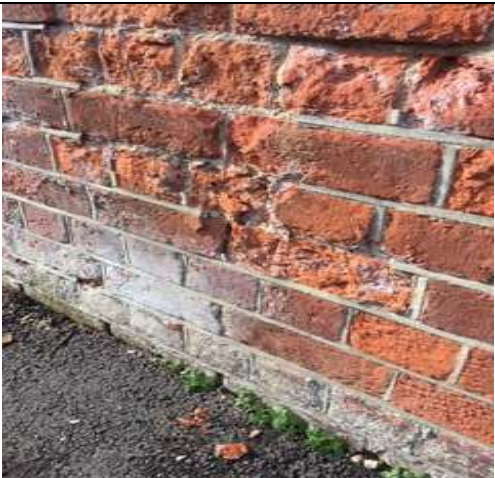
14 – Spalled brickwork

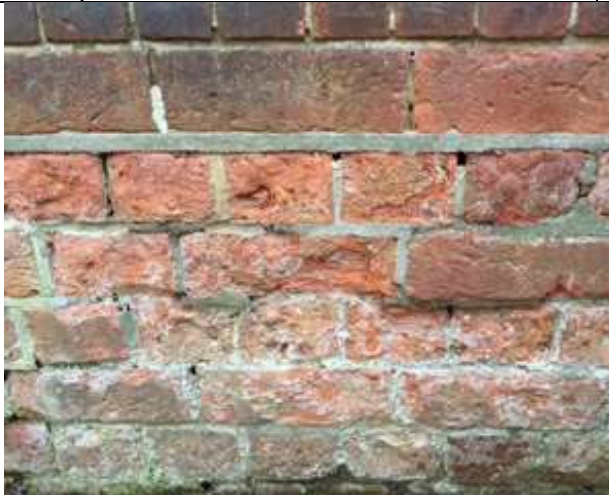
15 – Spalled brickwork

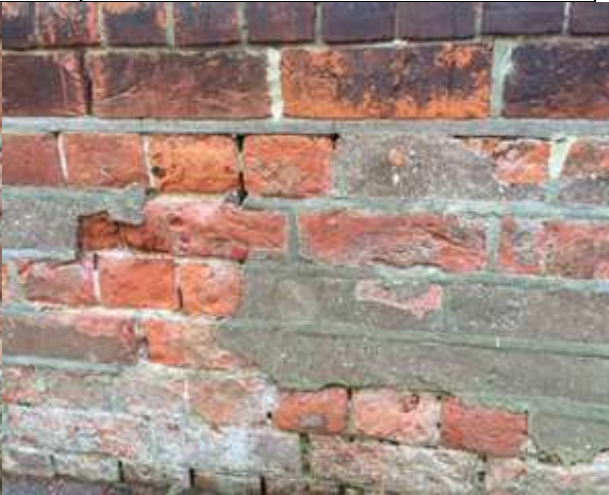
16 – Spalled brickwork

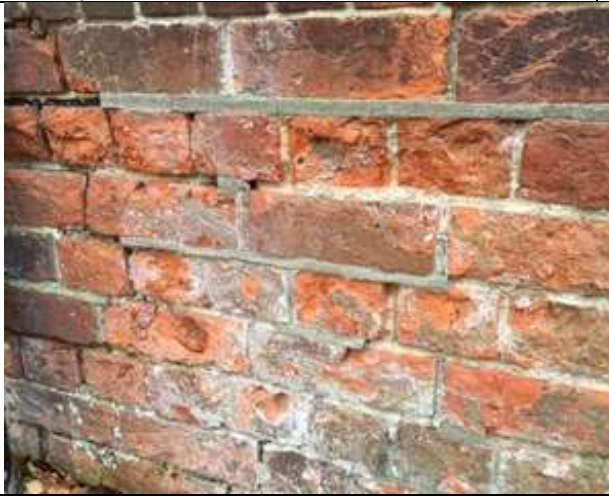
17 – Spalled brickwork

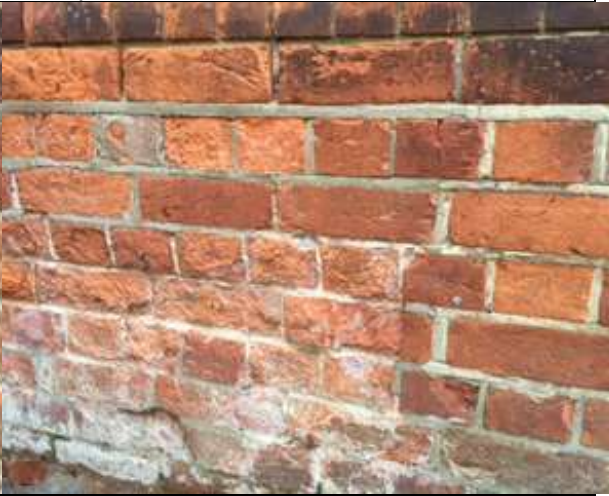
18 – Spalled brickwork

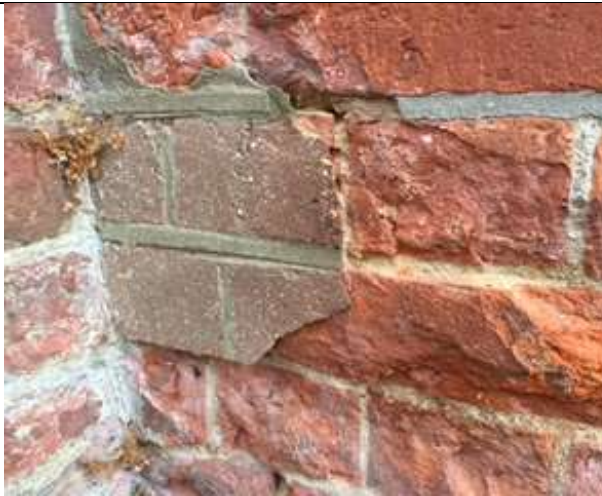
19 – Spalled brickwork that has blown the brick face

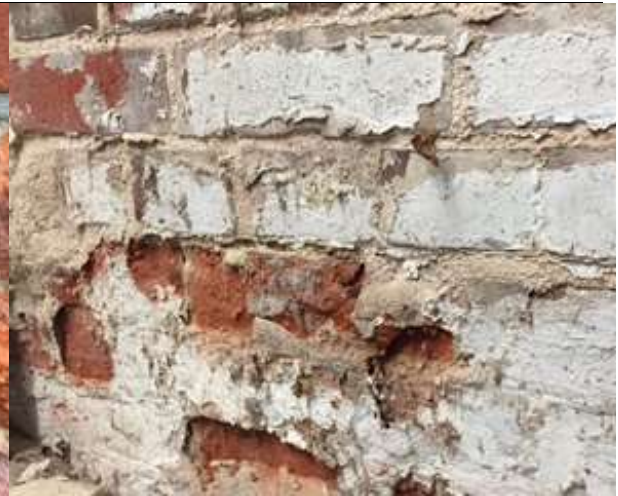
20 – Spalled brickwork increasing brick porosity

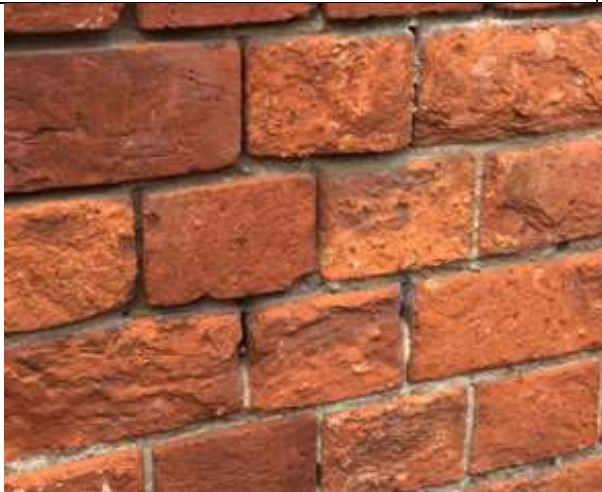
21 – Defective mortar

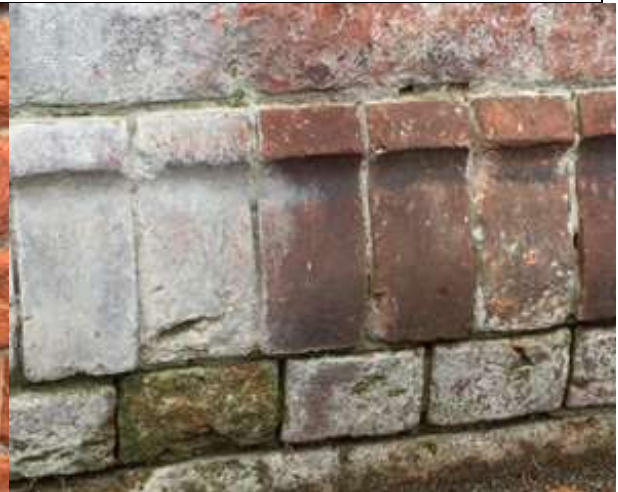
22 – Defective mortar

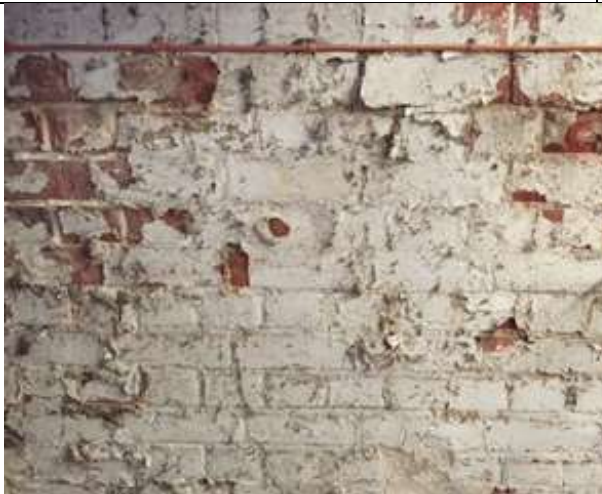
23 – Dampness to brickwork internally

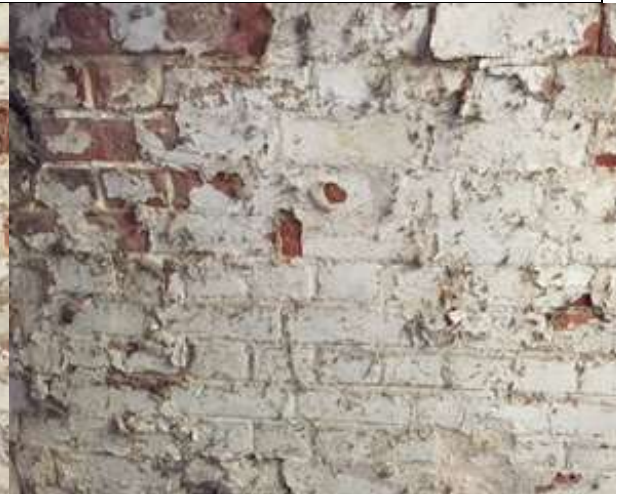
24 – Dampness to brickwork internally

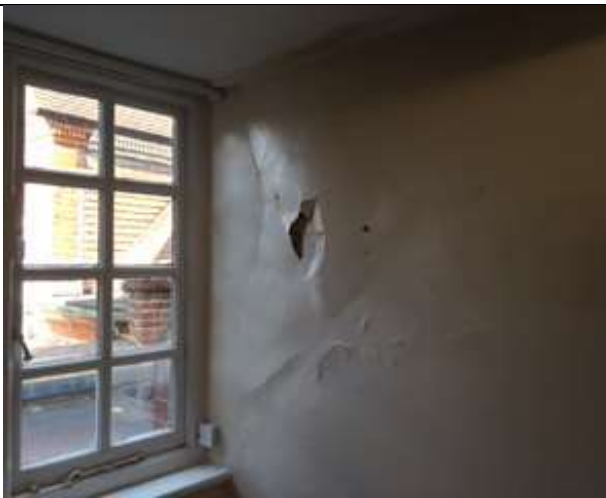
| 25 – Blown plaster internally | 26 – Blown plaster internally |

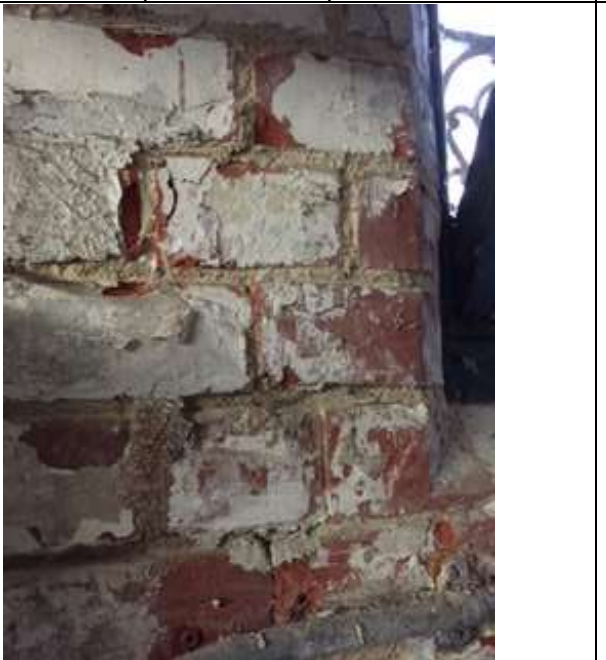
| 27 – Defective internal brickwork | 28 – Defective internal brickwork |

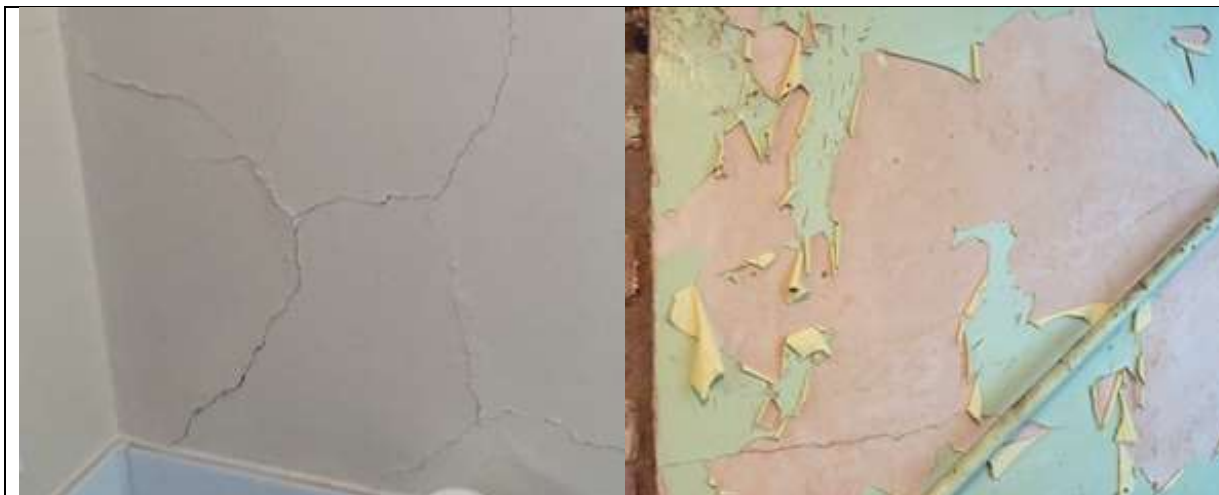
29 – Damaged plaster from water ingress

30 – Damaged plaster from water ingress
